**MINERALS PROGRAM INSPECTION REPORT**  
**PHONE: (303) 866-3567**

<b>MINE NAME:</b> Q-2	<b>MINE/PROSPECTING ID#:</b> M-2017-046	<b>MINERAL:</b> Gemstones	<b>COUNTY:</b> Teller
<b>INSPECTION TYPE:</b> Monitoring	<b>INSPECTOR(S):</b> Elliott Russell	<b>INSP. DATE:</b> August 23, 2021	<b>INSP. TIME:</b> 12:00
<b>OPERATOR:</b> Gary W Pollack	<b>OPERATOR REPRESENTATIVE:</b> Gary Pollack	<b>TYPE OF OPERATION:</b> 110(1) - Hard Rock Limited Impact

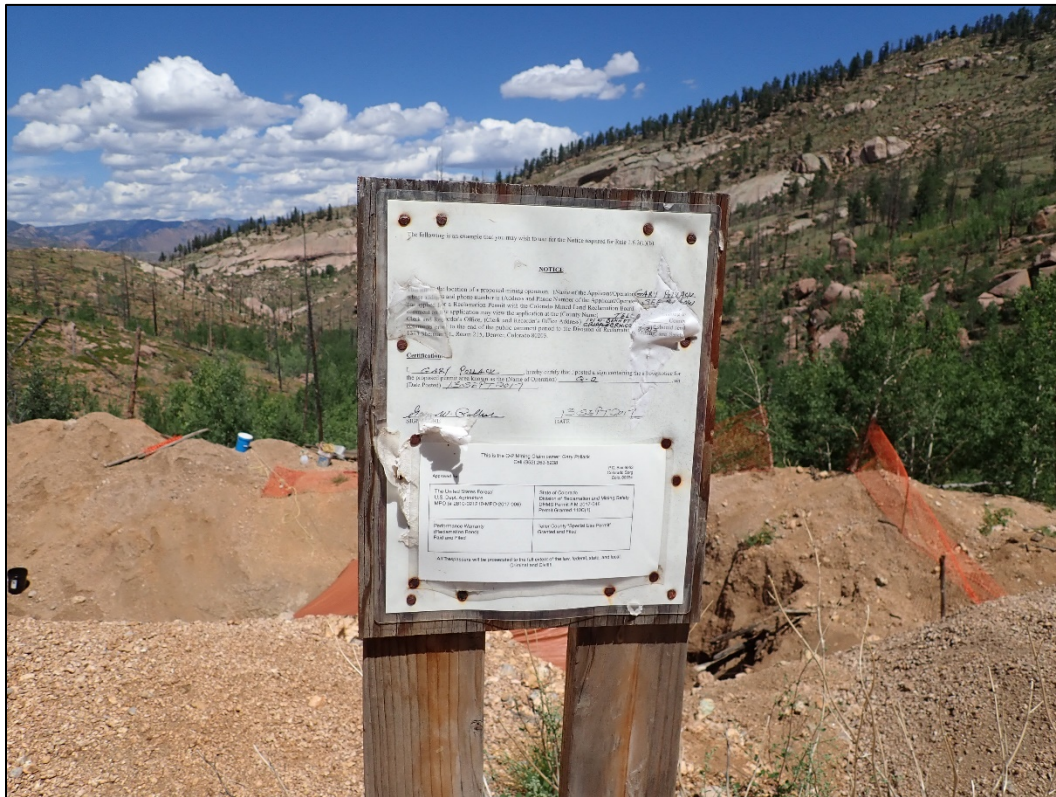
**COMPLIANCE PROBLEM #1:** The mine identification sign was not posted at the entrance of the mine site. This is a problem for failure to post a mine identification sign as required by Rule 3.1.12(1).

Signs and Markers: The permit boundary was delineated by markers. A sign was posted on the southwest side of the dig, however this sign is the 110(1) application notice and a small list of approved permits. The Division discussed with the Operator that this would be cited as a compliance problem within the inspection report, requiring the Operator post a sign in accordance with Rule 3.1.12(1). On September 1, 2021 the Operator emailed a photo showing a new permit identification sign had been posted. The Division considers this compliance problem resolved.

**Photo 1.** Posted sign; looking north.

**CORRECTIVE ACTIONS:** The Operator shall, at the entrance of the mine site post a sign, which shall be clearly visible from the access road, with a minimum size equaling one hundred and eighty-seven (187) square inches, such as eleven (11) inches in height and seventeen (17) inches in width, with appropriate font size, with the following: the name of the Operator, a statement that a reclamation permit for the operation has been issued by the Colorado Mined Land Reclamation Board; and the permit number. The Operator shall submit photo documentation that a proper sign has been posted by the corrective action date.

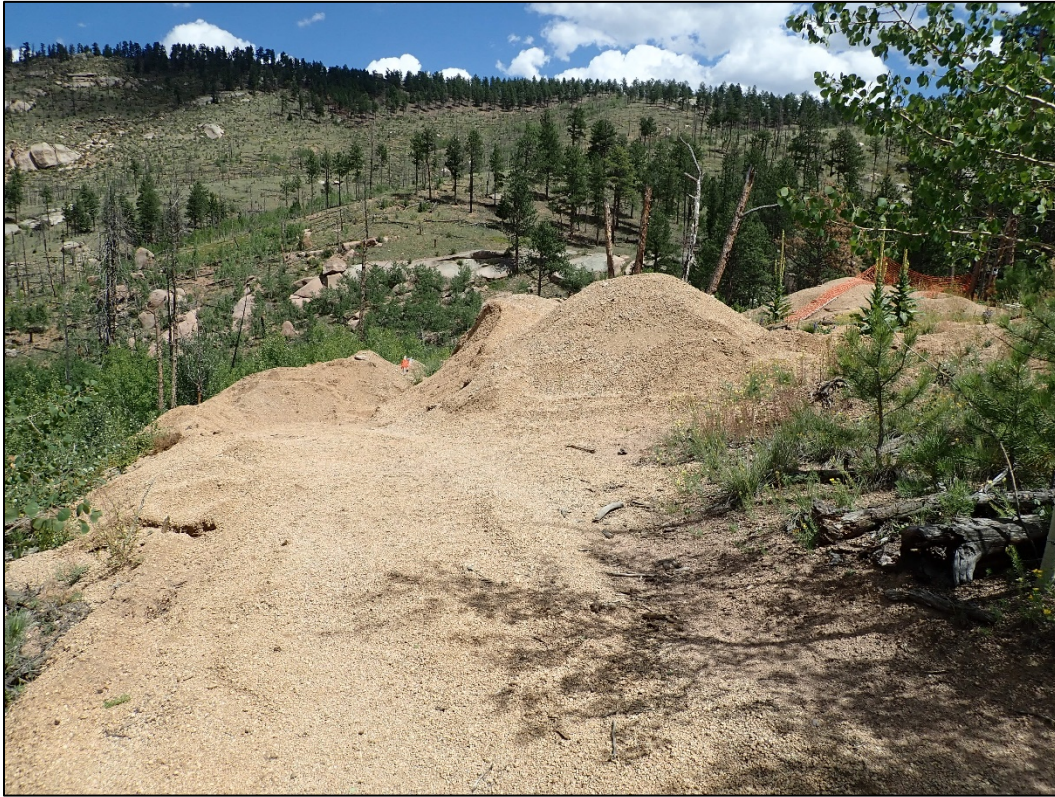
**Photo 2.** Northwest portion of dig site with access trail (left) leading down into the dig; looking east.

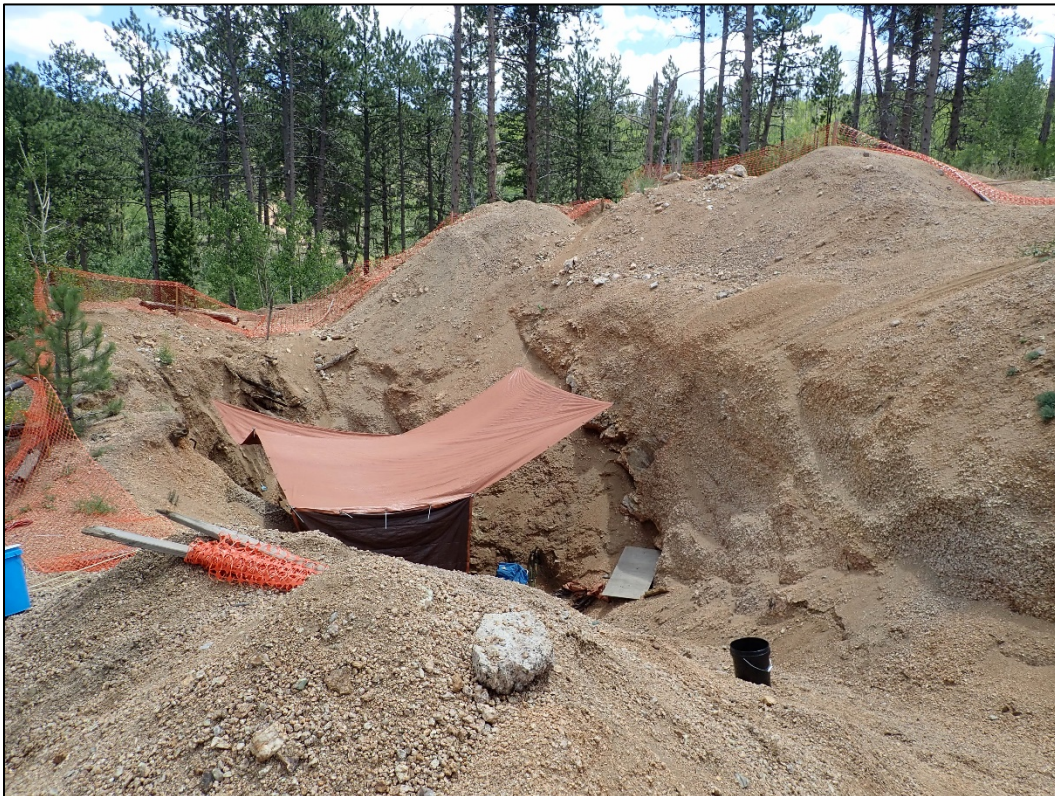
**Photo 3.** Dig site overview; looking south.

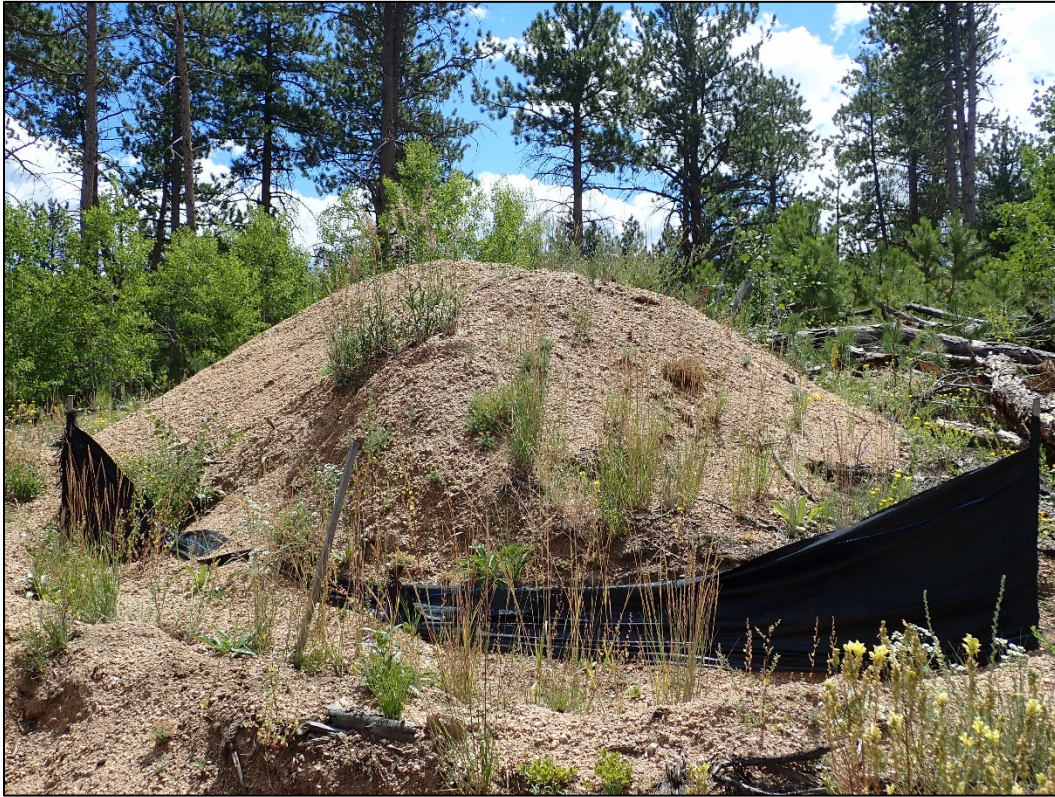
**Photo 4.** Topsoil stockpile; looking south.

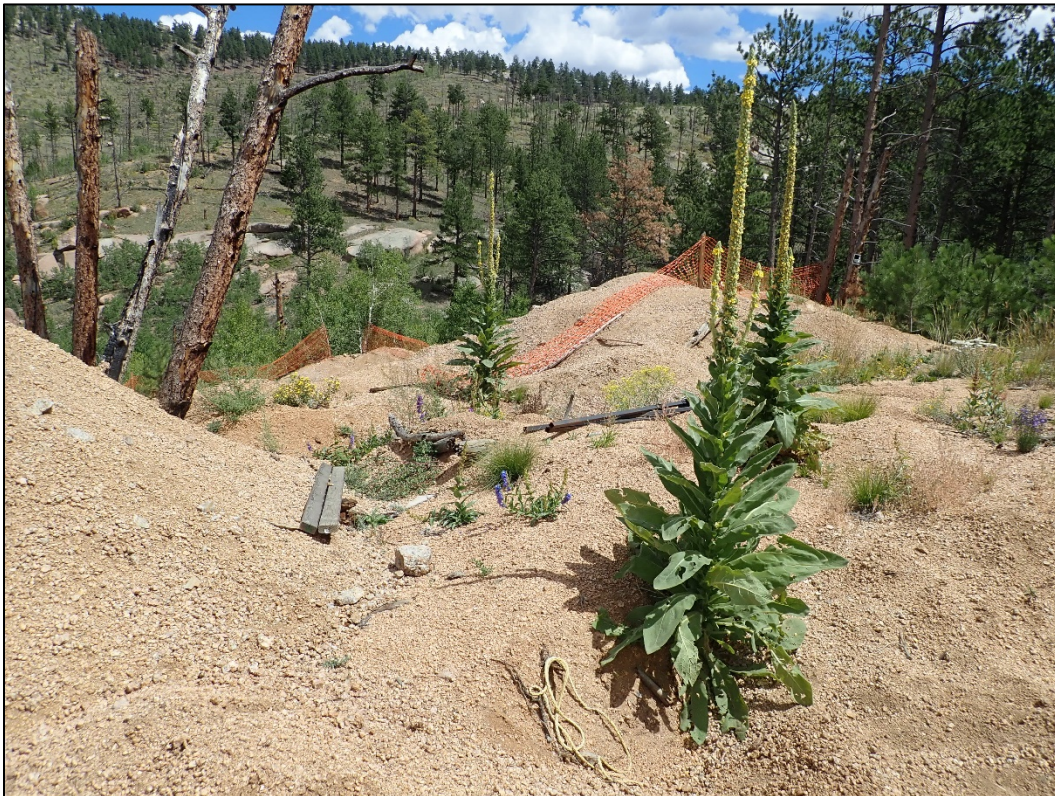
**COMPLIANCE PROBLEM #2:** There are state-listed noxious weeds present on site. This is a problem for failure to employ weed control methods for state listed noxious weed species within the permitted area, and to reduce the spread of weeds to nearby areas as required by Rule 3.1.10 (6).

Revegetation: The Division observed common mullein, a List C noxious weed, and yellow toadflax, a List B

**Photo 5.** Common mullein (List C noxious weed); looking east.

**CORRECTIVE ACTIONS:** Implement approved weed control plan and provide proof to the Division that this has been done.

noxious weed, on site during the inspection. The Division discussed with the Operator that this would be cited as a compliance problem within the inspection report, requiring the Operator to treat the noxious weeds in accordance with Rule 3.1.10(6). On September 1, 2021 the Operator emailed photos showing the common mullein had been dug up and removed from the site. On September 14, 2021, the Operator submitted photos of herbicide treatment on the yellow toadflax. The Division considers this compliance problem resolved. The Operator should monitor the site to ensure effective treatment of these noxious weeds has occurred.

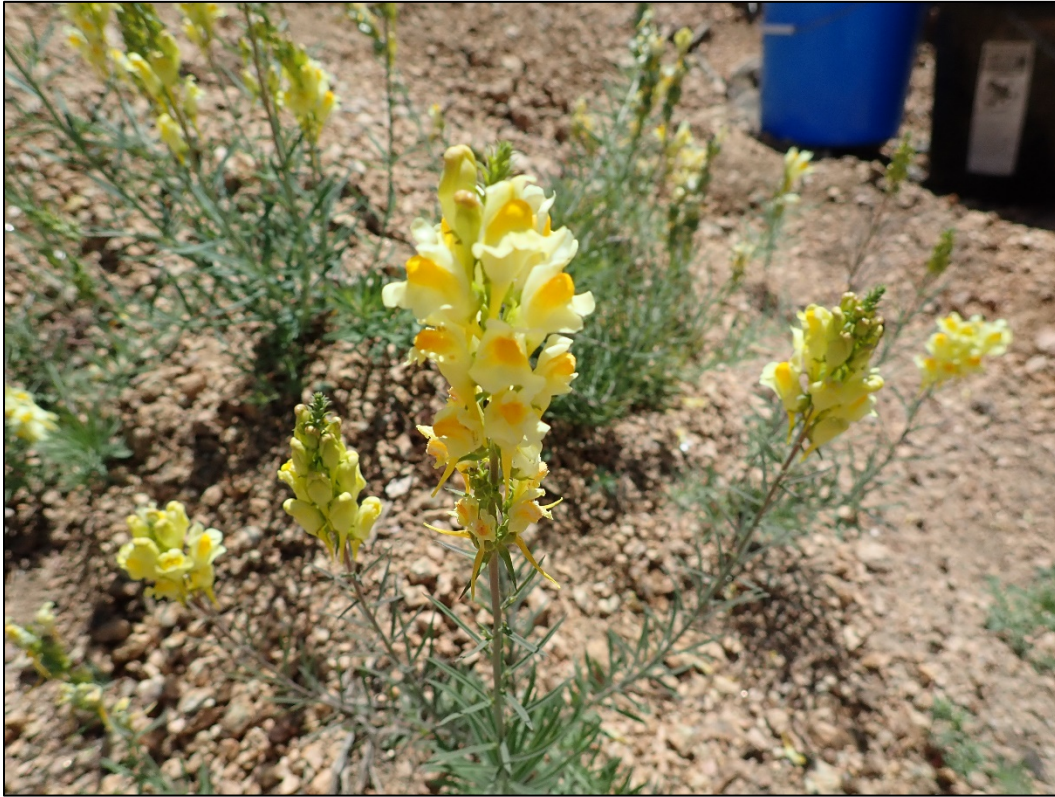
**Photo 6.** Yellow toadflax (List B noxious weed); looking south.
