**Daniels Sand Pit 2, Permit No. M-1973-007-SG: Monthly Monitoring Report**

March 11, 2022  
Project No.: 19125

Regarding: Daniels Sand Pit 2, Permit No. M-1973-007-SG  
Slope Stability Monthly Monitoring Report

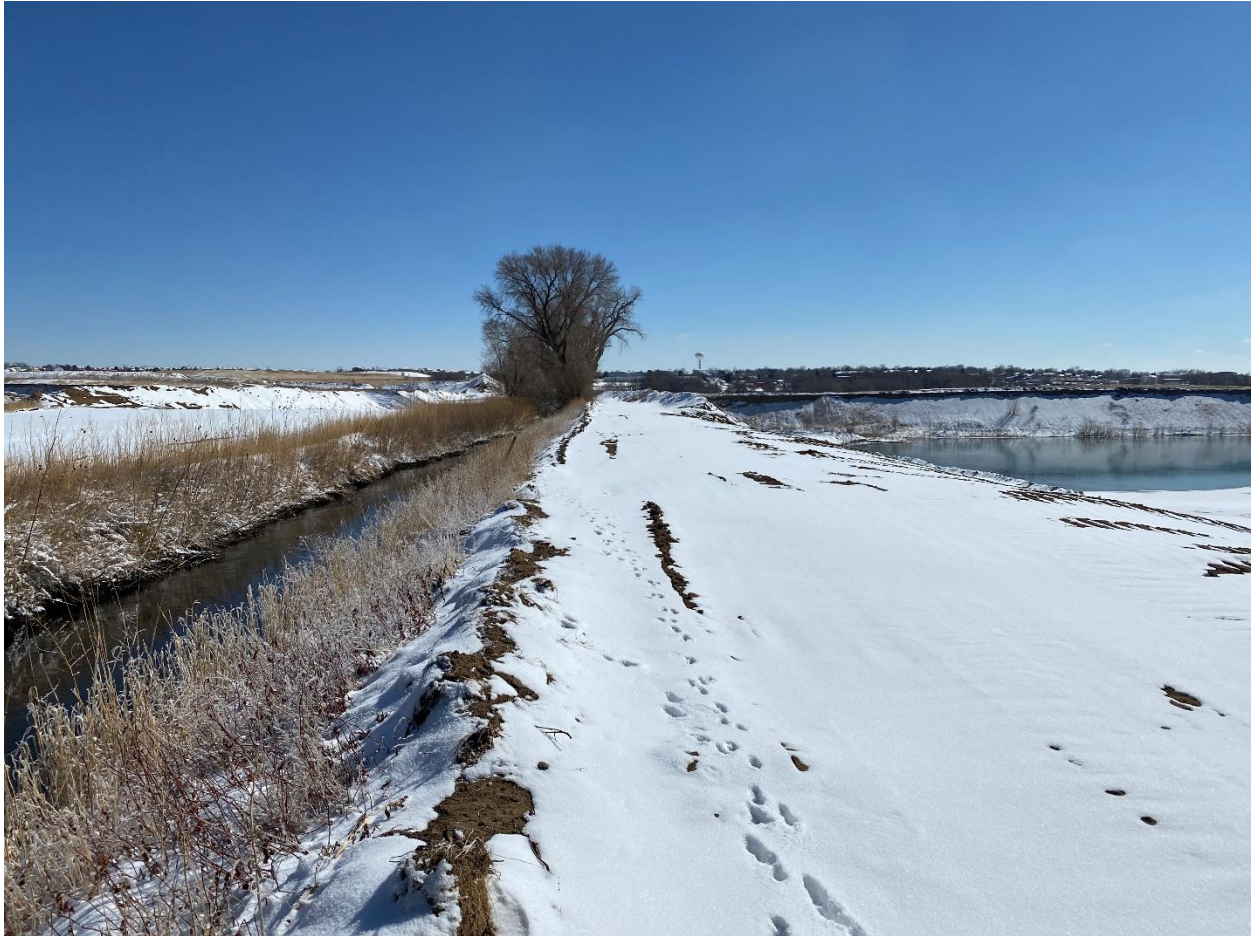
- Weather: 18-33°, sunny, winds 5-10 mph, snow cover
- Visual observation of the Fountain Mutual Ditch:
  - No tension cracks
  - No toe erosion that was visible due to the presence of water
  - Water flowing, approximately 3 feet deep
  - No sloughed slope surfaces
  - Several broken branches near crest
  - The condition of the ditch is stable

Photo 1. Fountain Mutual Ditch looking east with buttress slope

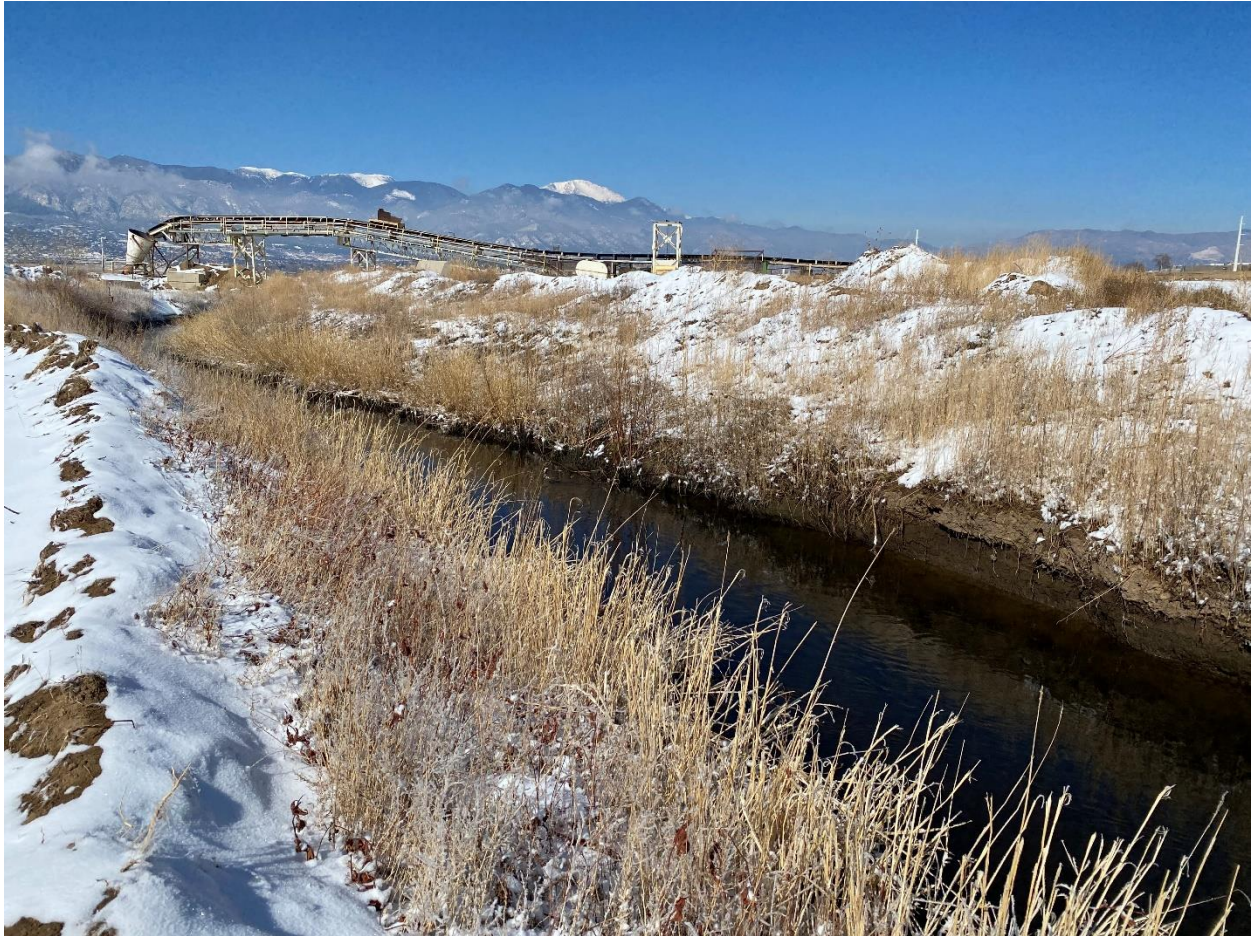
Photo 2. Fountain Mutual Ditch looking west

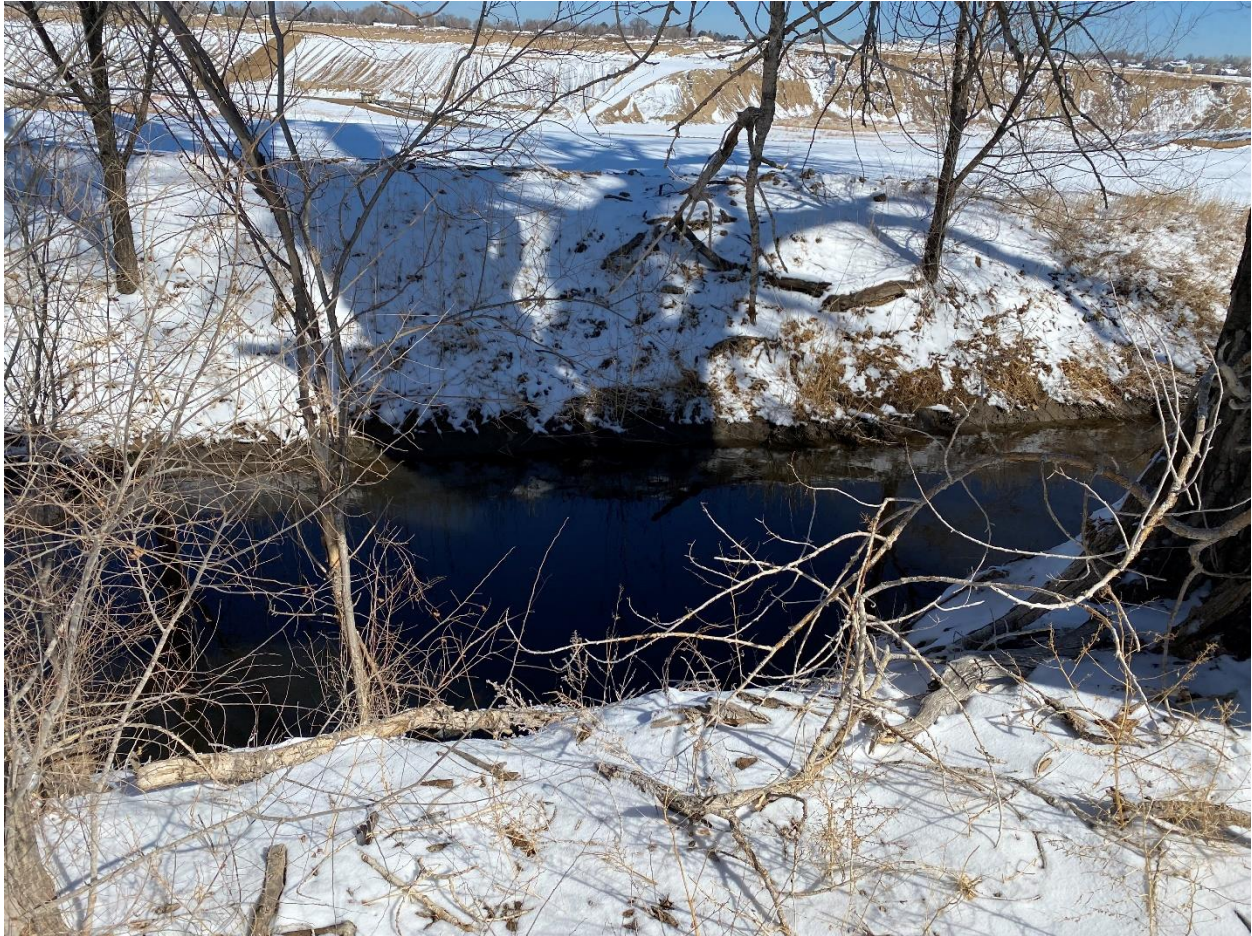
Photo 3. Fountain Mutual Ditch looking north

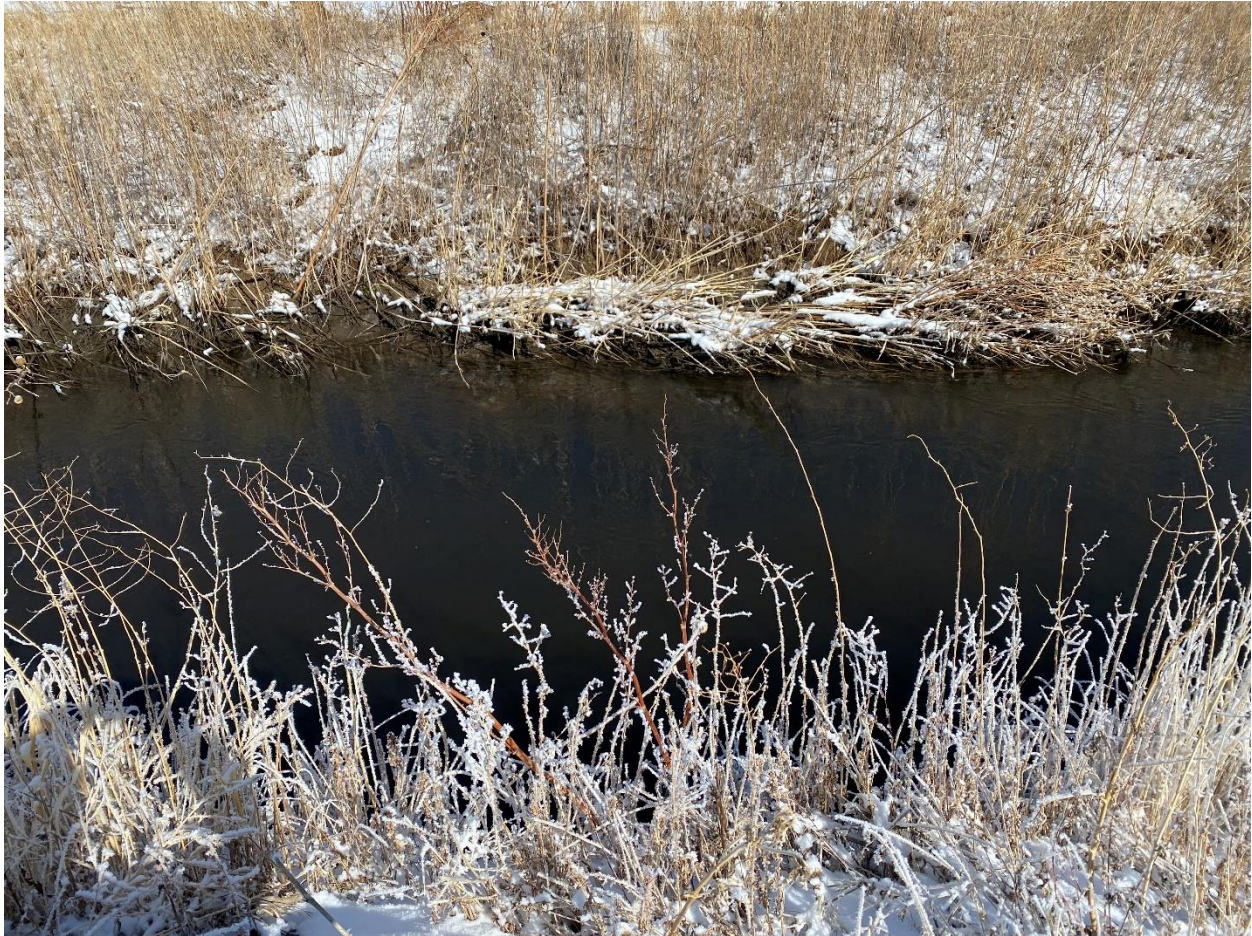
Photo 4. Fountain Mutual Ditch invert with water

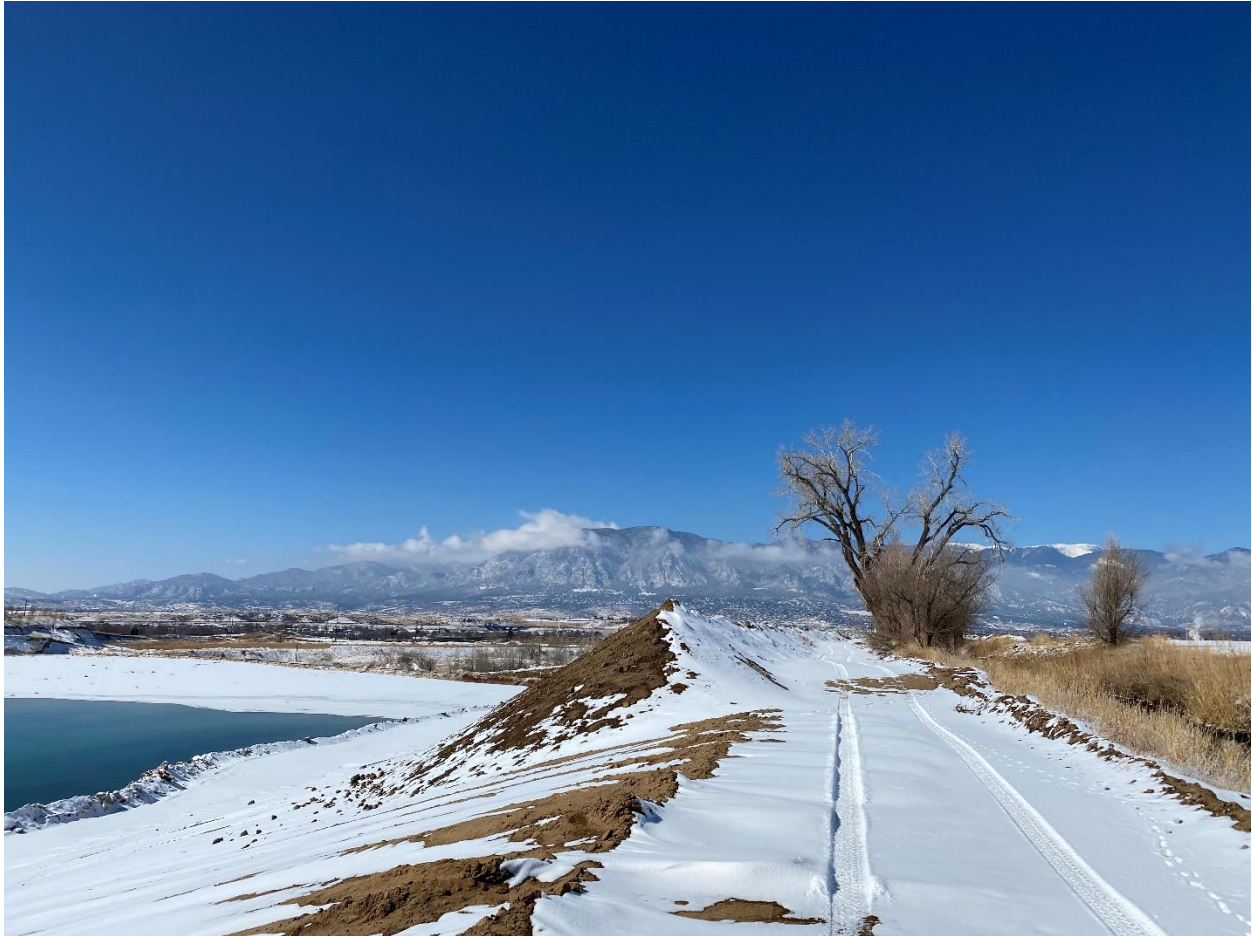
- Construction sequence
  - At this time, the buttress slope varies from 3H:1V to 4H:1V
  - Approximately 110 LF (from the west) has been placed for the final lift, slope is approximately 3H:1V
  - Stockpiled sand located at the crest of the embankment for the remainder of the length in preparation for the final lift, some snow cover on the stockpiles

Photo 5. Stockpiled sand for final lift, access road and ditch (looking west)

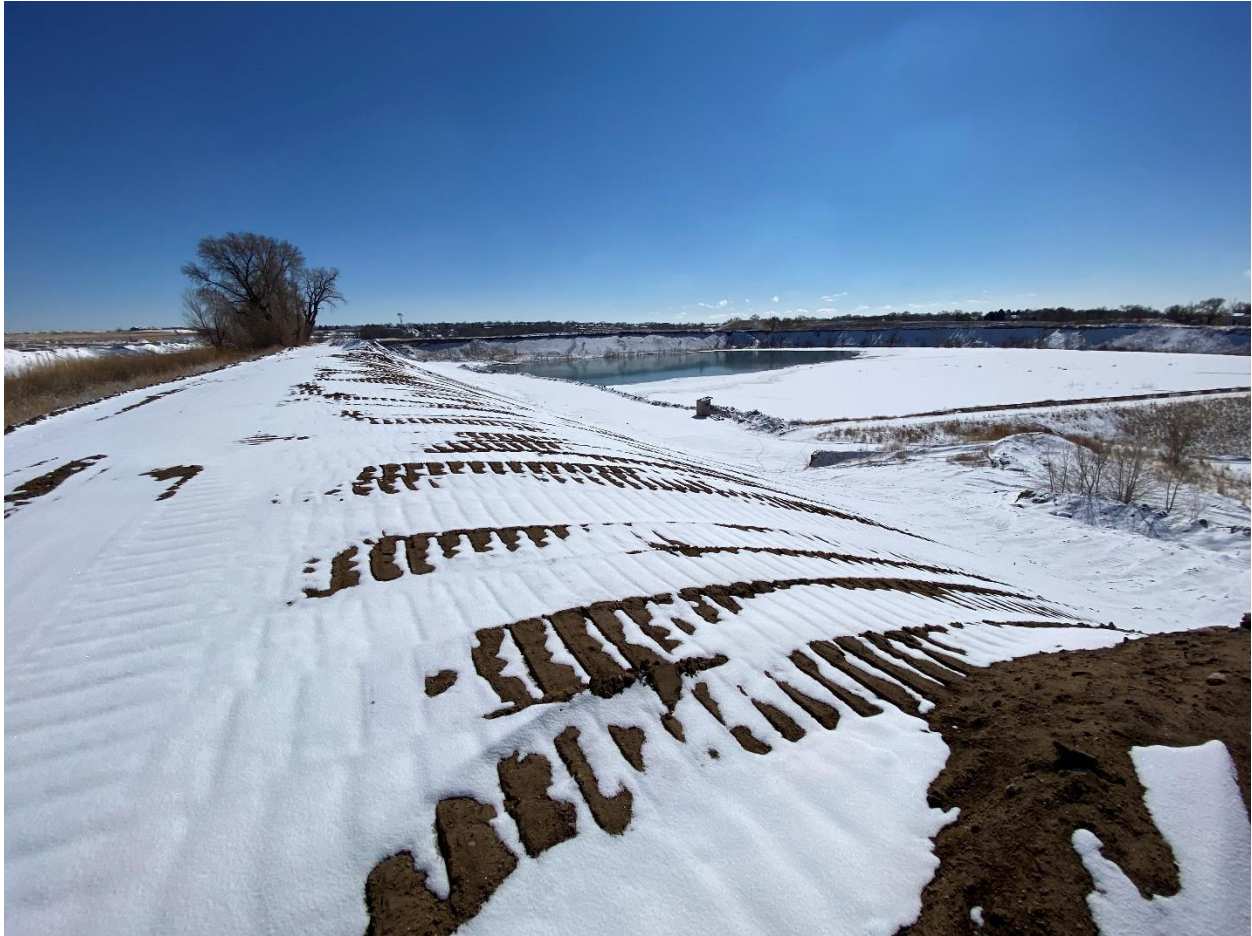
Photo 6. Buttress slope looking east

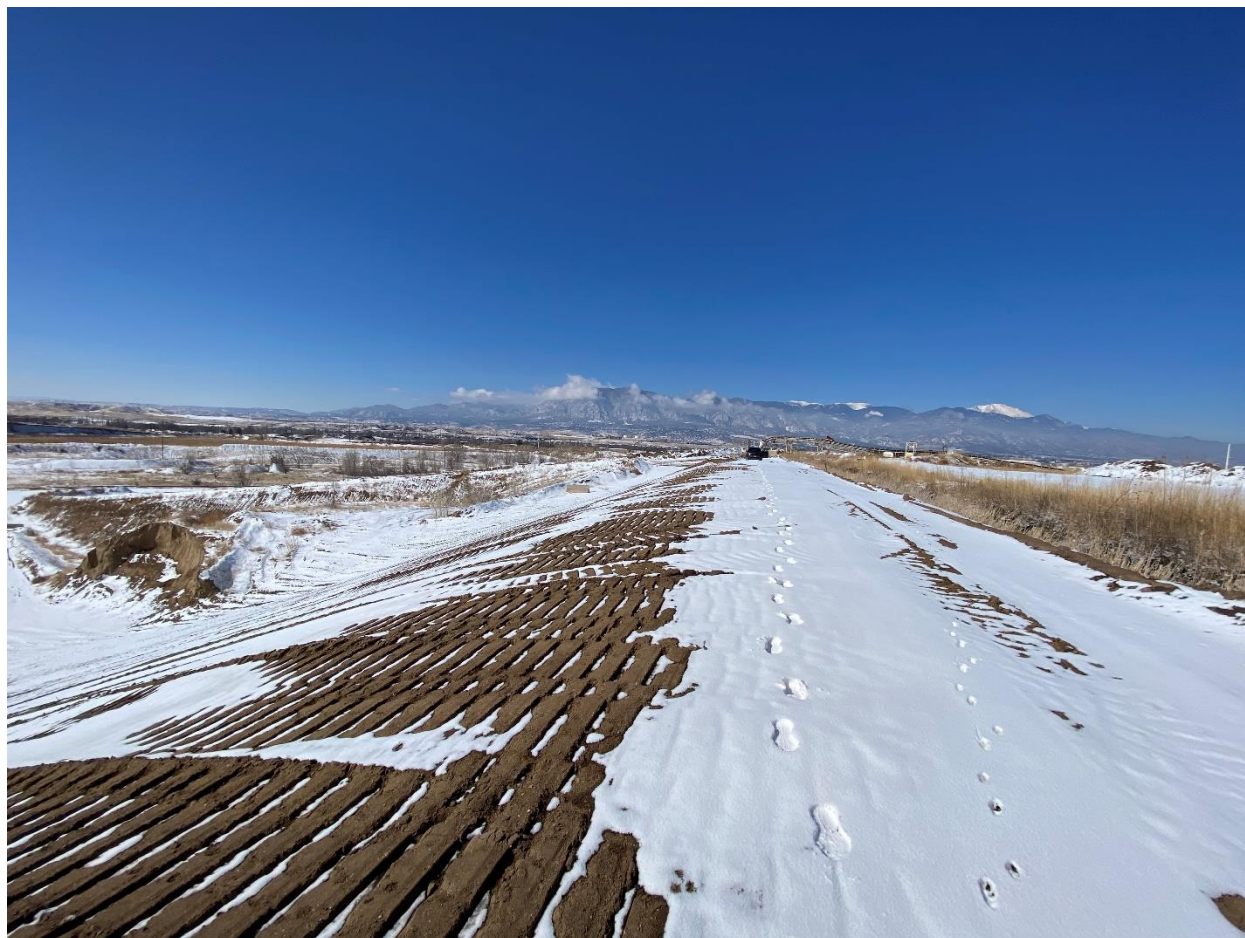
Photo 7. Buttress slope looking west

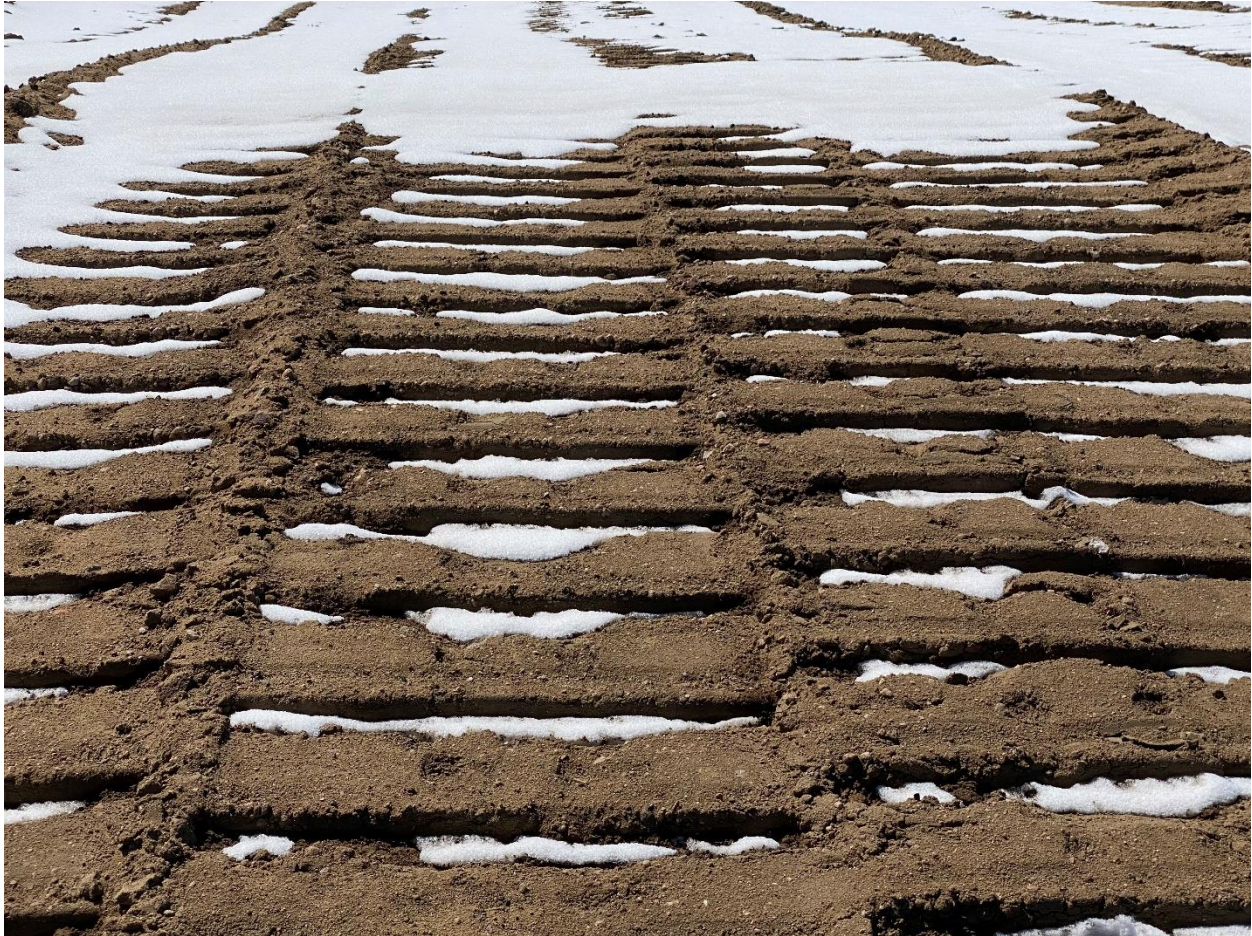
Photo 8. Buttress slope looking south (zoomed in)

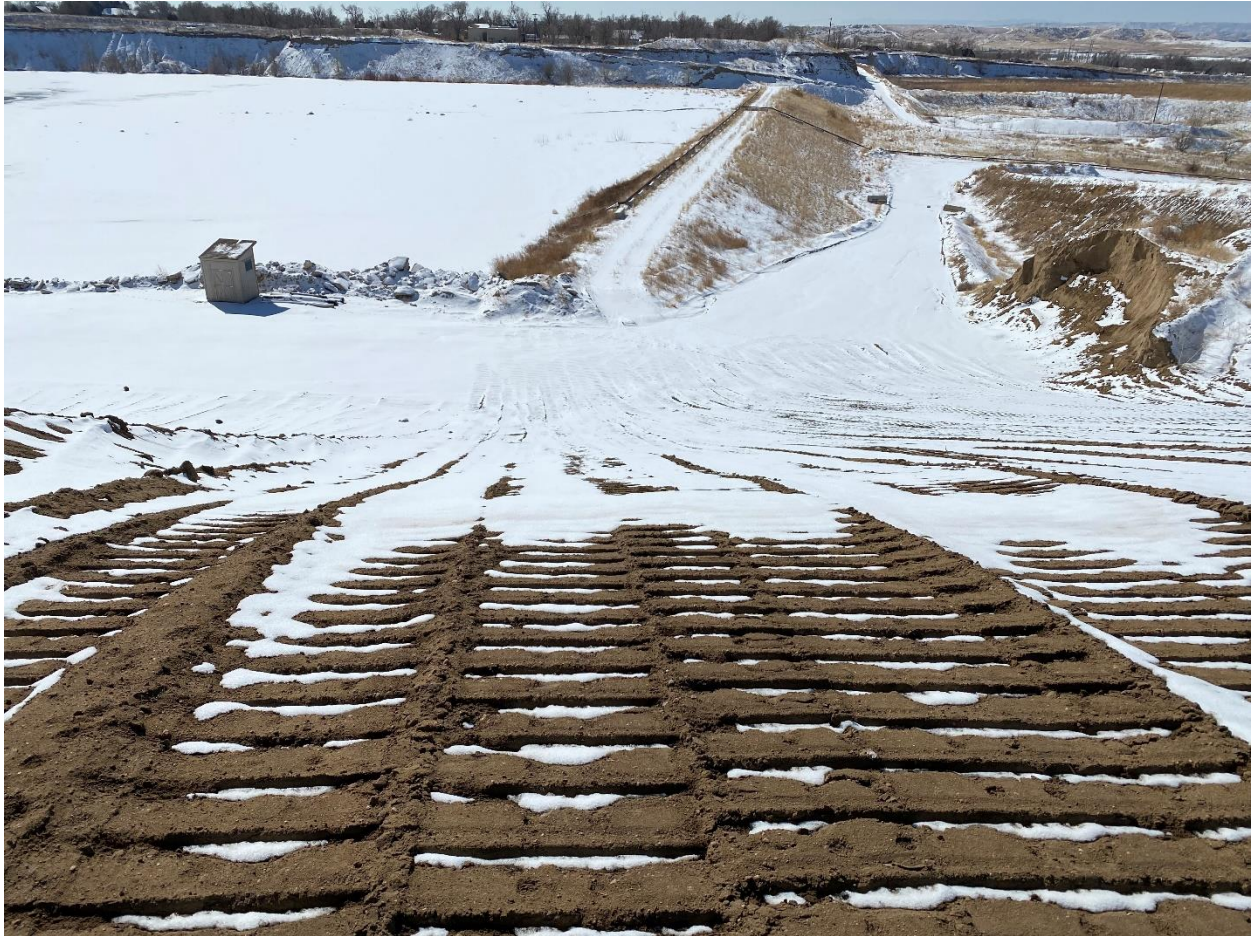
Photo 9. Buttress slope looking south
