## New Elk Mine, C-1981-012, Inspection Report

**PERMIT INFORMATION**

<b>Permit Number:</b> C-1981-012 <b>Mine Name:</b> New Elk Mine <b>Operator:</b> New Elk Coal Company, LLC <b>Operator Address:</b> Mr. Mark Gray 12250 Highway 12 Weston, CO 81091	<b>County:</b> Las Animas <b>Operation Type:</b> Underground <b>Permit Status:</b> Active <b>Ownership:</b> Private
	<b>Operator Representative Present:</b>  Vince Massarotti
<b>Operator Representative Signature: (Field Issuance Only)</b>

<b>Inspection Start Date:</b> March 15, 2022 <b>Inspection Start Time:</b> 09:40 <b>Inspection End Date:</b> March 15, 2022 <b>Inspection End Time:</b> 12:15		<b>Inspection Type:</b> Coal Partial Inspection <b>Inspection Reason:</b> Normal I&E Program <b>Weather:</b> Clear	
<b>Joint Inspection Agency:</b>  None		<b>Joint Inspection Contacts:</b>	
<b>Post Inspection Agency:</b>  None		<b>Post Inspection Contacts:</b>	
<b>Inspector(s):</b>  Jared Ebert	<b>Inspector's Signature:</b>

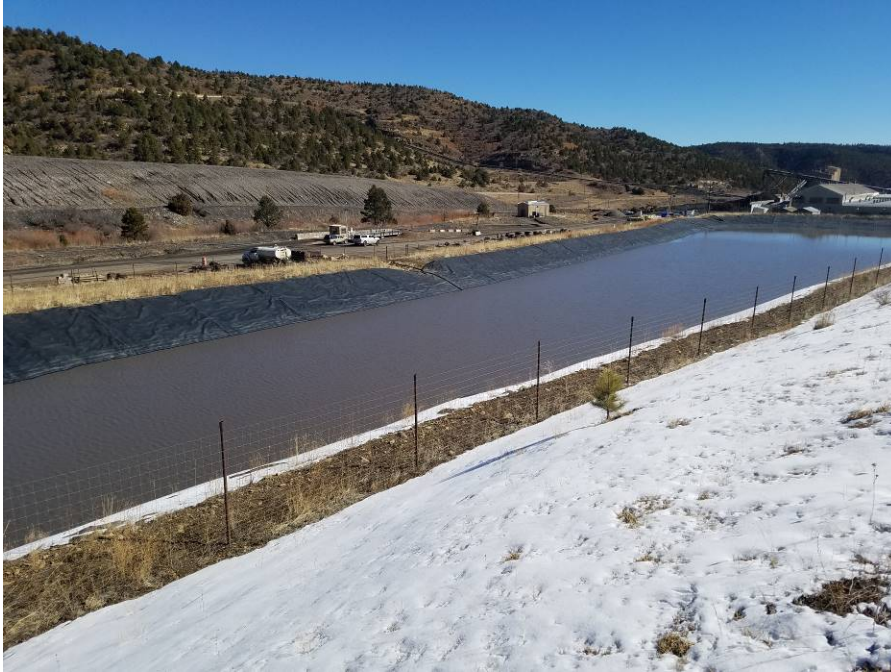
Pond 001a was holding water but was not discharging. The embankment was stable and vegetated. The new pump installed at the northeast corner of the pond was leaking slightly. The primary and emergency spillway was clear and functional.

Figure 1. Pond 001a

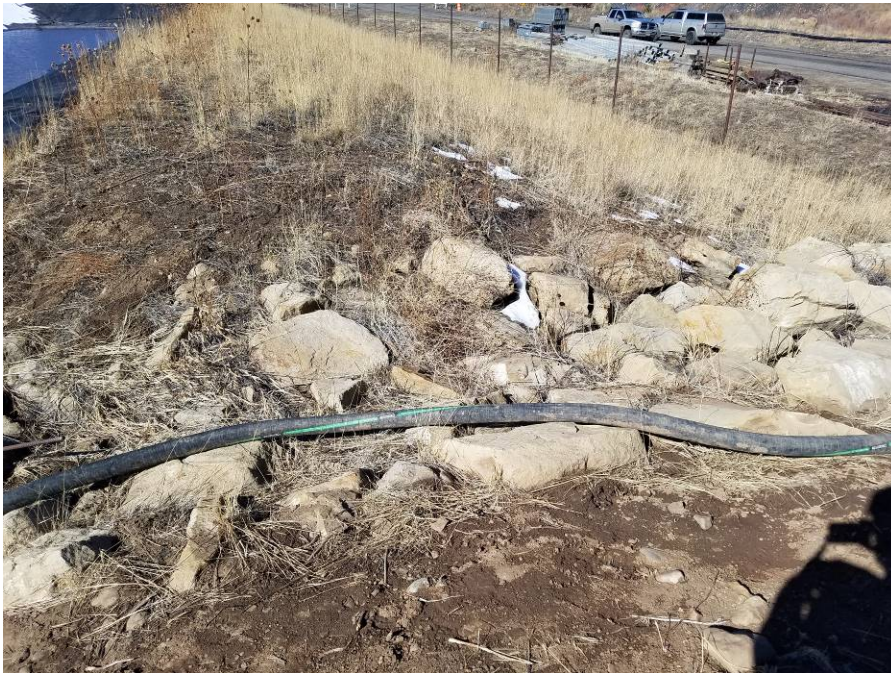
Figure 2. From emergency spillway of Pond 001a looking west.

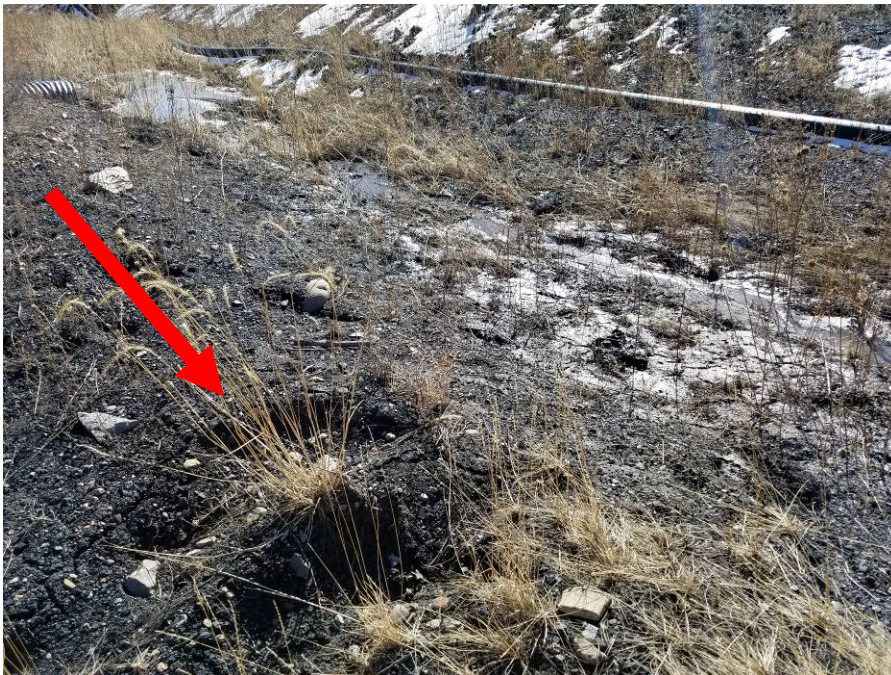
The sediment control ditching was walked from where culvert C-19 discharges to ditch D15 to where the water discharges to Pond 007a. Overall this ditch is clear and functional, but several areas were noted to have more sediment built up in the ditch and where the outer embankment of the ditch is less robust and slightly eroded. For example, **just west of culvert C13 the sediment is built up in ditch D15 and the embankment of the ditch appears to be slightly eroding on the north side. NECC should repair this area to insure mine water does not over-top the ditch and discharge into the river without treatment.**

*Figure 3. Ditch D15, location of where sediment built-up was noted. Erosion on the out-slope of the ditch embankment is noted with a red arrow above.*

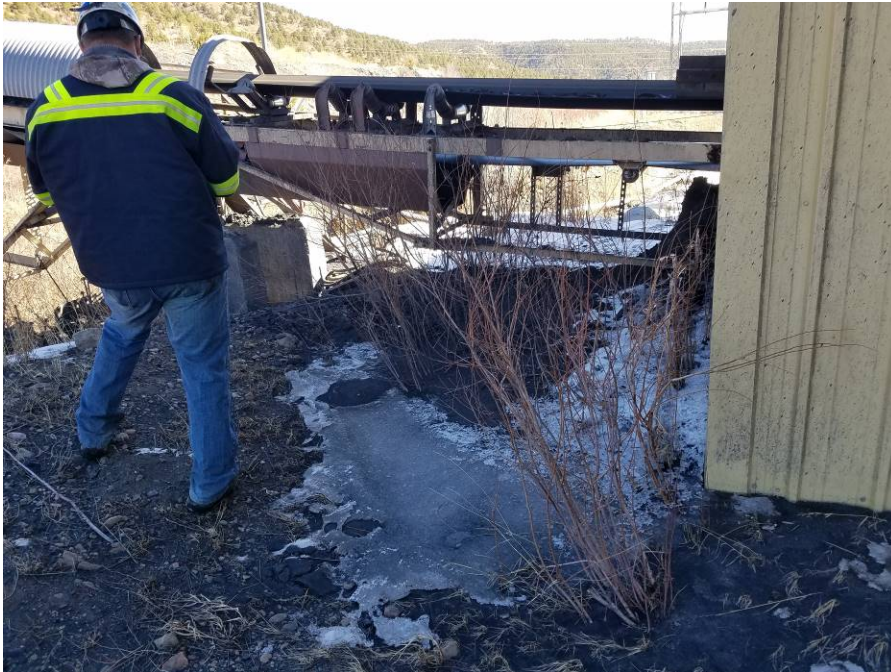
NECC appears to have previously placed hay bales and other sediment control devices to catch sediment and water from a small area north of the wash plant just under and adjacent to where the conveyor exits the plant. These hay bales were largely disintegrated and no longer functional. Water in the area is frozen. Mr. Massarotti indicated once the water has melted he plans to dig a small ditch in this location to direct water into the ditch that flows to Pond 007a and will also install sediment control devices, possibly hay bales, at this location again. **NECC must re-establish proper drainage in this area and install these sediment control devices.**

*Figure 4. Maintenance needed at this location just north of the wash plant. Sediment control devices need installation and water drainage needs to be improved.*

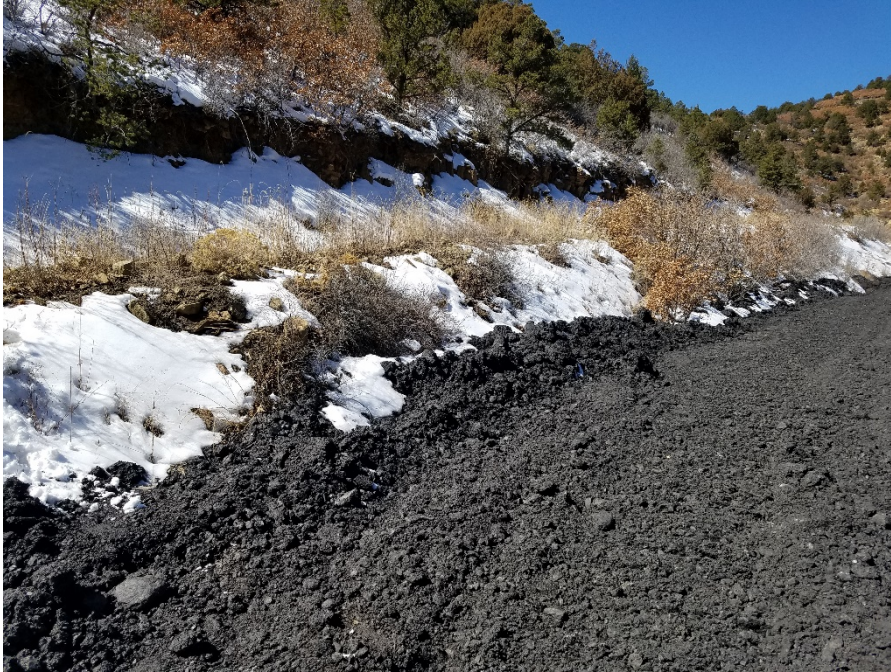
Ditch D55 was observed, no problems were noted. Coal waste is being placed very close to the southwest portion of ditch D55. Mr. Massarotti indicated that waste will not be placed any closer to the ditch at this location and will be off-set from the ditch and sloped to tie into the final slope face of the current upper lift of waste material.

*Figure 5. Waste being placed adjacent to ditch D55 on the southwest side of the RDA.*

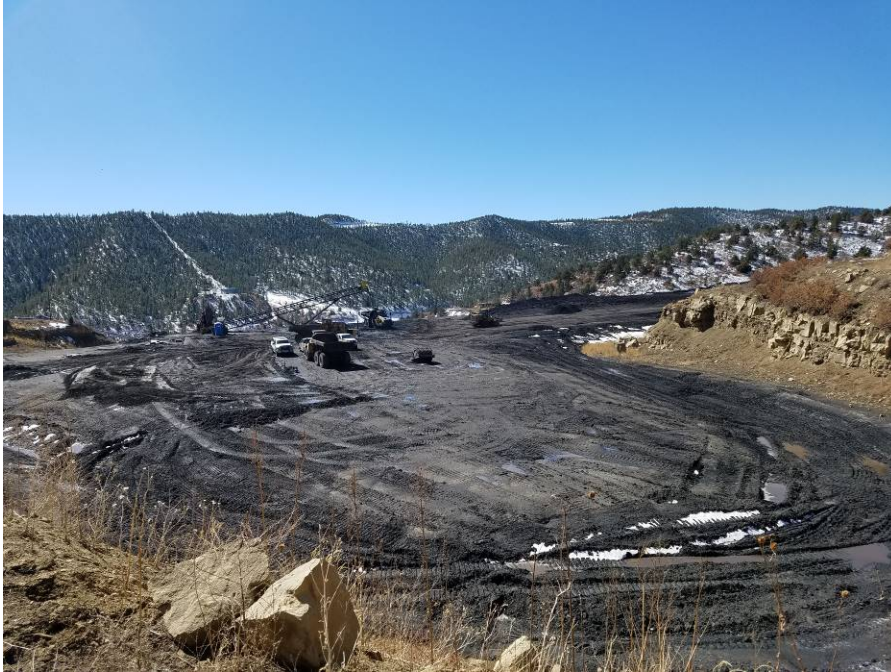
*Figure 6. RDA from the northeast side looking southwest.*

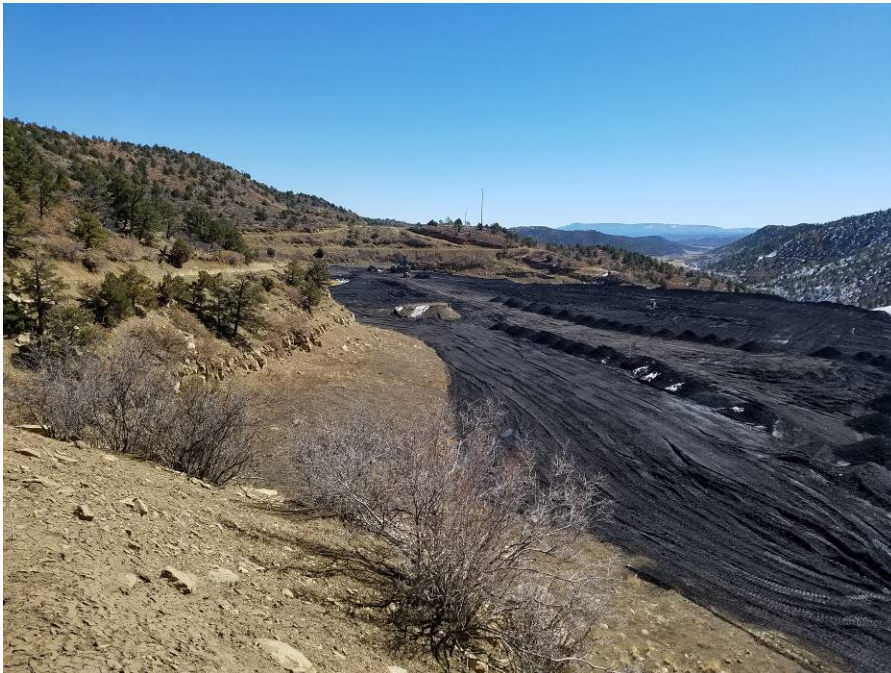
*Figure 7. RDA from the northwest end looking southeast.*

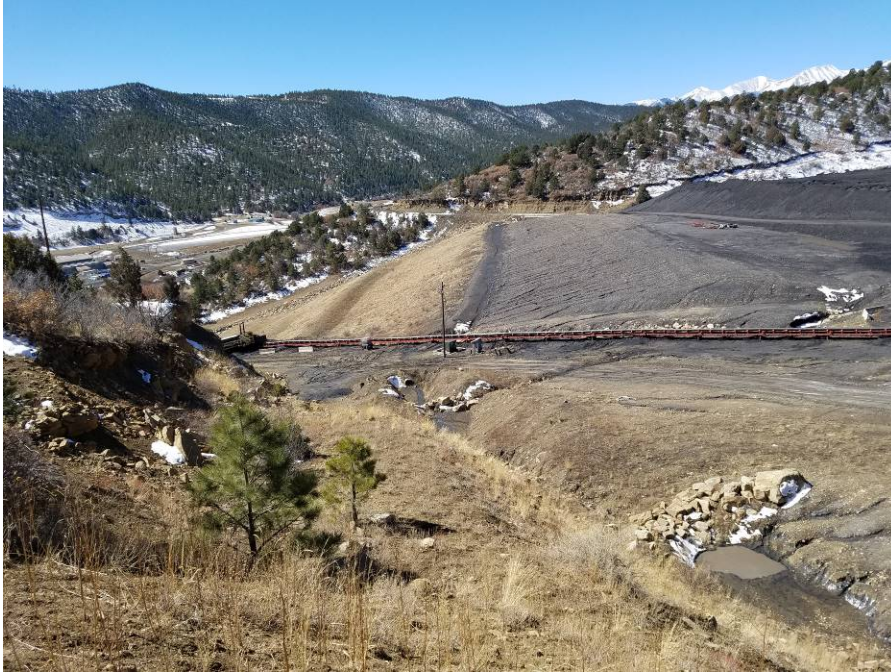
*Figure 8. From the east end of the RDA looking west.*
