## Lorencito Canyon Mine, C-1996-084, Inspection Report

**PERMIT INFORMATION**

<b>Inspection Start Date:</b> March 15, 2022 <b>Inspection Start Time:</b> 12:30 <b>Inspection End Date:</b> March 22, 2022 <b>Inspection End Time:</b> 14:30		<b>Inspection Type:</b> Coal Partial Inspection <b>Inspection Reason:</b> Normal I&E Program <b>Weather:</b> Clear	
<b>Joint Inspection Agency:</b>  None		<b>Joint Inspection Contacts:</b>  None	
<b>Post Inspection Agency:</b>  None		<b>Post Inspection Contacts:</b>  None	
<b>Inspector(s):</b>  Jared Ebert	<b>Inspector's Signature:</b>

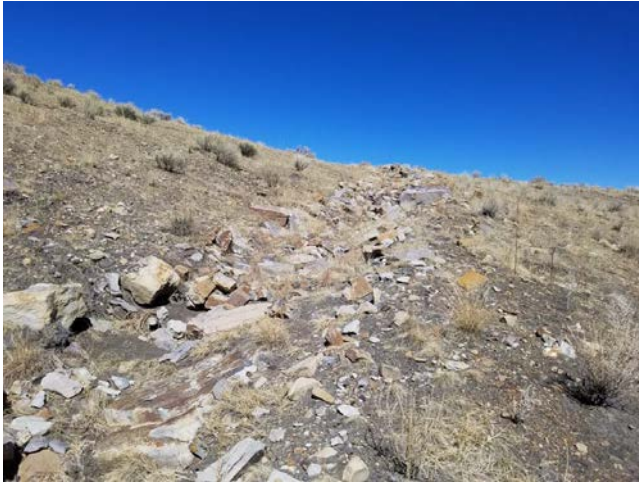
The reclaimed area around the Knob was observed. The areas above ditches D2, D14, D11 and D5 have sparse vegetation established in some areas and these areas have a number of rills and gullies that have developed. The area reported to have been reclaimed in 2006 and 2005 above the area where pond and ditch cleanings are being stored was observed as well. This area has sparse vegetation established and the area has a significant number of rills and gullies that have formed. NECC has placed straw waddles on this slope and have placed brush in most of the rills. It appears elk and wildlife have heavily used this area and have damaged the waddles. The brush does seem to help prevent the rills from growing, and the brush seems to catch and hold soil and growth medium. These areas were discussed with Vince Massarotti and NECC is exploring options in addressing similar rills and gullies that have formed in the reclaimed area above Pond 006a. **Given the age of the reclamation of these areas in question, NECC will need to evaluate these areas around the Knob, above the pond cleanings and above Pond 006a to determine the best methods to fill, regraded, or otherwise stabilized these areas from erosion.**

*Figure 1. Ditch D2*

Also, it is likely these areas will need to be reseeded in places given the sparse nature of the vegetation that has established.

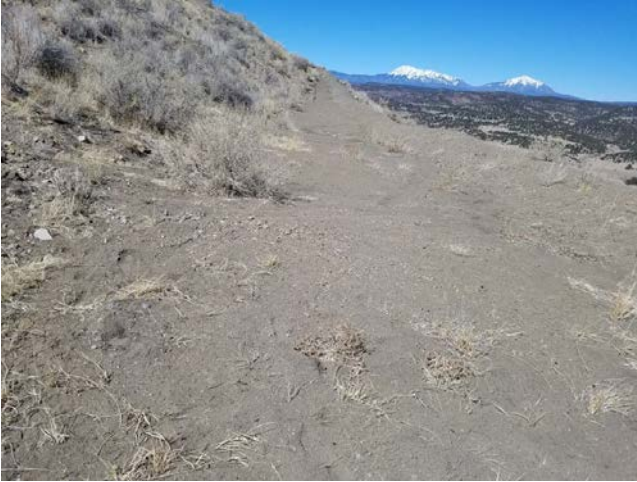
Figure 3. Sediment deposited below rills formed above ditch D2

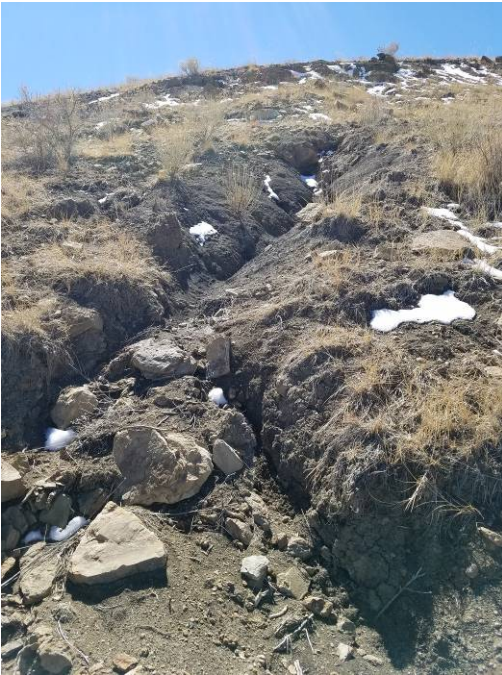
Figure 4. Rill above ditch D11.
