**RE: Permit No. M-1980-244; Cripple Creek & Victor Gold Mining Company; Cresson Project;
Schist Island Backfill Weekly Report**

FIELD WEEKLY PROGRESS REPORT

PROJECT: VALLEY LEACH FACILITY (VLF2) PHASE 3 CQA HIGH COMPACTION BACKFILL
SITE: CRIPPLE CREEK & VICTOR GOLD MINE (COLORADO)
CONTRACTOR: NEWMONT CC&V MINING OPERATIONS
WEEK ENDING: FRIDAY, MARCH 04, 2022

REPORTING PERIOD: 02.26.2022 THROUGH 03.04.2022

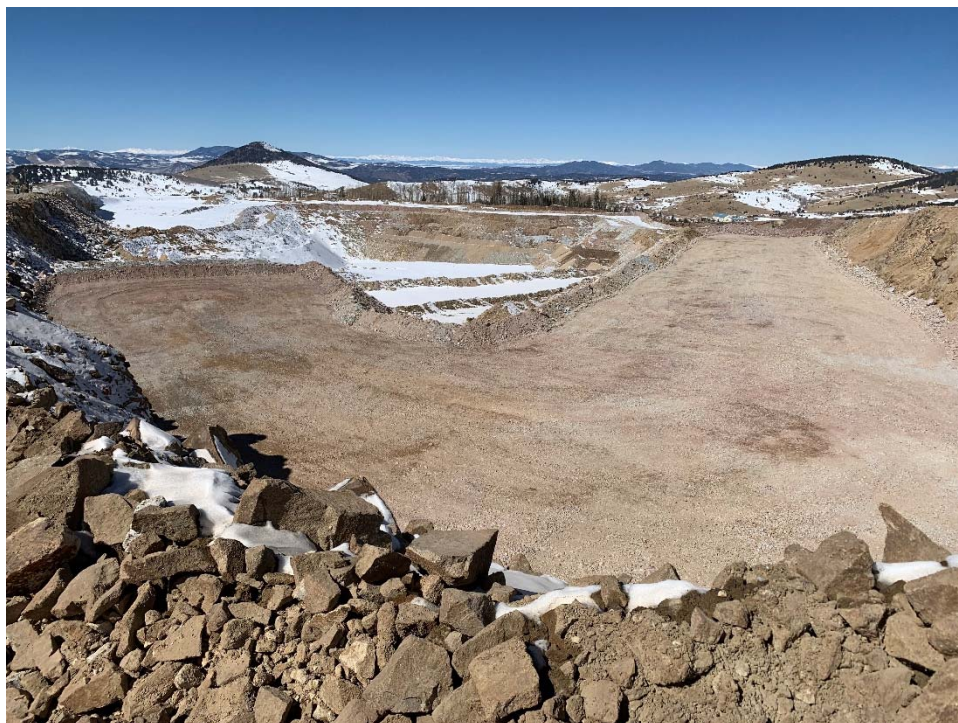
February 27, 2022 – High Compaction Backfill visual inspection (TW)

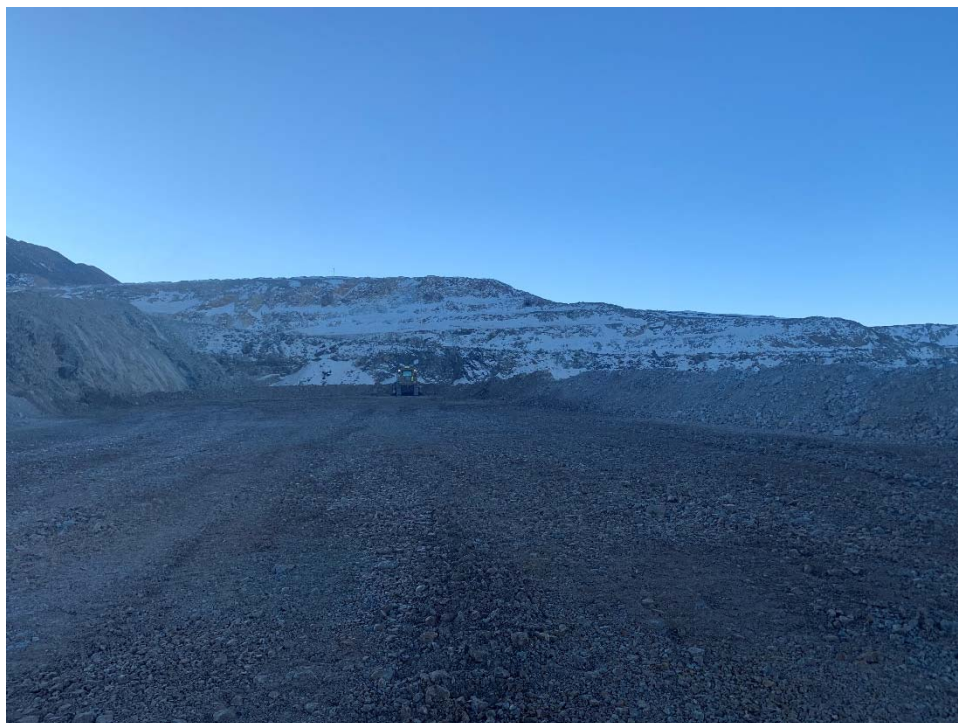
February 28, 2022 – High Compaction Backfill Placement (TW)

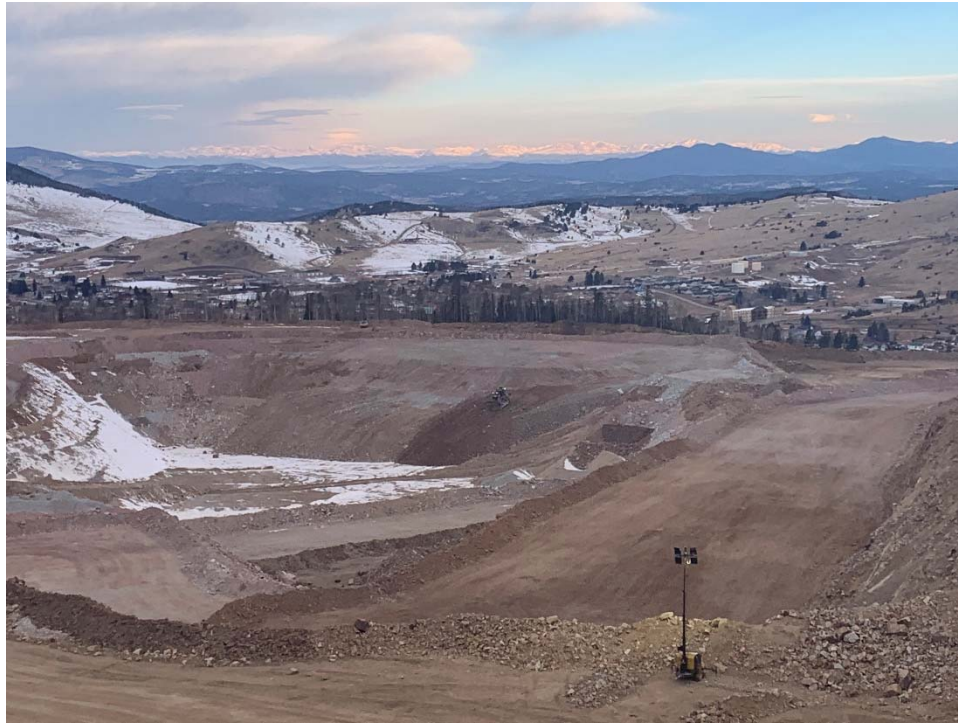
March 4, 2022 – High Compaction Backfill progress; PSSA Slope Overburden Cut progress (TW)

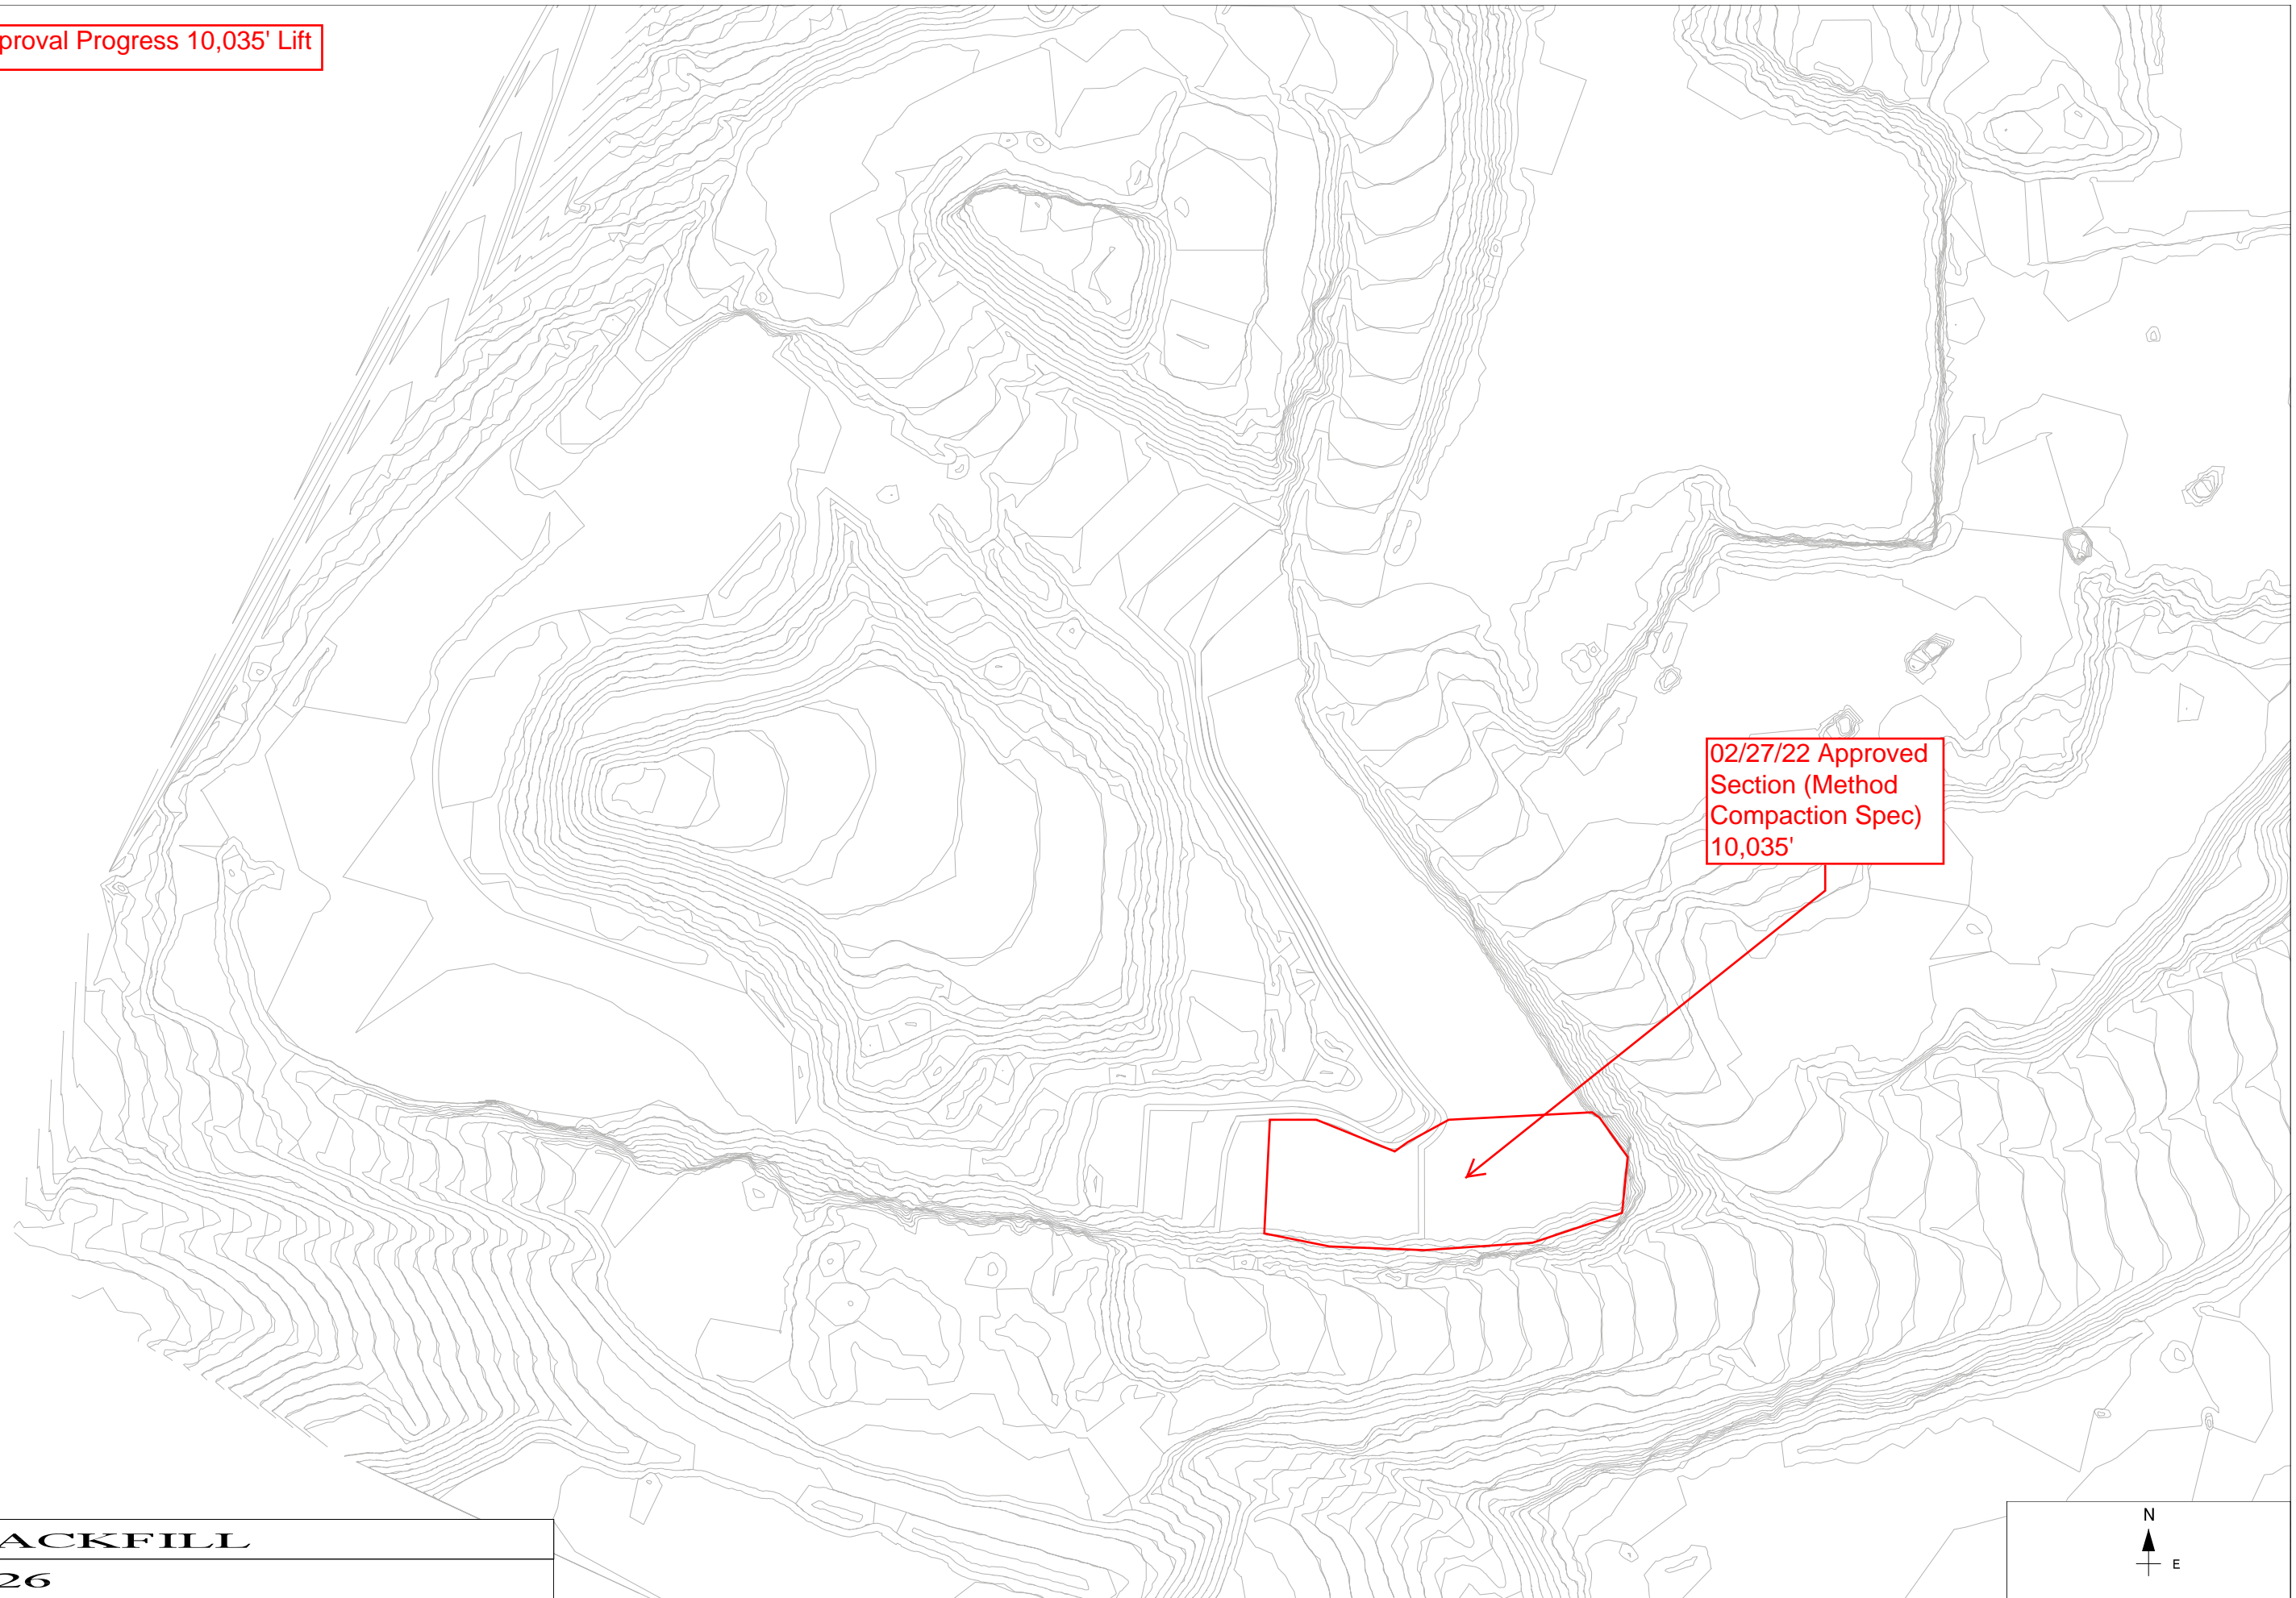
Figure 1: Section Approval Progress 10,035' Lift

- NewFields personnel completed the approval of the 10,035' lift. Visual inspection and the method compaction specification were utilized to approve the lifts.
- NewFields personnel completed a partial approval of the 10,040' lift. Visual inspection and the method compaction specification were utilized to approve the lift.
- A progress map provided by Newmont CC&V was utilized to create the attached figures showing high compaction backfill progress.
