MINERALS PROGRAM INSPECTION REPORT
PHONE: (303) 866-3567

MINE NAME: Pueblo West Pit	MINE/PROSPECTING ID#: M-1977-573	MINERAL: Sand and gravel	COUNTY: Pueblo
INSPECTION TYPE: Surety-Related Inspection	INSPECTOR(S): Patrick Lennberg	INSP. DATE: March 15, 2022	INSP. TIME: 10:00
OPERATOR: Colorado Water Protective and Development	OPERATOR REPRESENTATIVE: Bruce Humphries Kent Ricken	TYPE OF OPERATION: 112c - Construction Regular Operation

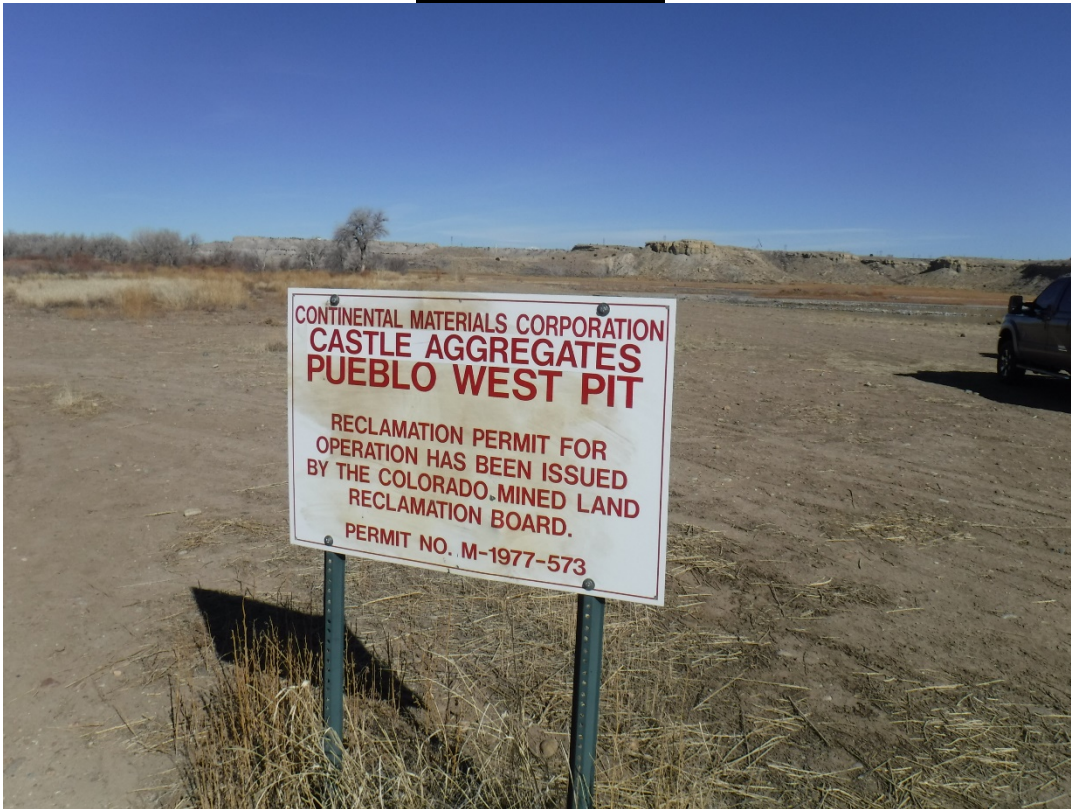
PROBLEM: The mine identification sign needs to be updated to reflect the new Operator. This is a problem for failure to post an accurate mine identification sign as required by Section 3.1.12(1) of the rule. The Operator shall, update the mine sign with the name of the new Operator.

Photo 1: Mine sign at entrance that needs to be updated

CORRECTIVE ACTIONS: The Operator shall submit photo documentation that the mine sign has been updated by the corrective action date.

CORRECTIVE ACTION DUE DATE: 5/04/22

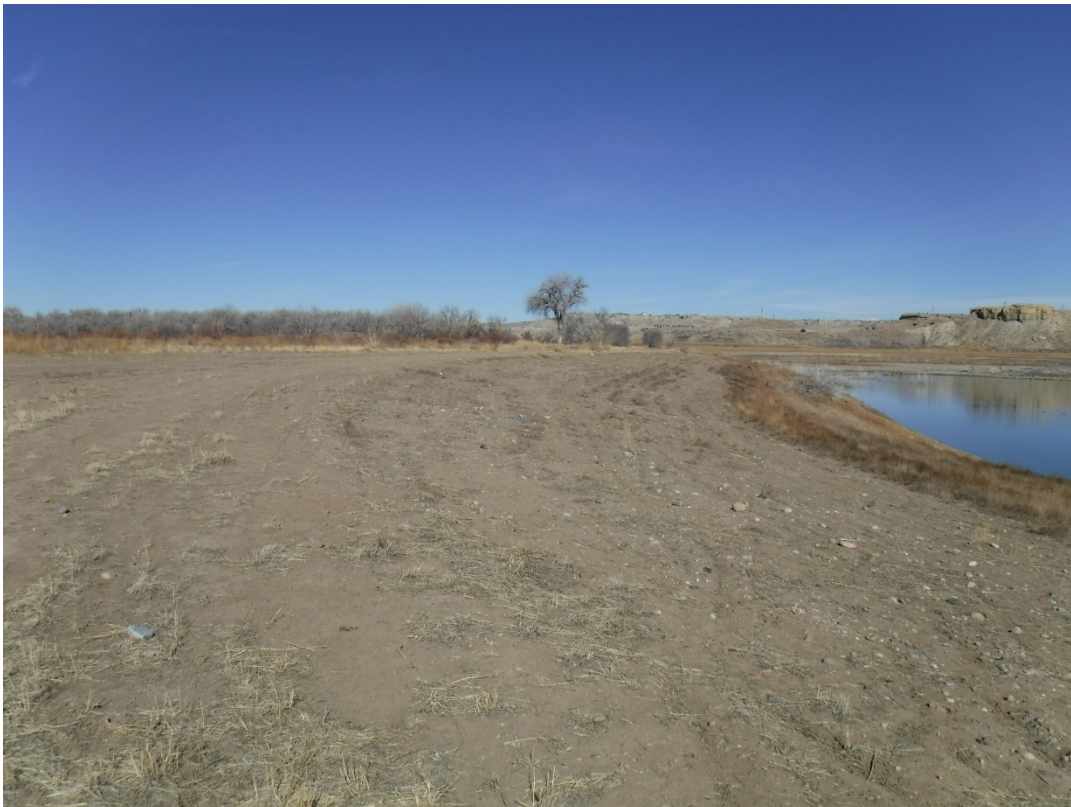
The site was not active at the time of inspection. It was noted the vegetation around the reservoir had been mowed late last year and it appeared some seeding may have occurred. The Division discussed with the Operator removing the topsoil island in the reservoir to create additional storage volume and generate some income. While it is still a possibility the current fuel costs make moving the topsoil unlikely in the near term. Moving forward on the site the Operator will continue to manage weeds through the year and plan to reseed in October with the new approved seed mixture.

Photo 2: Mowing and seeding area that occurred towards the end of 2021

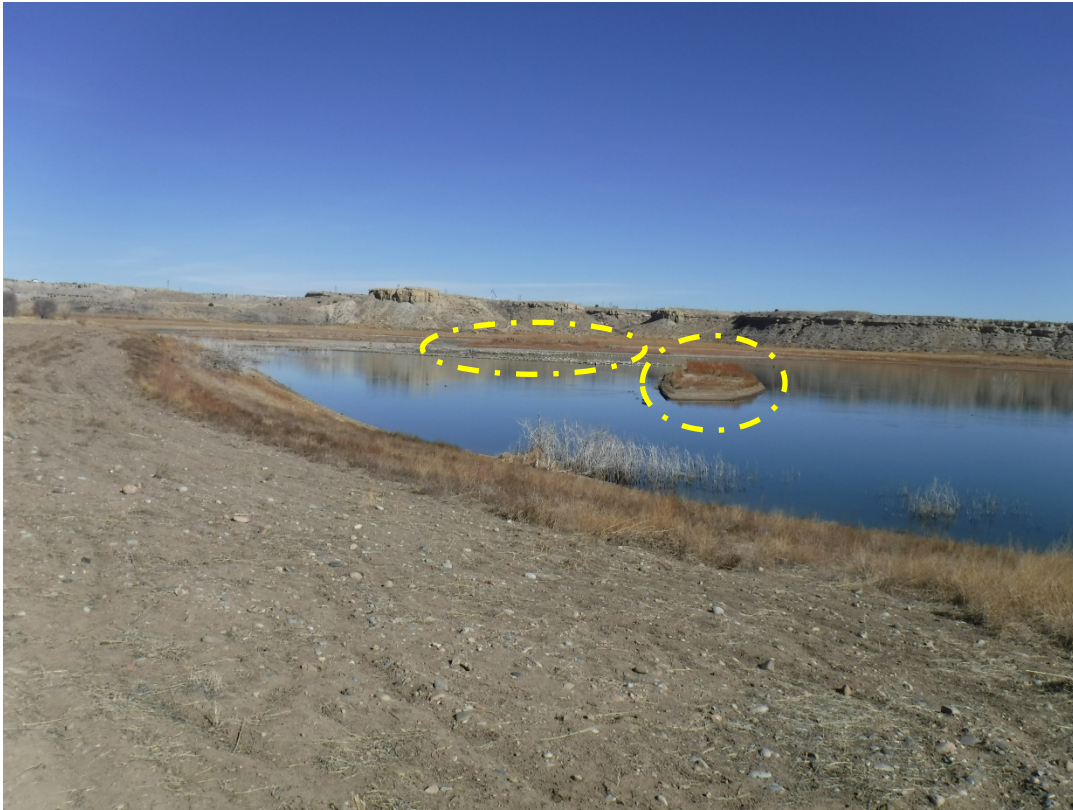
Photo 3: Remaining topsoil islands, circled yellow, that may be removed from reservoir

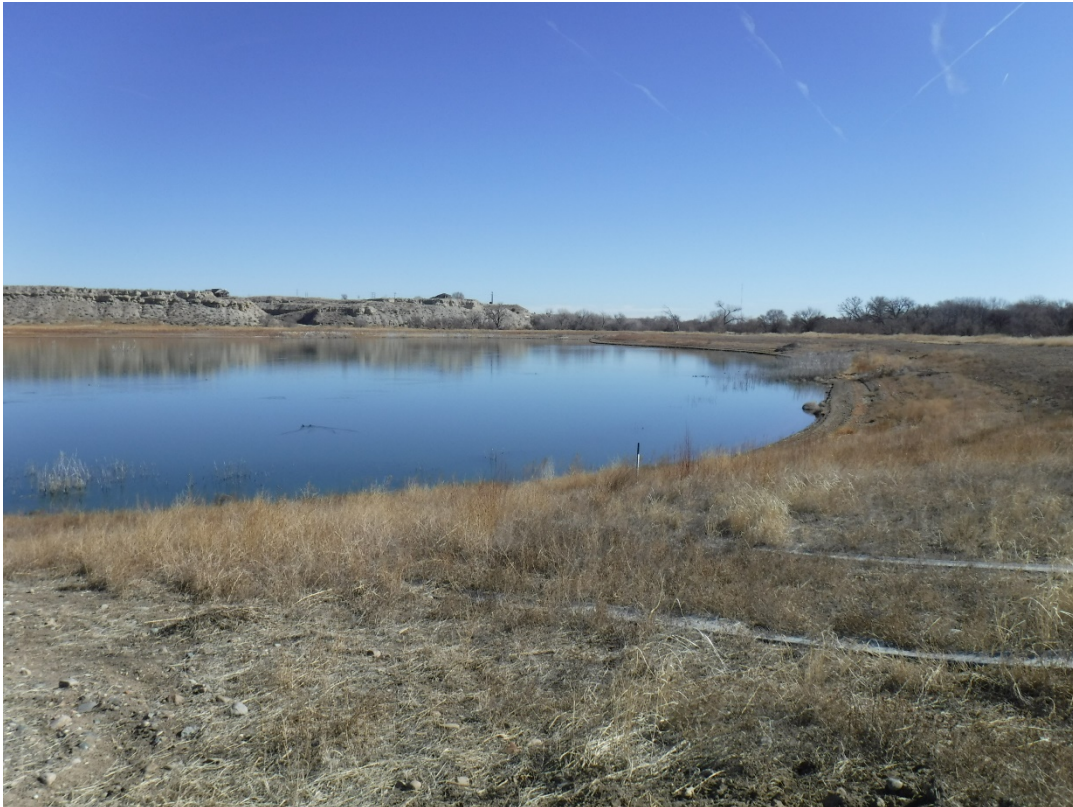
Photo 4: Reservoir conditions looking east
