MINERALS PROGRAM INSPECTION REPORT
PHONE: (303) 866-3567

MINE NAME: Pueblo East Pit	MINE/PROSPECTING ID#: M-1986-015	MINERAL: Sand and gravel	COUNTY: Pueblo
INSPECTION TYPE: Surety-Related Inspection	INSPECTOR(S): Patrick Lennberg	INSP. DATE: March 15, 2022	INSP. TIME: 11:00
OPERATOR: Colorado Water Protective and Development	OPERATOR REPRESENTATIVE: Bruce Humphries Kent Ricken	TYPE OF OPERATION: 112c - Construction Regular Operation

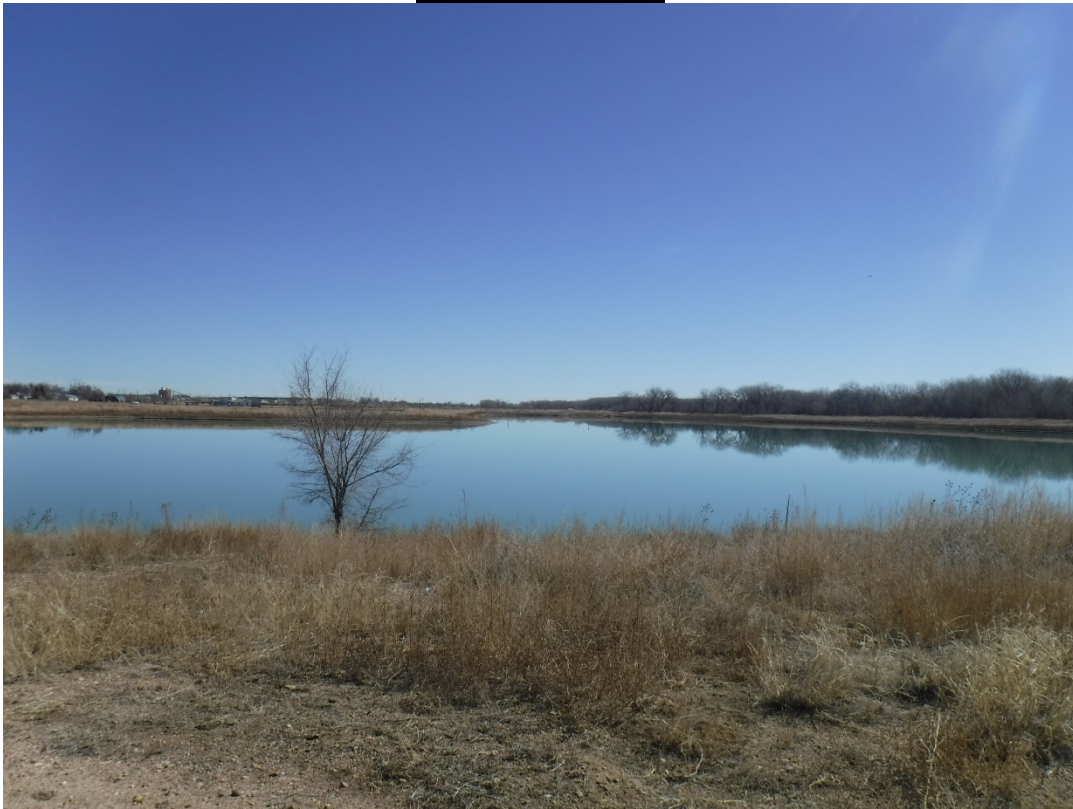
The mine site was not active at the time of inspection. The inspection did observe Phase 2 which is a lined water resources pond which is currently holding water left over from filling to capacity in 2018. Reclamation in Phase 2 requires weed management and reseeding. The Operator is planning on mowing and possibly disking in the weeds as a source of organic matter in the soil then reseeding with the approved seed mixture.

Photo 1: Looking across Phase 2 from west to east

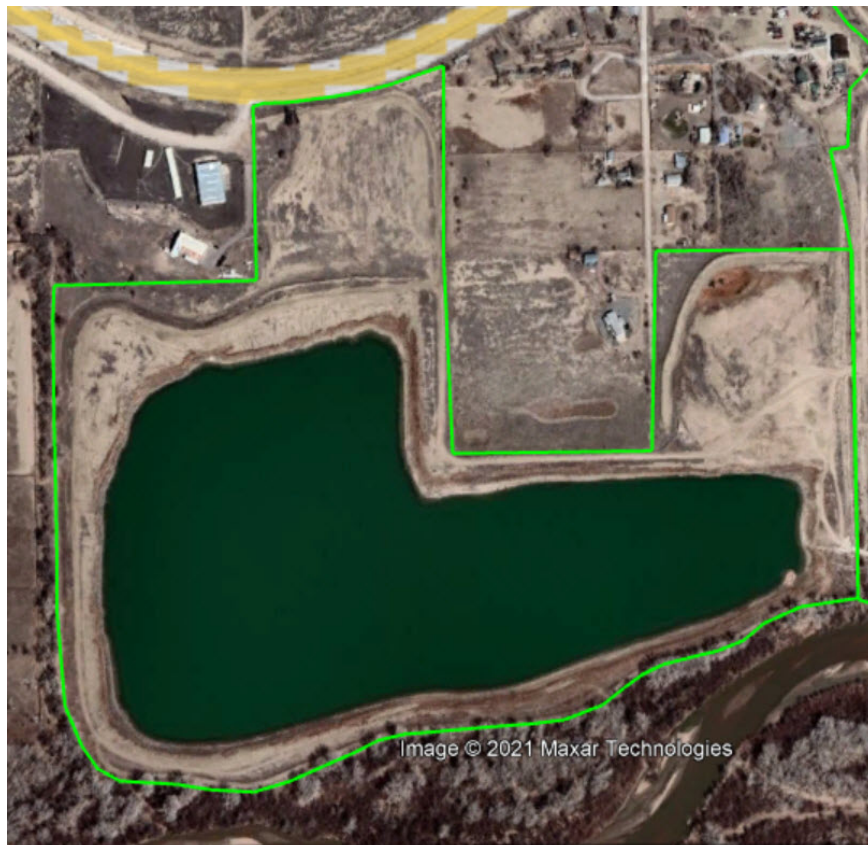
Photo 2: Aerial image of Phase 2 from March 2021

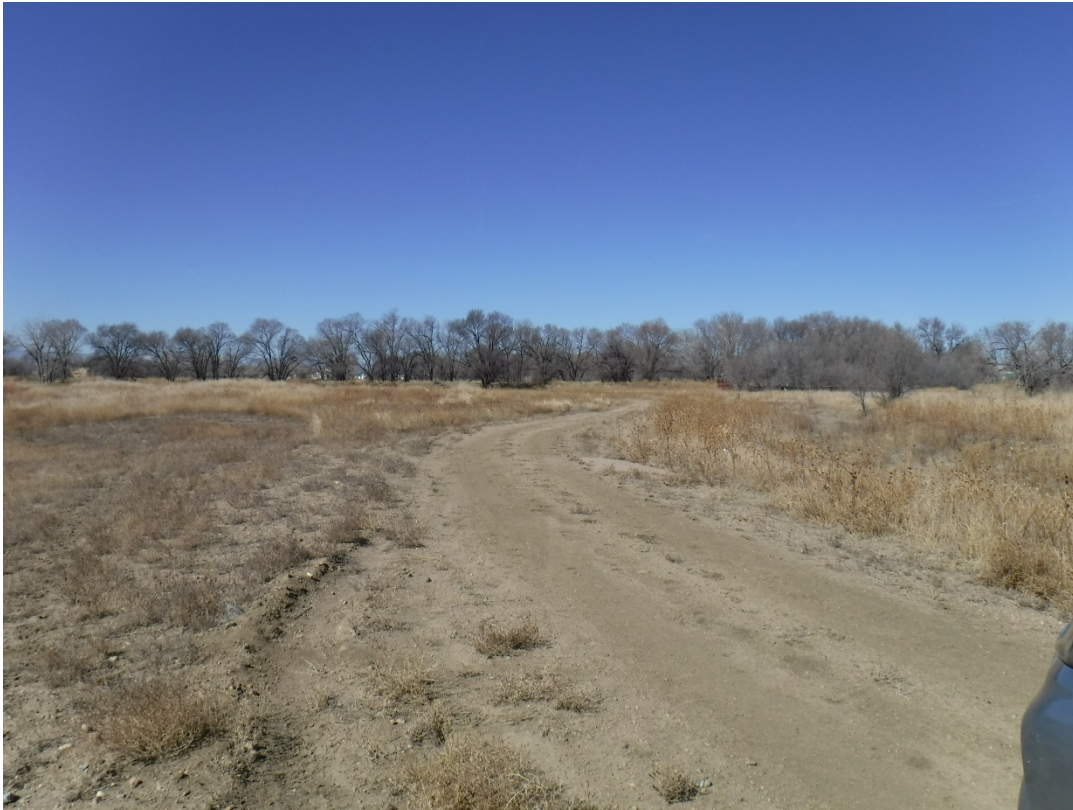
Photo 3: Typical vegetation around Phase 2

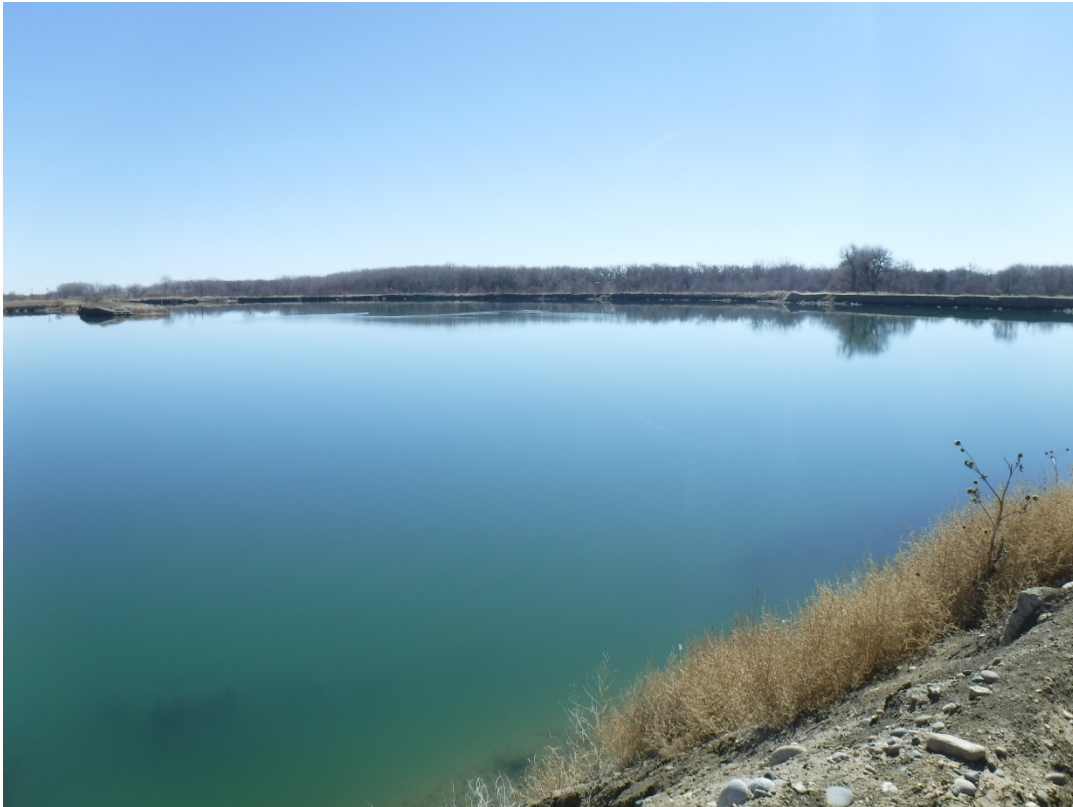
Phase 1 is still a large, ~55 acre, unlined reservoir. The approved reclamation plan is to line the reservoir walls then regrade the interior slopes to a 3:1 slope or shallower. CWPDA has a current SWSP in place with DWR to cover the exposed groundwater in both Phase 1 and 7. Adjacent to the Phase 1 are two former settlement basins the Operator is in discussions with Ducks Unlimited (DU) about. DU is interested in using the basins as research plots to investigate wetland development over time in this area of the Arkansas Basin.

Photo 4: Looking southeast across Phase 1

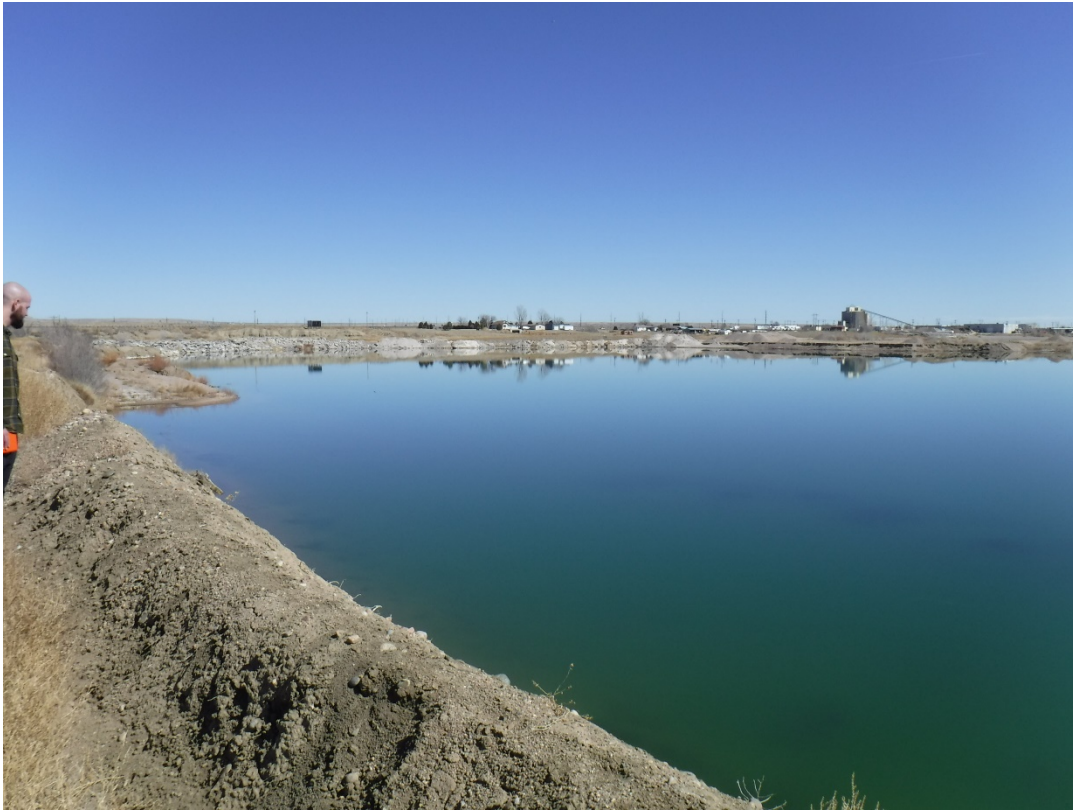
Photo 5: Looking northeast across Phase 1

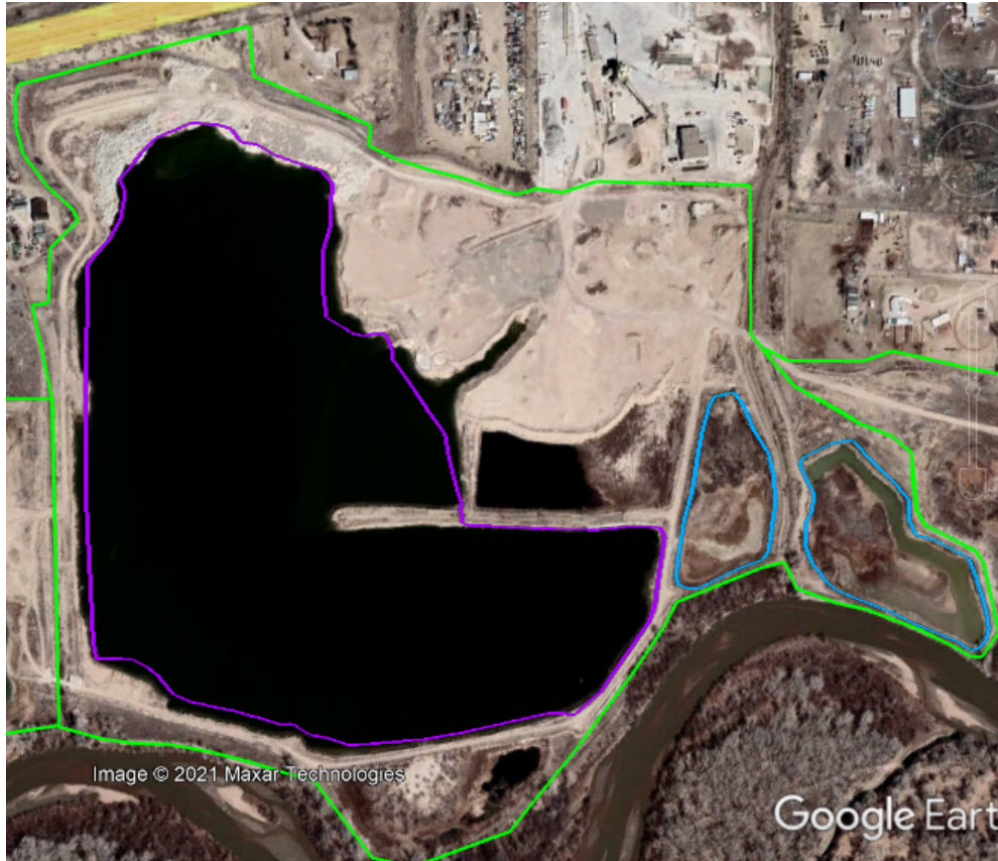
Photo 6: Aerial image of Phase 1 from March 2021

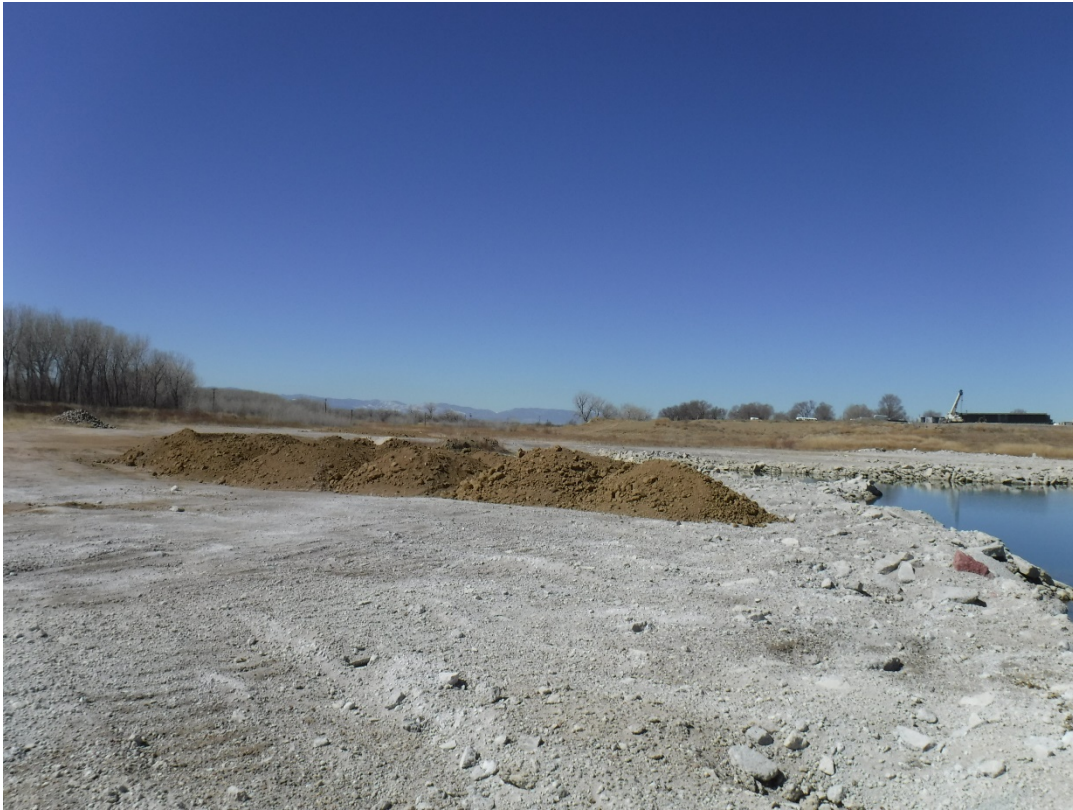
Phase 7 still has an exposed groundwater pond that is approximately 10 acres in size. It does appear there has been some minor backfilling of the pond since the last inspection.

Photo 7: Material being placed for backfill of Phase 7

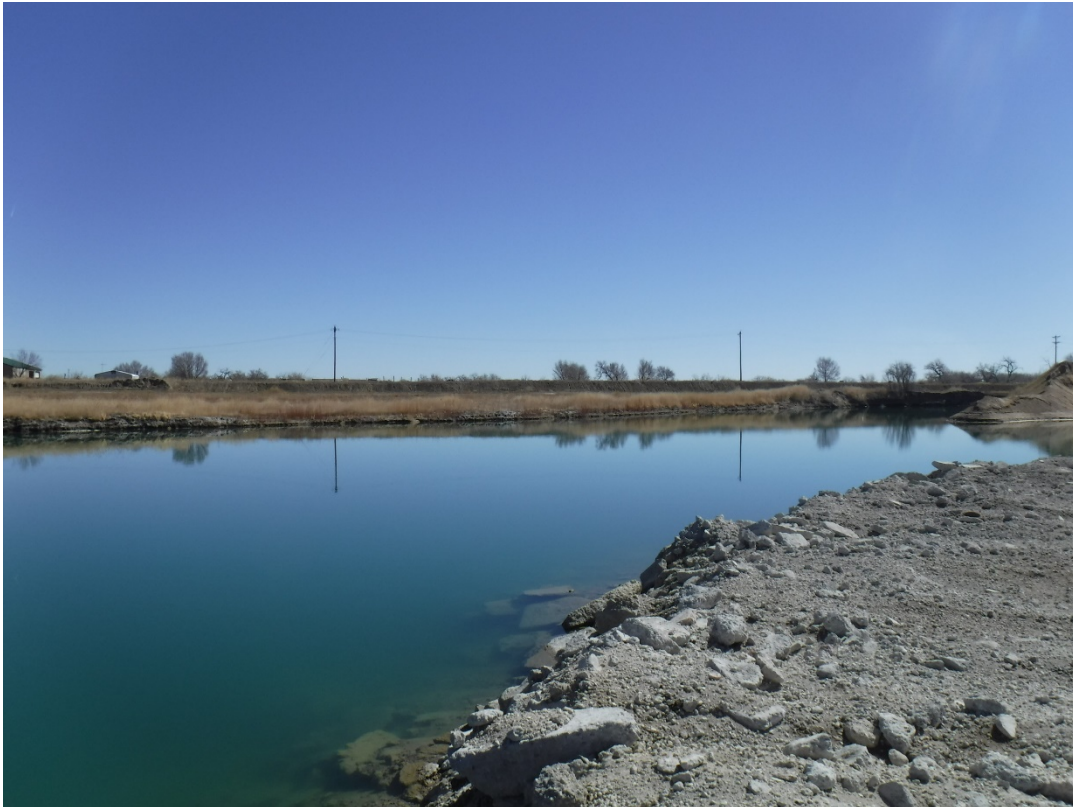
Photo 8: Looking southeast across Phase 7 open groundwater pond

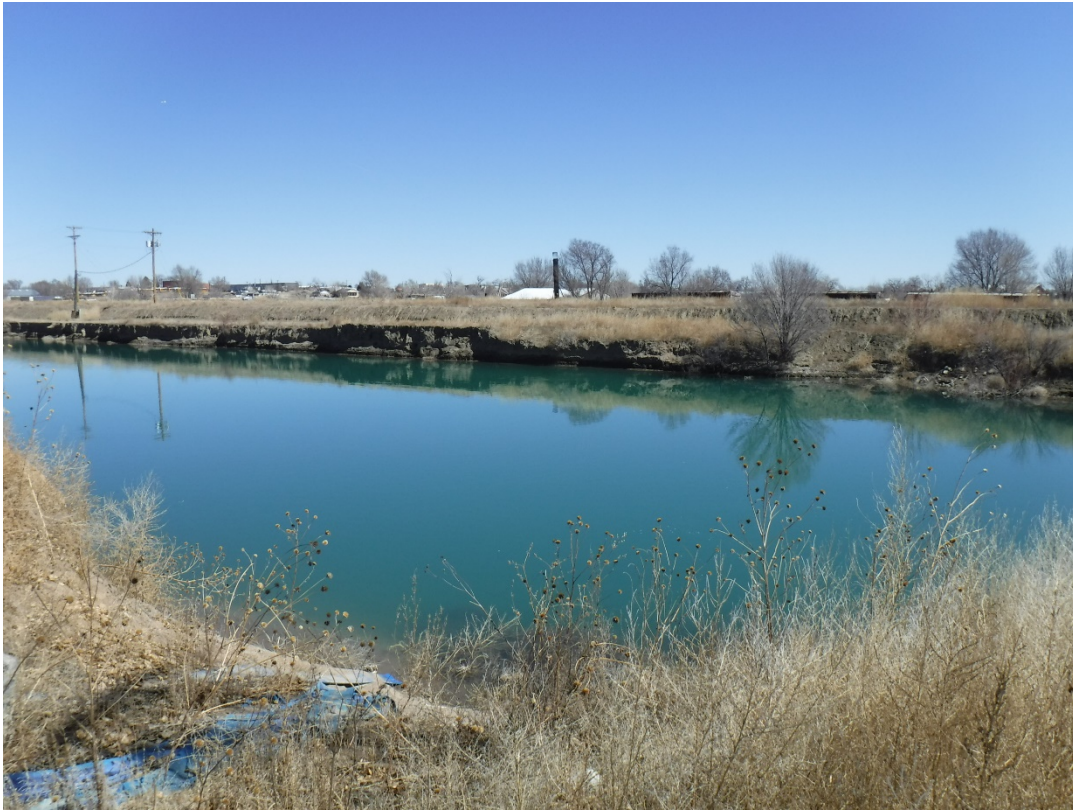
Photo 9: Phase 7 pond near former outlet to Arkansas River

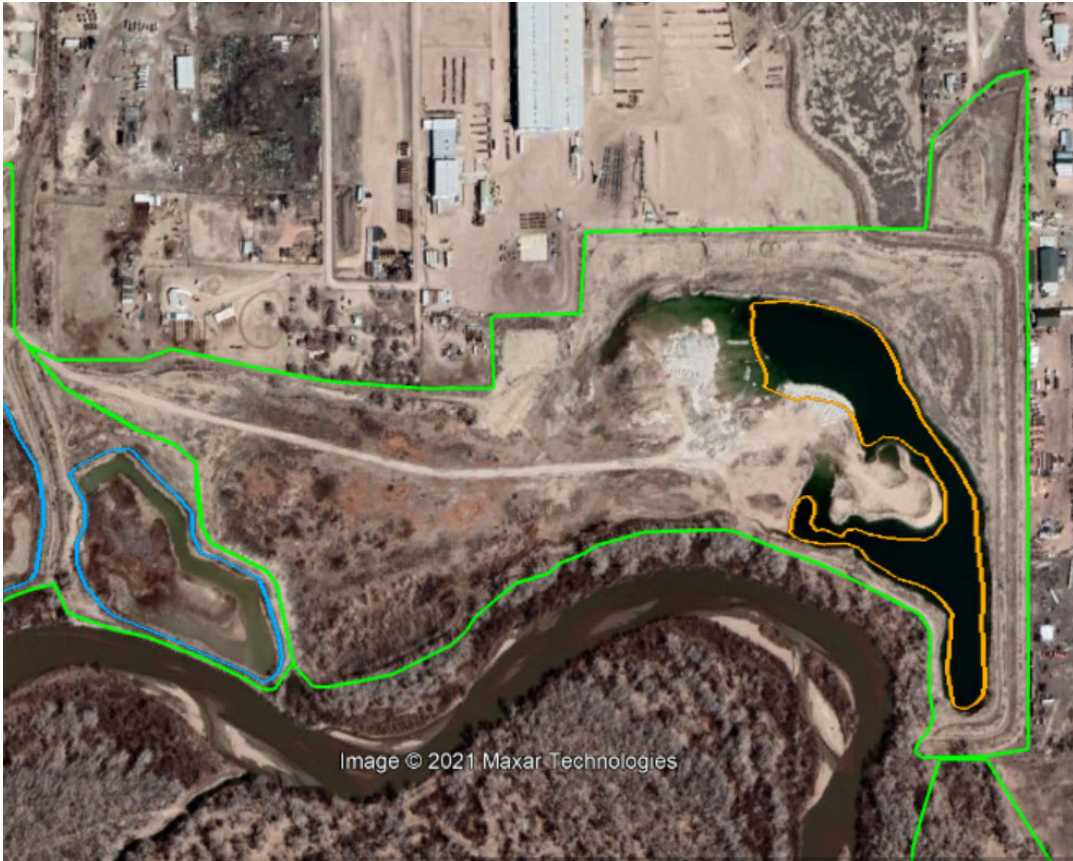
Photo 10: Aerial image of Phase 7 from March 2021
