MINERALS PROGRAM INSPECTION REPORT
PHONE: (303) 866-3567

MINE NAME: Pikeview Quarry	MINE/PROSPECTING ID#: M-1977-211	MINERAL: Limestone (general), granite, granite gneiss and dolomite	COUNTY: El Paso
INSPECTION TYPE: Multi Person Inspection	INSPECTOR(S): Timothy Cazier, P.E., Zach Trujillo	INSP. DATE: March 3, 2022	INSP. TIME: 10:00
OPERATOR: Continental Materials Corporation	OPERATOR REPRESENTATIVE: Jerry Schnabel	TYPE OF OPERATION: 112c - Construction Regular Operation	
REASON FOR INSPECTION: Priority	BOND CALCULATION TYPE: None	BOND AMOUNT: \$13,389,784.00	
DATE OF COMPLAINT: NA	POST INSP. CONTACTS: U.S. Forest Service	JOINT INSP. AGENCY: U.S. Forest Service	
WEATHER: Clear	INSPECTOR'S SIGNATURE:

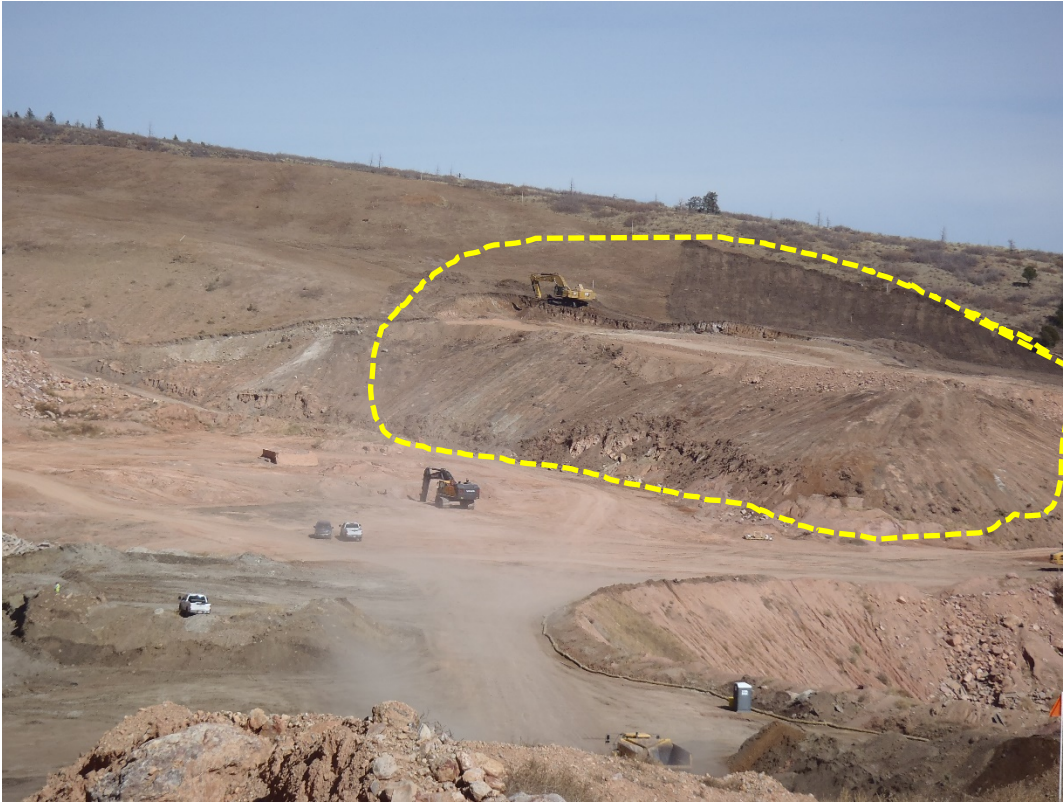
The primary focus of this inspection was to observe backfill placement and compaction effort. Site representatives stated construction began on February 28th. The north borrow area (see **Photo 1**) had been cleared and grubbed. A large excavator was parked there, but not operating at the time of the inspection. During the inspection, onsite backfill material from the "peninsula area" (just north of the pit floor stormwater risers and adjacent to the former screen plant location - see **Photo 2**) was being loaded and hauled to the pit floor for placement using off-road articulated haul trucks. Three dozers were observed spreading fill material on the southern half of the pit floor, while two compactors were seen working the area north of that (see **Photo 3**). Offsite fill material (as approved by TR-19) was being imported and dumped from on-highway haul trucks. Mr. Harold Henry stated the one-foot lift thickness was being controlled using standard survey methods, but they expected to get GPS receivers for the dozers soon.

Photo 1. Cleared and grubbed north borrow area (looking NNE).

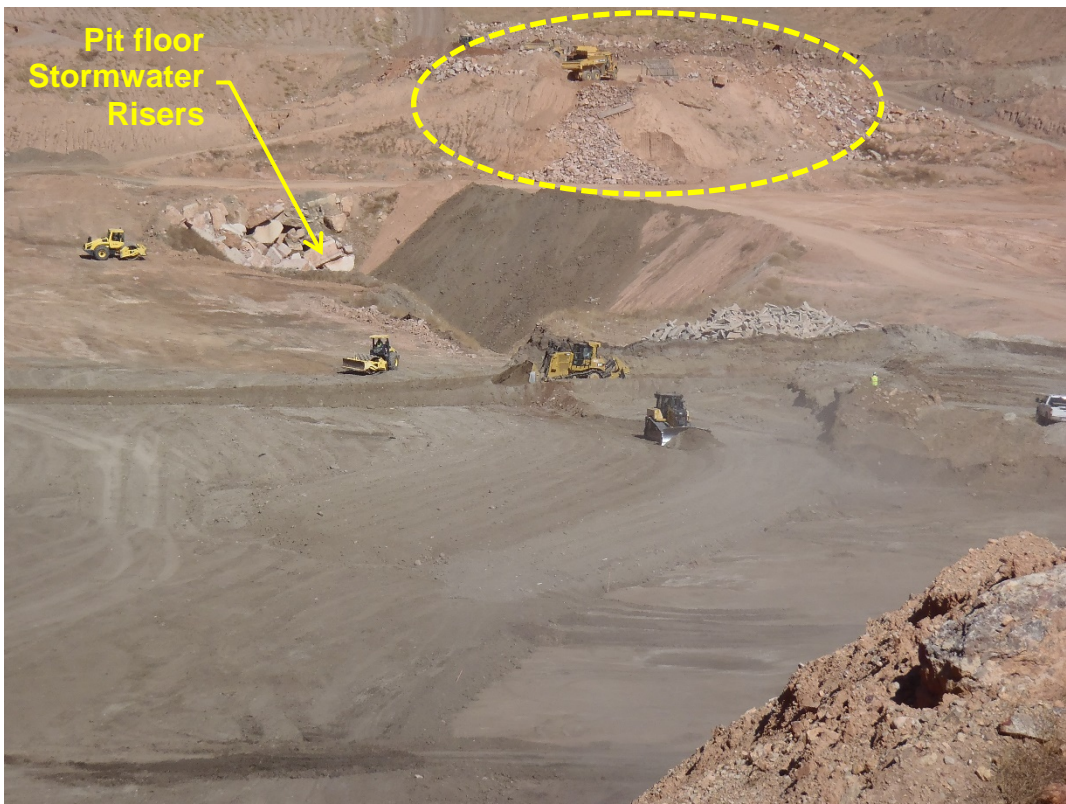
Photo 2. Backfilling operation (looking north at onsite "peninsula area" borrow).

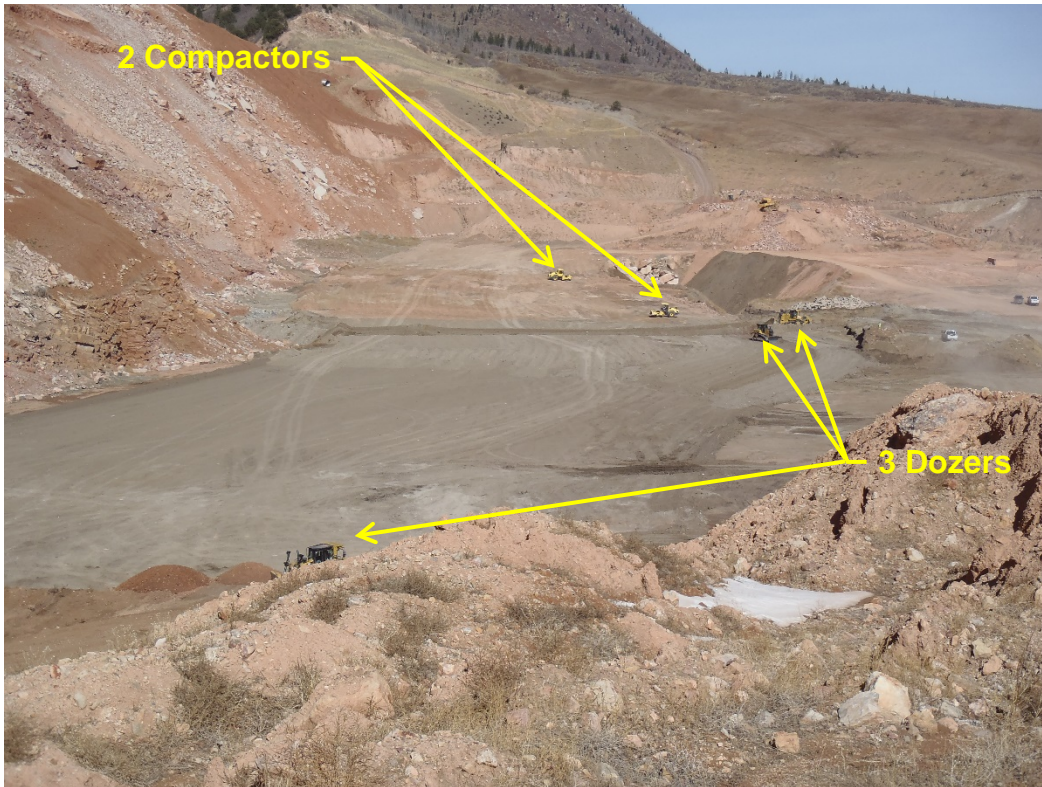
Photo 3. Backfilling operation (pit floor, looking north).

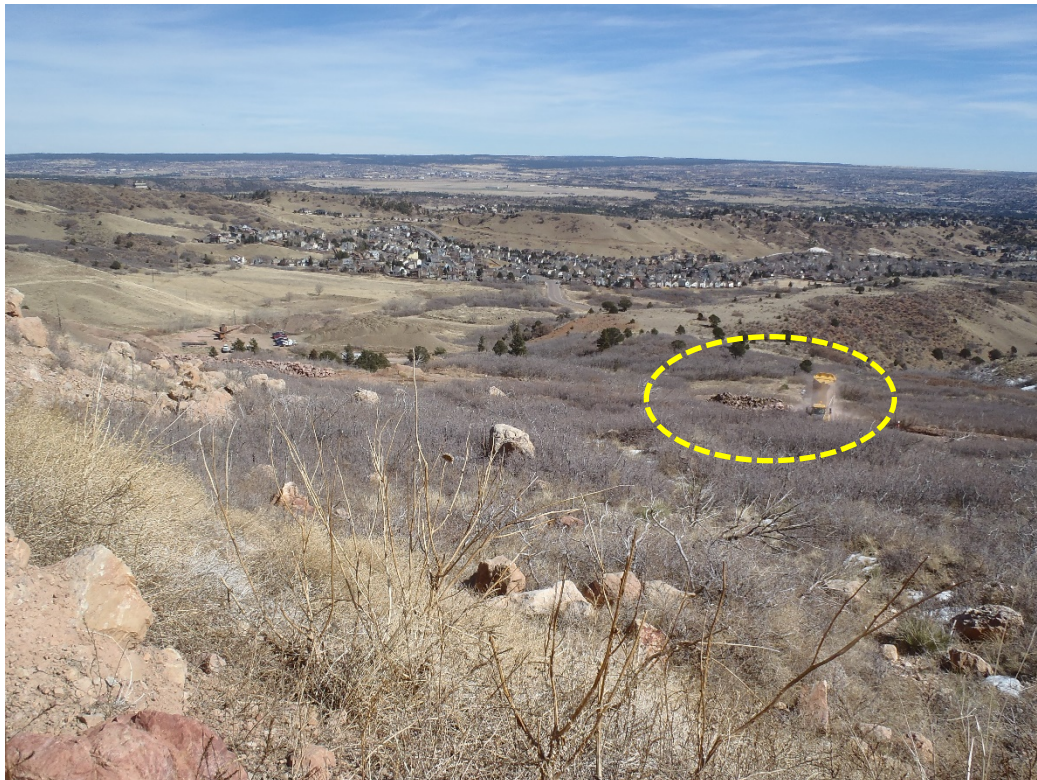
Riprap for stormwater channel construction was being stockpiled near the south borrow area (see **Photo 4**).

Photo 4. Stockpiling riprap (SE corner of site, looking NE).
