Battle Mountain Resources, Inc.
San Luis Project
P.O. Box 310
San Luis, Colorado 81152-0310
(719) 379-0798

Re: Battle Mountain Resources, Inc.
San Luis Project - San Luis, Colorado
Annual Report and Fee 2021
CMLRB Permit No. M-1988-112

ATTACHMENT 2
SAN LUIS TAILINGS STORAGE FACILITY
2021 ANNUAL DAM SAFETY INSPECTION
JUNE 8, 2021
INSPECTION PHOTOS

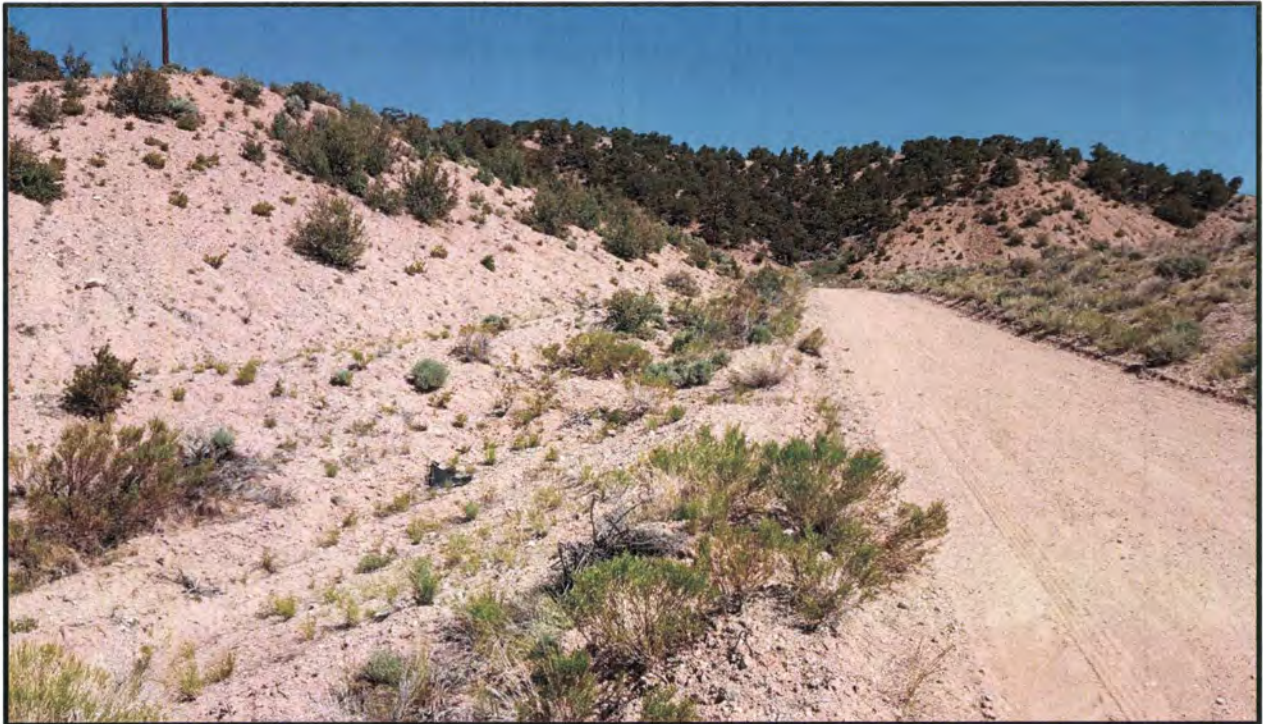
Photo 1 Looking east along the access road and run-on diversion channel from the north (right) end of the dam, showing good conditions.

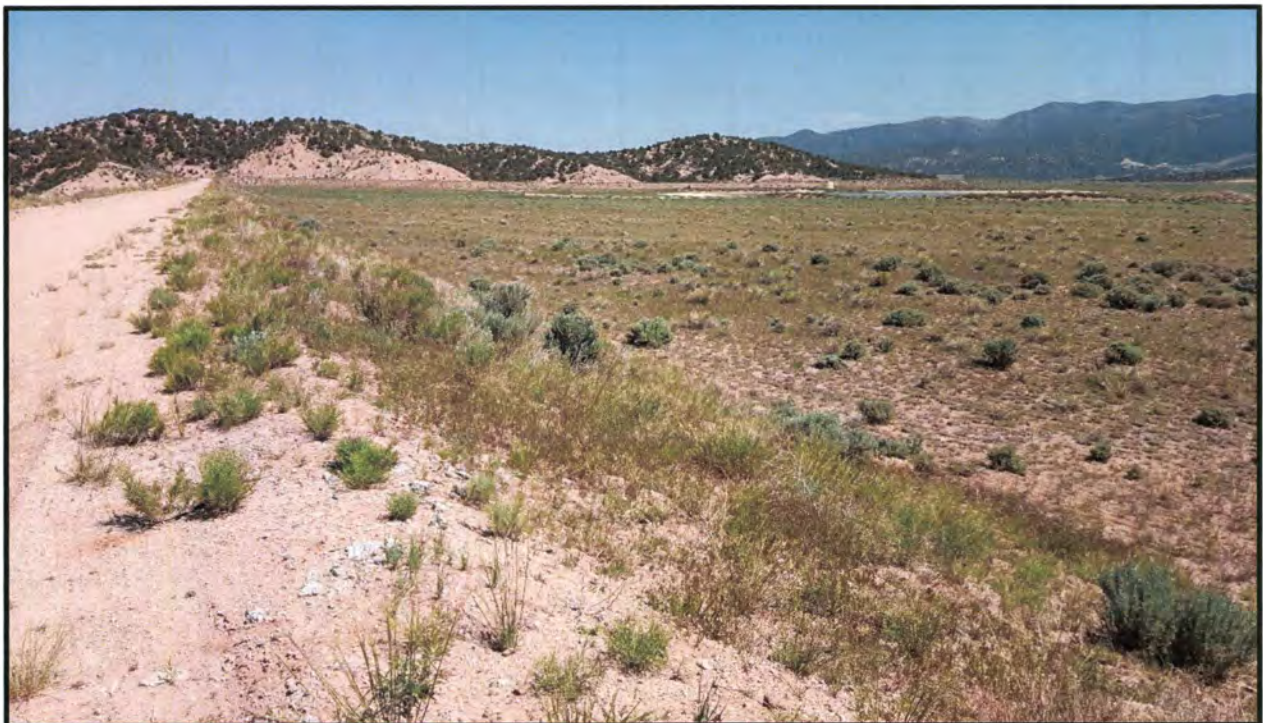
Photo 2 Looking north over the dam crest road, beach, and impoundment from the south (left) end of the dam, showing good conditions. The pool is seen in the background, and is within normal limits.

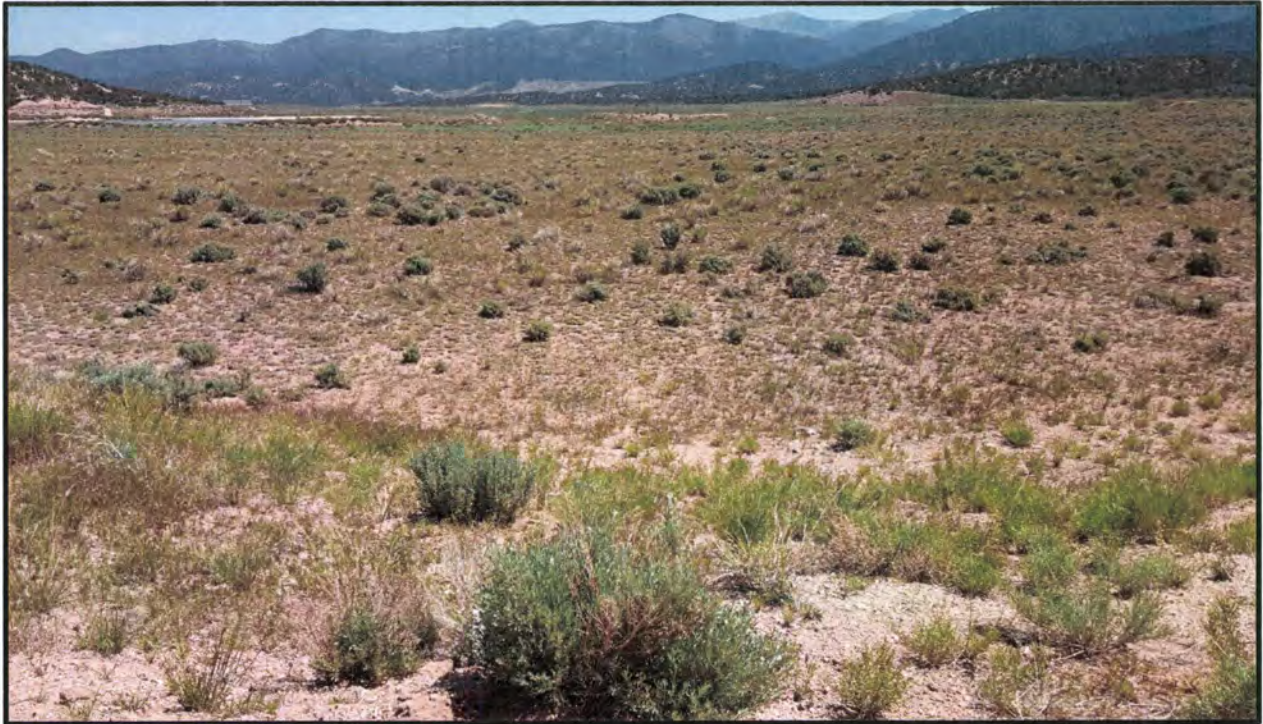
Photo 3 Looking northeast over the beach and impoundment from the south (left) end of the dam, showing good conditions.

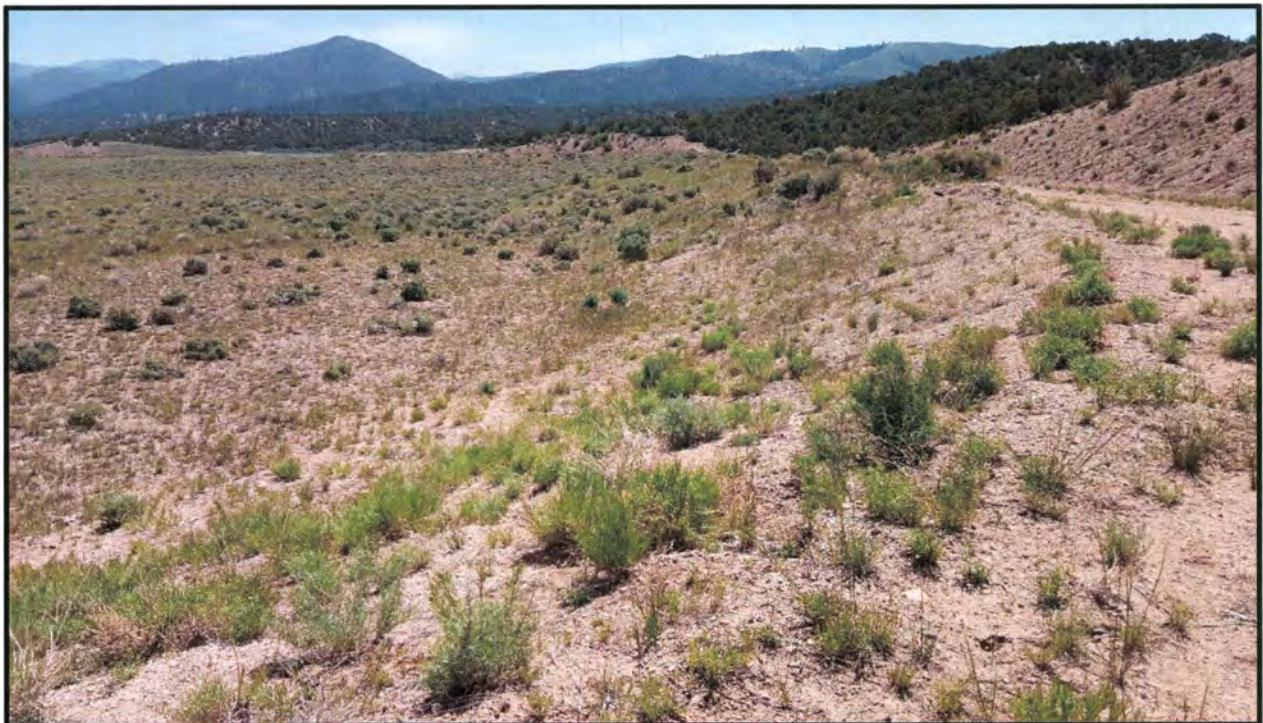
Photo 4 Looking east over the beach and impoundment from the south (left) end of the dam, showing good conditions. Note the South Diversion Channel along the right side of the photo.

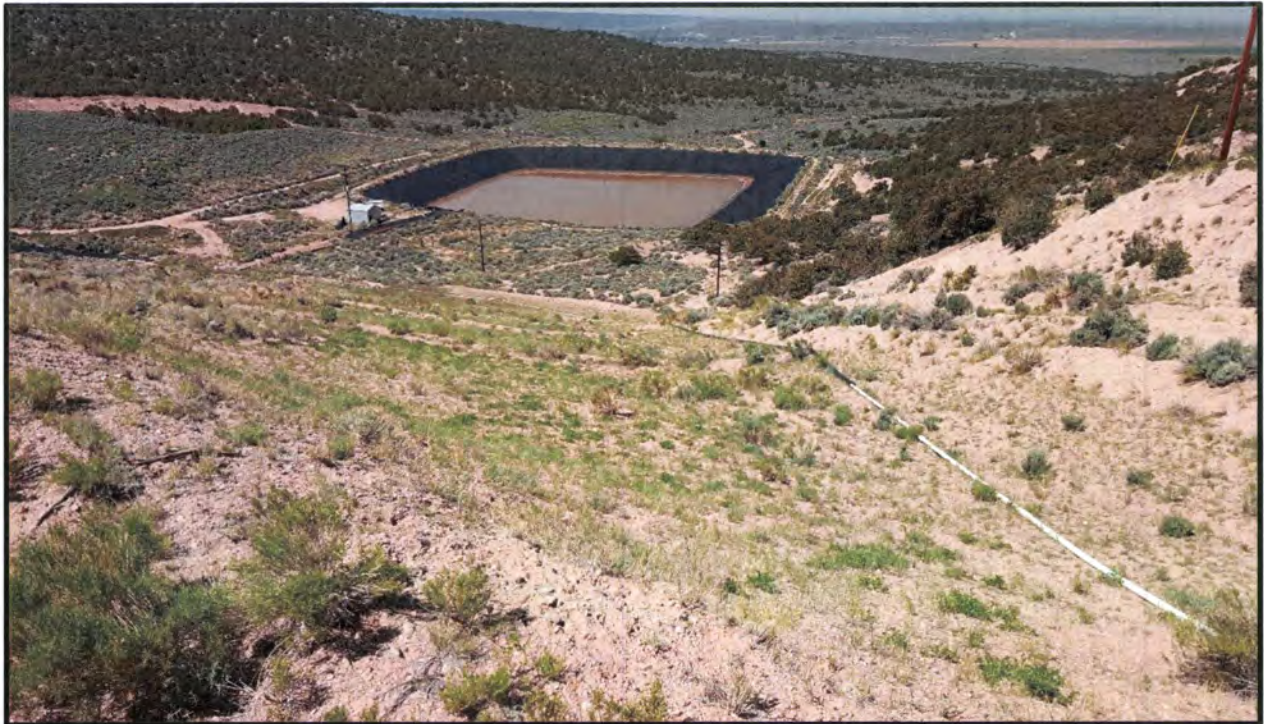
Right Downstream Groin: Revegetation in this area following repairs continues to improve. This area and also the cross-berms and rock-lined down-drains should be monitored closely to make sure erosion does not progress to detrimental levels.

Photo 5 Looking west over the downstream face and the right downstream abutment, showing good conditions overall, and improving revegetation conditions following 2013/2014 erosion repairs. Note the seepage collection pond in the background.

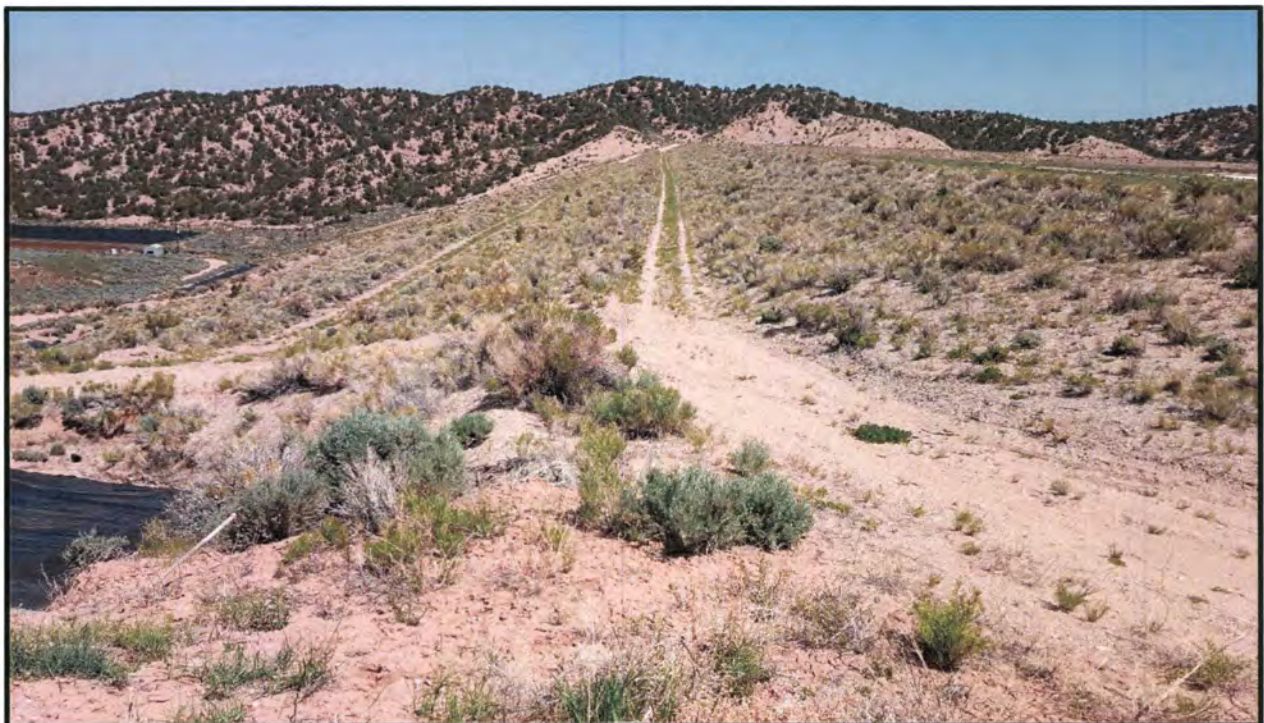
Photo 6 Looking north over the downstream face from the left abutment, showing good conditions.

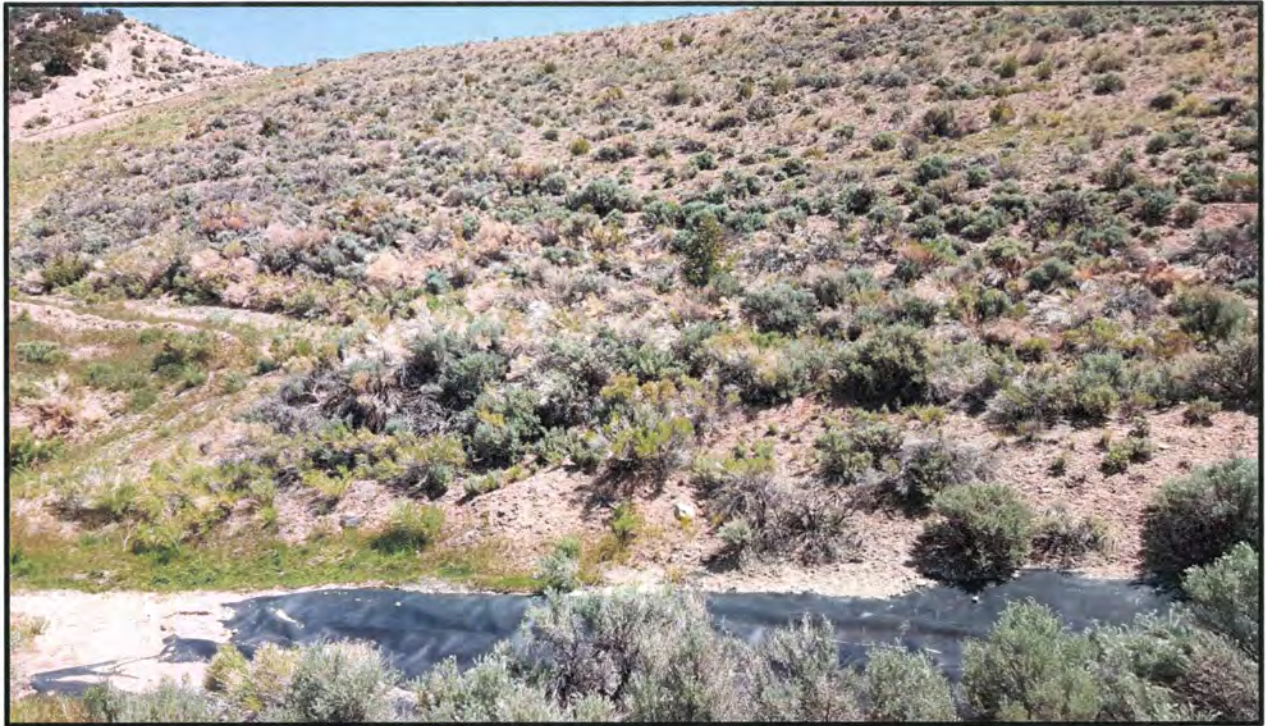
Photo 7 Looking northeast across the downstream face from just south of the toe drain outlet, showing good conditions. Note the lined runoff collection swale in the foreground.

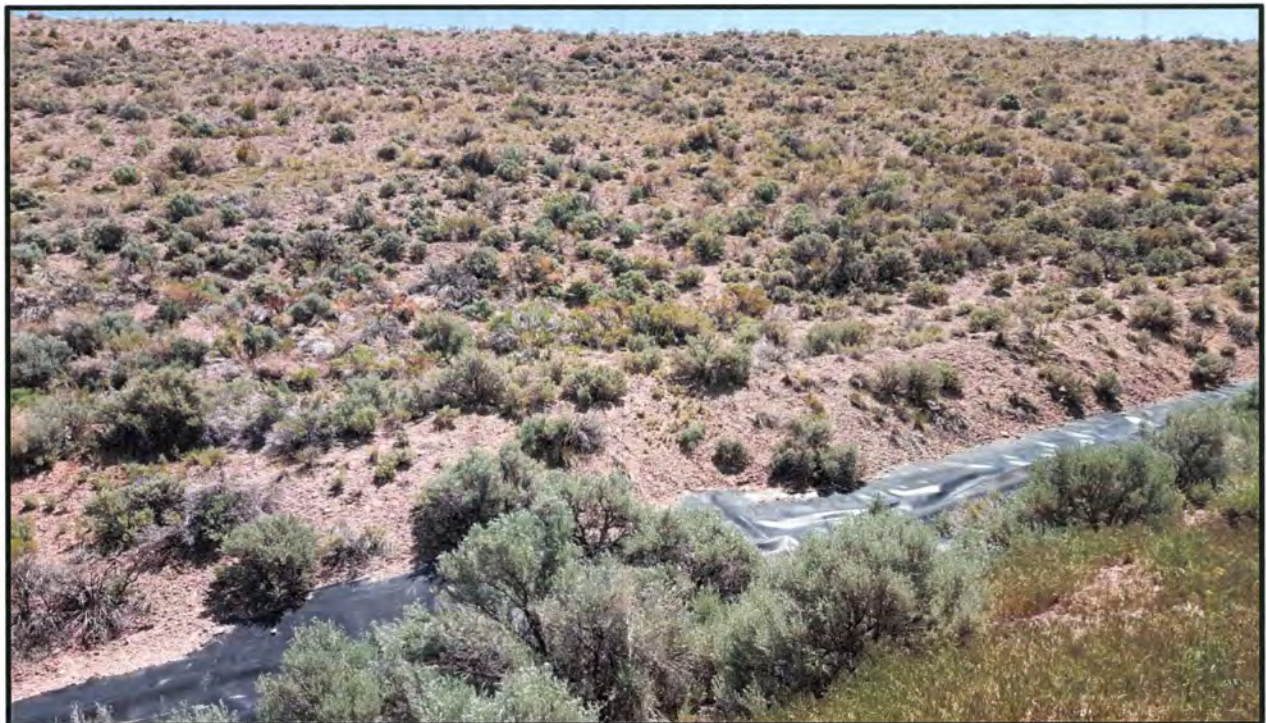
Photo 8 Looking east across the downstream face from just south of the toe drain outlet, showing good conditions. Note the lined runoff collection swale in the foreground.

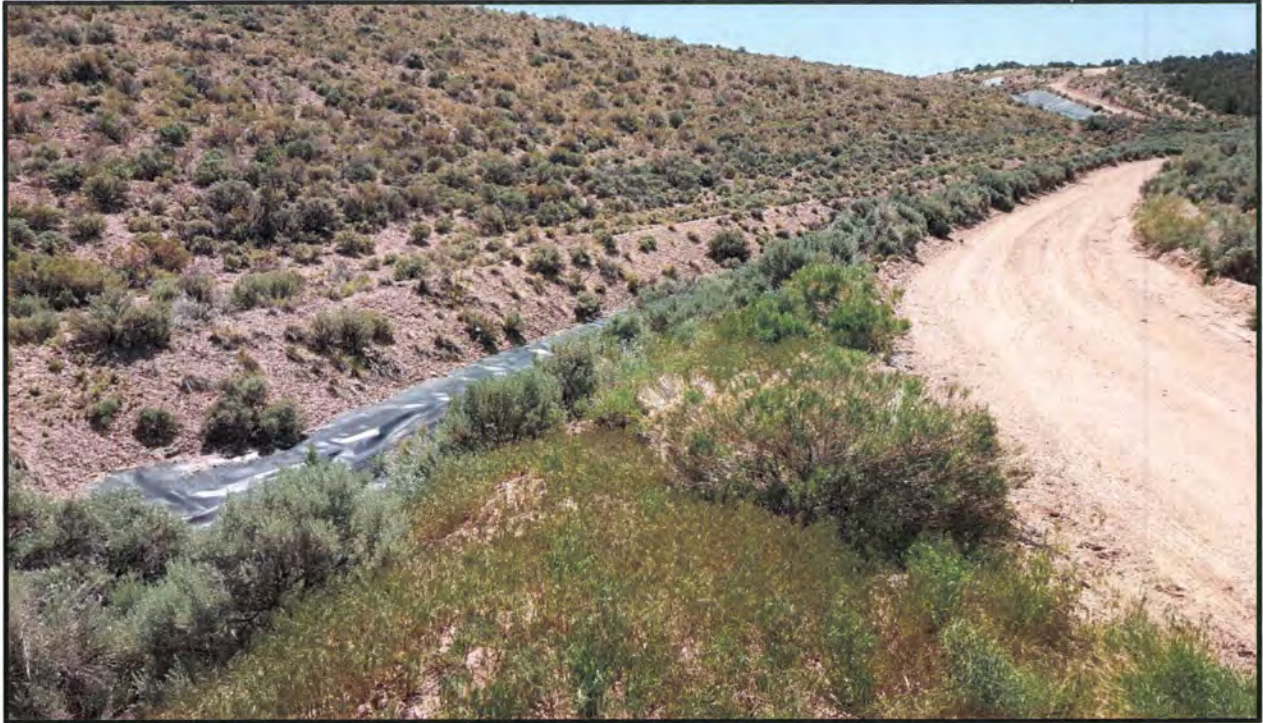
Photo 9 Looking southeast across the downstream face, toe, and access road from just south of the toe drain outlet, showing good conditions. Note the lined runoff collection swale running across the center of the photo.

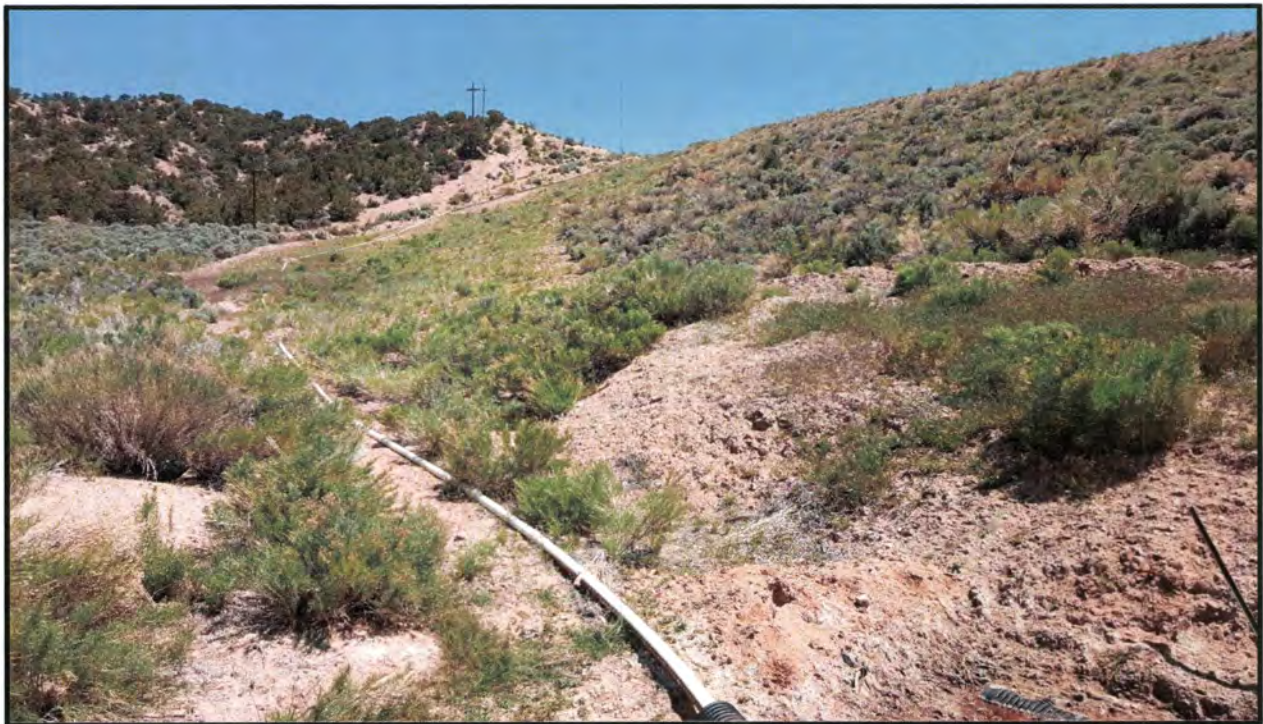
Photo 10 Looking north across the right downstream face and toe from the toe drain outlet, showing generally good conditions. Note the improved vegetation condition of the repaired groin area, and cattle footprints in the soft accumulated sediments surrounding the drain outlet (seen exposed at lower right). The PVC pipe is the pump-back line that returns seepage from the collection pond to the TSF impoundment.

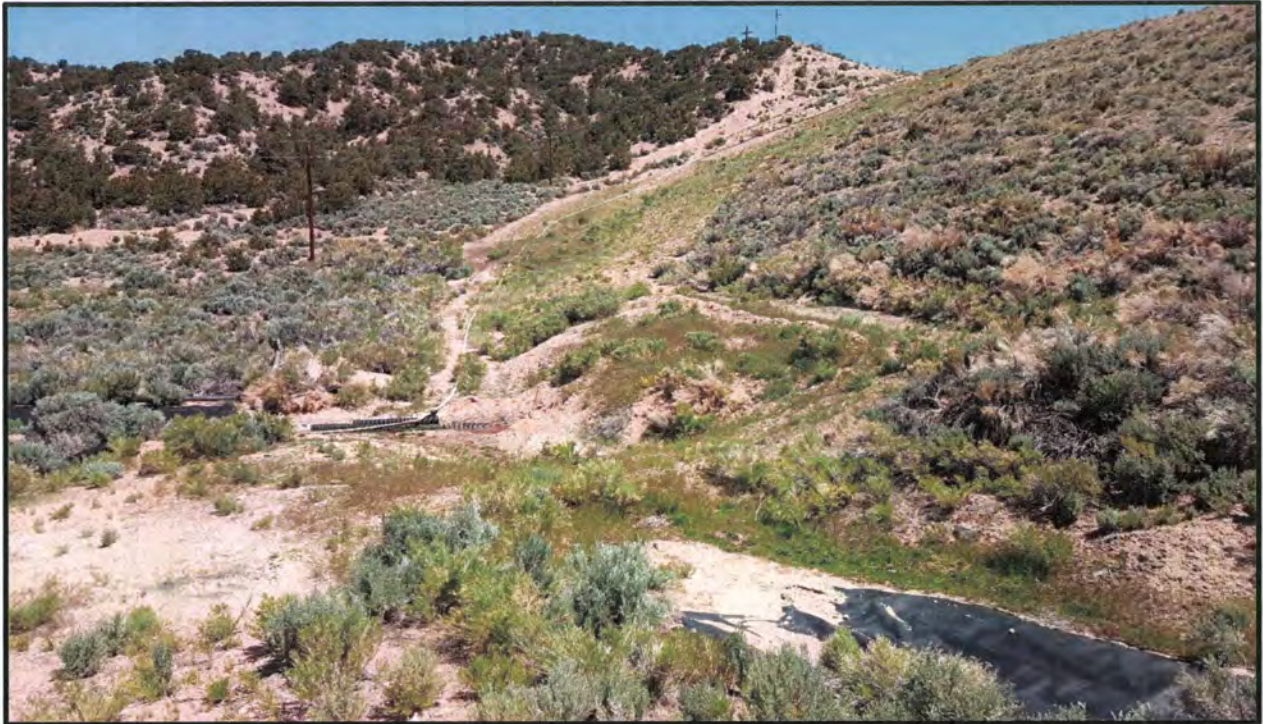
AND INDICATE AMOUNT AND QUALITY OF SEEPAGE Minor leakage from toe drain creates puddle, attracting animals, but no pipe damage.**CONDITIONS OBSERVED:**

Photo 11 Looking south over the toe drain outlet area, showing generally good conditions. Note shallow standing water around the pipes, but no seepage from the embankment face above the pipes.

| ITEMS REQUIRING ACTION BY OWNER TO IMPROVE THE SAFETY OF THE DAM | |
|---|---|
| <input checked="" type="checkbox"/> (9) OTHER: Protect toe drain area from disturbance by cattle. Fix leak in outfall pipe to prevent water ponding in this area. | |

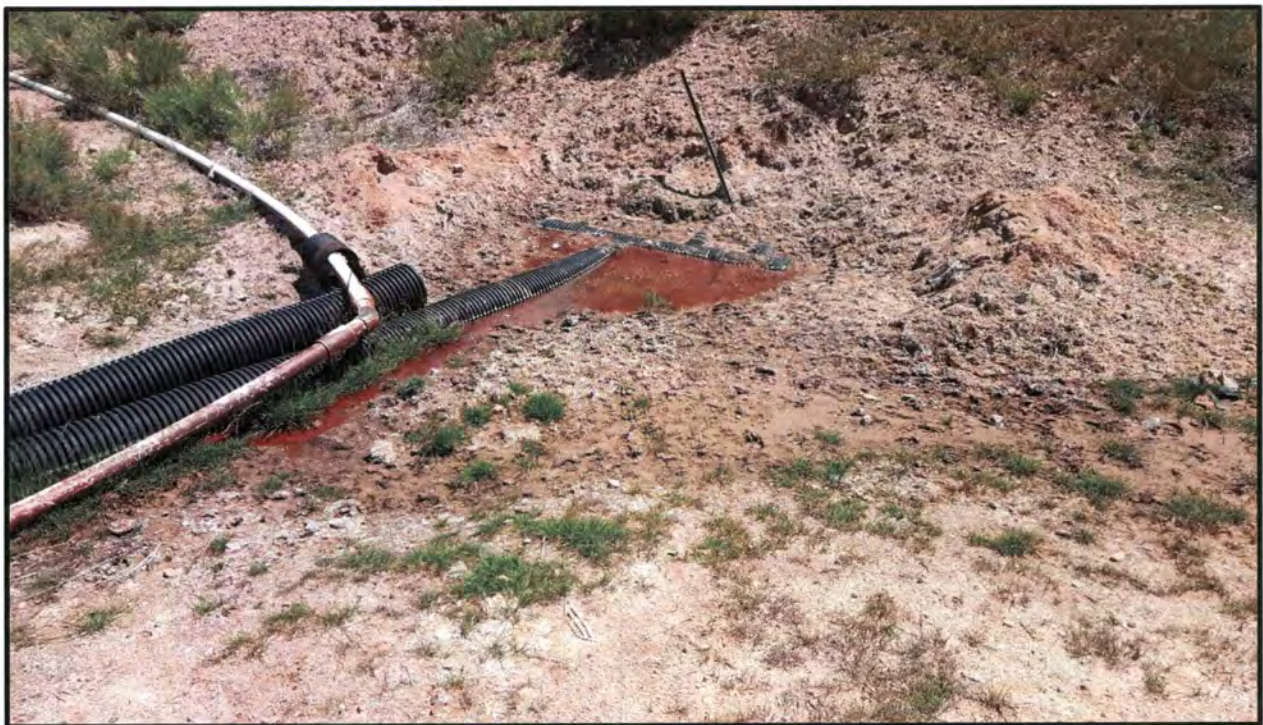
Photo 12 Looking northeast over the toe drain discharge pipes and pump-back line. Note 3 pipes draining to a single manifold, then to a single outfall pipe.

Seepage Underdrain Collection System: Continue the jetting and video inspection program to ensure the drain pipes do not become clogged. Consider installing a concrete structure for collecting underdrain flows from the toe drains to facilitate maintenance in the toe drain area, improve conditions for monitoring and inspecting the drain system, and to prevent the attraction of animals to the area by pooling of leakage from the drain pipes.

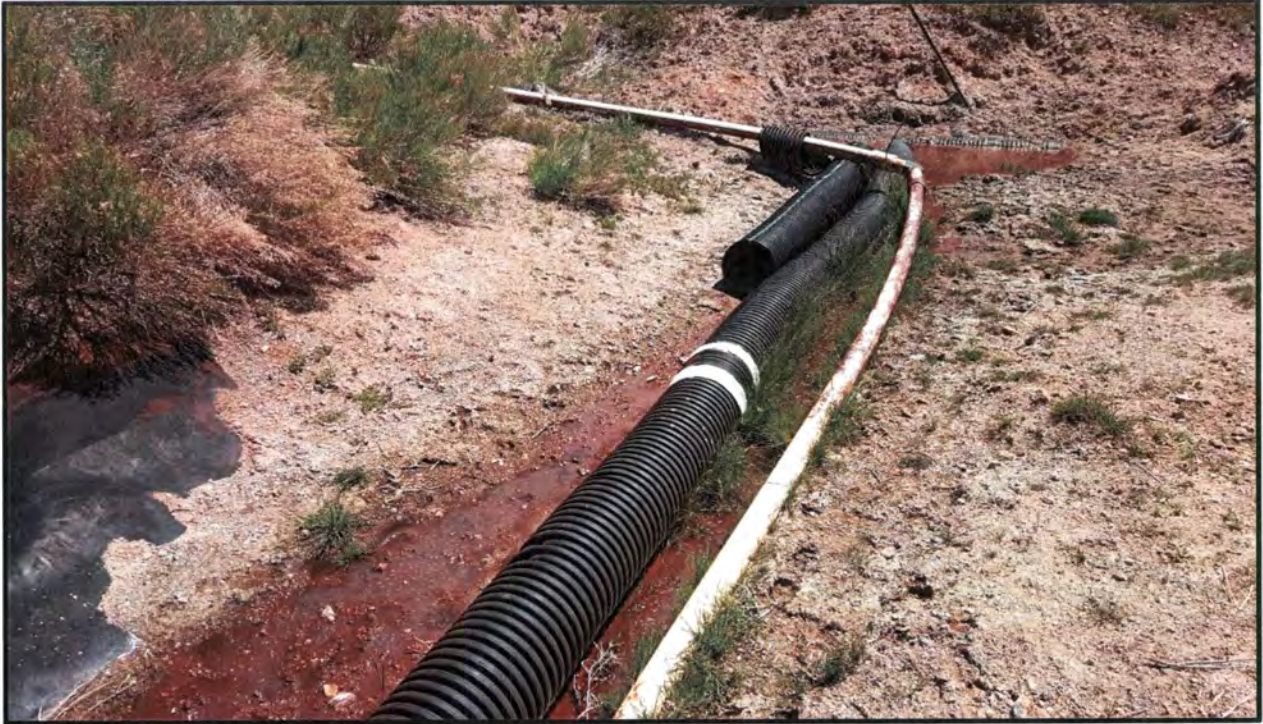
Photo 13 Looking east over the toe drain pipe (black) and pump-back line toward the outlet, showing generally good conditions. Note the low seepage flow conditions along the pipe in the lined channel.

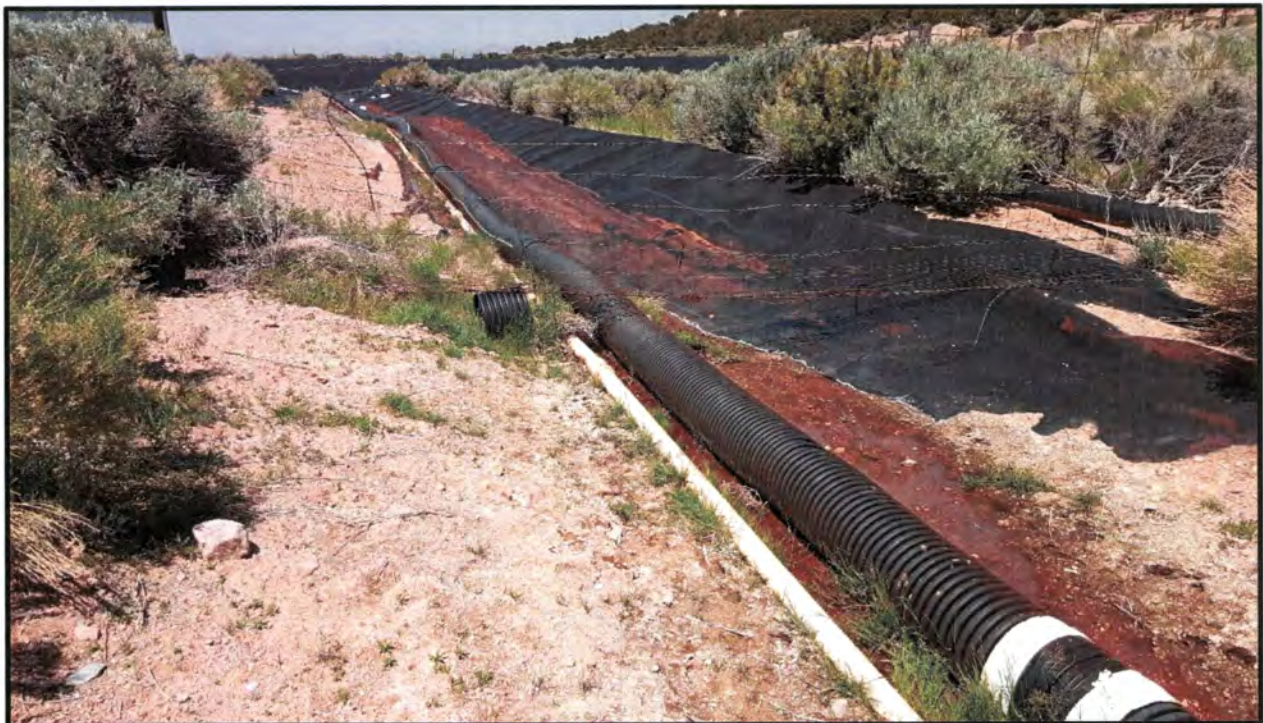
Photo 14 Looking west toward the seepage collection pond over the toe drain outfall pipe and pump-back line, showing generally good conditions. Note the low seepage flow conditions along the pipe in the lined channel.

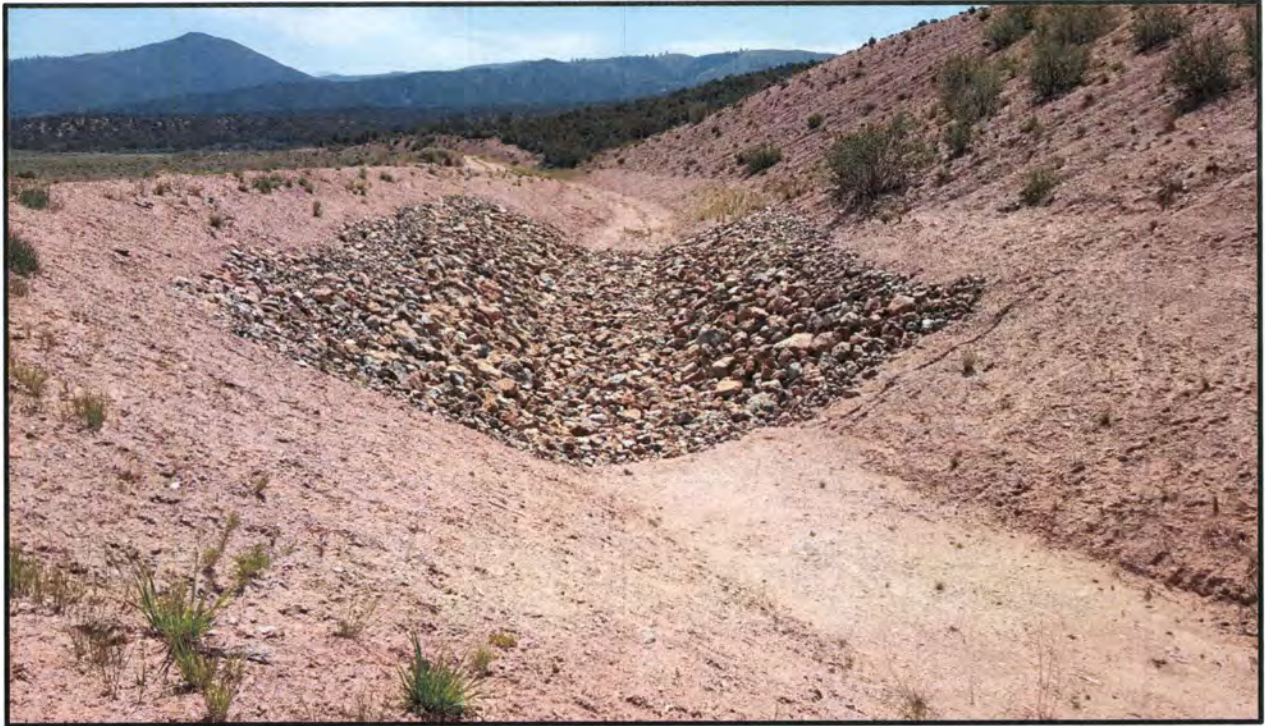
Photo 15 Looking east (upstream) at the South Diversion Channel from the east end of the drop structure, showing good conditions.

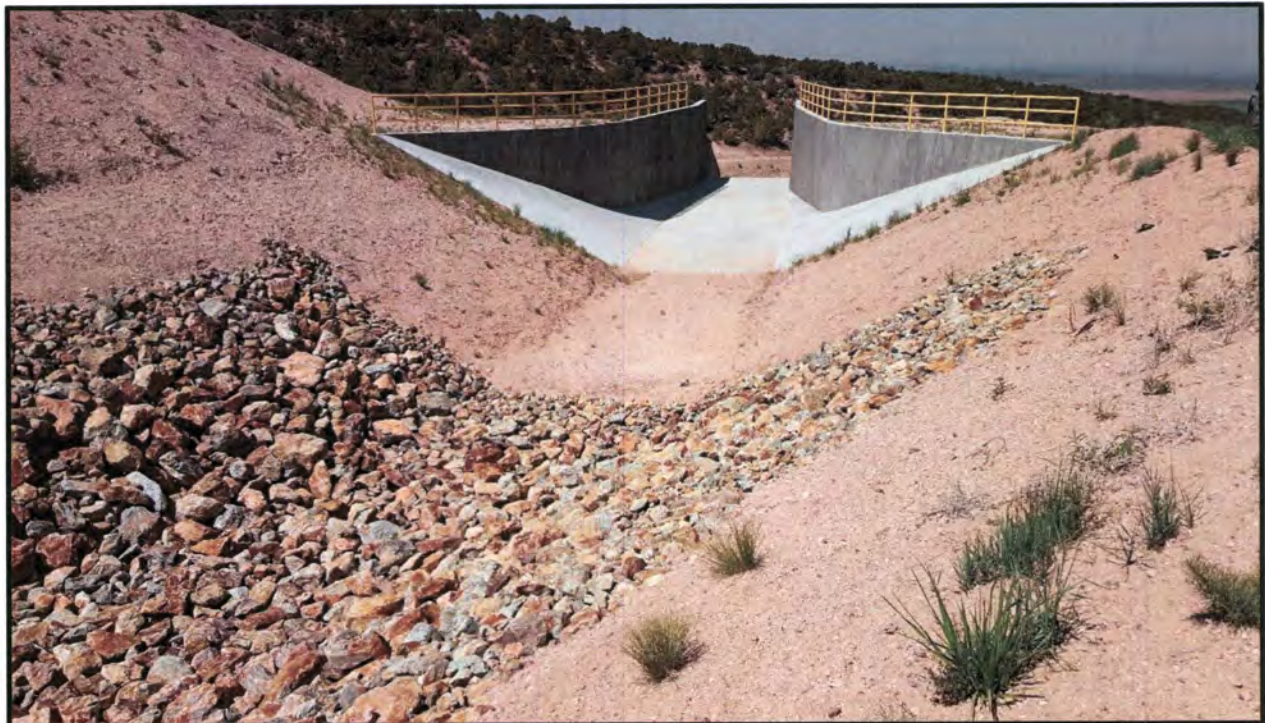
Photo 16 Looking west (downstream) at the South Diversion Channel toward the drop structure, showing good conditions.

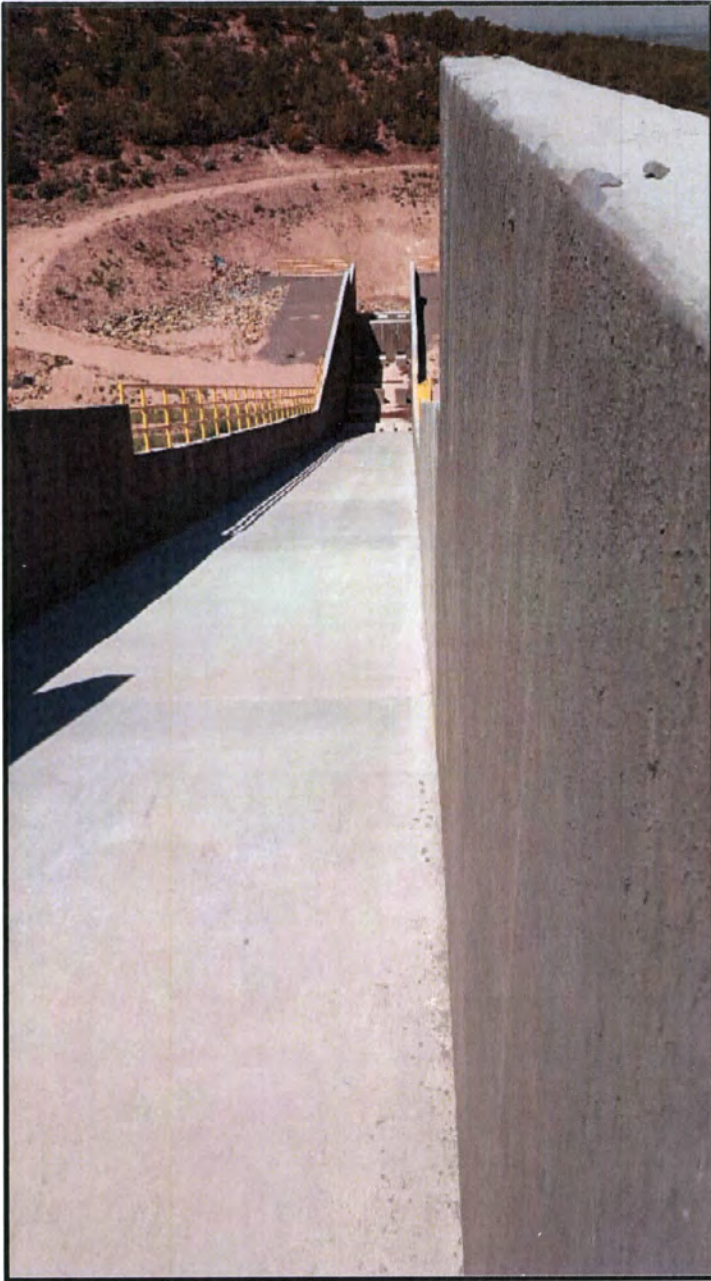
Photo 17 Looking west (downstream) into the drop structure from near the top, showing good conditions.

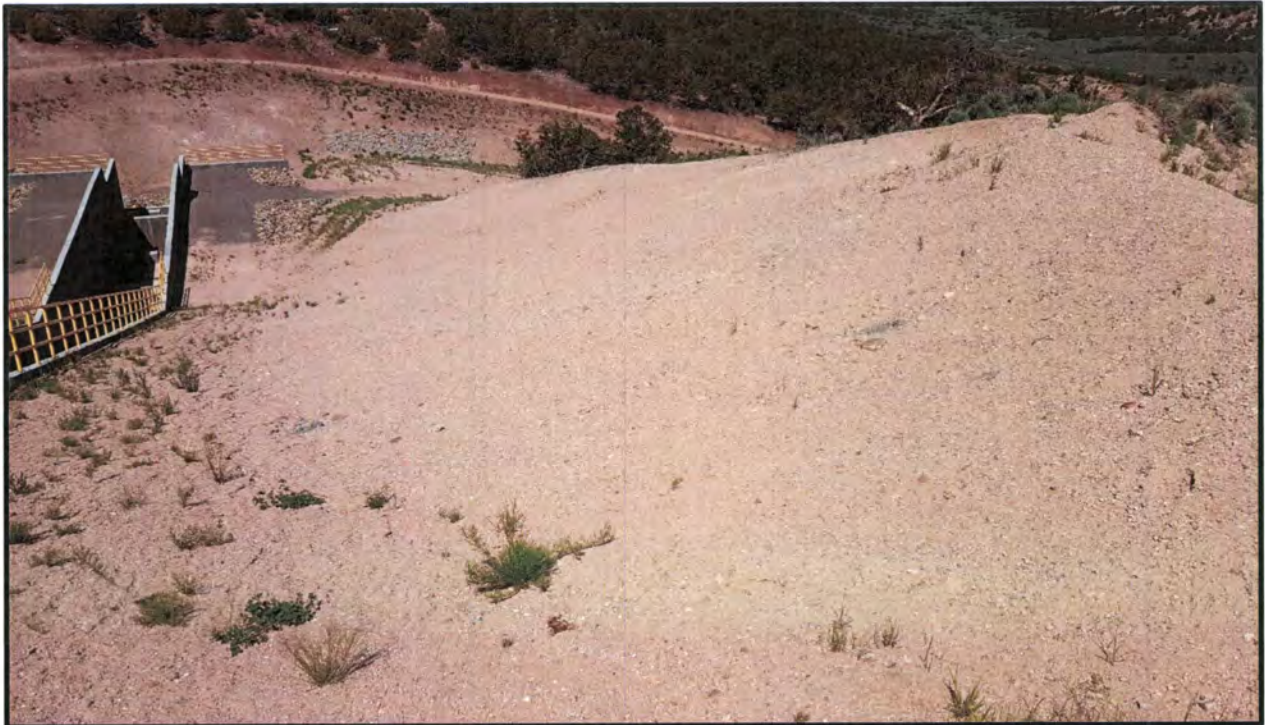
South Diversion Ditch Drop Structure: Disturbed areas adjacent to the drop structure that are not protected by riprap were seeded in 2019. However, vegetation establishment is poor to date due to extended drought conditions, and erosional rilling is beginning to develop in these areas. The condition is presently judged to be minor; however, erosion will progress in the absence of vegetation, and mitigation will likely be required in the coming years. Mitigation may entail erosion repair, erosion control blankets, revegetation, and/or cutting in shallow swales along the slope to reduce runoff flow path lengths.

- ☐ (40) NONE
 ☐ (41) NO EMERGENCY SPILLWAY
 ☒ (42) EROSION AT DROP STRUCTURE
 ☐ (43) CONCRETE DETERIORATED/UNDERMINED
 ☐ (45) STRUCTURE MAY BE TOO SMALL
 ☐ (46) DIVERSION CHANNEL EROSION
 ☐ (47) INADEQUATE CHANNEL FLOW CAPACITY
 ☐ (48) CHANNEL FLOW OBSTRUCTED
 ☒ (49) OTHER Rilling beginning right side of drop structure- continue monitoring.

Photo 18 Looking west at the slope on the north side of the drop structure, showing generally good conditions at present. Erosional rilling is beginning to develop at the lower portions of the slopes due to long drainage runs and the lack of vegetation.

| ITEMS REQUIRING ACTION BY OWNER TO IMPROVE THE SAFETY OF THE DAM | |
|---|---|
| <input checked="" type="checkbox"/> (8) MONITOR: Per Item 49, continue monitoring erosion along the side slopes of the drop structure. Erosion will likely progress in the absence of vegetation. Mitigation may require erosion repair, erosion control blankets, revegetation, and/or cutting in shallow swales along the slope to reduce runoff flow path lengths. | |

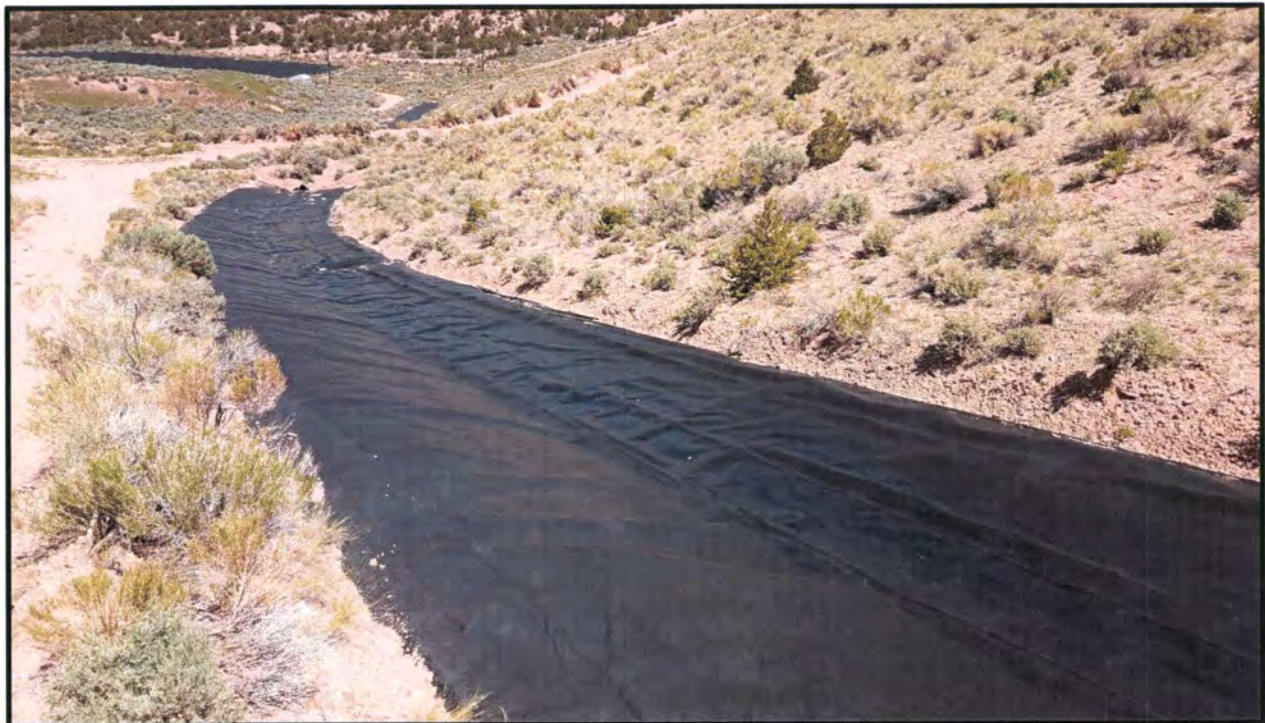
Photo 19 Looking northwest over the runoff collection swale along the left downstream dam toe, showing good conditions.

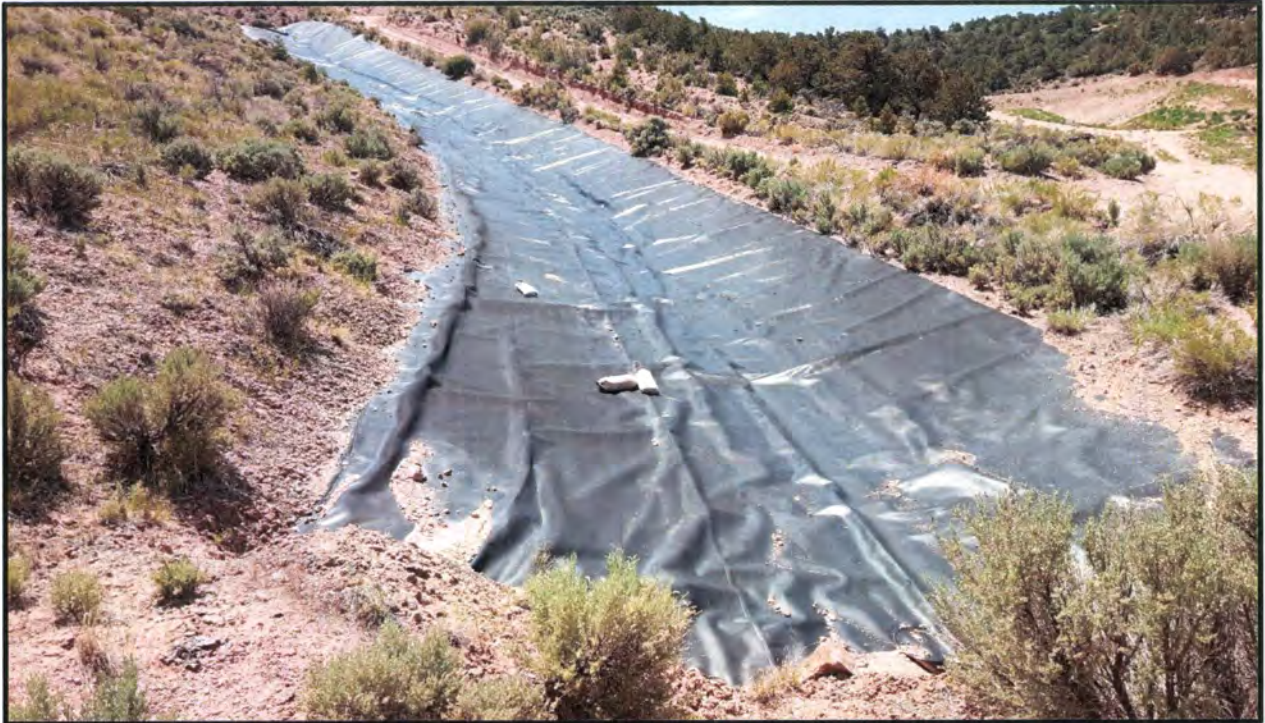
Photo 20 Looking southeast over the runoff collection swale along the left downstream dam toe, showing good conditions.

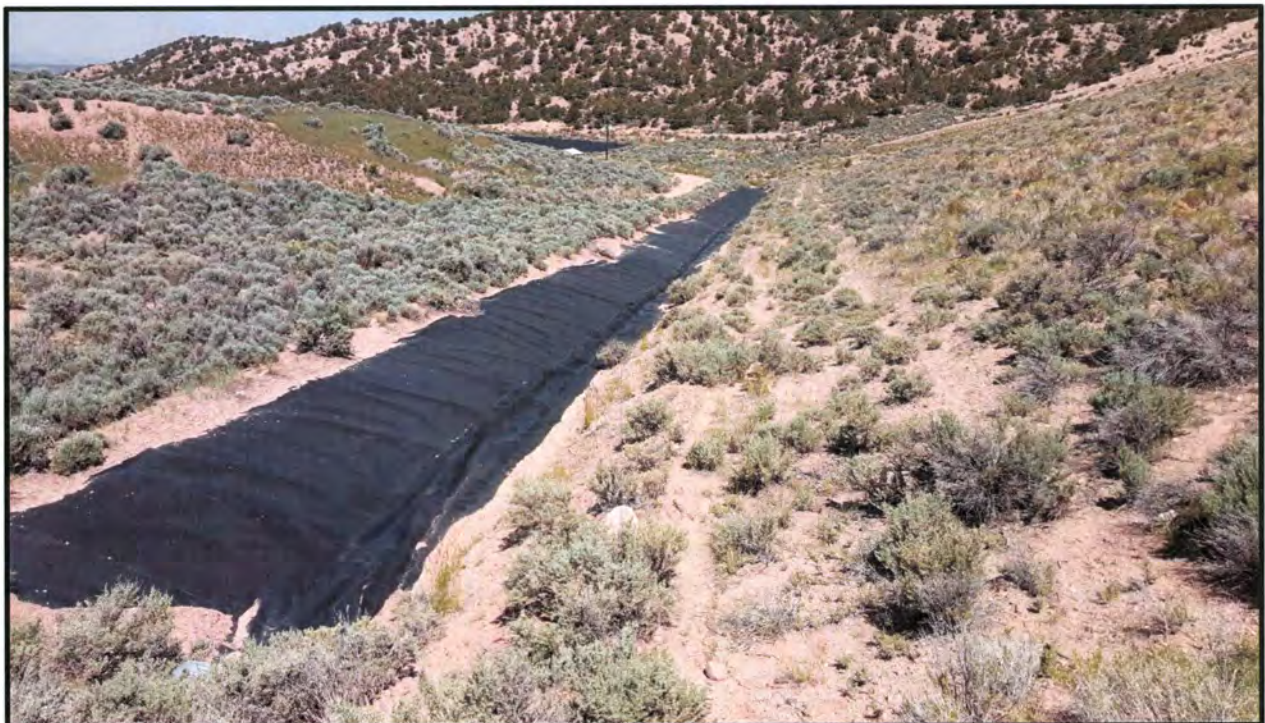
Photo 21 Looking northwest over the lower runoff collection swale along the left downstream dam toe, showing good conditions.
