PERMIT INFORMATION

Permit Number: C-1981-015 Mine Name: Fruita No 1 & 2 Operator: Dorchester Coal Company Operator Address: Greg Lewicki 9054 South Forrest Drive Highlands Ranch, CO 80126	County: Mesa Operation Type: Underground Permit Status: Revoked Ownership: Private
	Operator Representative Present: NA
Operator Representative Signature: (Field Issuance Only)

INSPECTION INFORMATION

Inspection Start Date: March 23, 2022 Inspection Start Time: 11:30 Inspection End Date: March 23, 2022 Inspection End Time: 12:15	Inspection Type: Coal Complete Inspection Inspection Reason: Normal I&E Program Weather: Clear	
Joint Inspection Agency: None	Joint Inspection Contacts: None	
Post Inspection Agency: None	Post Inspection Contacts: None	
Inspector(s): Clayton Wein	Inspector's Signature: <i>Clayton Wein</i>	Signature Date: 3/24/2022

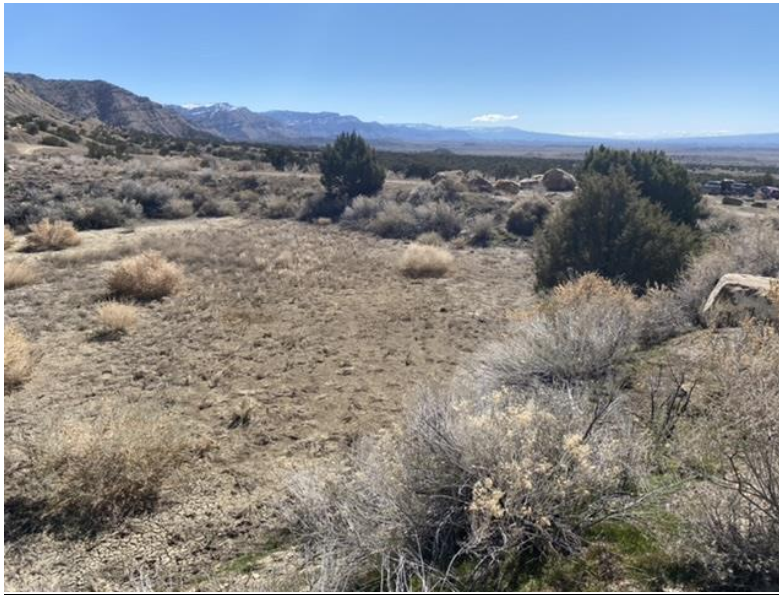
The sediment pond is located at the southern portion of the permit boundary. The embankments were stable with vegetative cover (Photo 1). There were no indications of erosional features. The riprap lining the pond's outlet was stable and in good condition. The pond was dry during the inspection. The reclaimed haul road was stable with vegetative cover (Photos 2 and 3). Some of the small plants and grasses were beginning to green up. The rills on the reclamation have been identified and documented in previous Division inspection reports. The rills were observed to be in the same condition as previous inspections. The rills have reached a stable state and do not appear to be affecting the reclamation's stability. The slope of the reclaimed portal bench was observed to be stable. This slope is south-facing and is sparsely covered with vegetation (Photo 4). There were no indications of erosional concerns during this inspection. The riprap lined channel extending from the top of the reclaimed bench to the base of the slope was stable. The reclaimed portal bench was covered with vegetation and stable. There were no new erosional features identified. The gully on the bench has been documented in previous Division inspection reports. The gully appeared to be the same size as in previous inspections. The gully seems to be stable and does not affect the reclamation's stability.

Photo 1: The southern embankment of the sediment pond.

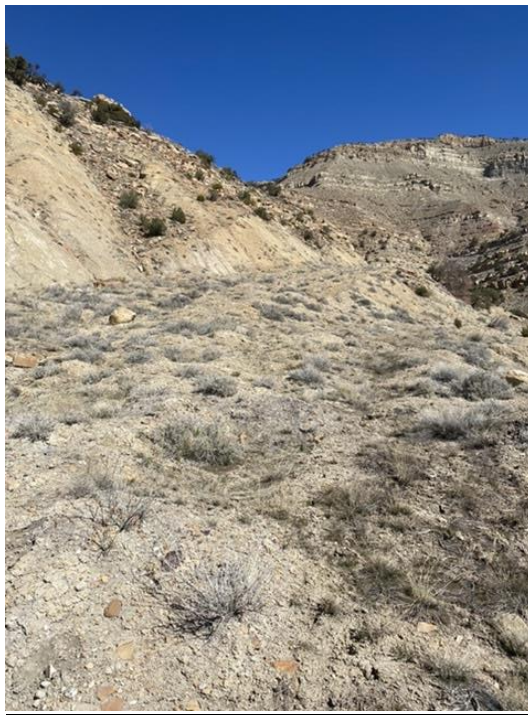
Photo 2: The lower portion of the reclaimed haul road.

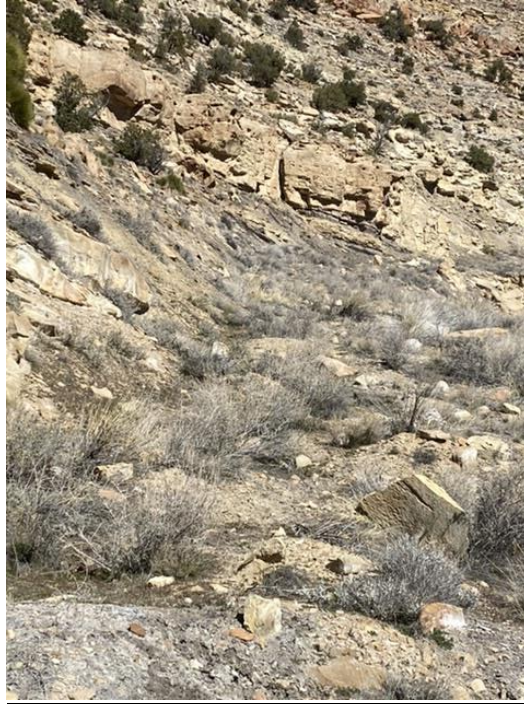
Photo 3: The upper portion of the reclaimed haul road.

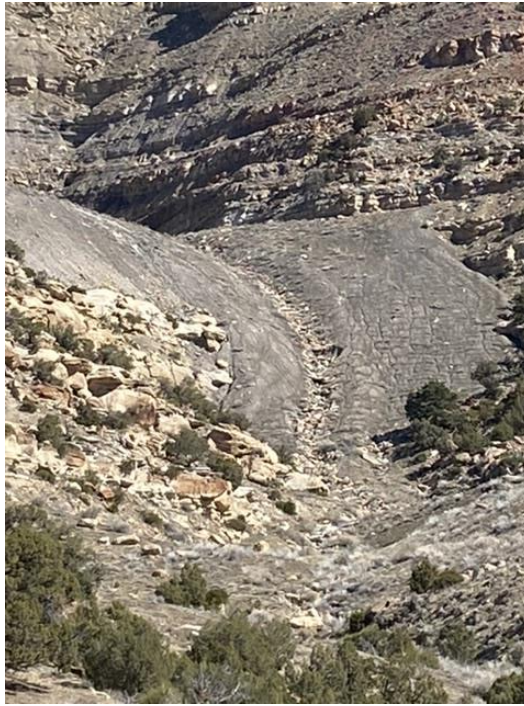
Photo 4: The reclaimed slope of the portal bench.
