MINERALS PROGRAM INSPECTION REPORT
PHONE: (303) 866-3567

MINE NAME: Cresson Project	MINE/PROSPECTING ID#: M-1980-244	MINERAL: Gold	COUNTY: Teller
INSPECTION TYPE: Aerial Inspection	INSPECTOR(S): Elliott Russell	INSP. DATE: March 1, 2022	INSP. TIME: 15:00
OPERATOR: Cripple Creek & Victor Gold Mining Company	OPERATOR REPRESENTATIVE: None	TYPE OF OPERATION: 112d-3 - Designated Mining Operation	
REASON FOR INSPECTION: Normal I&E Program	BOND CALCULATION TYPE: None	BOND AMOUNT: \$209,491,188.00	
DATE OF COMPLAINT: NA	POST INSP. CONTACTS: None	JOINT INSP. AGENCY: None	
WEATHER: Clear	INSPECTOR'S SIGNATURE:

SIGNATURE DATE: March 24, 2022

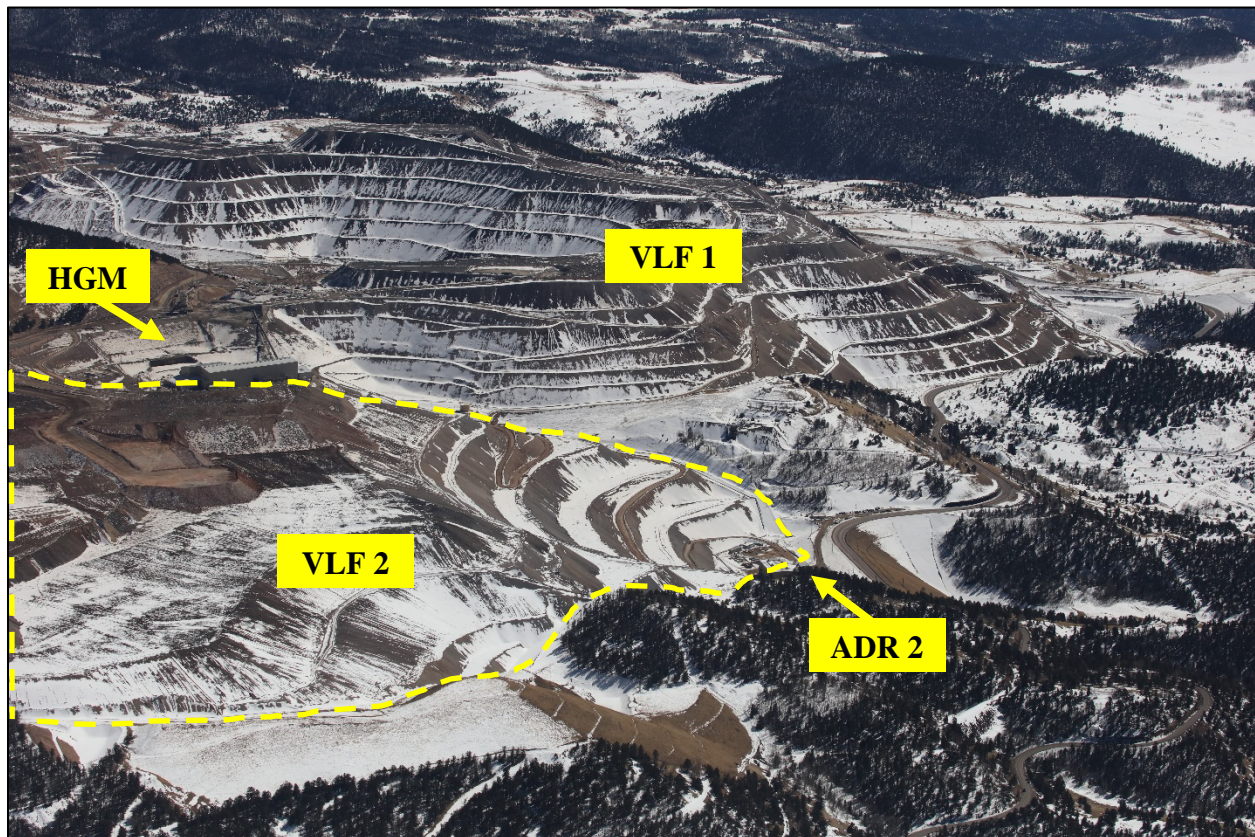
Aerial images of the two Valley Leach Facilities (VLF 1 and VLF 2) are used to perform a broad visual inspection for ponded solution, slope stability concerns, ore stacking compliance, and other potential issues that cannot easily be obtained from the ground (see **Photo 1**). No ponded process solution was observed in the active leach areas of VLF 1 (see **Photo 2** and **Photo 3**). No observable issues are noted for VLF 1. No ponded process solution was observed in the active leach areas of VLF 2. Active ore stacking was occurring in the central portion of VLF 2 and consisted of Run of Mine (RoM) material (see **Photo 4**). Active ore stacking appeared to be in compliance with the stacking guidelines provided in TR103, however, the Division is reviewing the TR103 operational ore slopes and minimum bench widths and will add this as an area of focus in a future regular inspection.

Photo 1. VLF 1 and VLF 2 (outlined) overview; looking southeast.

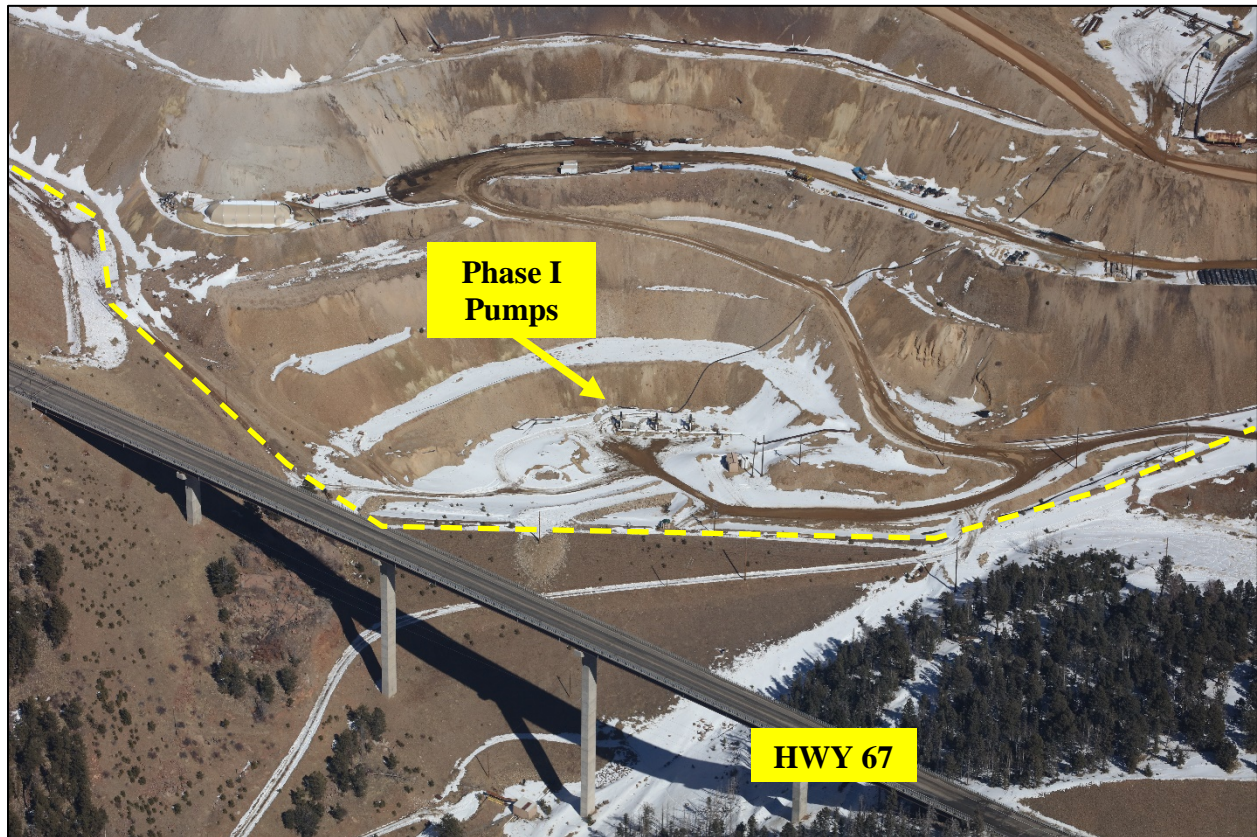
Photo 2. VLF 1, approximate Edge of Liner highlighted; looking northeast.

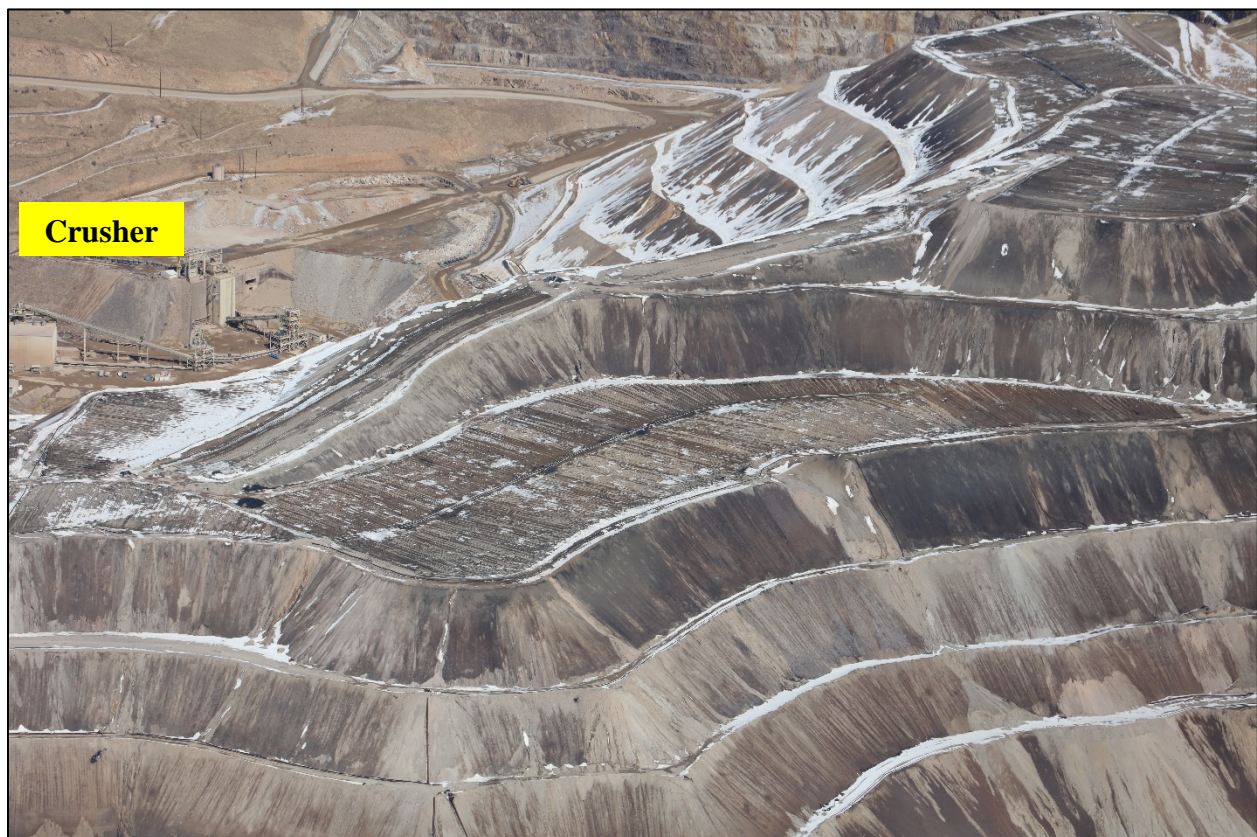
Photo 3. VLF 2; looking southeast.

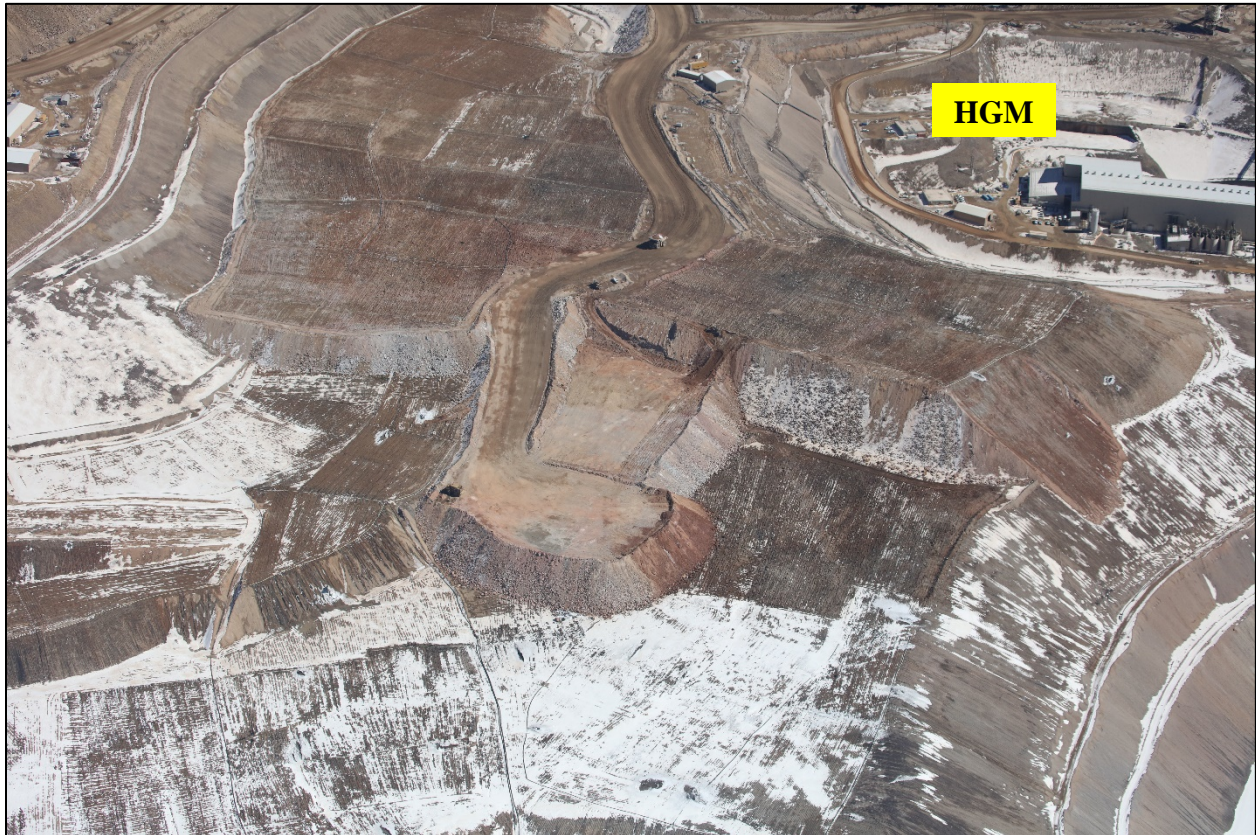
Photo 4. VLF 2 active ore stacking; looking southeast.

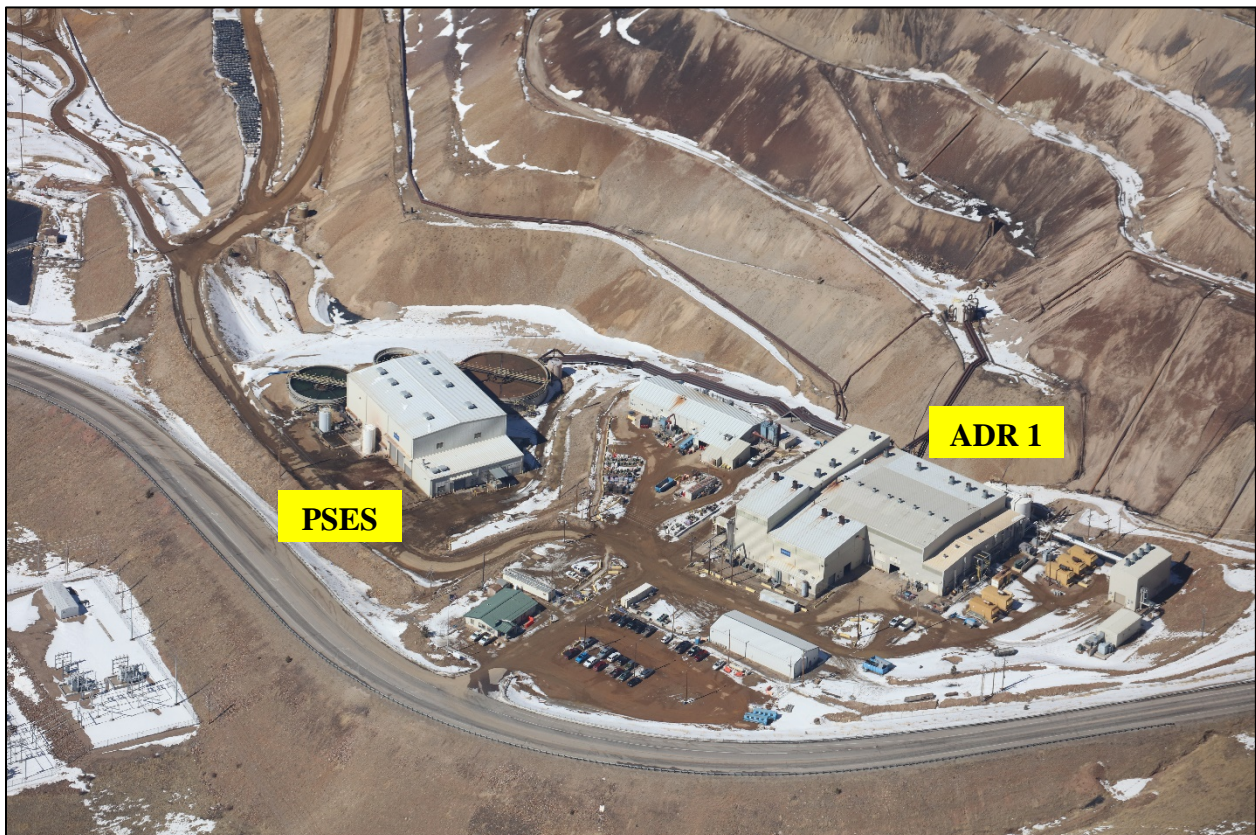
Photo 5. ADR 1 and PSES; looking northwest.

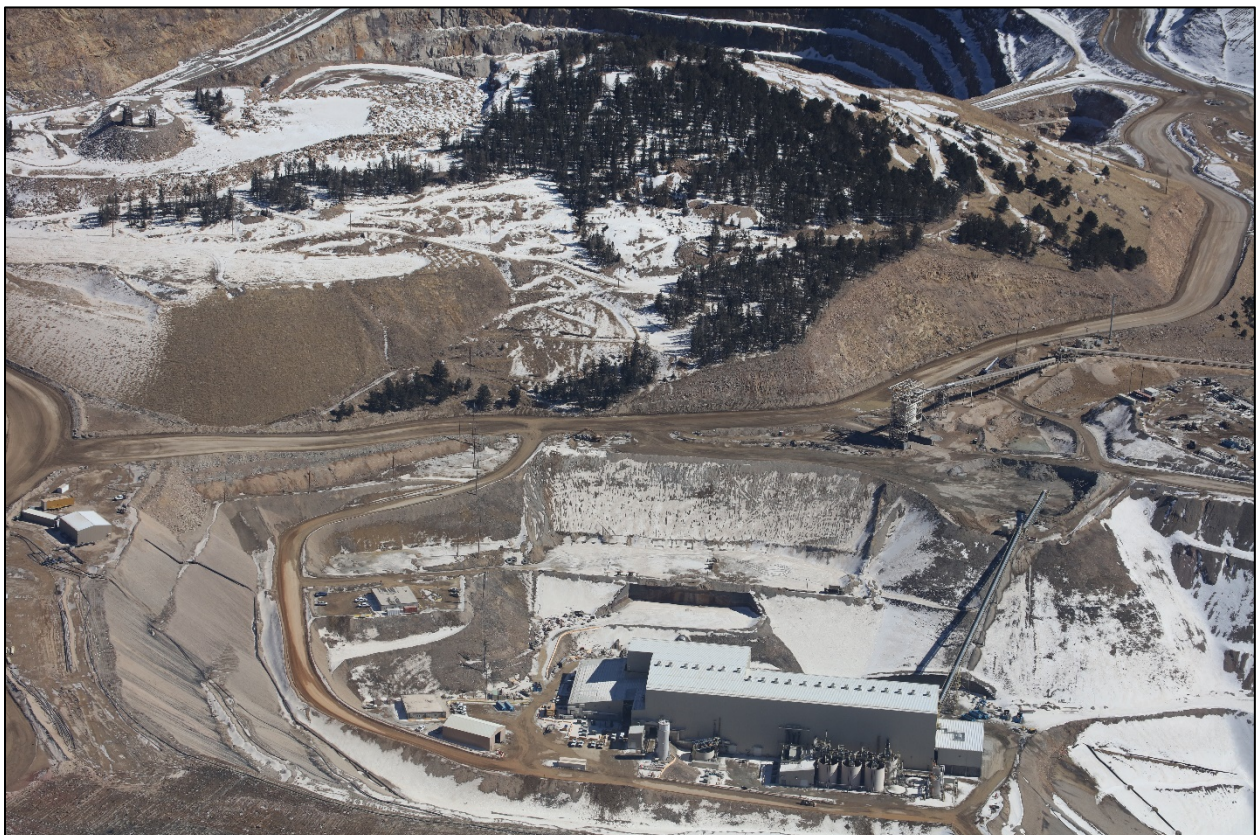
Aerial images of the two Adsorption, Desorption, and Recovery Facilities (ADR 1 and ADR 2), the Process Solution Enhancement System Facility (PSES), and the High Grade Mill (HGM) are used to perform a broad visual inspection for leaks, spills, secondary containment problems, and other potential issues that cannot easily be obtained from the ground. The ADR 1 and the PSES are both located on the south side of VLF 1 (see **Photo 5**). The ADR 2 is located on the west side of VLF2 (see **Photo 6**). The HGM is located between VLF 1 and VLF 2 (see **Photo 7**). No observable issues are noted for ADR 1, PSES, ADR 2, or the HGM facilities.

Photo 7. HGM; looking southeast.

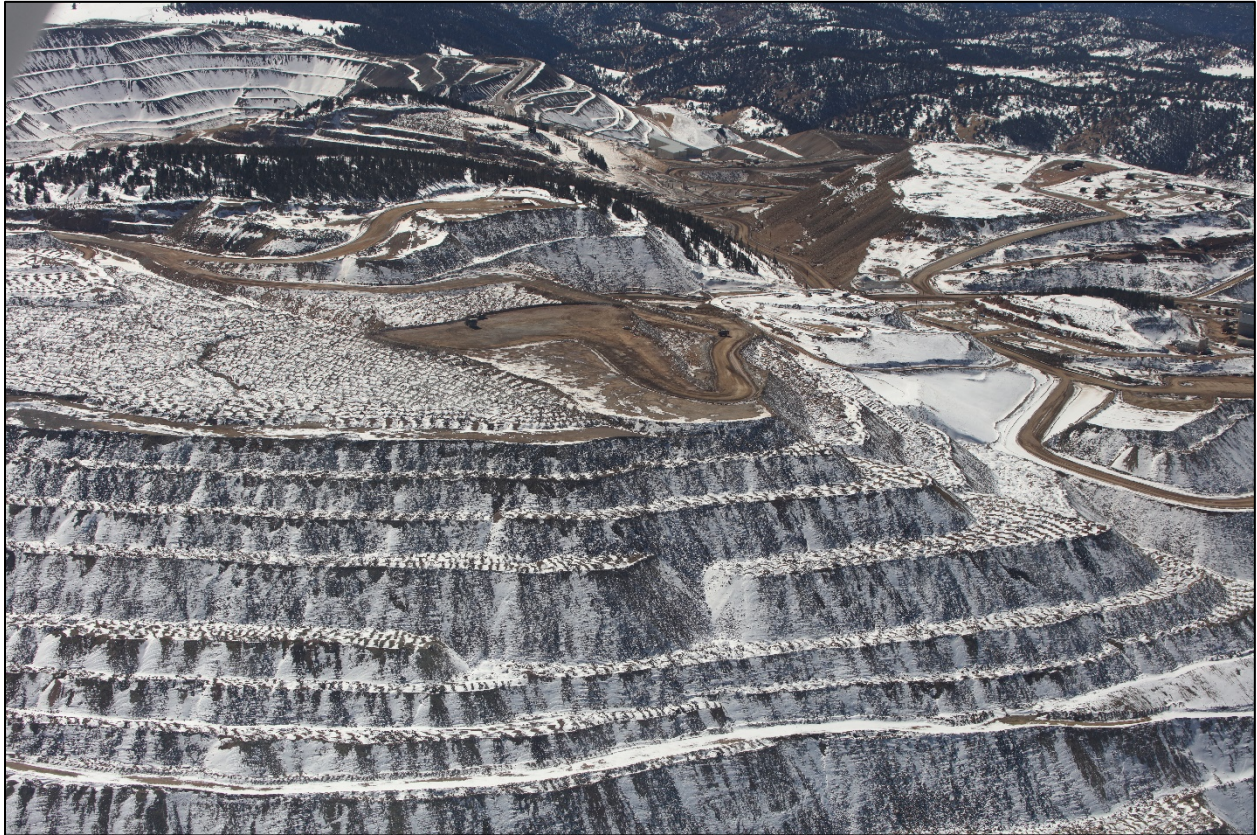
Active overburden placement was occurring on the western portion of the ECOSA (see **Photo 8**). In 2020 and 2021, the Operator conducted concurrent reclamation on the eastern portion of the ECOSA. The 2020 reclamation area is located at the far eastern edge of the ECOSA and consists of slope grading, topsoil replacement, and initial seeding. The 2021 reclamation area is just adjacent to the 2020 area to the west and currently consists of partially completed slope grading on the upper half of the ECOSA. Clay was being mined from the area just below the 2020 reclamation area at the time of the aerial inspection (see **Photo 9**).

Photo 8. Active overburden material placement on the ECOSA; looking southwest.

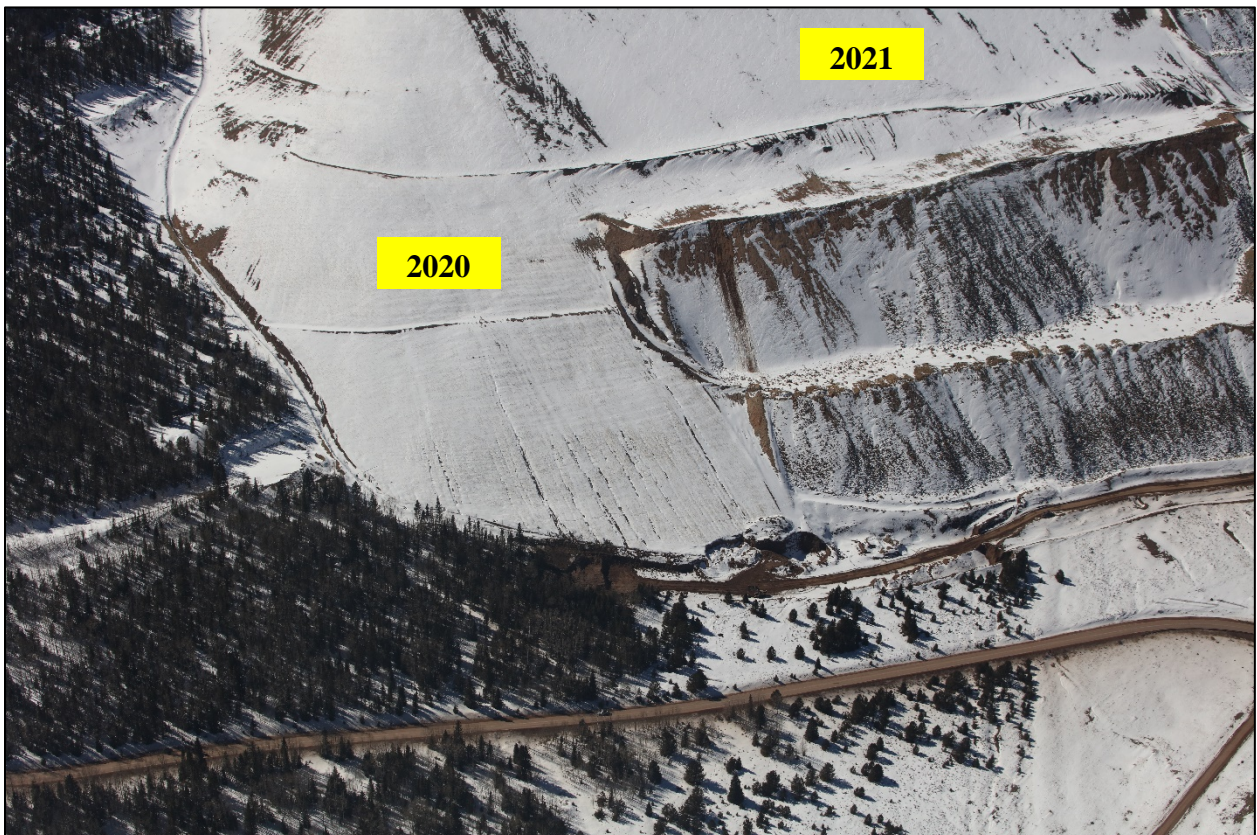
Photo 9. Concurrent reclamation areas of the ECOSA; looking southwest.

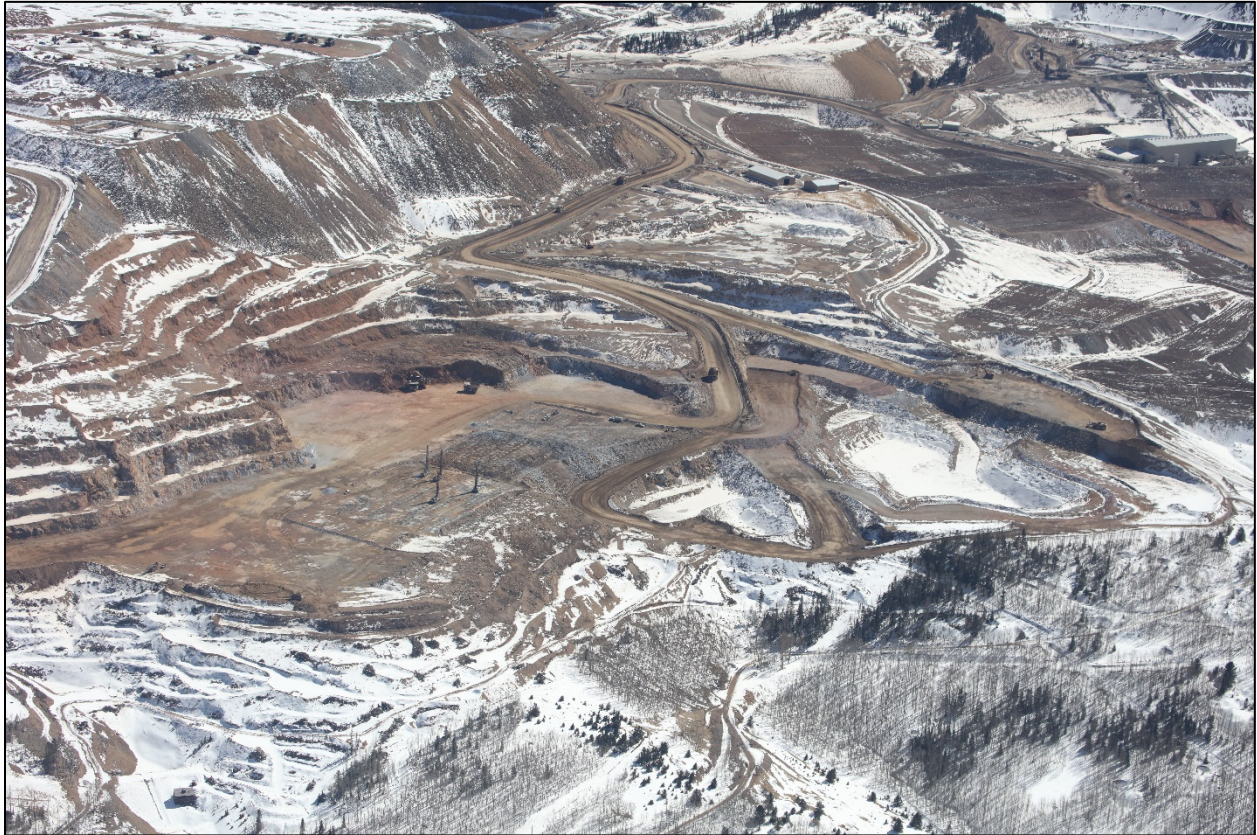
Photo 10. Schist Island Pit; looking southeast.

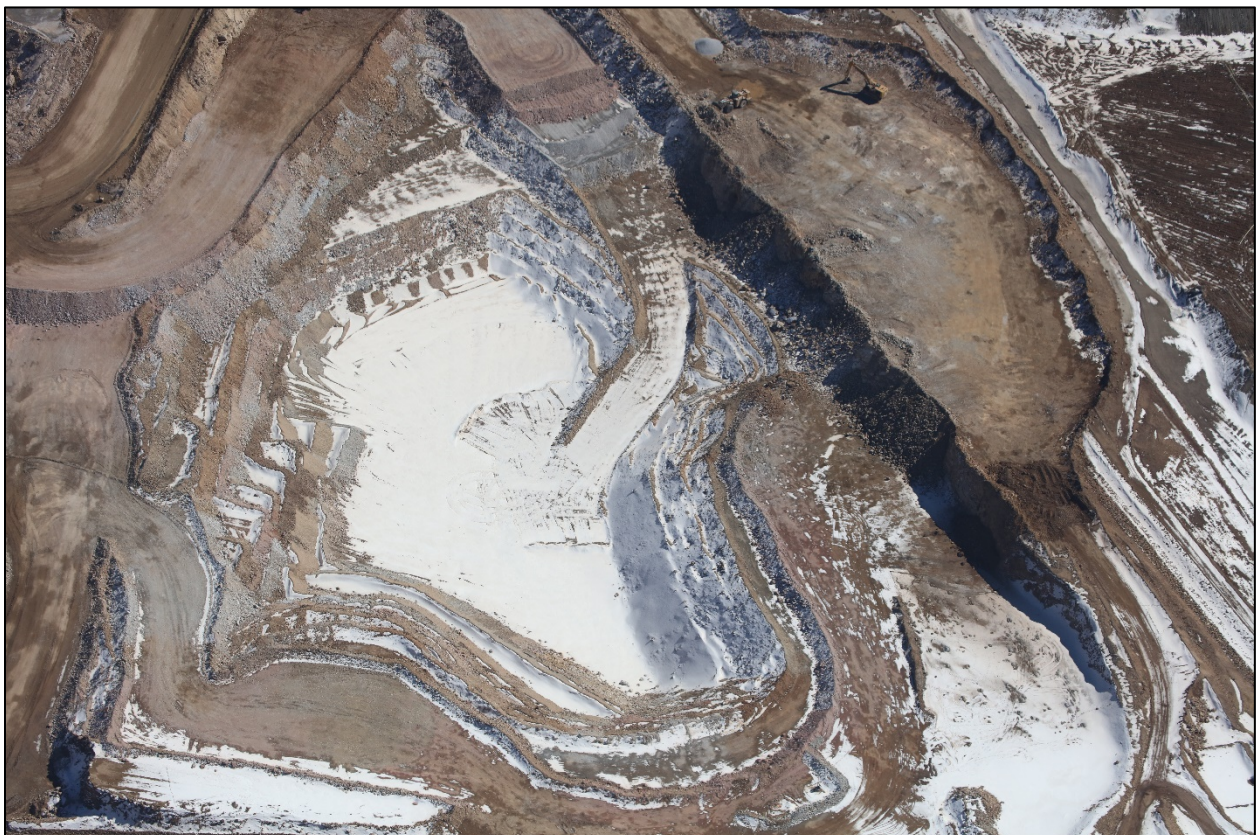
Photo 11. Backfilled area of Schist Island Pit for VLF 2 - Phase 3; looking east.

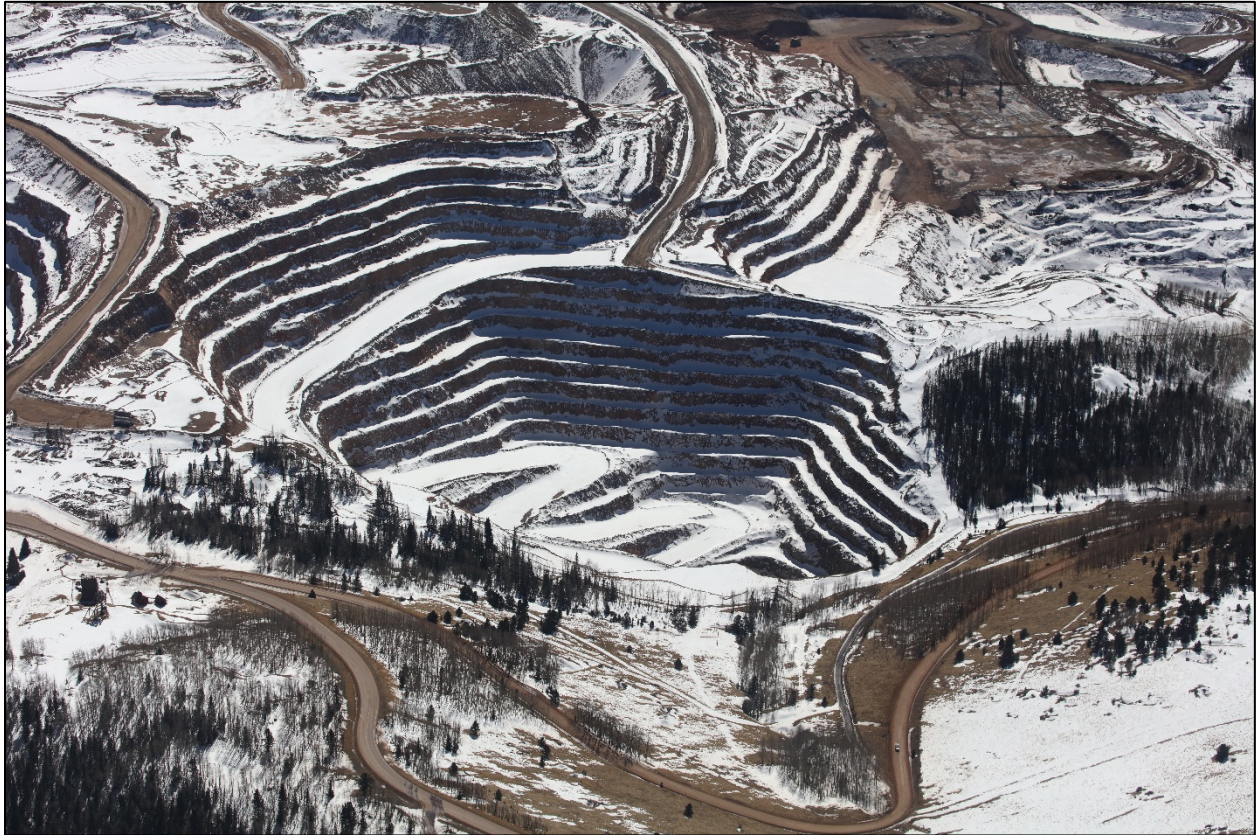
Photo 12. Globe Hill Pit; looking southeast.

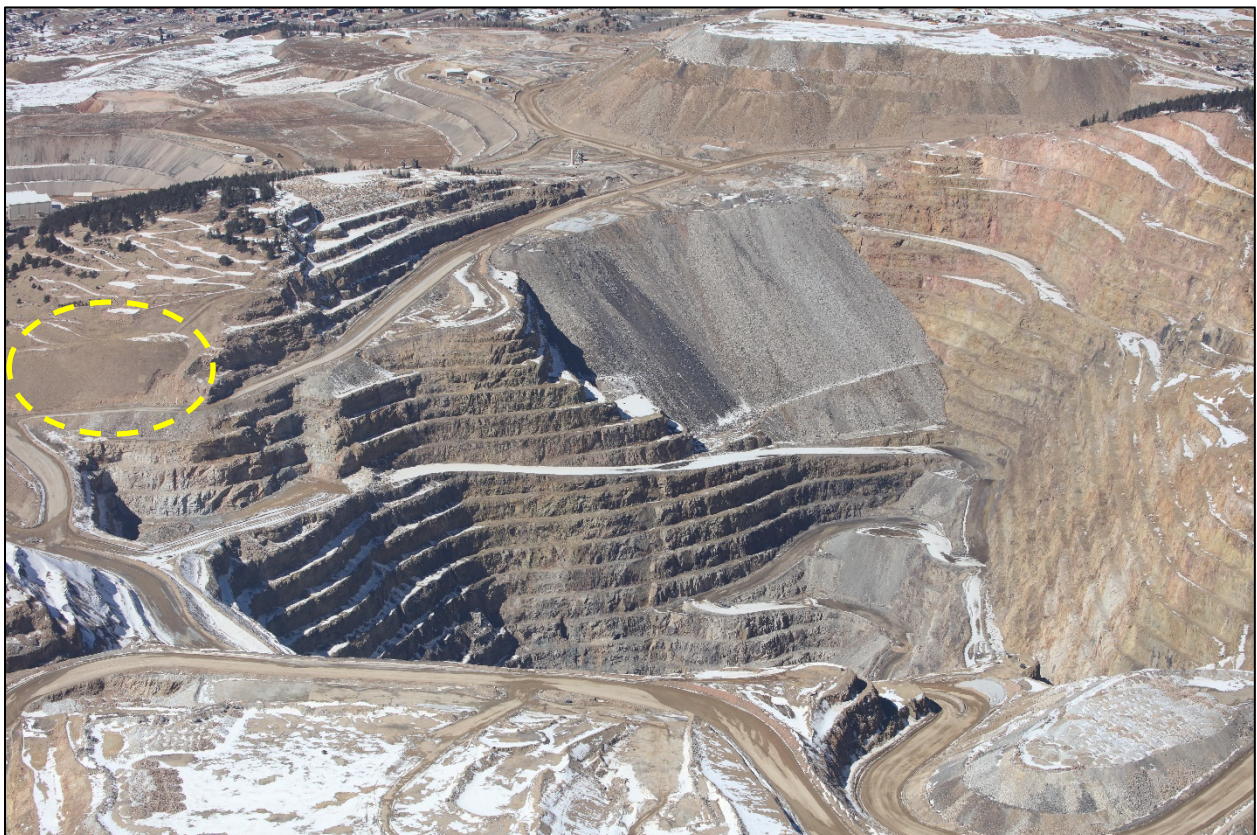
A small portion of Topsoil Stockpile #32 has sloughed (see **Photo 13** and **Photo 16**). It appears this slope failure has occurred due to the rerouting of an access/haul road constructed near the toe of the topsoil stockpile to support mining in the West Cresson Layback area (as named within AM13 Adequacy Review Response #3). The Division will add this as an area of focus in a future regular inspection.

Photo 13. Main Cresson Pit, Topsoil Stockpile #32 circled; looking northwest.

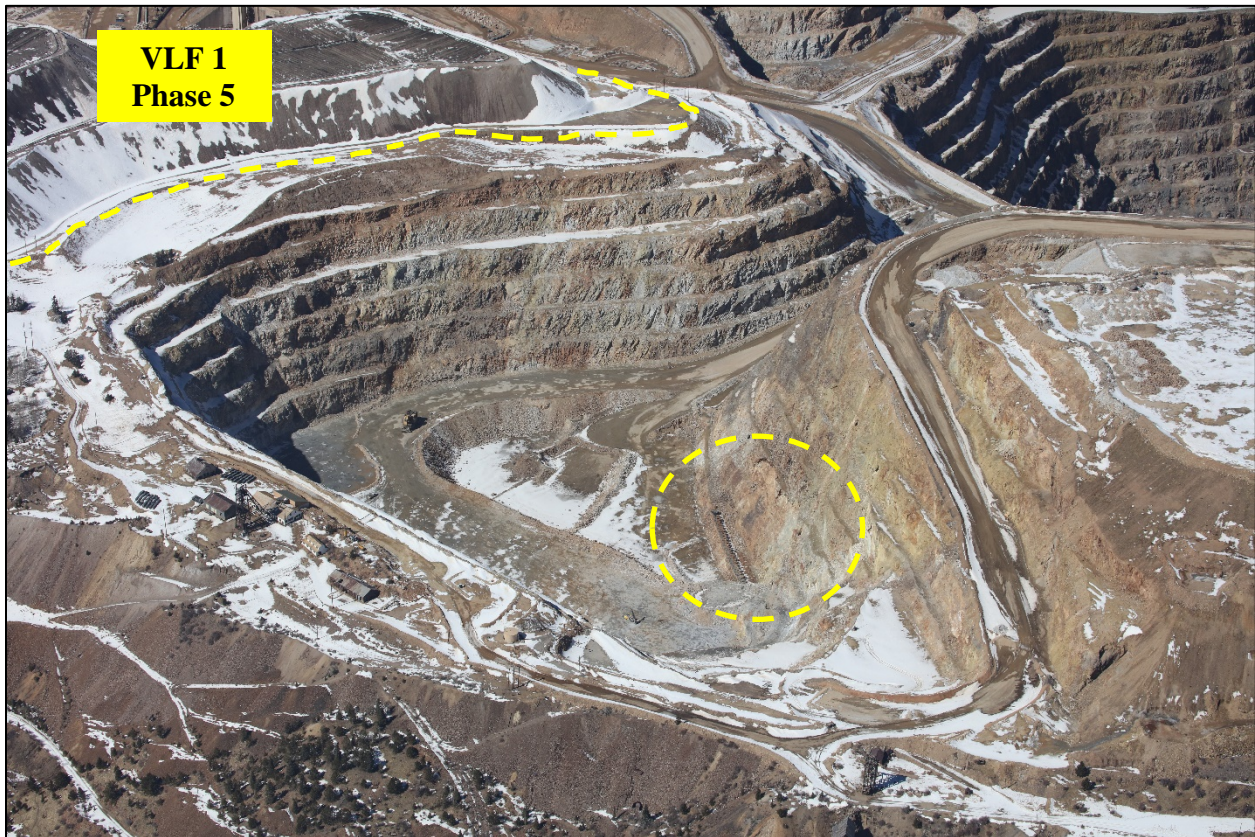
13), Main Cresson (see **Photo 14**), and South Cresson Pits (see **Photo 15**) are presented for comparison with previous aerial inspection reports. Based on aerial photos taken at the time of the inspection, active mining was occurring in the Schist Island Pit. Based on a review of Photo 15, there appears to have been a small area of highwall bench failure within the Schist Island Pit; the Division will add this as an area of focus in a future regular inspection.

Photo 14. South Cresson Pit, highwall bench failure circled; looking northwest.

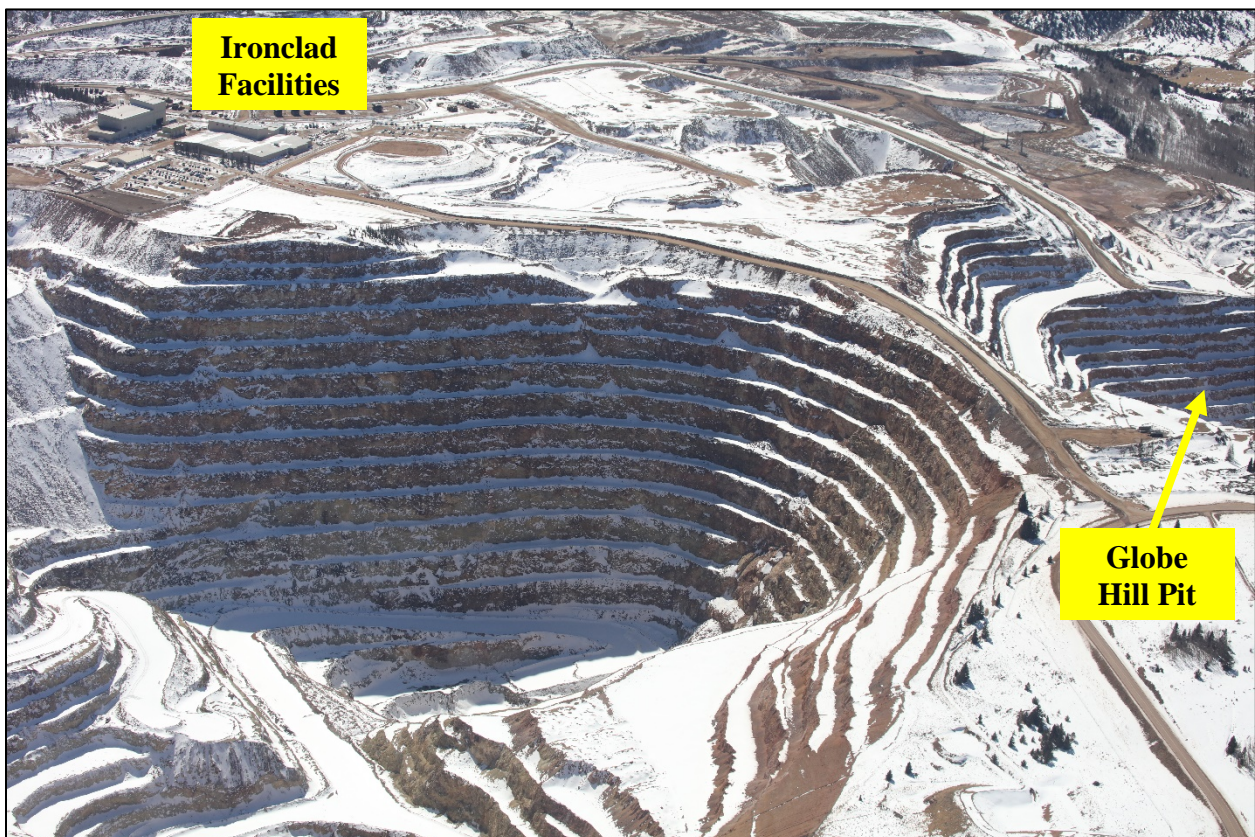
Photo 15. WHEX Pit; looking southwest.

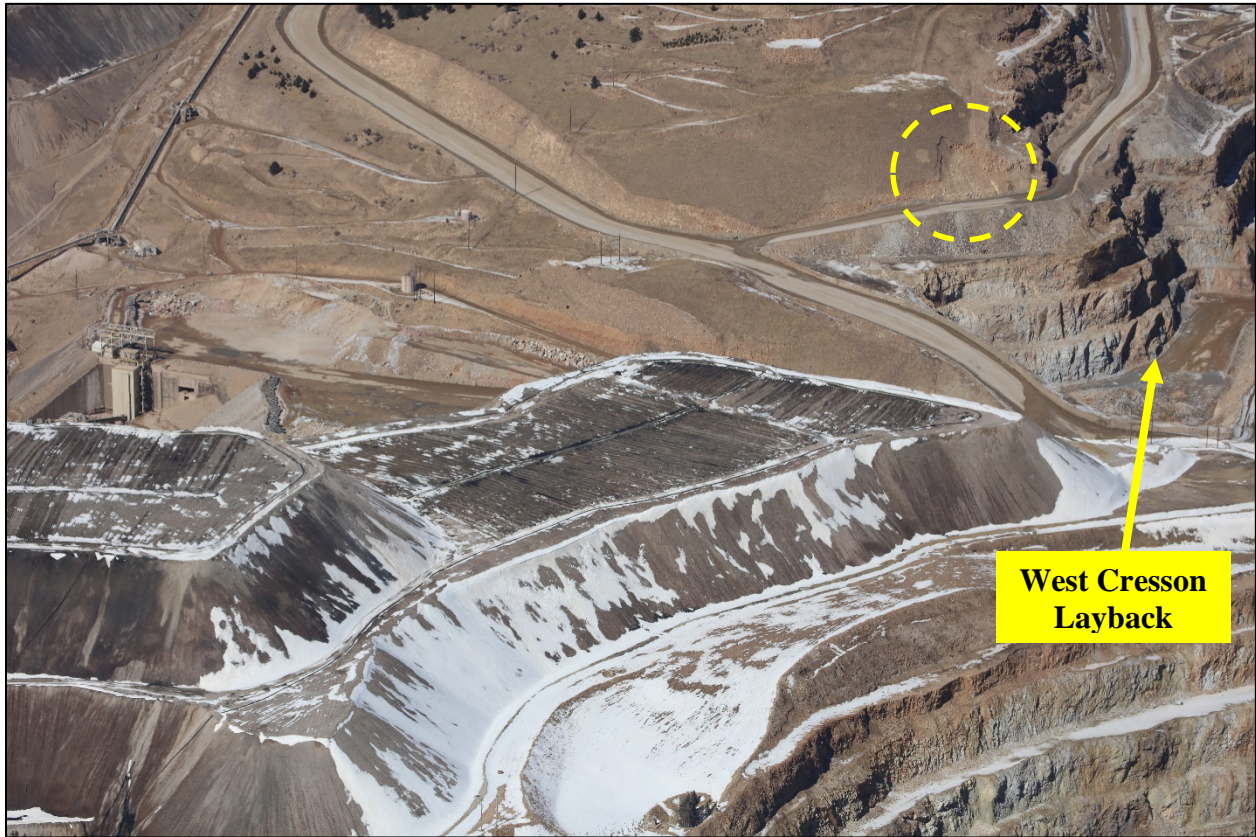
Photo 16. Topsoil Stockpile slope failure (circled); looking north.
