## Two views south to north along the central axis of the pit

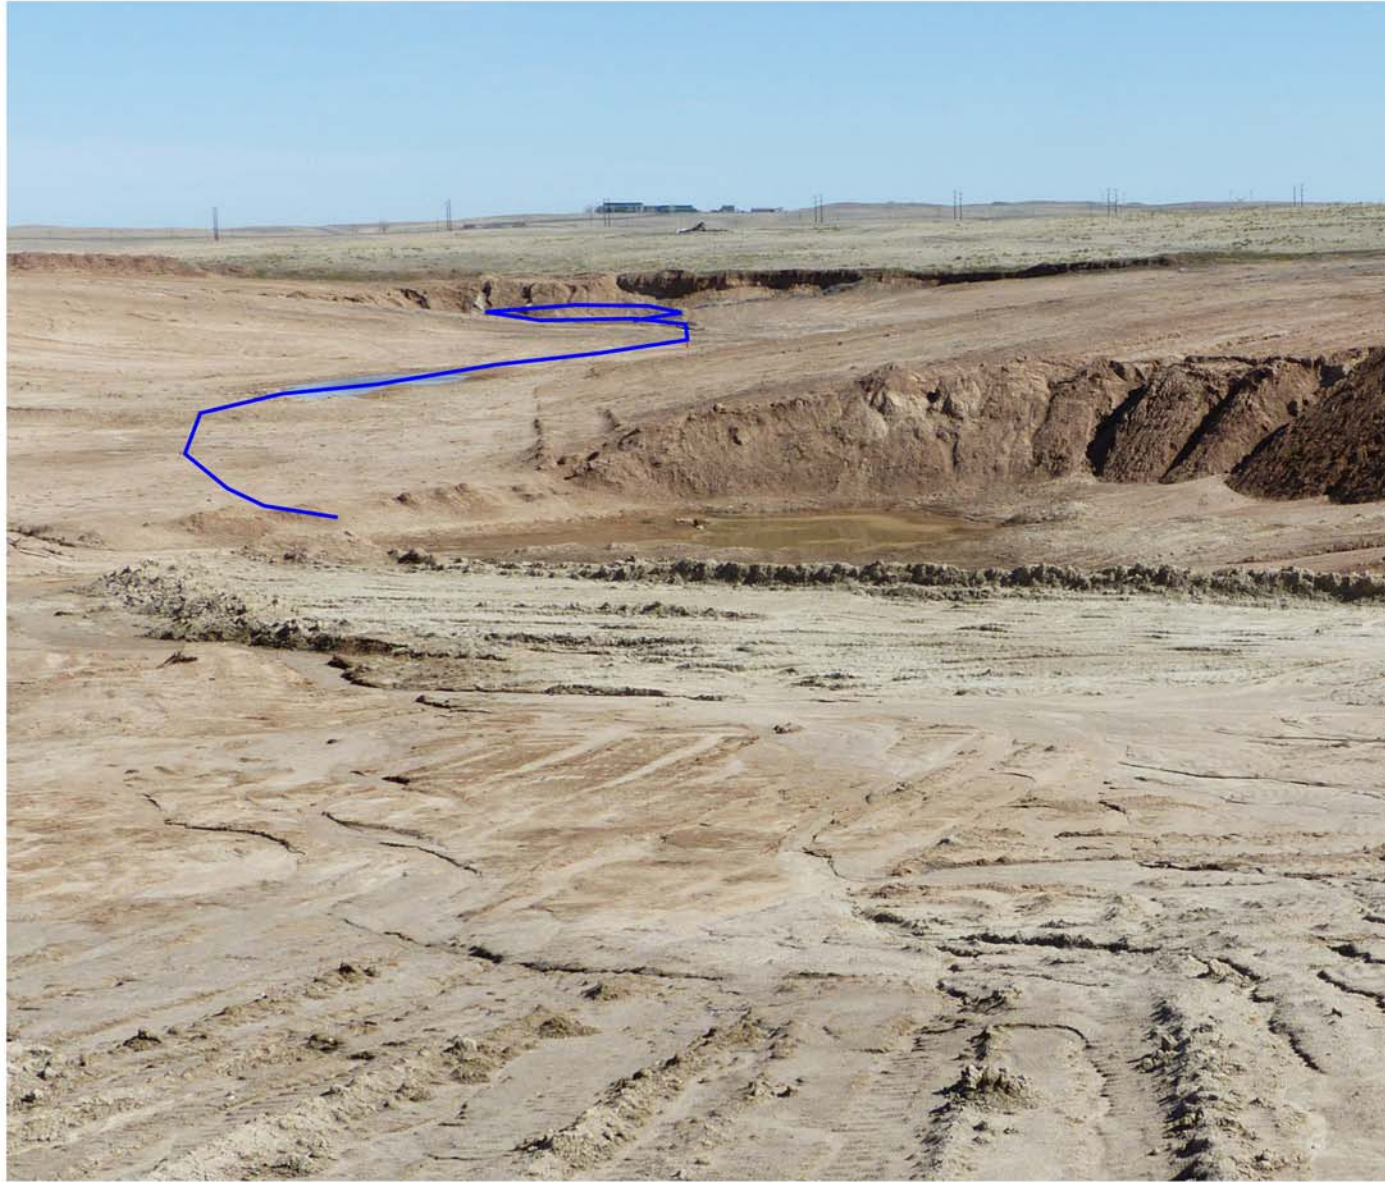
April 6, 2020

During the operation of the pit, water discharge from the pit area into an adjacent drainageway and via the original drainage from this area prior to mining was not allowed due to a large barrier that was constructed at the outlet. Eventually the outlet area was mined for sand leaving a deep hole where water from the entire pit would collect after large thunderstorms. This maintained a complete surface disconnect between the pit area and the adjacent drainage.

Note: The elevation difference between the original and the new flow line - as shown in the adjacent photo - is a matter of inches.
