MINERALS PROGRAM INSPECTION REPORT
PHONE: (303) 866-3567

MINE NAME: Journey Ventures Pit	MINE/PROSPECTING ID#: M-2008-080	MINERAL: Aggregate, gravel and sand	COUNTY: Weld
INSPECTION TYPE: Monitoring	INSPECTOR(S): Peter Hays	INSP. DATE: March 3, 2022	INSP. TIME: 13:30
OPERATOR: Journey Ventures, LLC	OPERATOR REPRESENTATIVE: Chris Leone	TYPE OF OPERATION: 112c - Construction Regular Operation	
REASON FOR INSPECTION: Normal I&E Program	BOND CALCULATION TYPE: None	BOND AMOUNT: \$487,550.00	
DATE OF COMPLAINT: NA	POST INSP. CONTACTS: None	JOINT INSP. AGENCY: None	
WEATHER: Clear	INSPECTOR'S SIGNATURE:

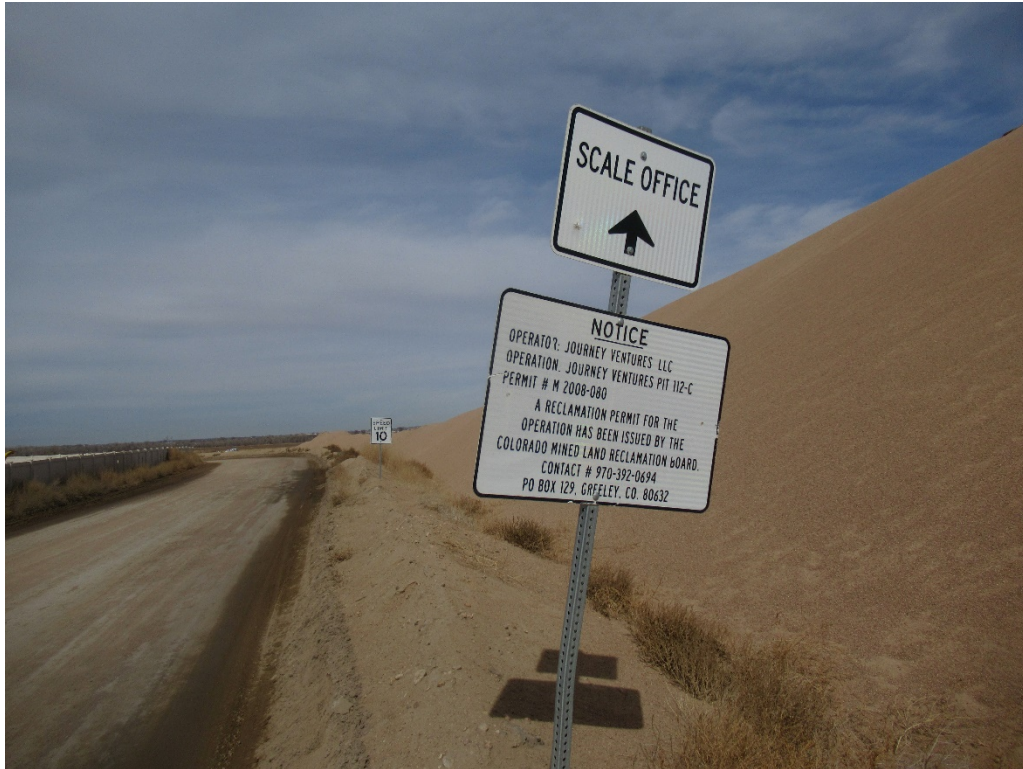
An entrance sign was posted and permit boundary markers were observed as required by Rule 3.1.12. Photographs taken during the inspection are attached. If you need additional information or have any questions, please contact me at the Division of Reclamation, Mining and Safety, 1313 Sherman Street, Room 215, Denver, CO 80203, by telephone at 303.866.3567 x 8124, or by email at peter.hays@state.co.us.

Journey Ventures mine sign

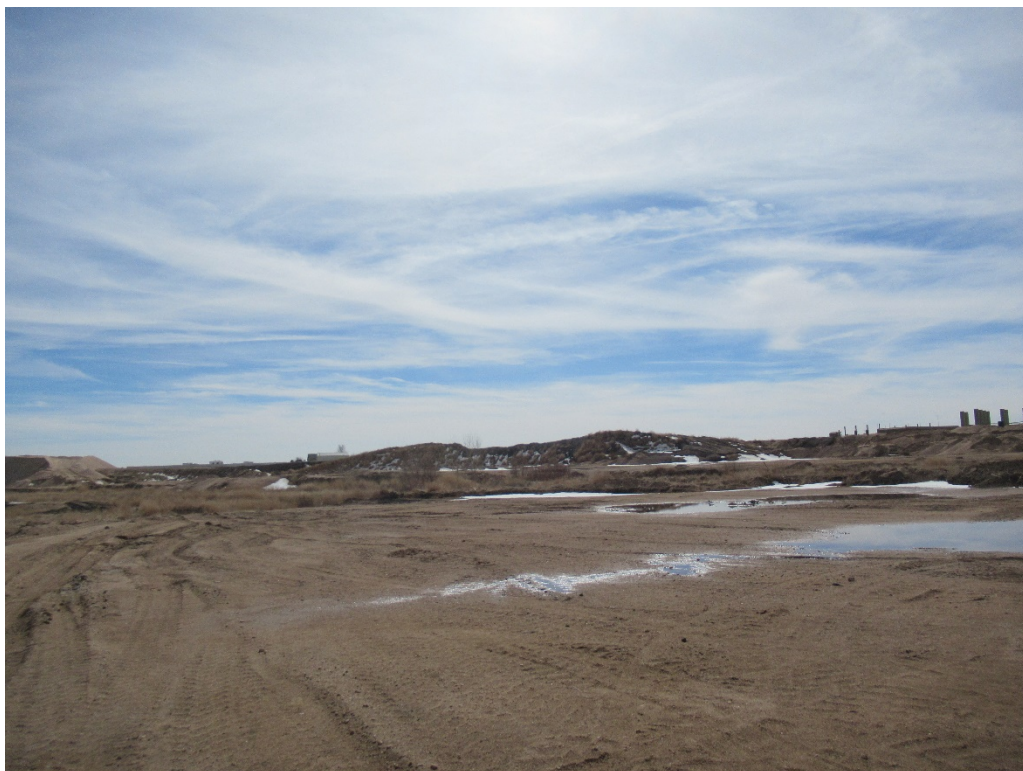
The approved post-mining land use for the site is developed water resources. A slurry wall was constructed around the perimeter of Phase 2 creating a reservoir. The approved Reclamation Plan states the Operator will replace 12 inches of topsoil during reclamation. Stockpiles of topsoil were observed in the northwest, west and southeast corners of the site. Sufficient topsoil is available on-site to complete reclamation of the site.

View of the topsoil stockpile located south of the scale house

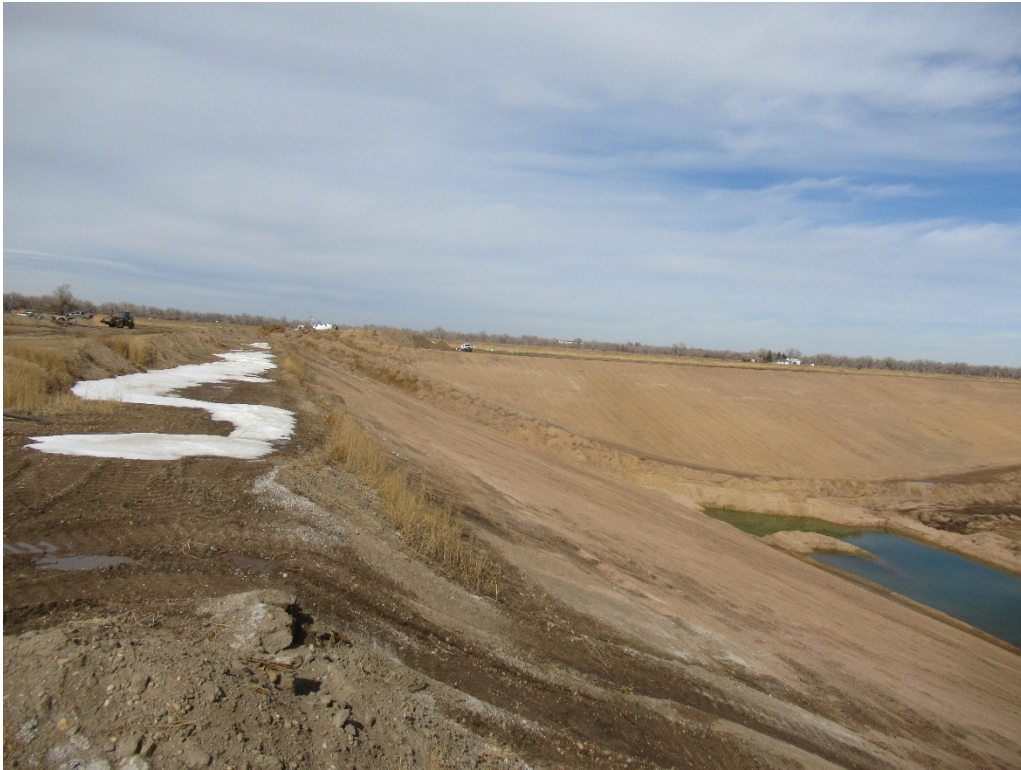
The site is an 82.95 acre 112c permitted operation. The site is in the final stages of mining activities. The only remaining product to be removed is a stockpile of sand located in the southern portion of the site. The Operator estimated the stockpile would be removed from the site in 4 months. The loading of sand into haul trucks was observed during the inspection. The processing plants previously located in Phase 1 have been removed from the site. Two stockpiles of claystone remain on the pit floor of the reservoir. The northwest and west access ramps into the reservoir have not been graded to the final 3H:1V slope. The Operator stated the claystone and ramp materials would be used by the reservoir owner to construct the required spillways. The remaining slopes of the reservoir have been graded to 3H:1V as required by the approved Reclamation Plan. The Operator stated the slopes were surveyed to verify the grading. The Division will require the Operator to submit the final reservoir survey results verifying the 3H:1V slopes with any future final release request for the site.

View of the northwest corner of the reservoir with the remaining access ramp

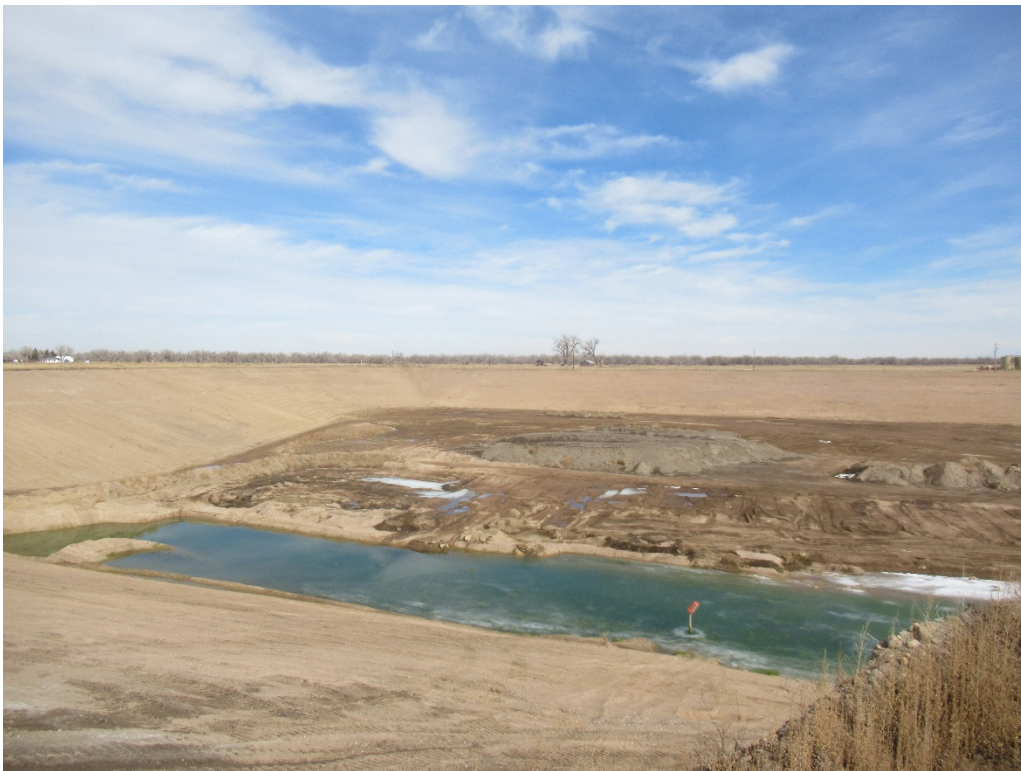
View of the northeast corner of the reservoir and the claystone stockpiles on the pit floor

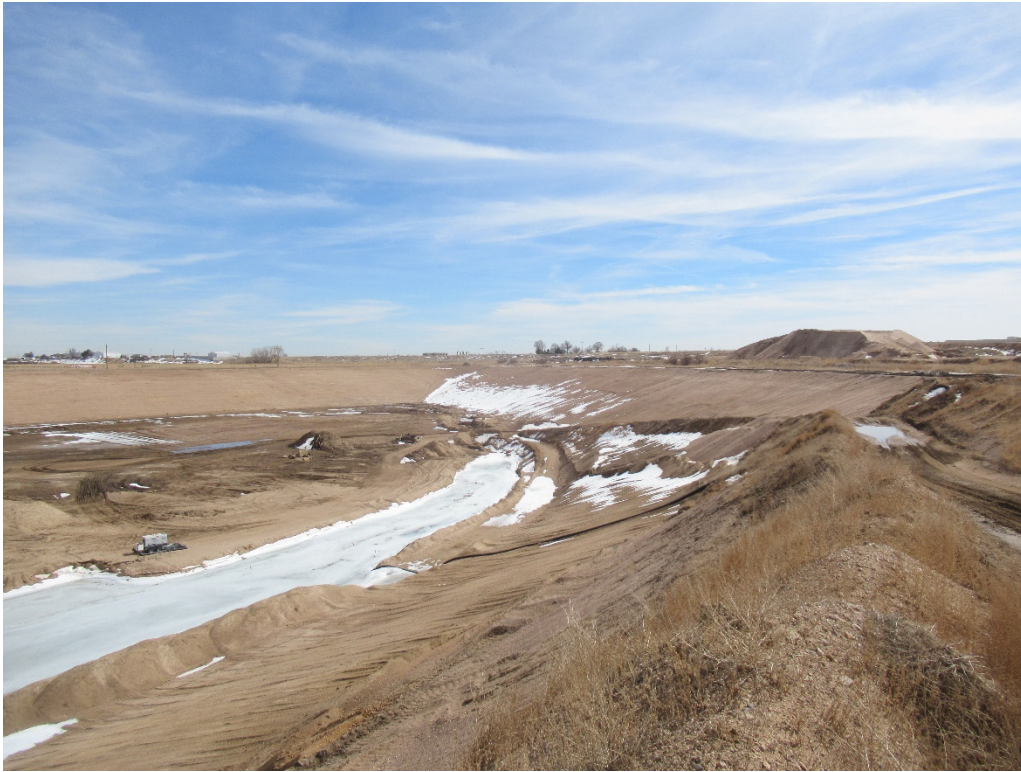
View of the western slope of the reservoir with the remaining access ramp

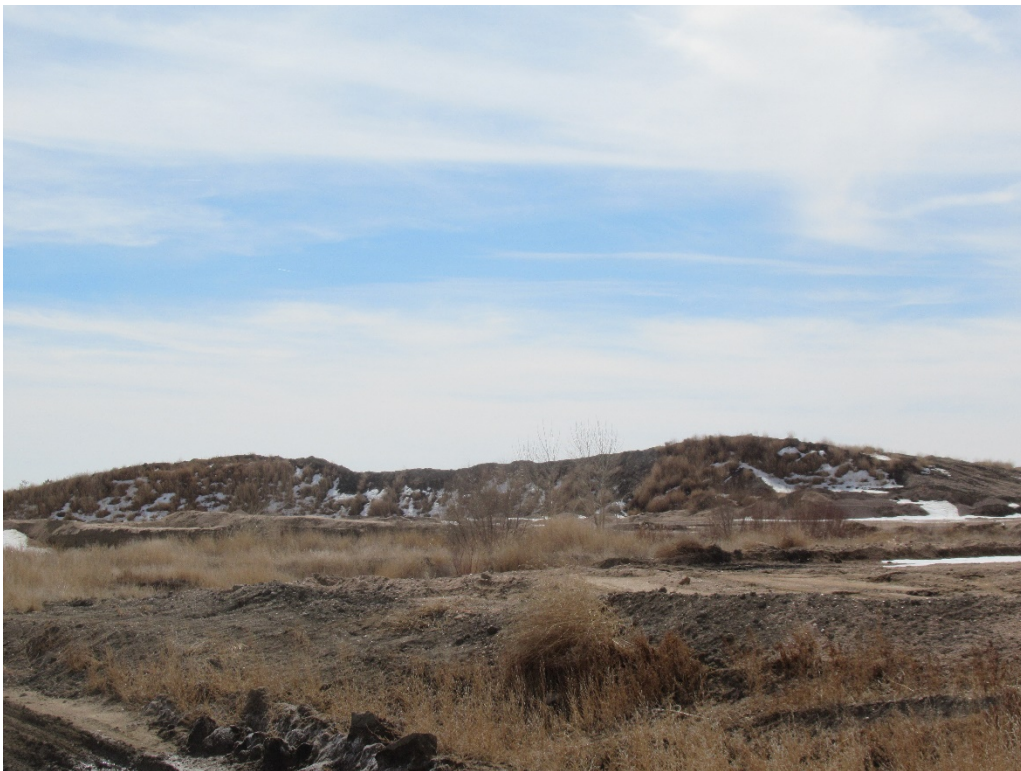
View of the topsoil stockpile located in the southeast portion of the site

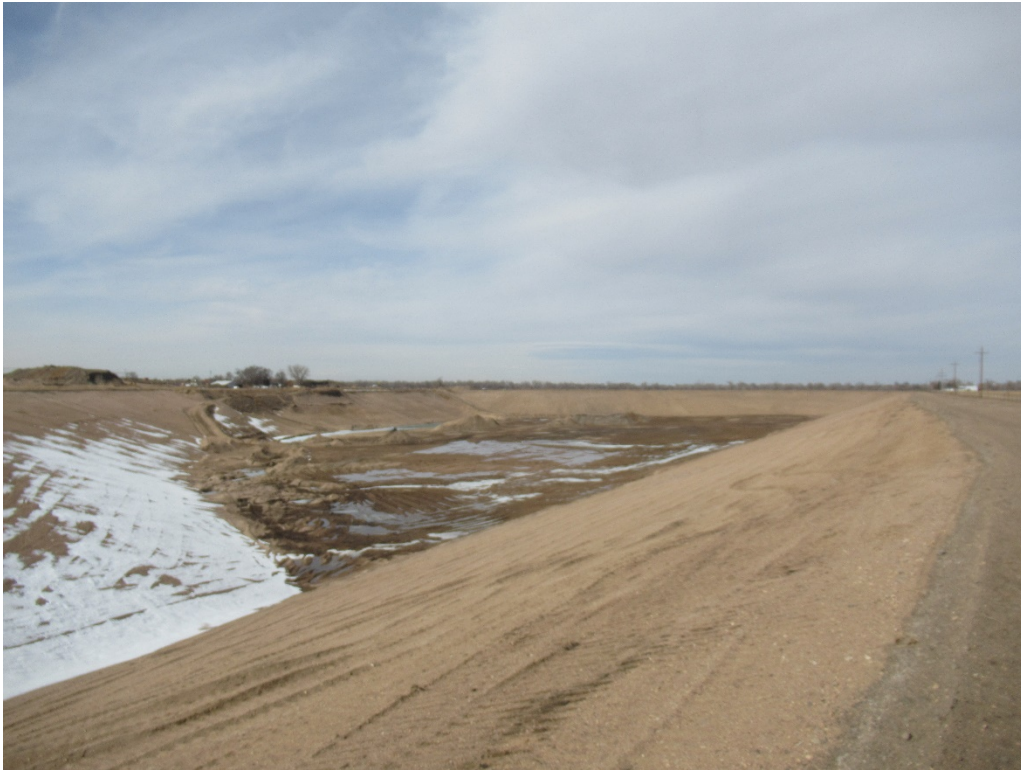
View of the reservoir from the southeast corner looking northwest

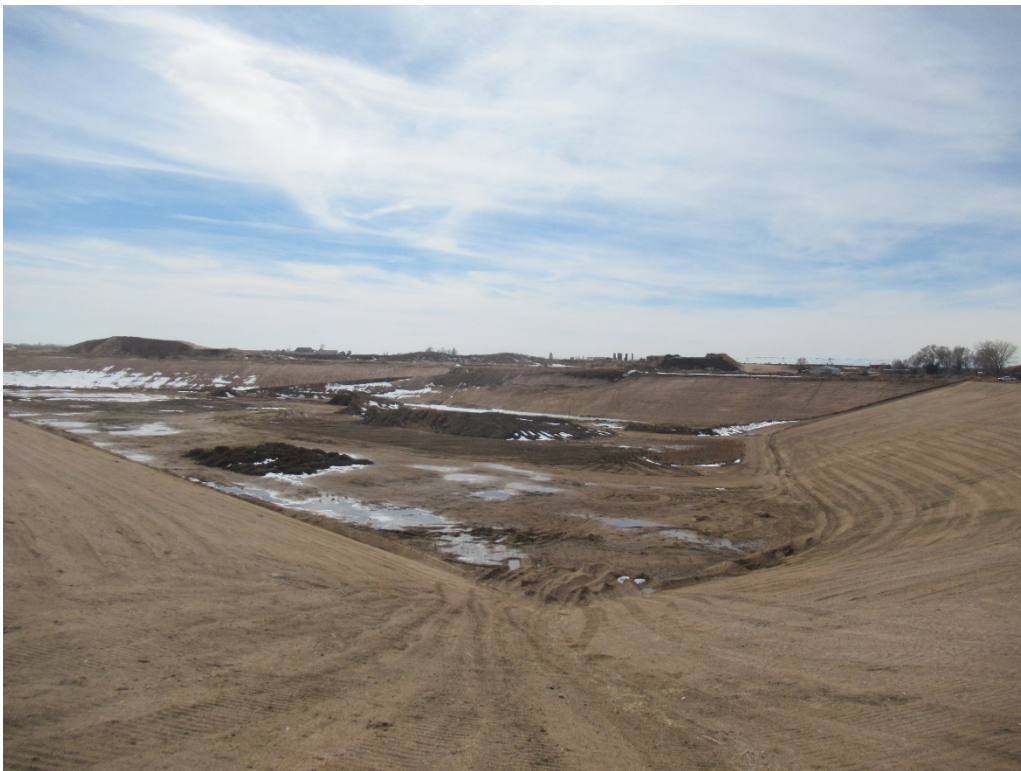
View of the reservoir from the northeast corner looking southwest
