PERMIT INFORMATION

| Permit Number: C-1981-018 Mine Name: Deserado Mine Operator: Blue Mountain Energy, Inc. Operator Address: Mr. Kurtis Blunt 3607 County Road 65 Rangely, CO, 81648 | County: Moffat, Rio Blanco Operation Type: Underground Permit Status: Active Ownership: Private |

INSPECTION INFORMATION

| Inspection Start Date: March 21, 2022 Inspection Start Time: 11:00 Inspection End Date: March 21, 2022 Inspection End Time: 13:00 | | Inspection Type: Coal Complete Inspection Inspection Reason: Normal I&E Program Weather: Clear | |

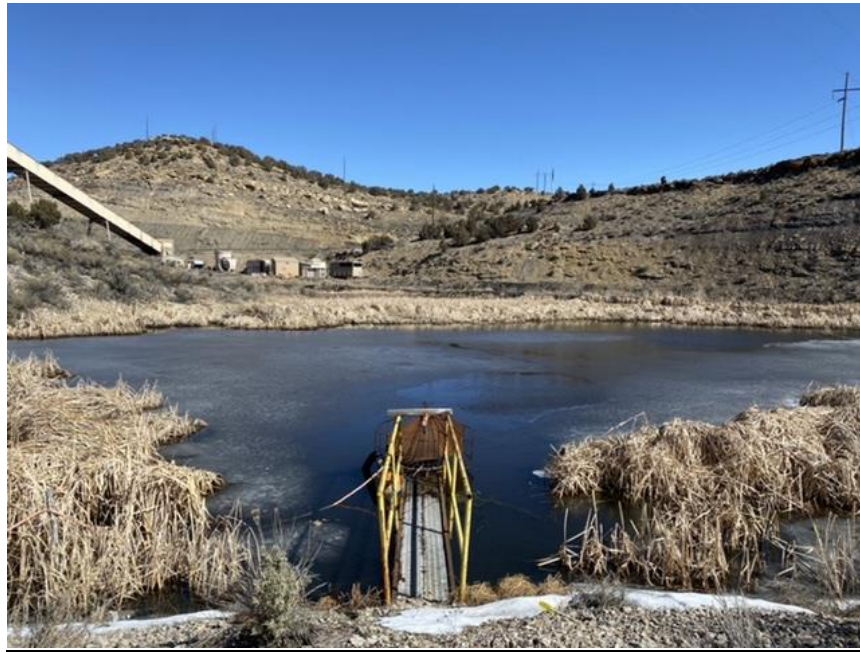
There are three ponds within the main facilities area, the DP-1 pond, PP-1 pond and the PP-2 pond. The DP-1 pond is located at the south end of the lower facilities bench. The pond accepts water from the entire main facilities area. DP-1 was impounding water at the time of the inspection. The pond was partly frozen over. Discharge was observed through the primary spillway. The trash rack on the spillway was clear of debris (Photo 1). The embankment for the pond was stable with vegetative cover. There were no indications of erosion. The PP-1 pond is located on the middle bench, next to the prep plant. The pond was holding water during the inspection. There was no discharge observed from the pond. The embankments were stable with no erosional concerns. The PP-2 pond is located on the upper bench. The pond was holding water. No discharge was occurring from the pond. The pond was partly frozen. The embankment was vegetated and stable. No erosional features were identified.

Photo 1: The discharge outlet of the DP-1 pond.

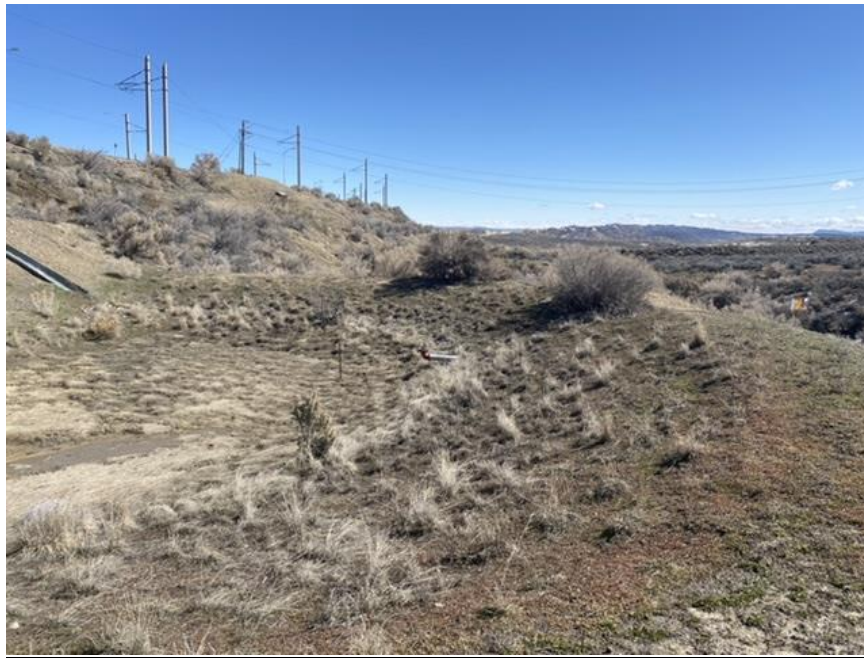
The RS-1 sump and the RR-1 pond are located on the south side of the rail loadout. The RS-1 sump was dry during the inspection. The embankments of the sump were stable with vegetation. There were no erosional features identified. The RR-1 pond was also dry during the inspection. The embankment of the pond was vegetated and stable (Photo 2). No erosion was identified.

Photo 2: The embankment of the RS-1 pond.

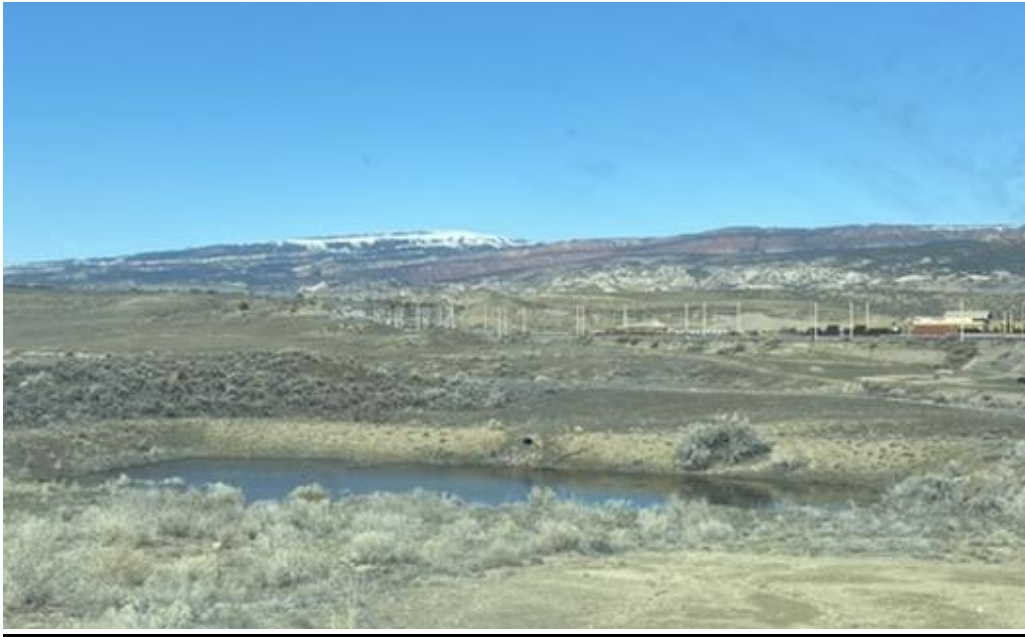
There are two ponds located to the north of the Slot Storage facility. The SS-1 pond was holding a small amount of water during the inspection. There was no discharge occurring from the pond. The outlet was clear of debris. The pond's embankments were stable with vegetative cover. The SS-2 pond was also holding a small amount of water (Photo 3). There was no discharge from the pond. The outlet was clear of debris. The embankment of the pond was vegetated and stable. There were no erosional features seen.

Photo 3: The SS-2 Pond holding water.

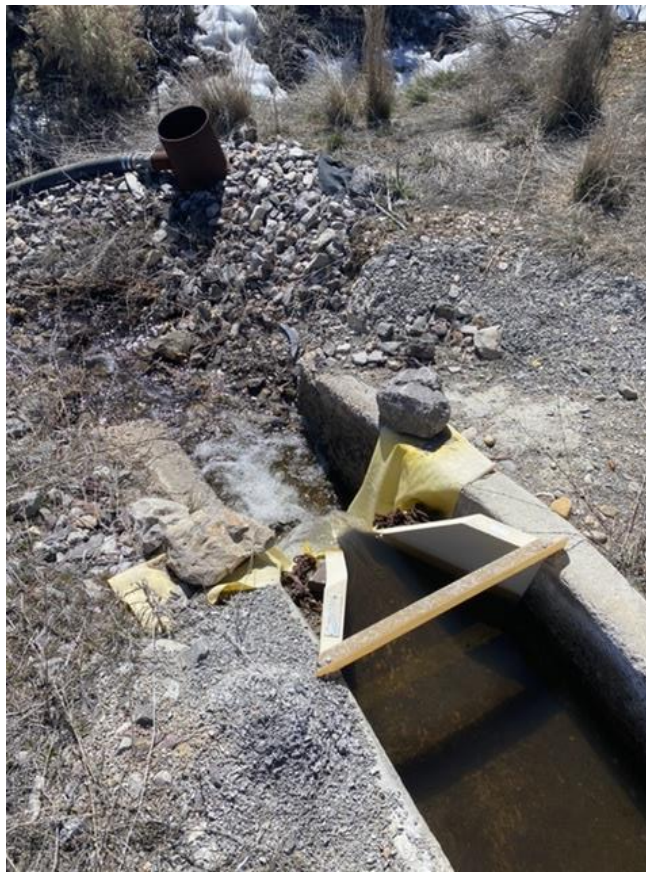
All cells of the B Seam Dewatering System #1 were impounding water during the inspection. Water was observed discharging from the Last Chance Pond. The discharge outlet was clear of debris (Photo 4). The embankments of the cells were stable with vegetated cover. There were no indications of erosion.

Photo 4: The outlet of the Last Chance Pond.

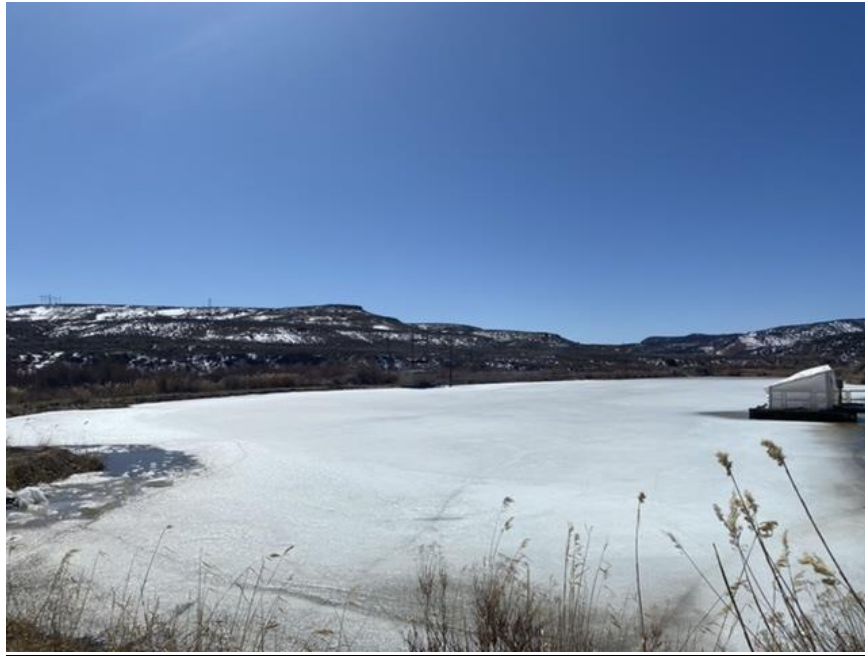
The Raw Water Lagoon was holding water during the inspection (Photo 5). The embankment was stable with vegetative cover. No erosional features were seen.

Photo 5: The Raw Water Lagoon was frozen over during the inspection.
