**PERMIT INFORMATION**

<b>Permit Number:</b> C-1980-004 <b>Mine Name:</b> McClane Canyon Mine <b>Operator:</b> ARC McClane Canyon, LLC <b>Operator Address:</b> Jim E Stover 2352 N 7th Street, Unit C Grand Junction , CO 81501	<b>County:</b> Garfield <b>Operation Type:</b> Underground <b>Permit Status:</b> Temporary Cessation <b>Ownership:</b> Private
	<b>Operator Representative Present:</b>  Chuck Silengo
<b>Operator Representative Signature:</b> (Field Issuance Only)

**INSPECTION INFORMATION**

<b>Inspection Start Date:</b> March 23, 2022 <b>Inspection Start Time:</b> 09:40 <b>Inspection End Date:</b> March 23, 2022 <b>Inspection End Time:</b> 10:30		<b>Inspection Type:</b> Coal Complete Inspection <b>Inspection Reason:</b> Normal I&E Program <b>Weather:</b> Clear	
<b>Joint Inspection Agency:</b>  None		<b>Joint Inspection Contacts:</b>  None	
<b>Post Inspection Agency:</b>  None		<b>Post Inspection Contacts:</b>  None	
<b>Inspector(s):</b>  Clayton Wein	<b>Inspector's Signature:</b>  <i>Clayton Wein</i>		<b>Signature Date:</b>  3/28/2022

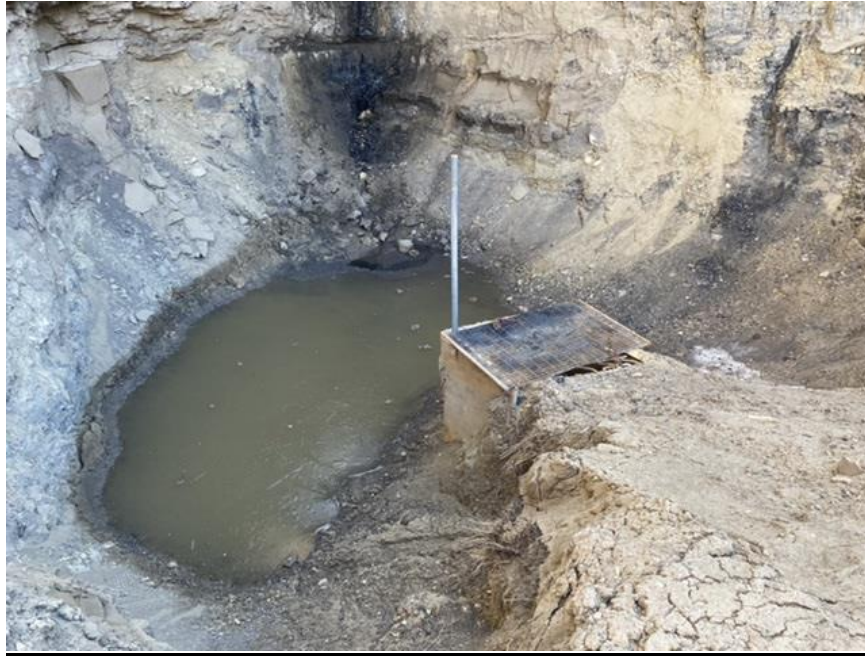
There are two sumps located within the portals area of the mine. There is one sump to the east of the portals and one to the north. The eastern sump was muddy with a small amount of water in it during the inspection. The sump had been cleaned out since the Division's 4<sup>th</sup> quarter 2021 inspection (Photo 1). The outlet for the sump was clear of debris. There were no indications of erosional features or signs of instability. The northern sump was holding a small amount of water. There was no discharge observed. The outlet of the sump was clear of debris. There were no indications of instability or erosion.

**Photo 1:** The eastern sump at the portals bench.

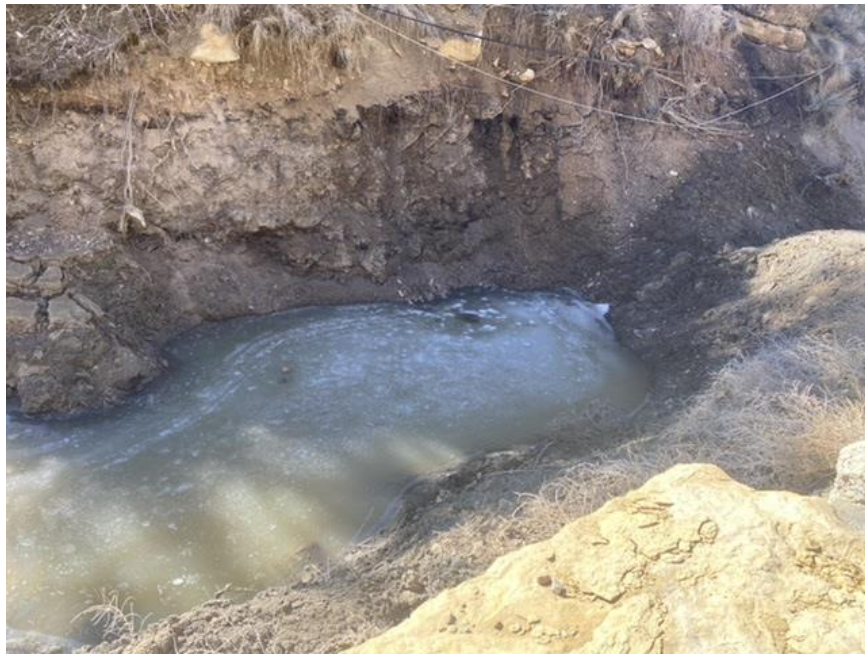
The water diversions throughout the portals area were in good condition. There were no indications of channels being blocked or water bypassing the diversions. The sumps along the haul road were observed to be stable. There were no indications of erosional features. Small amounts of water were impounded in the sumps (Photo 2). No discharge was observed from any of the sumps.

**Photo 2:** The last sump along the haul road before the sediment pond.

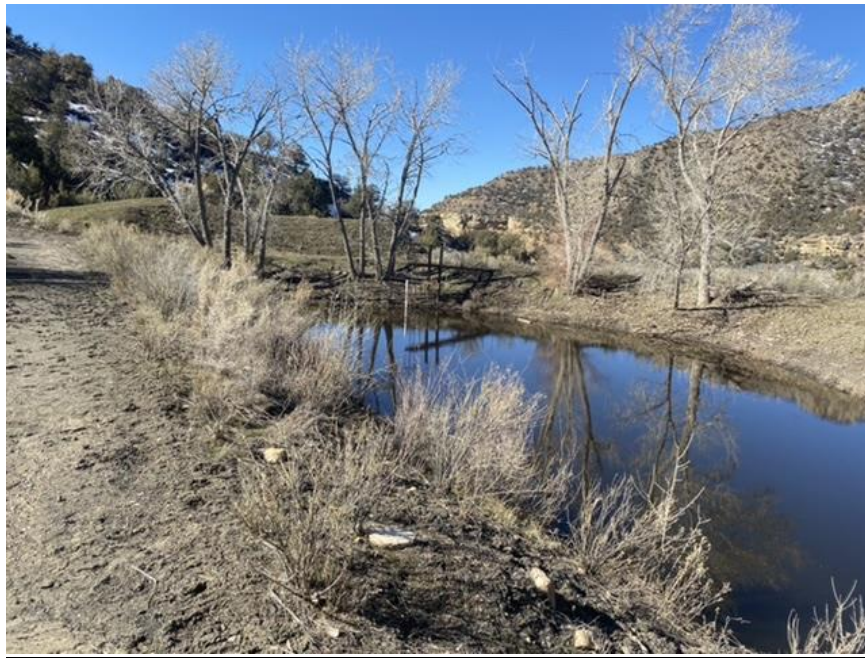
The sediment pond was holding water during the inspection (Photo 3). The level of water in the pond had not reached the level of the primary spillway. The primary and emergency spillways were clear of debris. The pond's embankment was stable with vegetative cover. There were no erosional features identified.

**Photo 3:** The Sediment Pond, the photo was taken next to the inlet to the pond, facing the embankment.

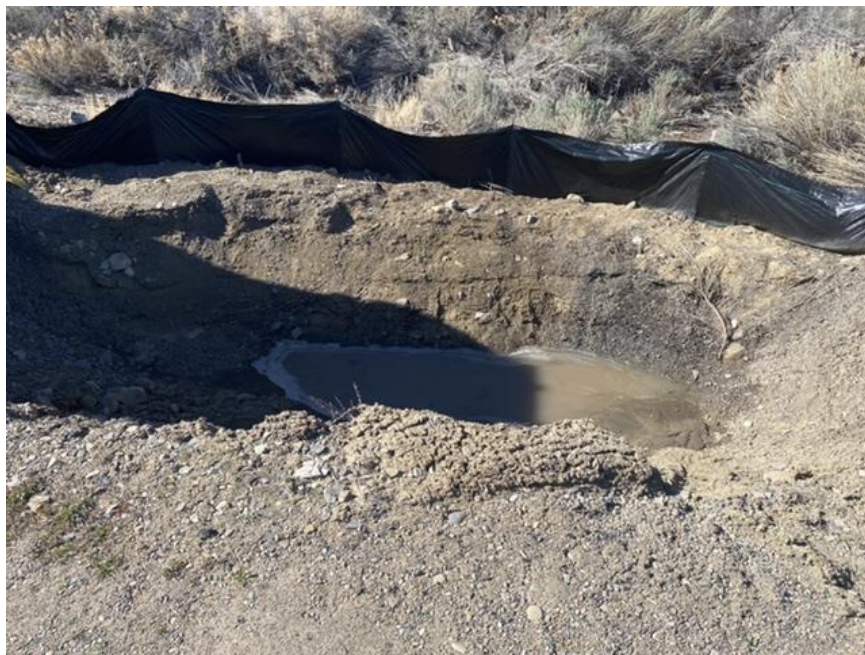
There are two sumps located on the downslope side of the mine office pad. One sump is located on the south side of the haul road and one sump is located on the north side of the road. The sump on the south side of the road was holding a small amount of water. There was no discharge. The silt fence on the outlet was in good condition (Photo 4). No off site impacts were observed. The sump located on the north side of the road was holding water. There was no discharge occurring from the sump. The silt fence on the outlet was in good condition. There were no off site impacts identified.

**Photo 4:** The sump on the south side of the haul road at the mine office pad.

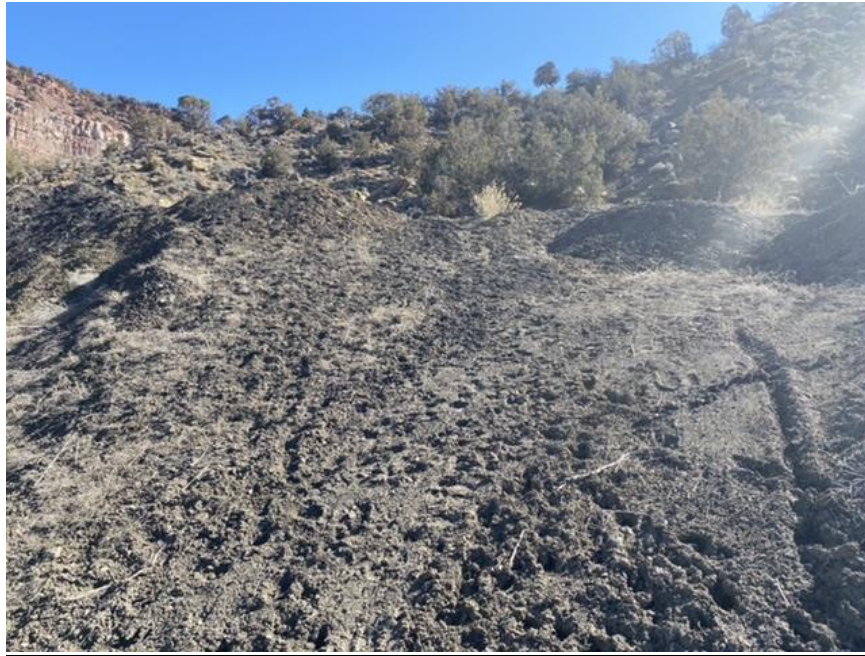
The refuse pile is located to the east of the sediment pond. The pile was dry and stable during the inspection (Photo 5). There were no indications of erosional features.

**Photo 5:** The refuse pile. The photo was taken at the pile's base. The marks in the pile are from wildlife.

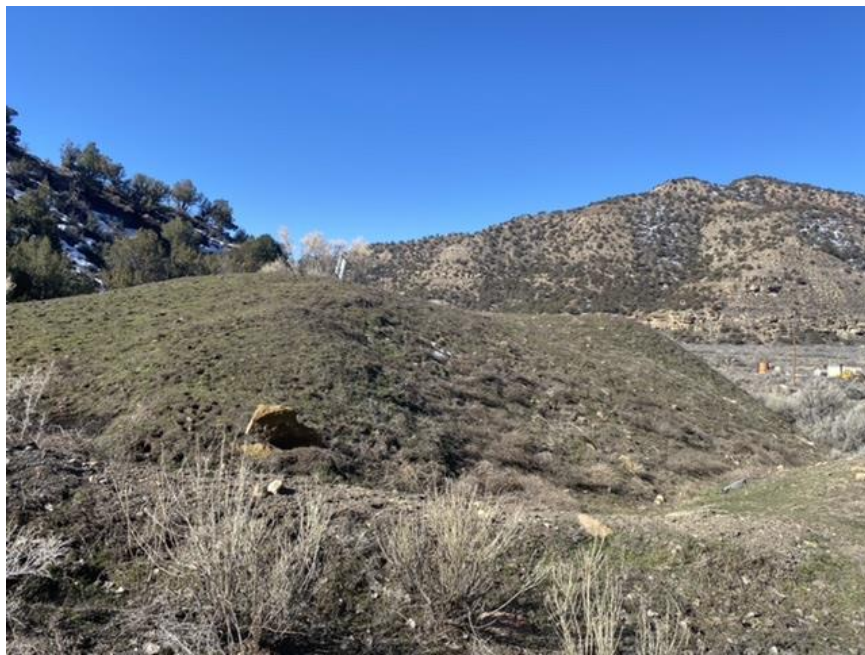
The topsoil pile is located to the south of the sediment pond. The pile was stable with vegetative cover (Photo 6). There were no indications of erosion. The perimeter ditch was stable with vegetative cover. The topsoil marker was on top of the pile in an easily identifiable location.

**Photo 6:** The Topsoil Pile. The photo was taken looking to the west.
