Fall 2021 Subsidence and Geologic Field Observations

Southern Panels and Sunset Trail Mining Areas

Gary D. Witt, P.G., Hydrogeologist/Geological Engineer
Jonathan M. Kelly, P.E., Project Manager
Wright Water Engineers, Inc.

March 2022

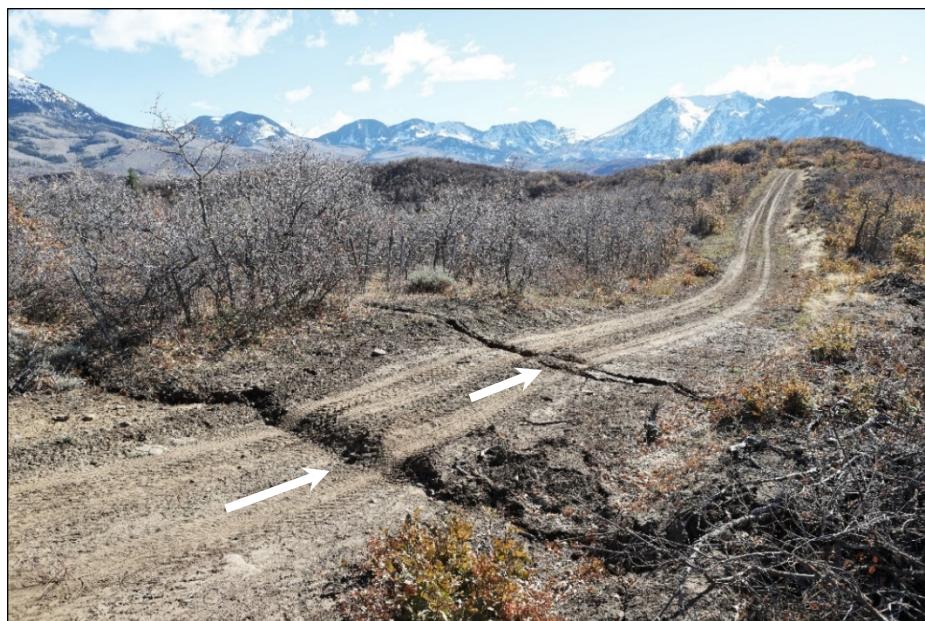
Two parallel subsidence cracks were observed approximately 300 feet south of the E7-12 MVB pad during WWE's fall 2018 field work (Figure 1). These cracks had a N60°W orientation and a separation distance of 13 feet. Observational evidence at that time (i.e., sharpness of crack edges) suggested that the cracks formed independently. The northern crack had rounded edges while the southern crack had sharp edges. E-seam overburden thickness at this location is about 800 feet.

Figure 1. Fall 2018 southeastward view two parallel subsidence cracks (see white arrows) that appeared as a result of recent longwall mining beneath the area. Crack edge features suggested the two cracks were created at different times.

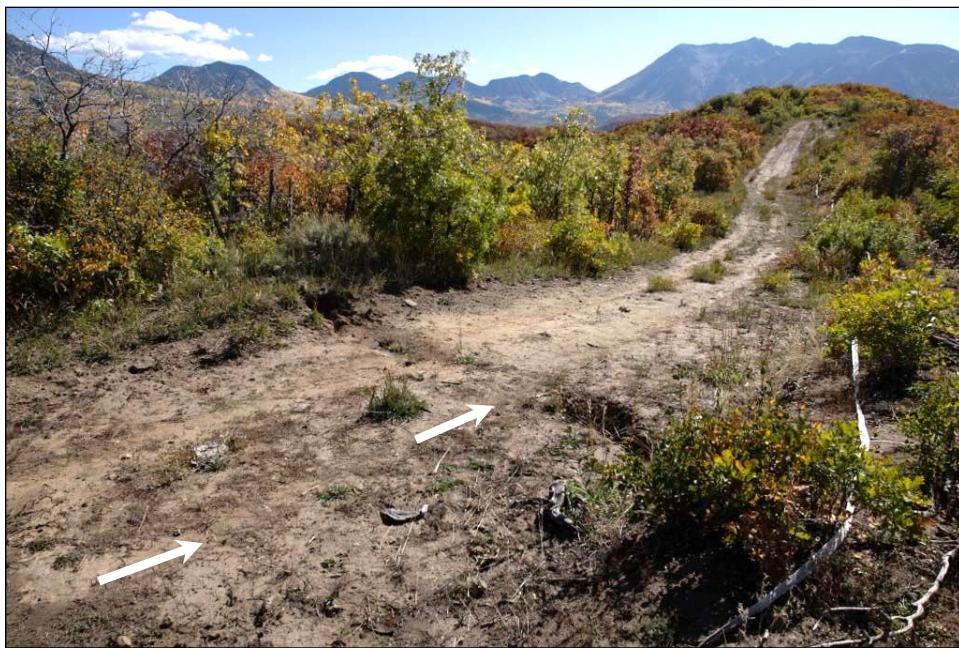
Observations made during the fall 2021 field visit found that the northern crack was nearly completely filled, while the southern crack was still present with a measurable width and depth at the edges of the road. Both cracks showed signs of healing and weathering (Figure 2). Future discussion of this feature is not likely unless there is a significant change.

Figure 2. Southeastward view during the fall 2021 field visit of the same area shown in Figure 1.

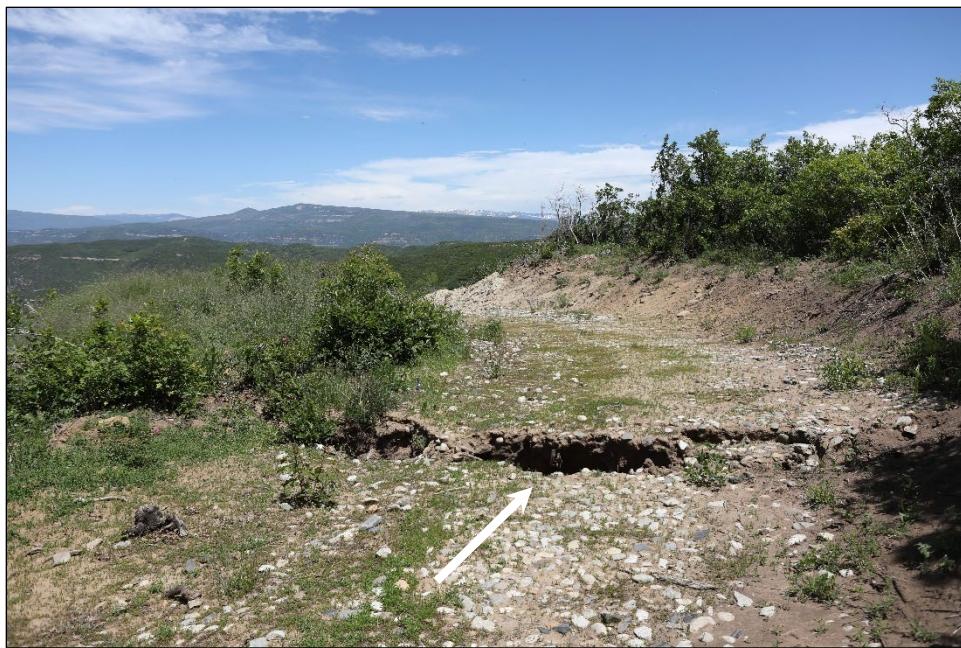
During the spring 2019 field visit, a new subsidence crack was observed approximately 1,000 feet north of the E6-14 MVB pad (Figure 3). This crack had a pronounced elevation offset across the crack of 6 inches (higher on the north) and extended completely across the road and beyond (20+ feet in length) in a N70°W orientation. The maximum dimensions were observed to be 24 inches both in width and depth. This location is over the tailgate entries of E-seam Longwall Panel E7 where tensional stresses are somewhat greater. E-seam overburden thickness at this location is about 800 feet.

Figure 3. Northward view during the spring 2019 field visit of a subsidence crack (see white arrow) with 6-inch elevation change from north to south observed approximately 1,000 feet north of the MVB E6-14 pad.

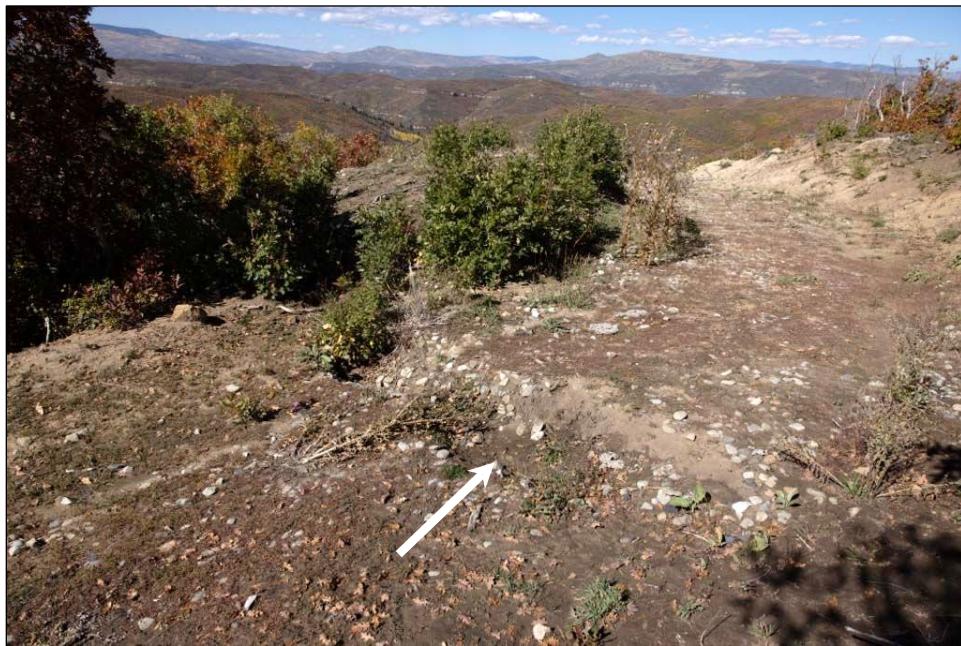
Observations made during the fall 2021 field visit found that the crack was still evident with continued signs of healing (Figure 4). Future discussion of these features is not likely unless there is a significant change.

Figure 4. Northwestward view during the fall 2021 field visit of the same subsidence crack shown in Figure 3.

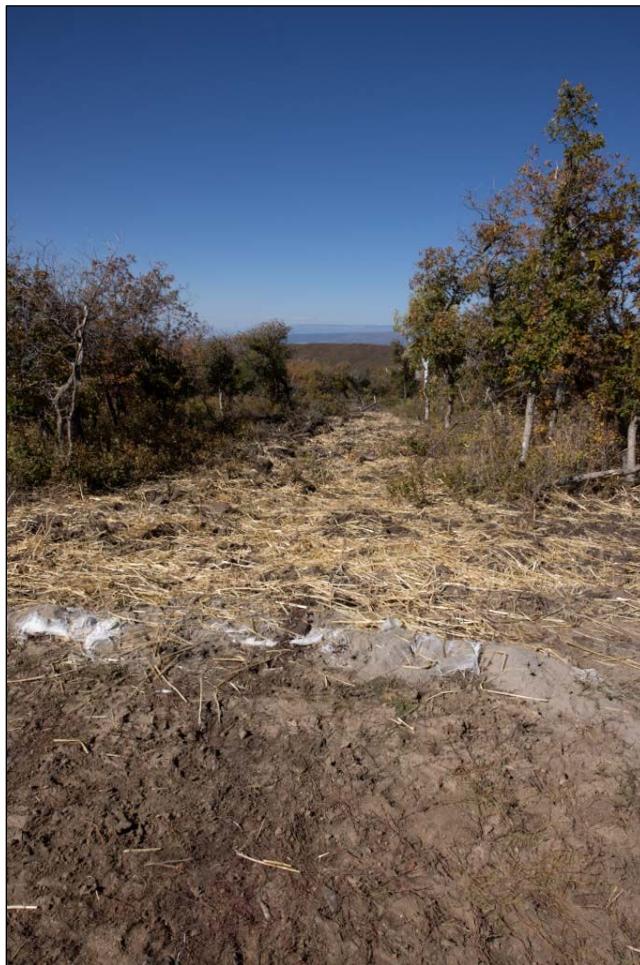
Longwall mining of E-seam Longwall Panel SS1 began in January 2020. As of our fall 2021 field visit, mining of this panel was complete and that portion of the traverse west of MVB pad had been reclaimed. As a result of reclamation, subsidence features originally observed during our spring 2021 field visit (both on MVB pad SS1-7 and the road leading to the pad) could not be located (Figure 5).

Figure 5. Westward view of reclaimed portion of Traverse G-G' west of the MVB SS1-6 pad as observed during our fall 2021 field visit.

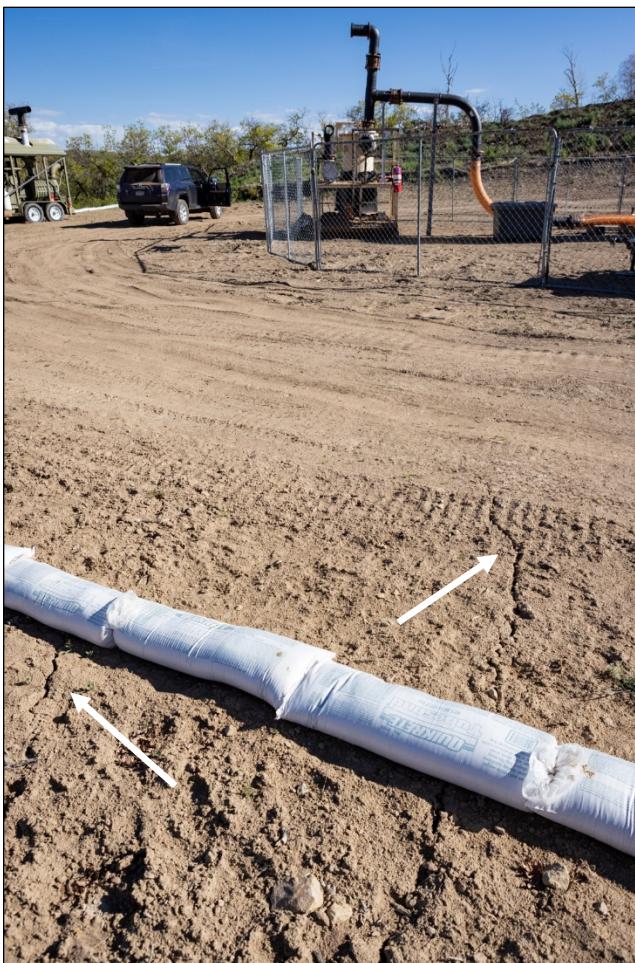
Multiple sub-parallel subsidence cracks were first observed on the MVB SS1-6 pad during the spring 2021 field visit. The E-seam overburden thickness beneath this pad is approximately 1,090 feet. The most dominant of those cracks appeared to be spaced approximately 6 to 8 feet apart, had an orientation of between N20°W and N40°W, and was located north of the well head. No evidence of these subsidence features could be found during our fall 2021 field visit. For example, Figure 6 shows two subsidence cracks located on the south side of the MVB SS1-6 pad as observed during our spring 2021 field visit and Figure 7 shows the same area as observed during our fall 2021 field visit.

Figure 6. Northward view during the spring 2021 field visit of two smaller subsidence cracks (see white arrows) on the southern portion of the MVB SS1-6 pad.

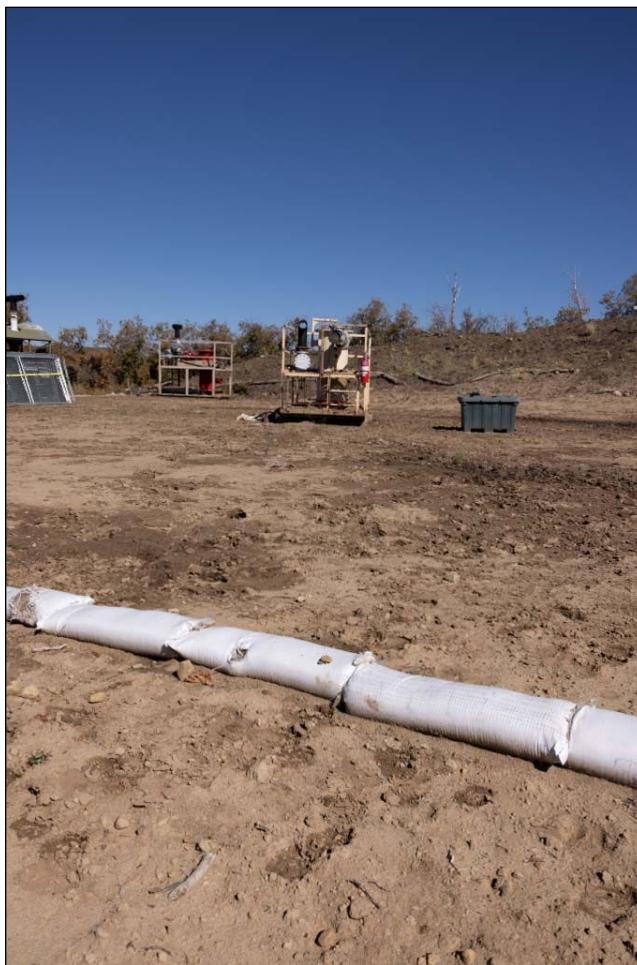
Figure 7. Northward view during the fall 2021 field visit of the same approximate area shown in Figure 6. Note that the previously-observed subsidence cracks are no longer visible.
