USR17-0055 CR 2 - Safety Concern

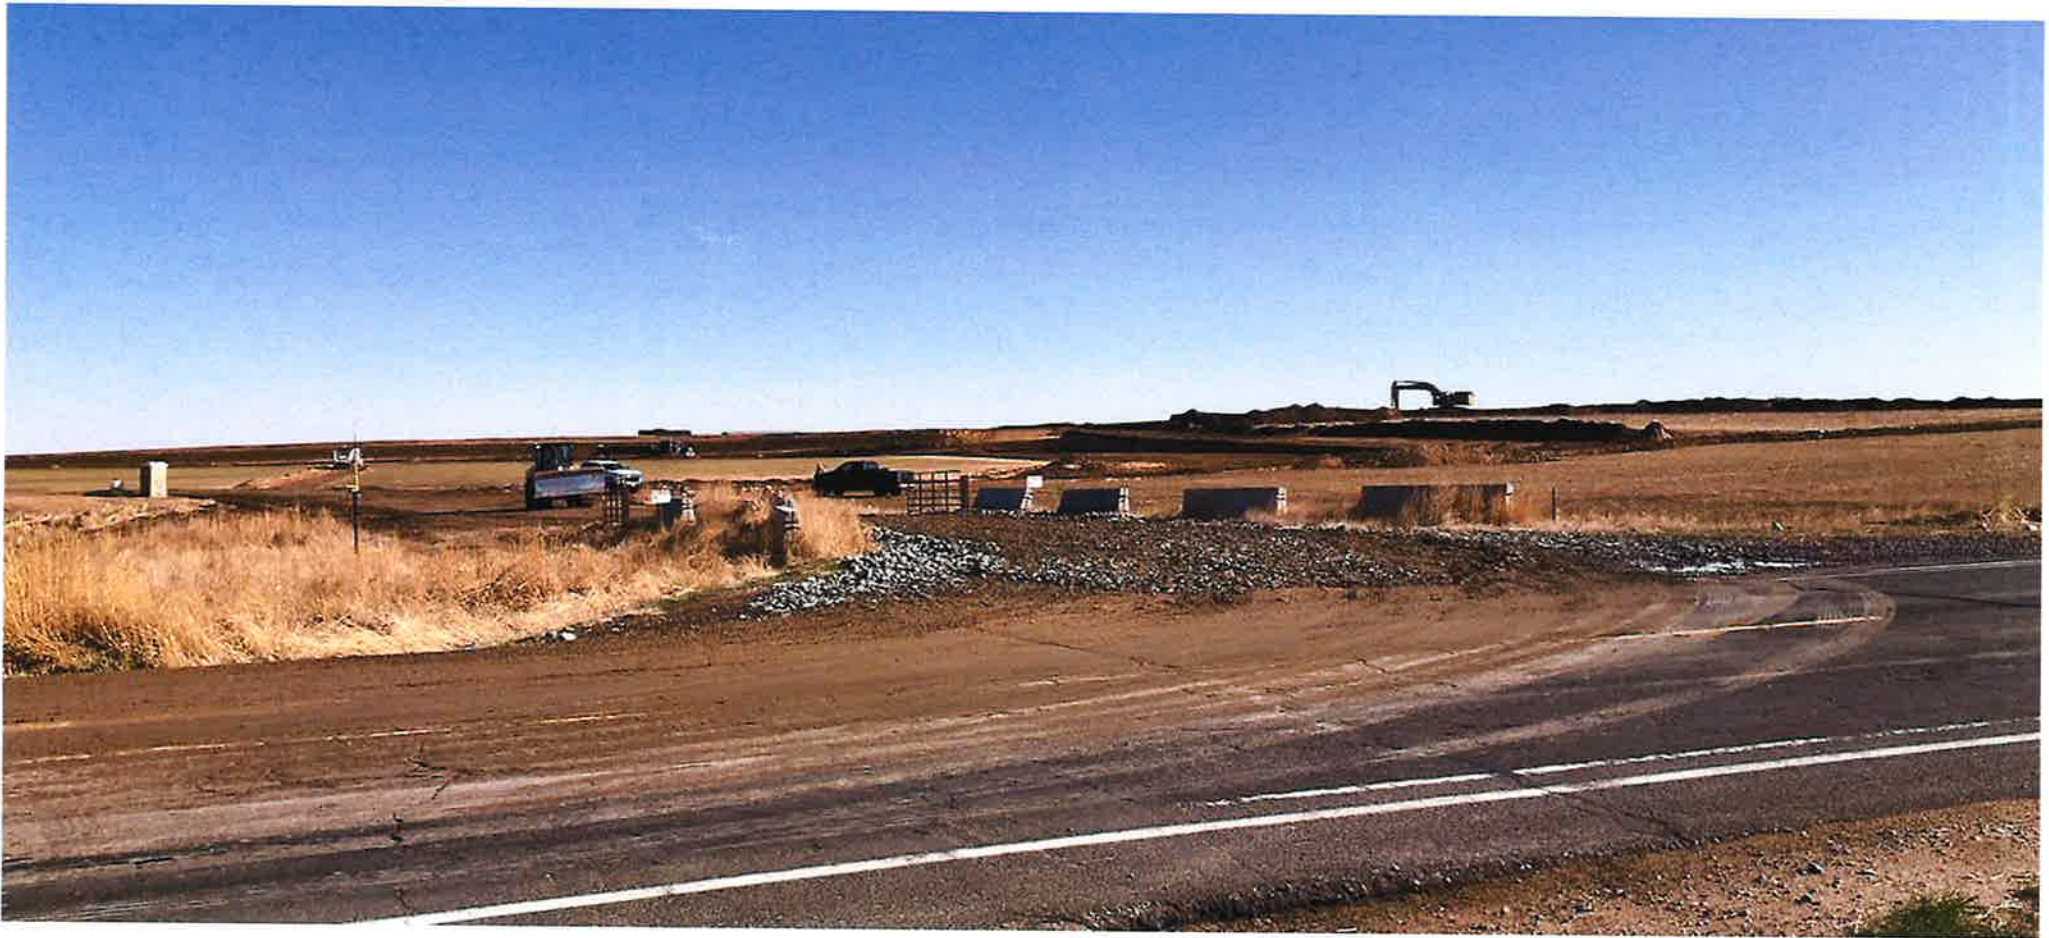
Mining operation appears to be on the east side of the access point not the west side as shown on the DRMS document.

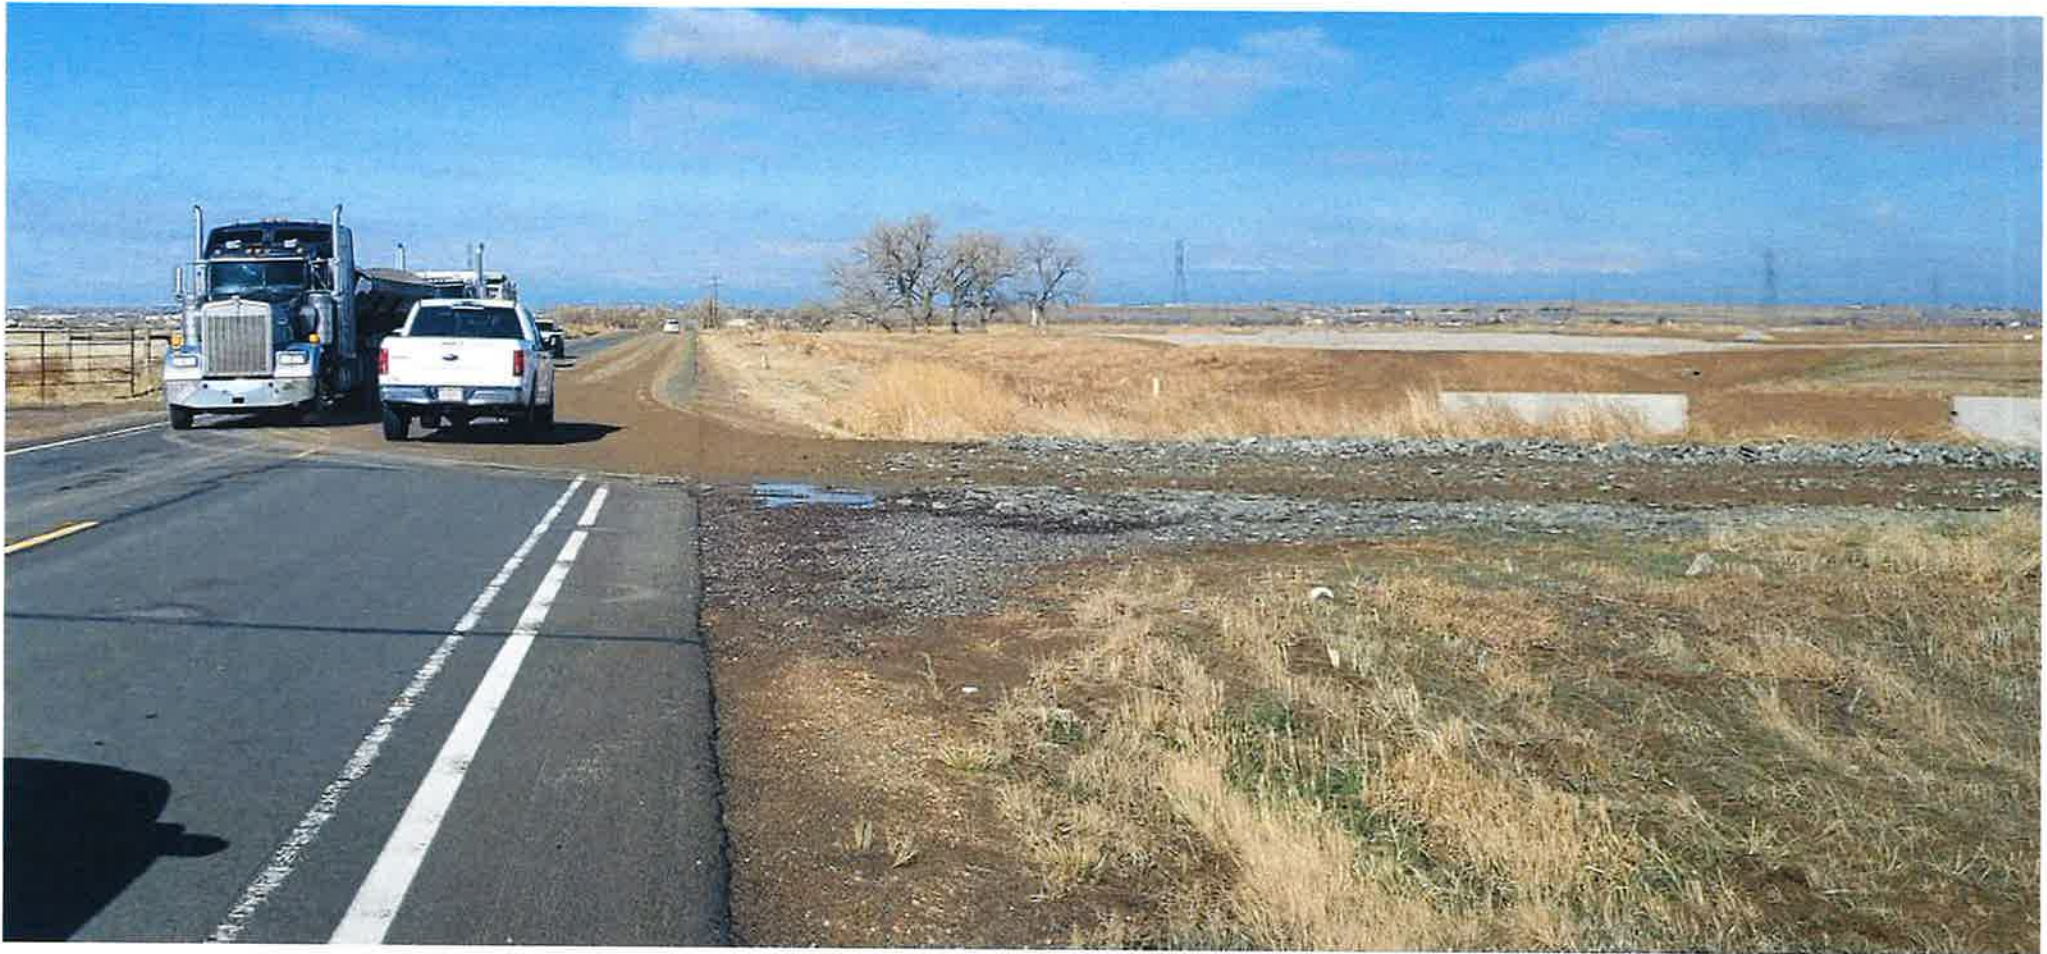
Mud on the road needs to be cleaned up.
Tracking control needs to be installed.
