March 1, 2022

Ms. Stephanie Fancher-English  
Loveland Ready-Mix Concrete, Inc.  
644 Namaqua Road  
Loveland, Colorado 80537

**Subject: Cell 4 – Green-Croissant Pit  
Reclamation Slope Evaluation Version 2**

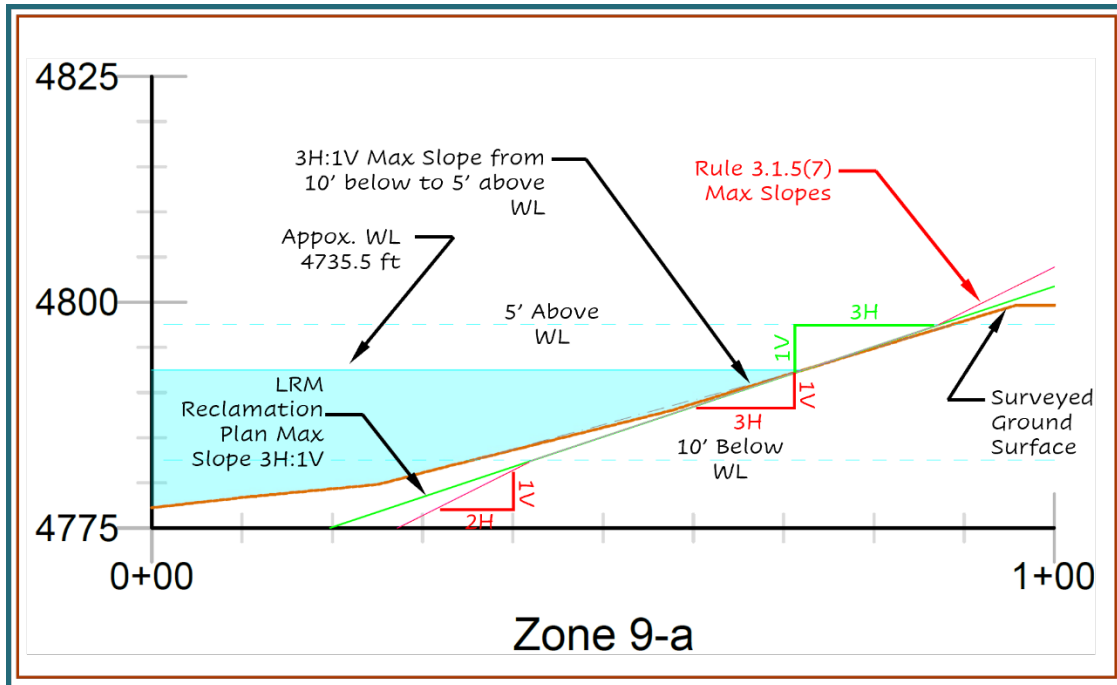
**Figure 1 Evaluation Approach Explanation**

We placed a cross section in each zone as labeled in the "King Survey" (Attachment 2). In zones where the King Survey indicated potential variation from Rule 3.1.5(7), we placed two cross-sections. We evaluated each cross-section for its compliance with LRM's reclamation plan and Rule 3.1.5(7) as shown in Figure 1 and documented in Table 1.

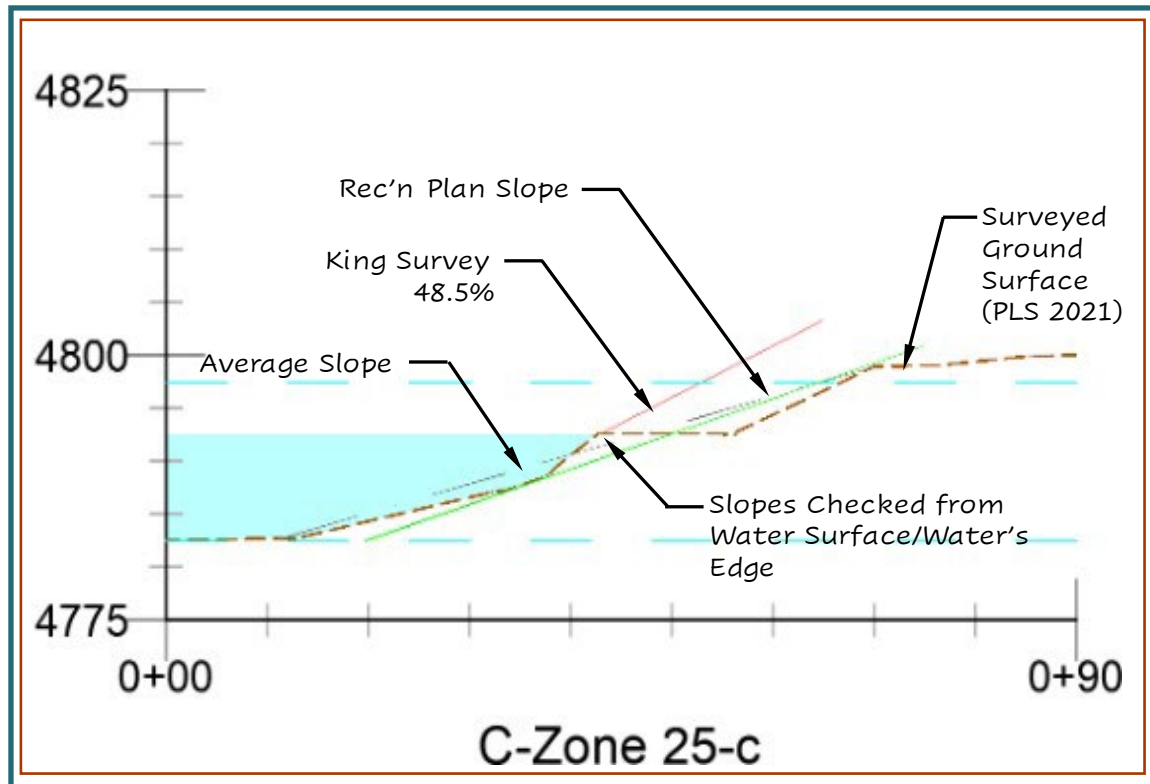
**Figure 2 Slope Evaluation at King's Maximum Indicated Slope**

Zone 25-c<sup>2</sup> in Sheet 2 is near King's indicated 48.5% slope (2:06H:1V), which, from visual inspection, is their common result in Zone 25. Figure 2 shows the evaluation of the slopes at King's indicated average. It could be that when the King survey was completed, the water level was 0.5 to 1 foot higher as shown in Figure 3. Regardless if one examines the section as in Figure 2 or Figure 3, the average overall slope from crest to toe is 3.61H:1V (grey dashed line in figures), meeting compliance with the reclamation plan.

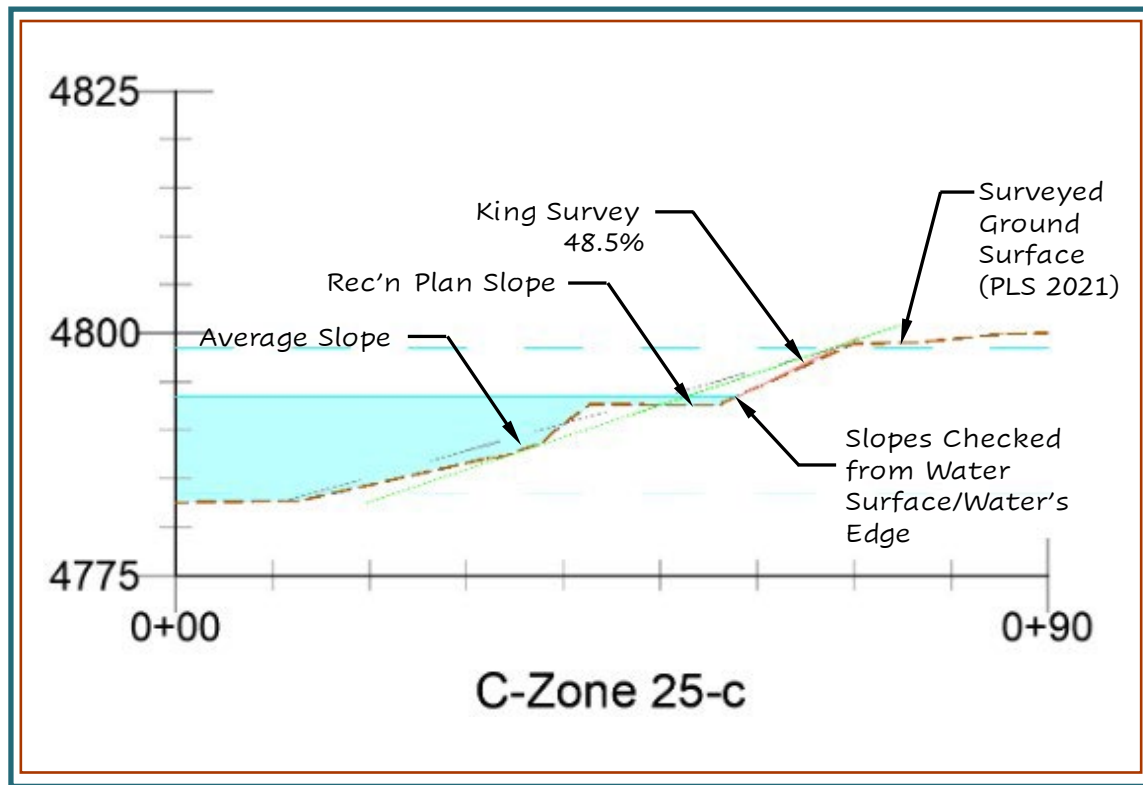
**Figure 3 Potential Conditions During King Survey**

The cross section shown in Figures 3 and 4 (and others shown in Sheet 1) result from erosion at the water's edge, which is a very natural occurrence in ponds along the Front Range as previously mentioned. Wave action erodes some of the bank above the water level, and deposits sediments immediately below the water surface, resulting in a "bench" and irregularities in the slope (Figure 5). Sometimes a high groundwater table helps exacerbate the problem (as is the case on the west side of Pit 4). We know that the walls of Pit 4 met slope requirements at the time of closure, and the slopes were "smooth" as indicated by:

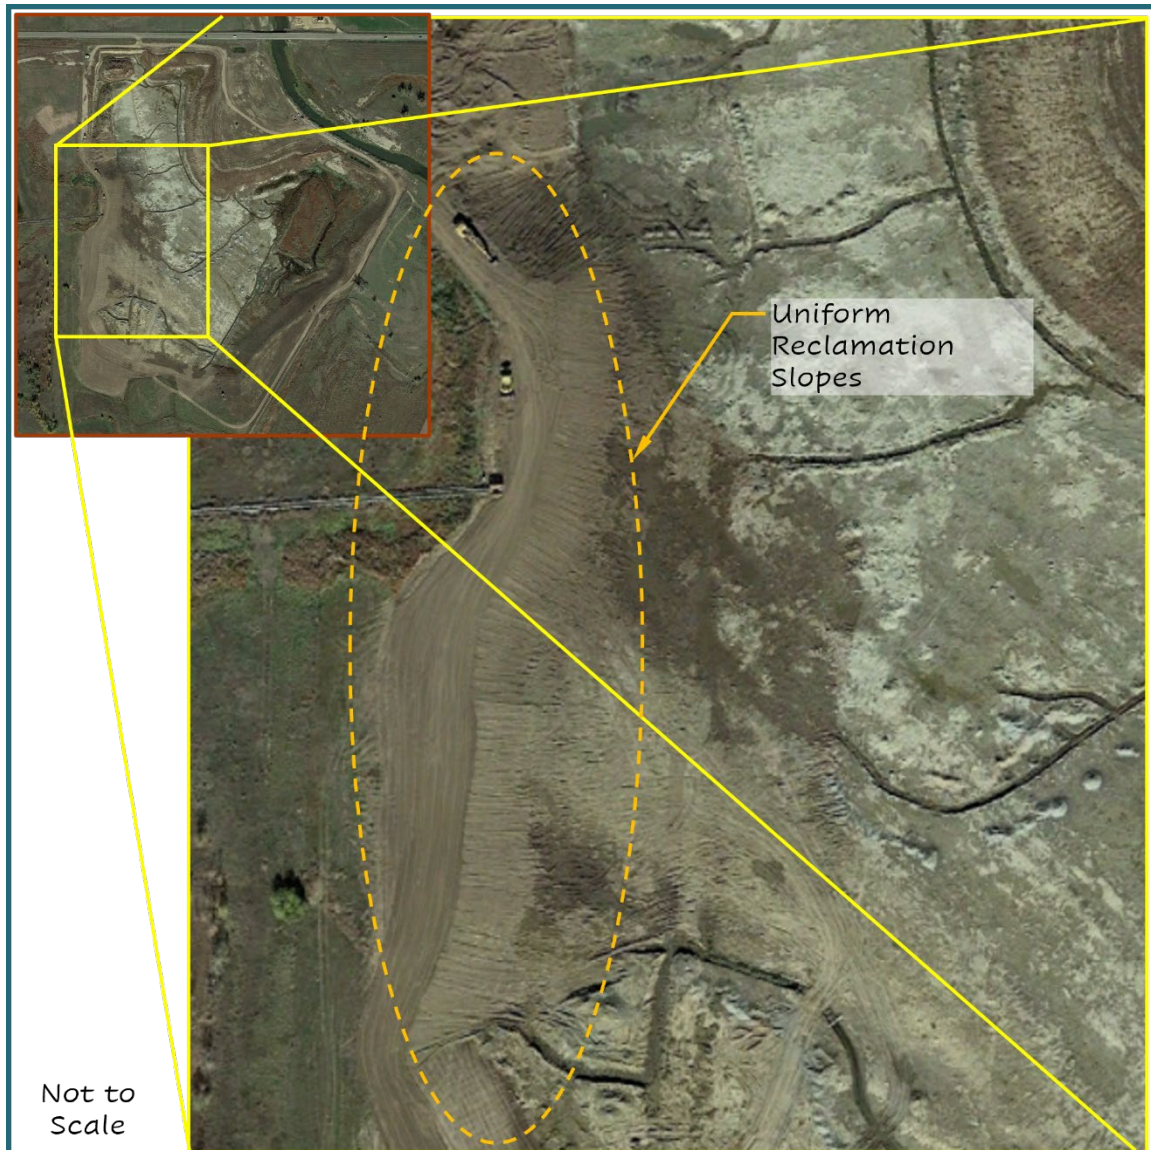
**Figure 4 National Agricultural Imagery Program (NAIP) October 2017**

- Recollection of reclamation (Fancher, 2021)
- An aerial photograph dated October 2017 (USGS, 2021), displayed in Figure 4
- Topographical survey of the above water level bank 1/2/2019 (CDS, 2019) as summarized in Attachment 4

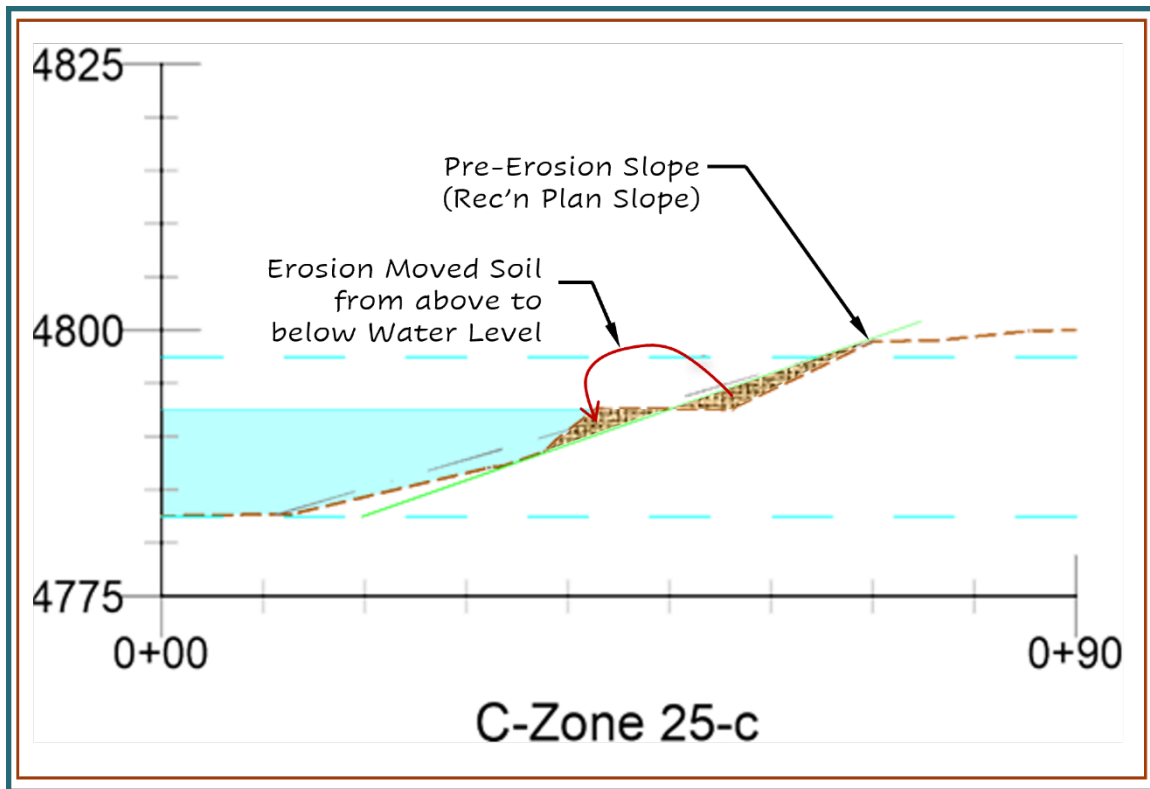
**Figure 5** Natural Pond Erosion at Water's Edge

Sometimes this erosional process results in a bank that is locally steep and may be up to three feet tall. For the post-mining land use of wildlife habitat and pasture, these features are completely safe. In fact, ponds with post-mining land use of recreation and that the public frequents also exhibit these features as shown in Figure 6.

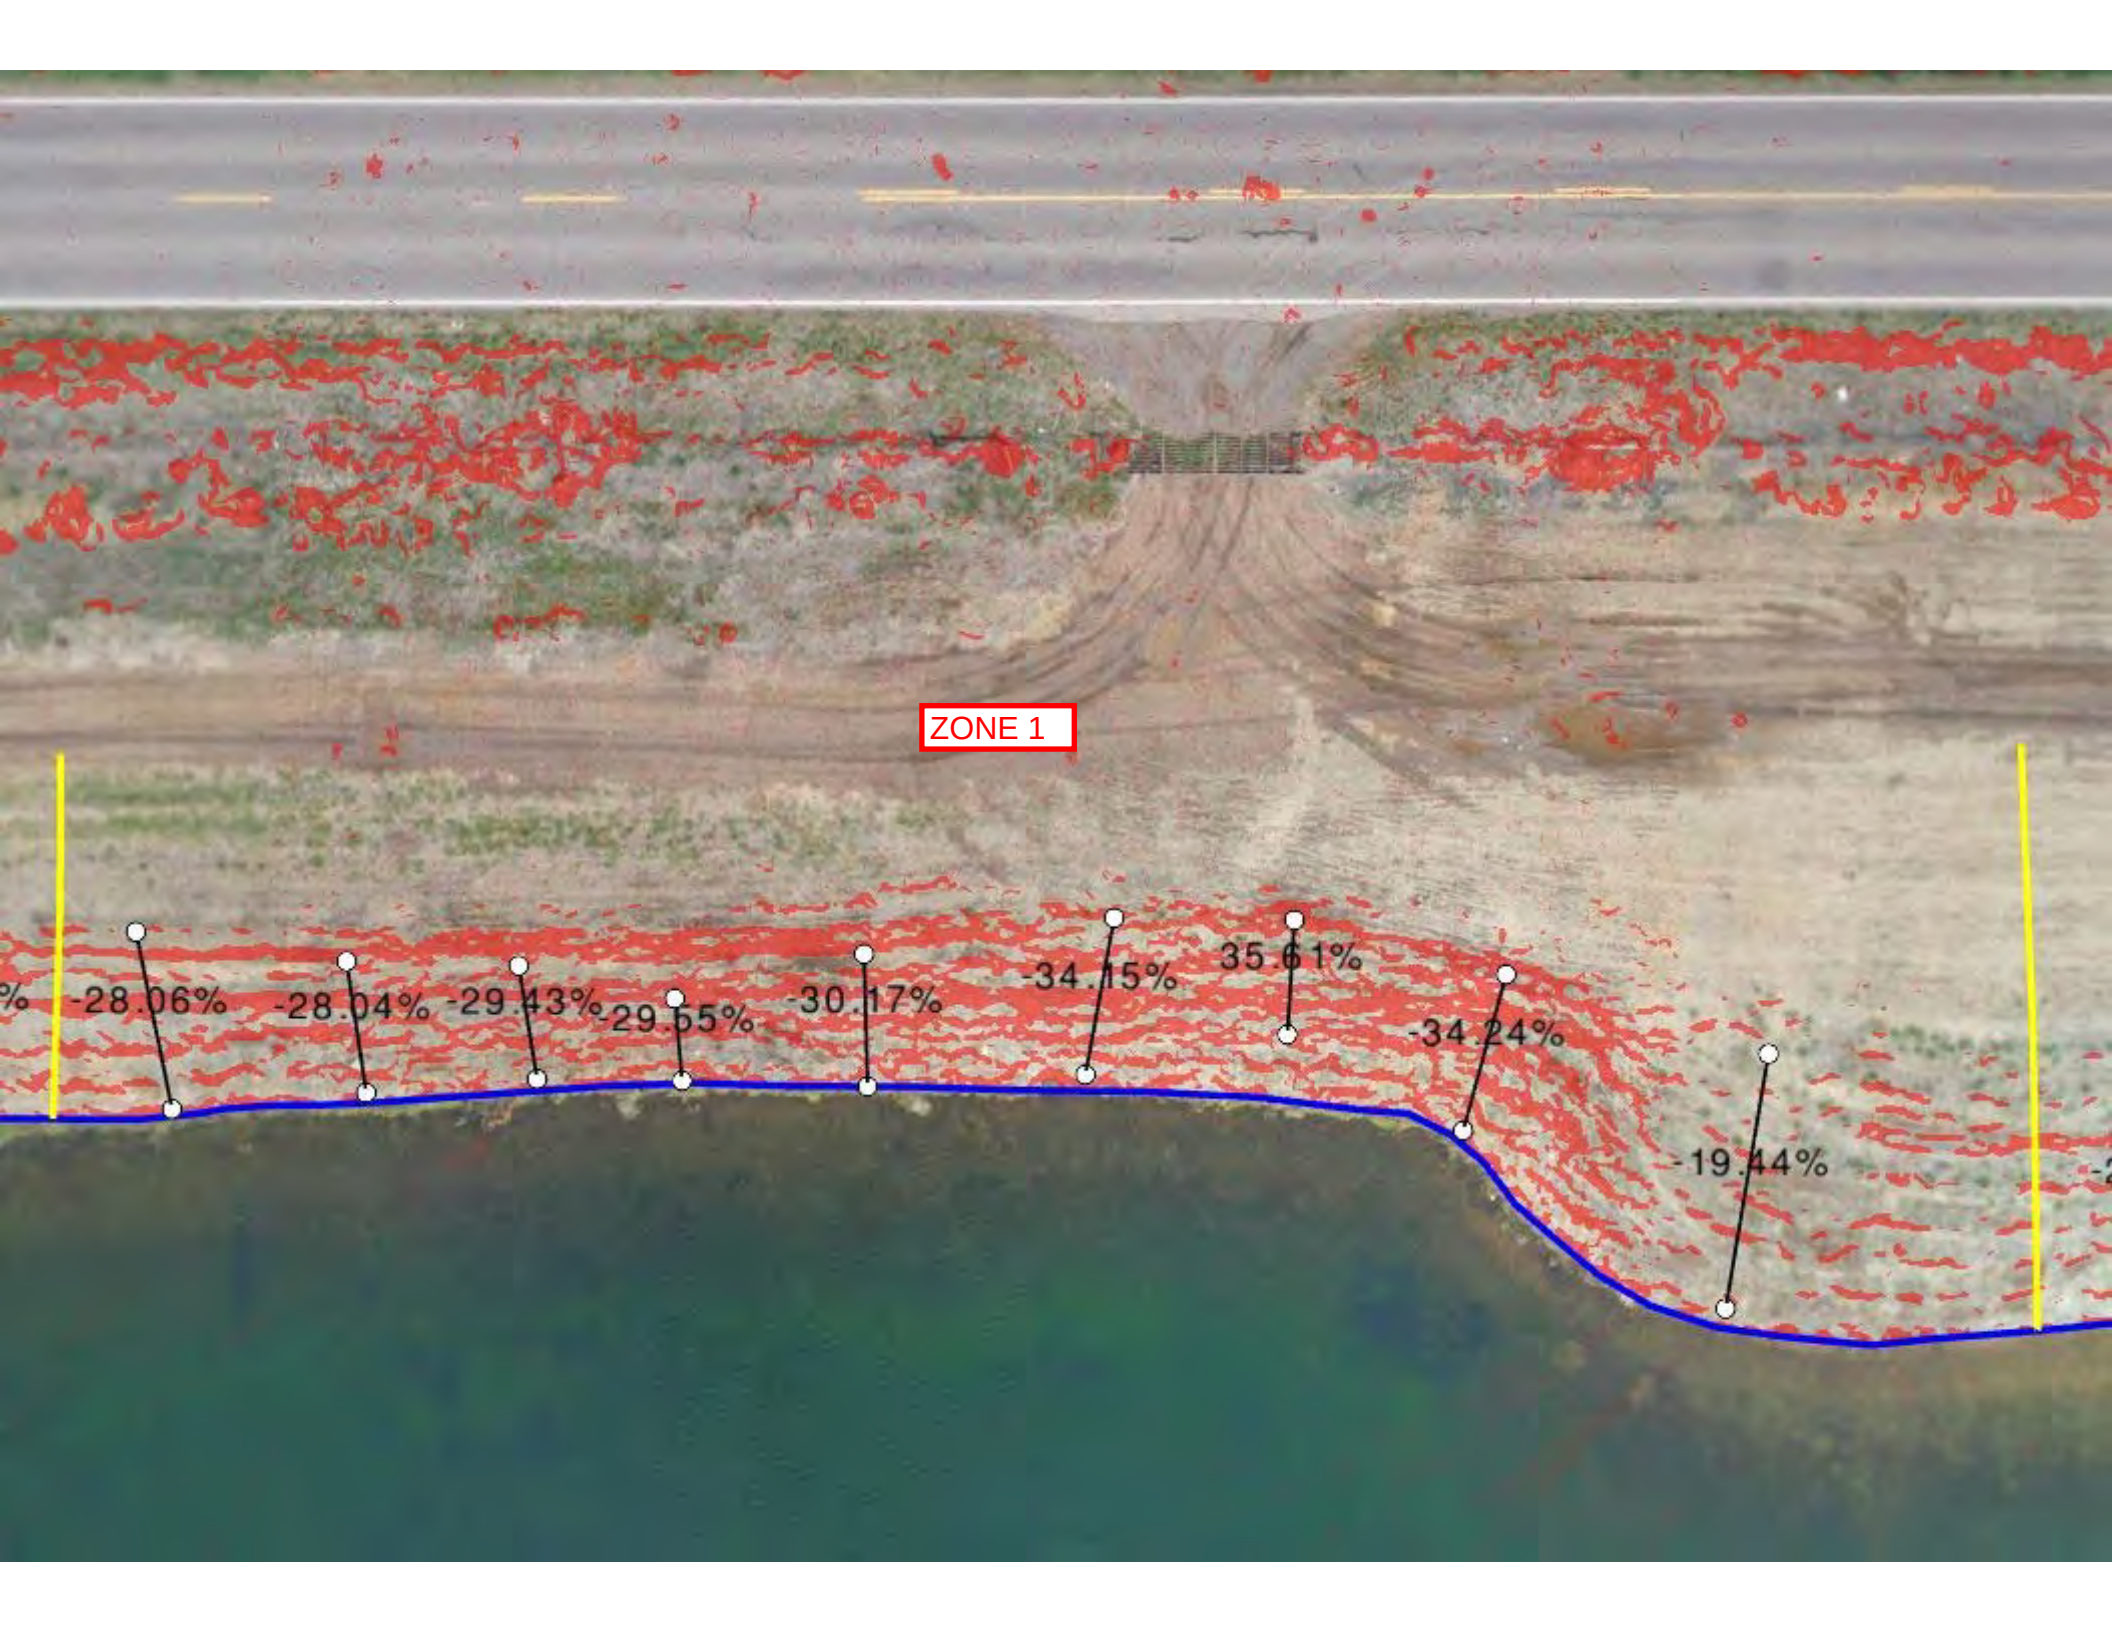
ZONE 1

The computer generated analysis shows areas where the slope exceeds 3:1 in RED.

The model indicates wind and wave erosion on the graded slopes along the waters' edge resulting in near vertical faces in some areas. Additionally, there are long slopes where it exceeds 3:1.
