## Pikeview monitoring report

To: Jerald Schnabel From: Paul Kos  
Continental Materials Corp. Denver, CO 80222  
File: February 2022 Monitoring Summary Date: March 31, 2022

**Reference: February 2022 Geotechnical Monitoring Summary Pikeview Quarry**

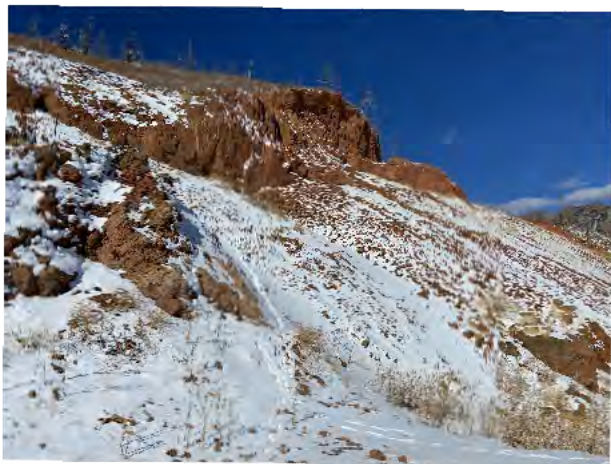
- No cracking was observed on the native granite slopes above the extents of the disturbed area (Photos 1 and 6).
- Previously Observed Cracks: Previously observed tension cracks remain on the production floor and at the crest of fill slopes. These cracks appeared the same as in previous inspections (Photos 2-4).

6. View of South Peak from haul road.

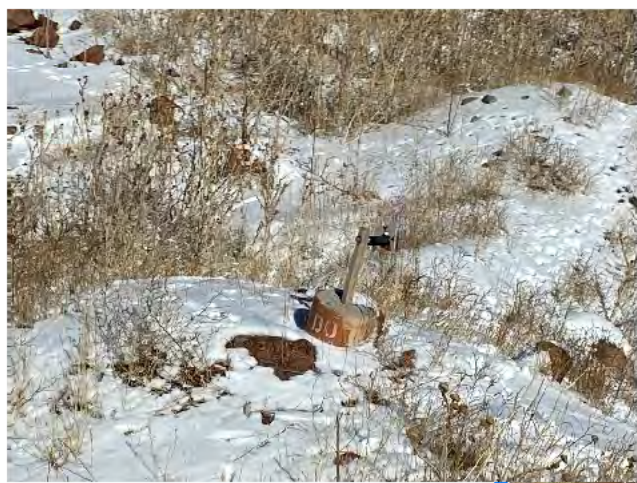
- Larger pieces of the slide continue break down into smaller pieces. (Photo 4)
- Several prisms were passed along the walking route and appeared to be in their original position and operating normally. Control points and most of the monitoring points are permanently cemented into the ground while some of the monitoring points are cemented into 5-gal buckets to be portable as needed. (Photo 5)

5. Prism on slide beneath South Peak.

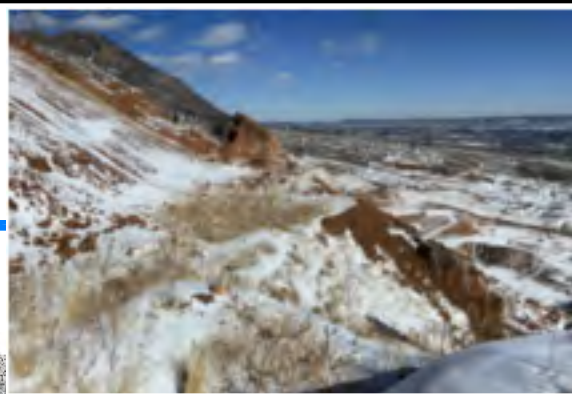
4. Large section of slide on the slope.

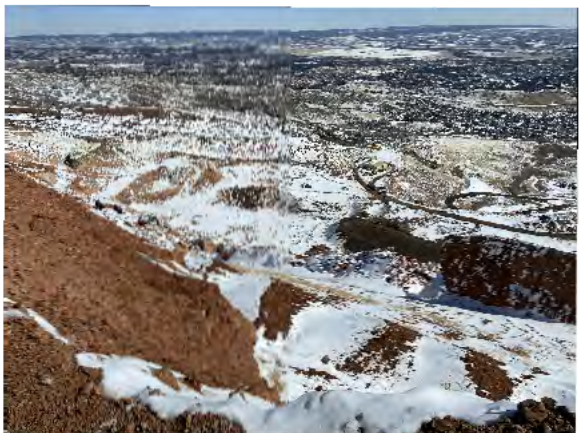
3. View to the northeast from top of haul road.

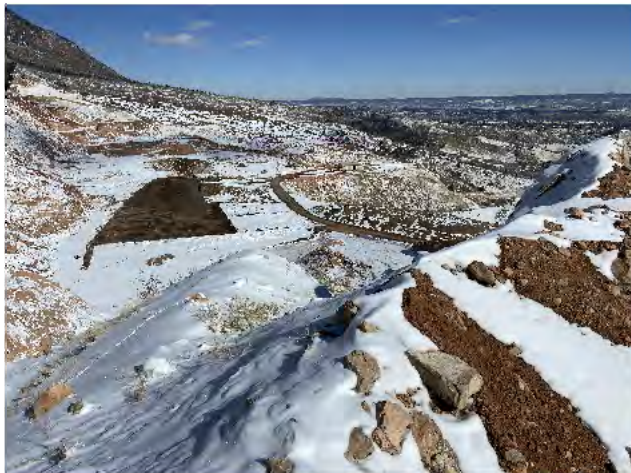
- Reclamation grading began in February 2022.
- The temporary fill stockpile is being removed. The material is being spread by dozers and compacted in one-foot lift in accordance with the project specifications. (Photo 7)

- Fill material continues to be delivered to the central location on the production floor where it was temporarily placed. Future fill material will not be stockpiled; it will be directly placed, spread, and compacted (Photo 7)

7. Material in pit is being spread by dozer.  
Snow was removed prior to placing fill.

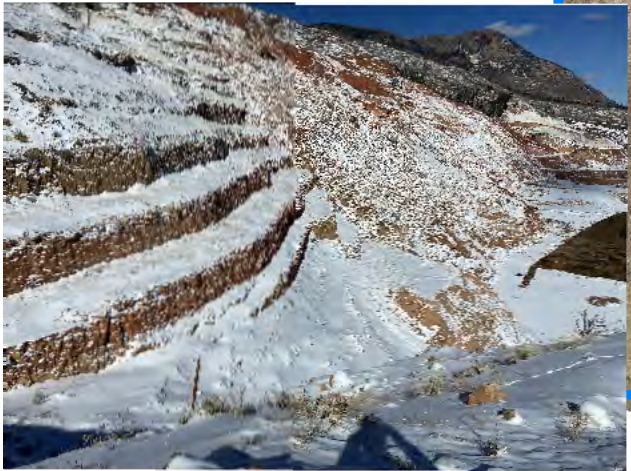
8. Reclamation benches on south-end.

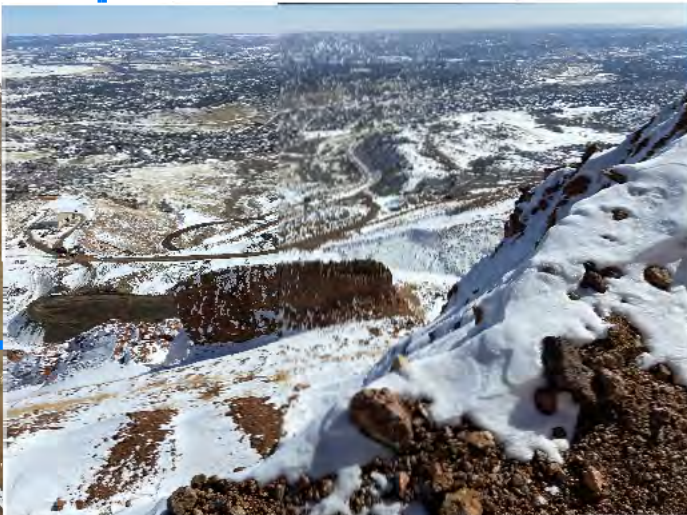
2. View to the southeast from top of haul road.

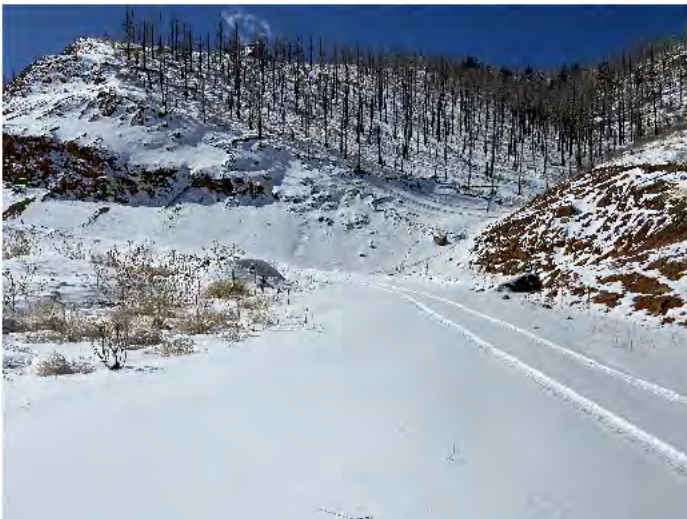
1. View of Middle Peak from haul road.

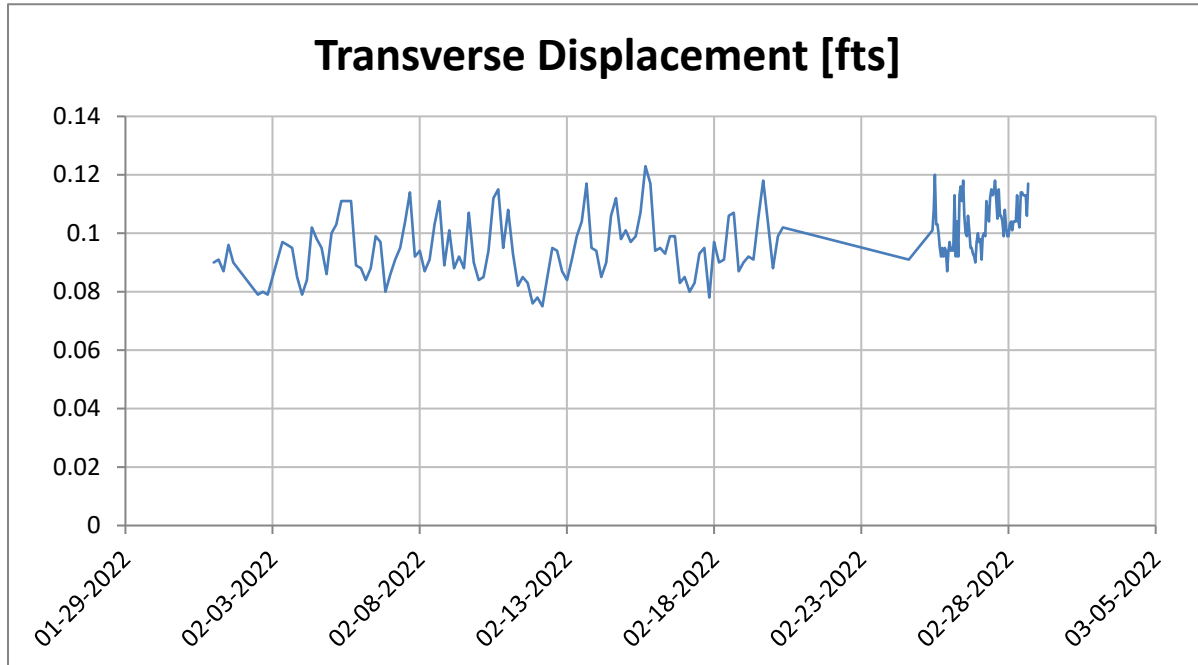
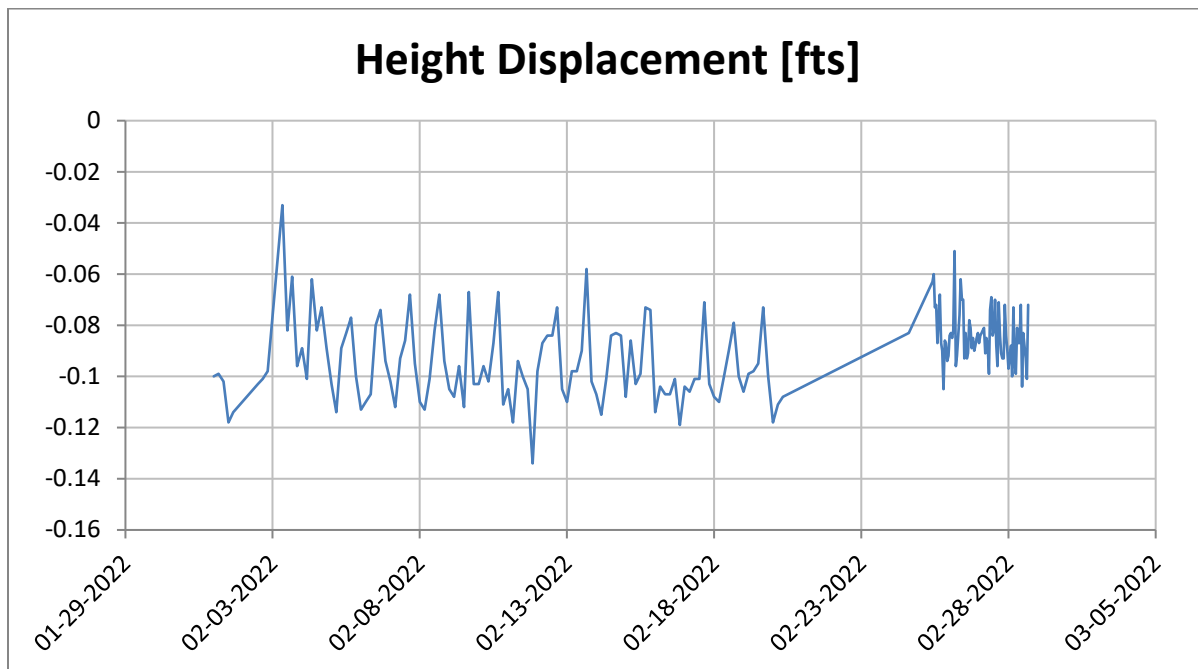
## Prism NP2

| Prism ID | Cumulative Transverse Displacement (ft) | Cumulative Height Displacement (ft) | Monthly Delta (ft) | Cumulative Delta (ft) | Notes / Recommendations |
|---|---|---|---|---|---|
| NP2 | 0.117 | -0.072 | 0.0144 | 0.1933 | Slope creep movements. |

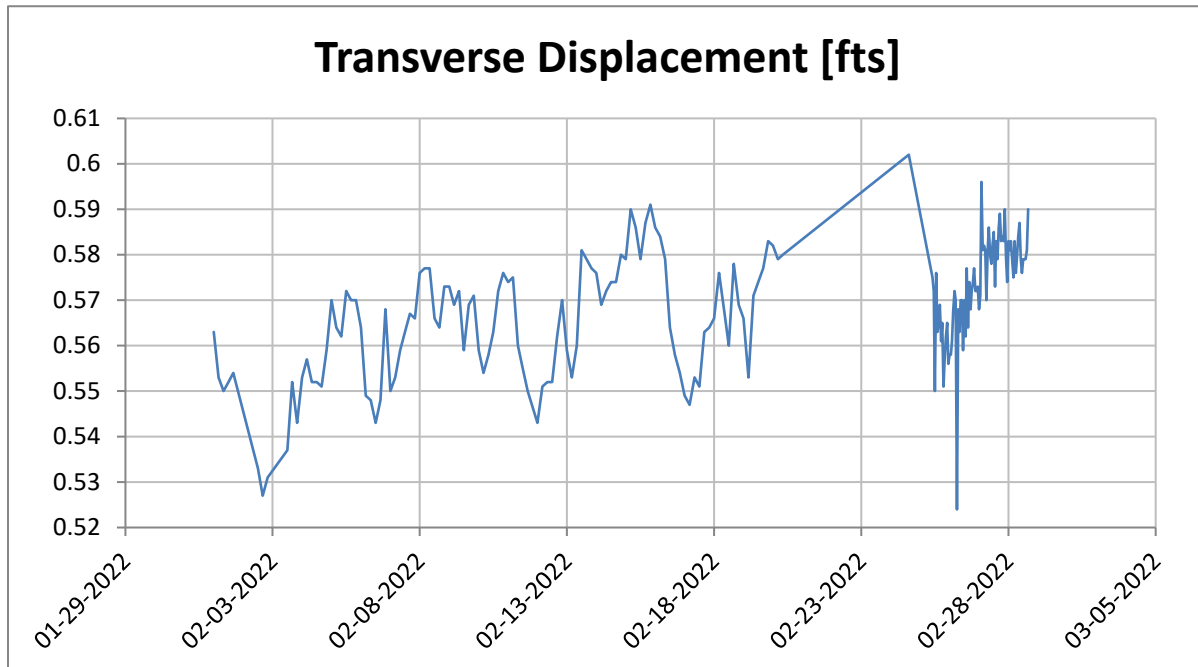
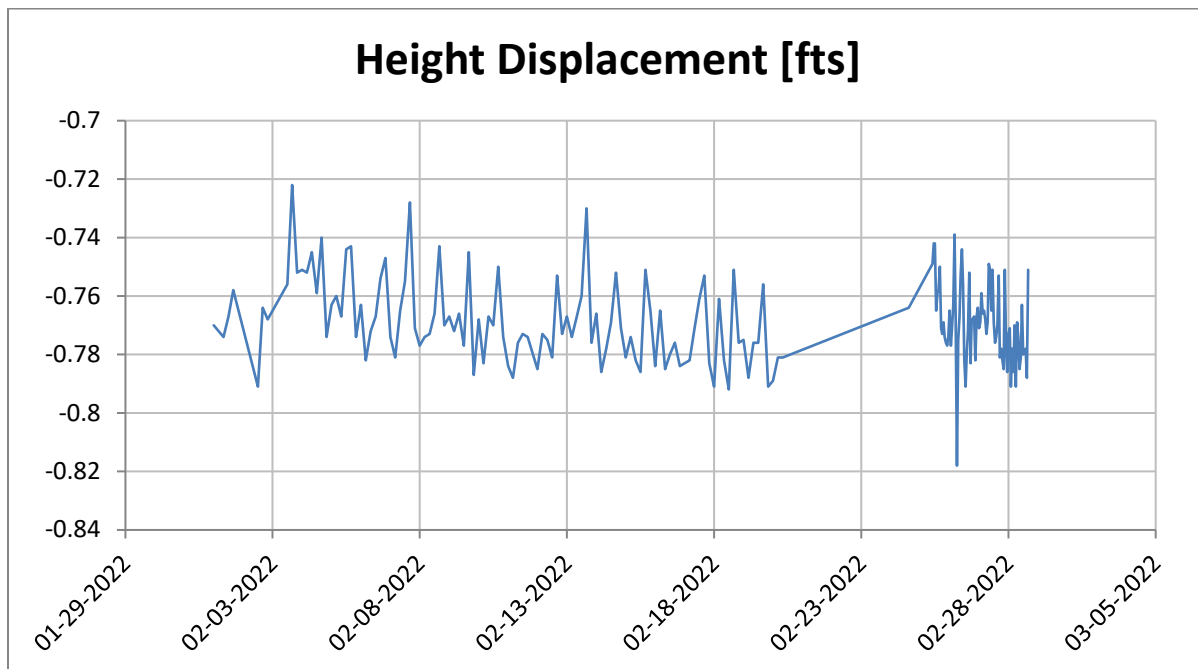
## Prism NP66

| Prism ID | Cumulative Transverse Displacement (ft) | Cumulative Height Displacement (ft) | Monthly Delta (ft) | Cumulative Delta (ft) | Notes / Recommendations |
|---|---|---|---|---|---|
| NP66 | 0.590 | -0.751 | 0.0306 | 1.1889 | Slope creep movements. |

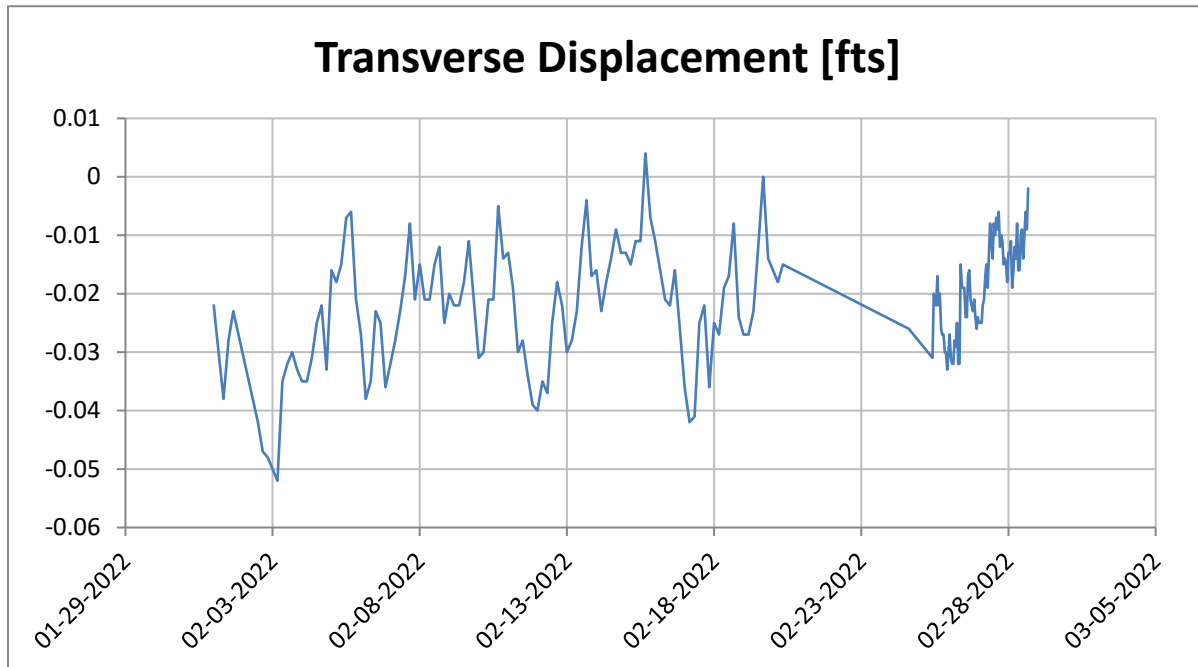
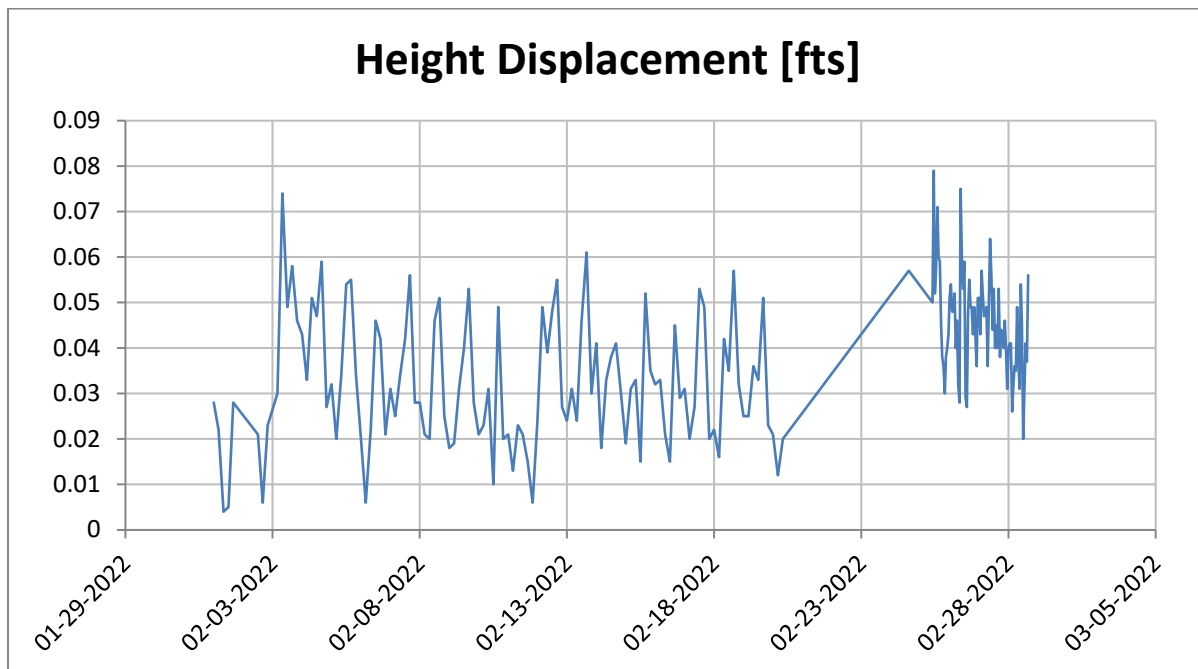
## Prism P25

| Date(s) | Alarm | Cause/Actions taken | Issue Resolved |
|---|---|---|---|
| 02/13/2022 | P25 Limit Check Level 1 Exceeded | Prism likely moved by sheep | 02/13/2022 |

The data show stable conditions with no movement for 15 of 20 prisms with recorded displacements limited to data scatter and not actual movements. As discussed above, Prism P25 was displaced by wildlife on February 13, 2022. There were no signs of movement in the areas of these prisms, and there were signs of wildlife in the area. Prisms P63 and TOE3 are located at the toe of the landslide, and these locations showed slope creep movements at slow velocities. Prisms NP2 and NP66 are located above the landslide, and these prism also recorded slope creep movements at slow velocity. This settlement is likely related to the landslide material consolidating under its own weight. Plots of the transverse and height displacements for each prism are included in Appendix B.

| Prism ID | Cumulative Transverse Displacement (ft) | Cumulative Height Displacement (ft) | Monthly Delta (ft) | Cumulative Delta (ft) | Notes / Recommendations |
|---|---|---|---|---|---|
| P25 | -0.002 | 0.056 | 0.0220 | 0.1771 | Wildlife interference. |

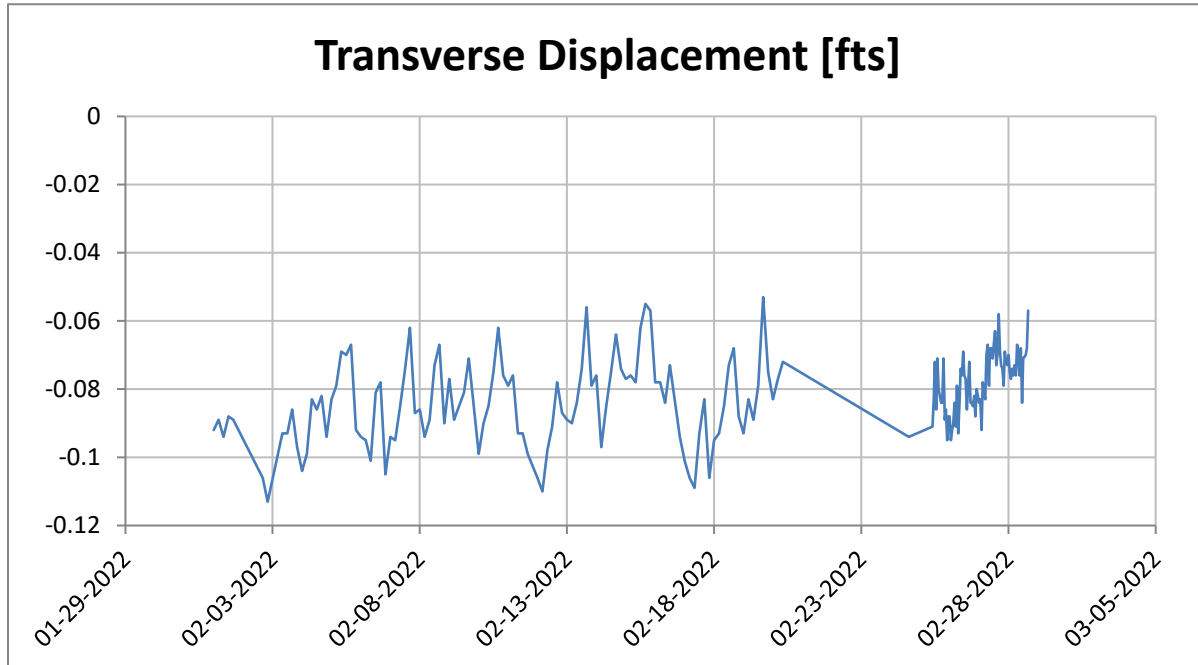
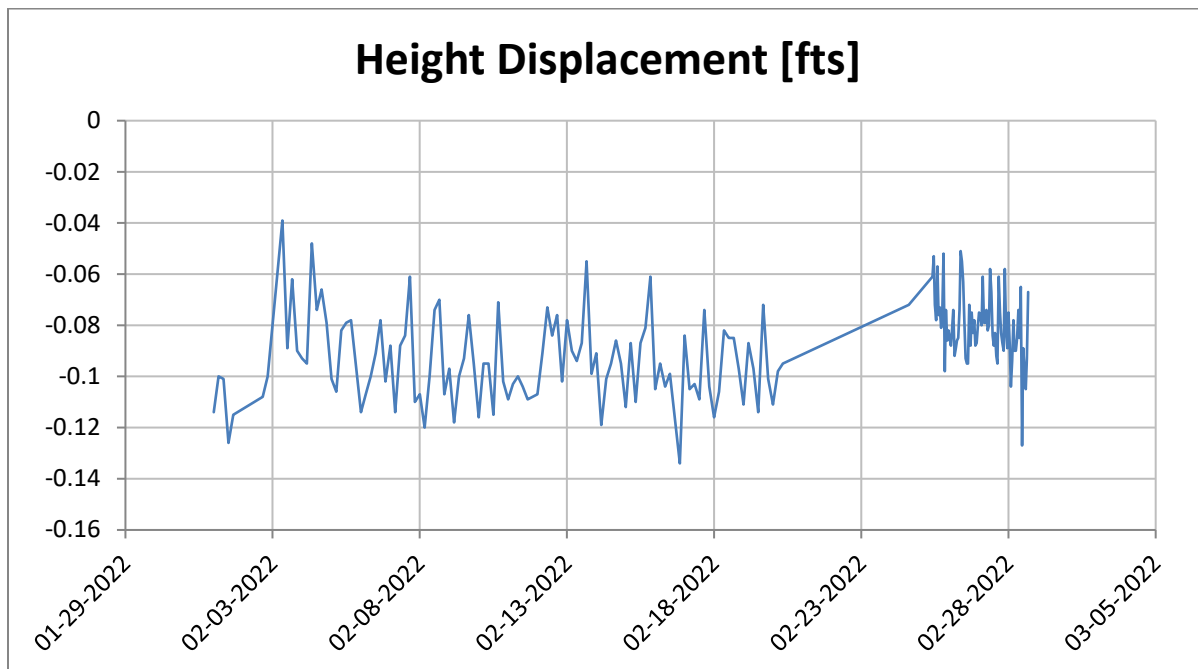
## Prism P32

| Date(s) | Alarm | Cause/Actions taken | Issue Resolved |
|---|---|---|---|
| 02/10/2022 | P32 Limit Check Level 1 Exceeded | P32 spiked then returned to normal the next morning. Assumed to be data error related to weather. | 02/10/2022 |

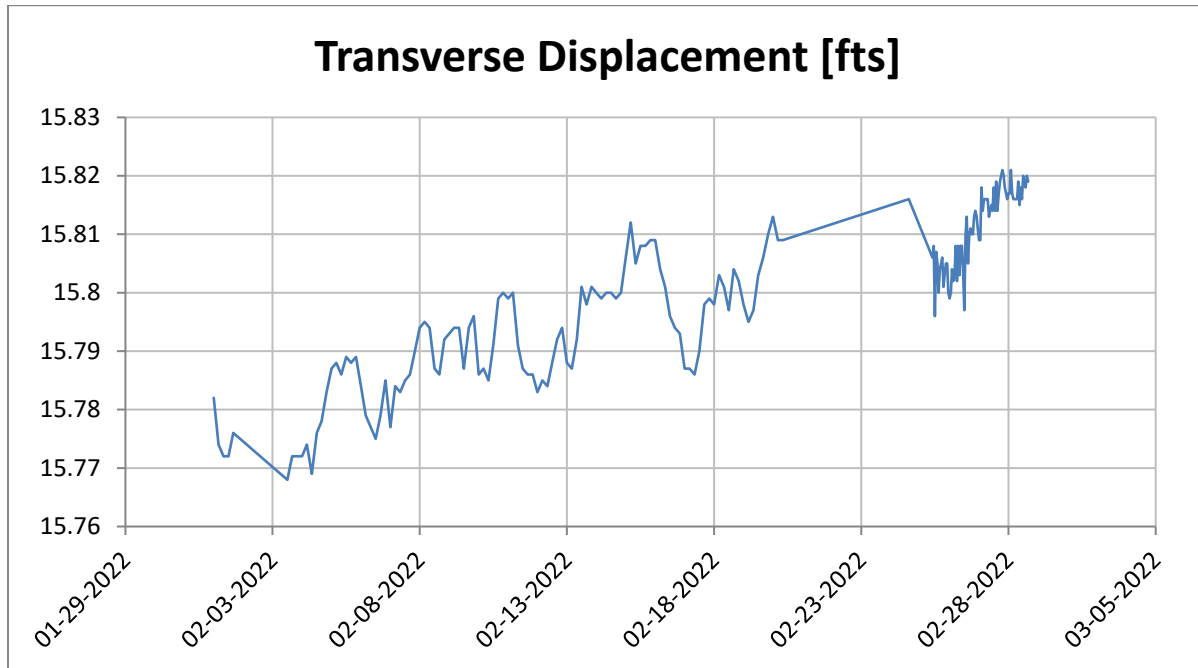
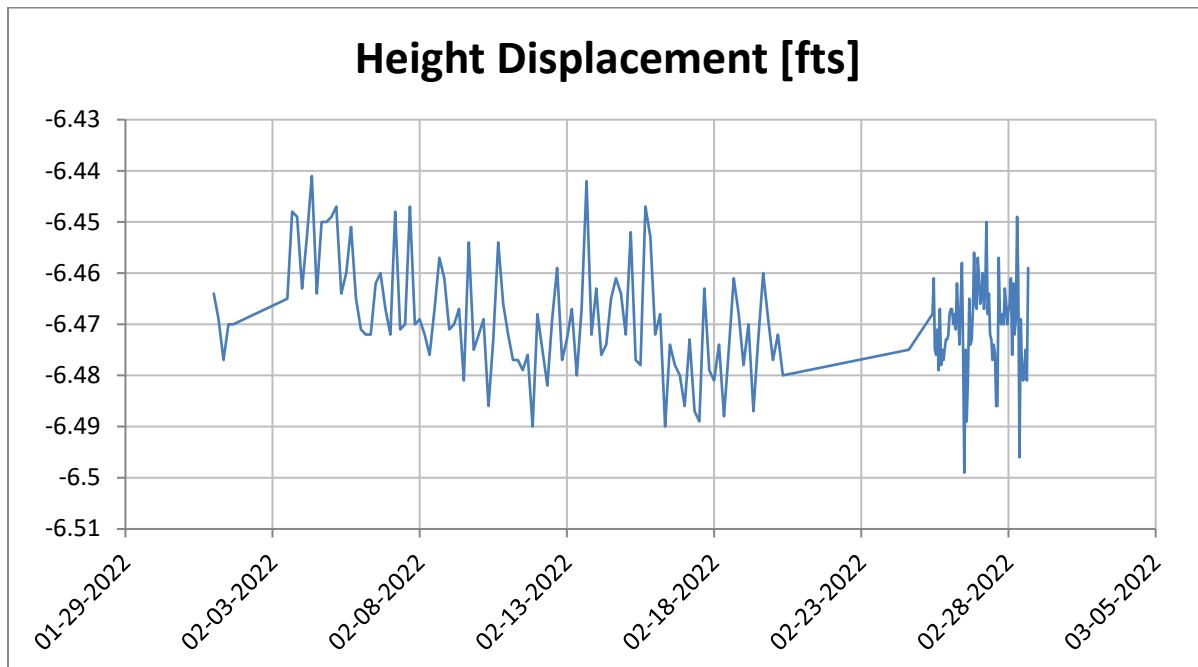
## Prism P63

| Prism ID | Cumulative Transverse Displacement (ft) | Cumulative Height Displacement (ft) | Monthly Delta (ft) | Cumulative Delta (ft) | Notes / Recommendations |
|---|---|---|---|---|---|
| P63 | 15.819 | -6.459 | 0.0325 | 17.0872 | Slope creep movements. |

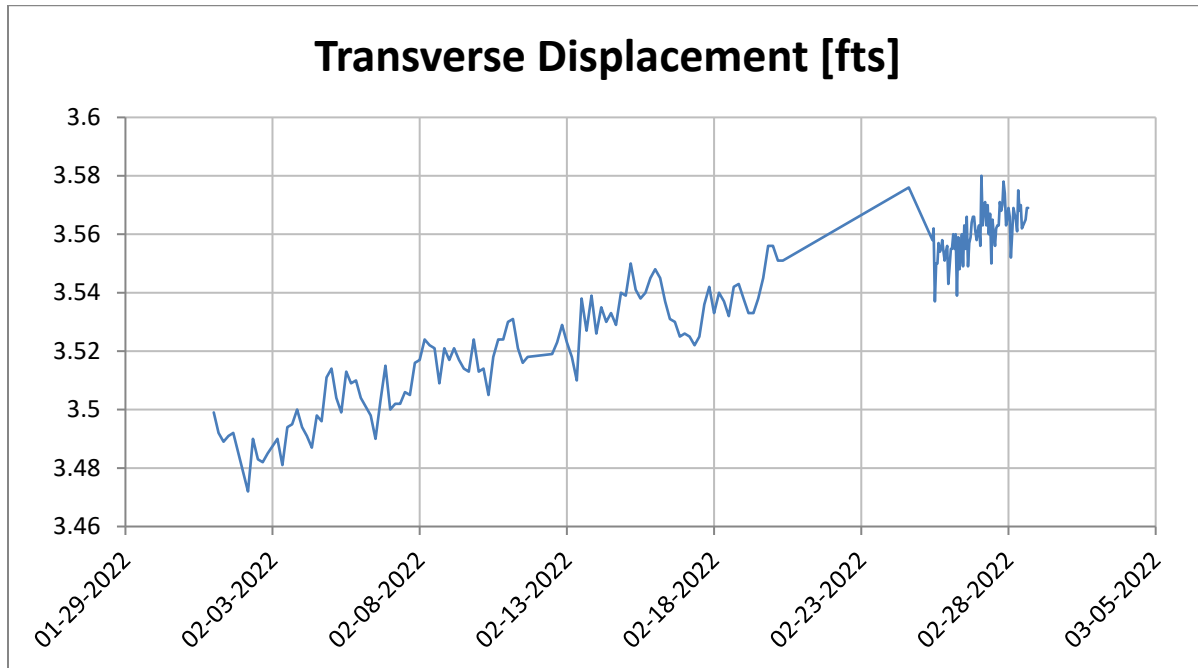
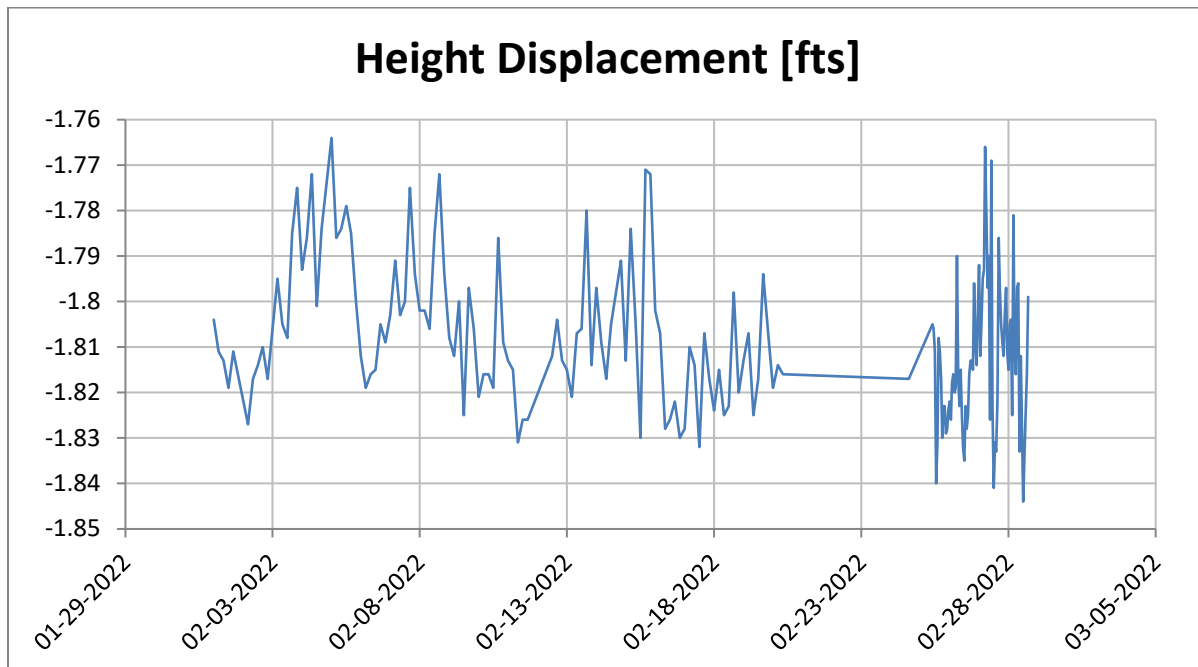
## Prism TOE3

| Prism ID | Cumulative Transverse Displacement (ft) | Cumulative Height Displacement (ft) | Monthly Delta (ft) | Cumulative Delta (ft) | Notes / Recommendations |
|---|---|---|---|---|---|
| TOE3 | 3.569 | -1.799 | 0.0578 | 4.2578 | Slope creep movements. |
