**MINERALS PROGRAM INSPECTION REPORT**  
**PHONE: (303) 866-3567**

<b>MINE NAME:</b> Thomas Pit	<b>MINE/PROSPECTING ID#:</b> M-1976-020	<b>MINERAL:</b> Sand and gravel	<b>COUNTY:</b> La Plata
<b>INSPECTION TYPE:</b> Monitoring	<b>INSPECTOR(S):</b> Lucas West	<b>INSP. DATE:</b> March 9, 2022	<b>INSP. TIME:</b> 09:30
<b>OPERATOR:</b> Oldcastle SW Group, Inc. dba Four Corners M	<b>OPERATOR REPRESENTATIVE:</b> Matt Carnahan	<b>TYPE OF OPERATION:</b> 112c - Construction Regular Operation	
<b>REASON FOR INSPECTION:</b> Normal I&E Program	<b>BOND CALCULATION TYPE:</b> Complete Bond	<b>BOND AMOUNT:</b> \$26,295.00	
<b>DATE OF COMPLAINT:</b> NA	<b>POST INSP. CONTACTS:</b> None	<b>JOINT INSP. AGENCY:</b> None	
<b>WEATHER:</b> Clear	<b>INSPECTOR'S SIGNATURE:</b>

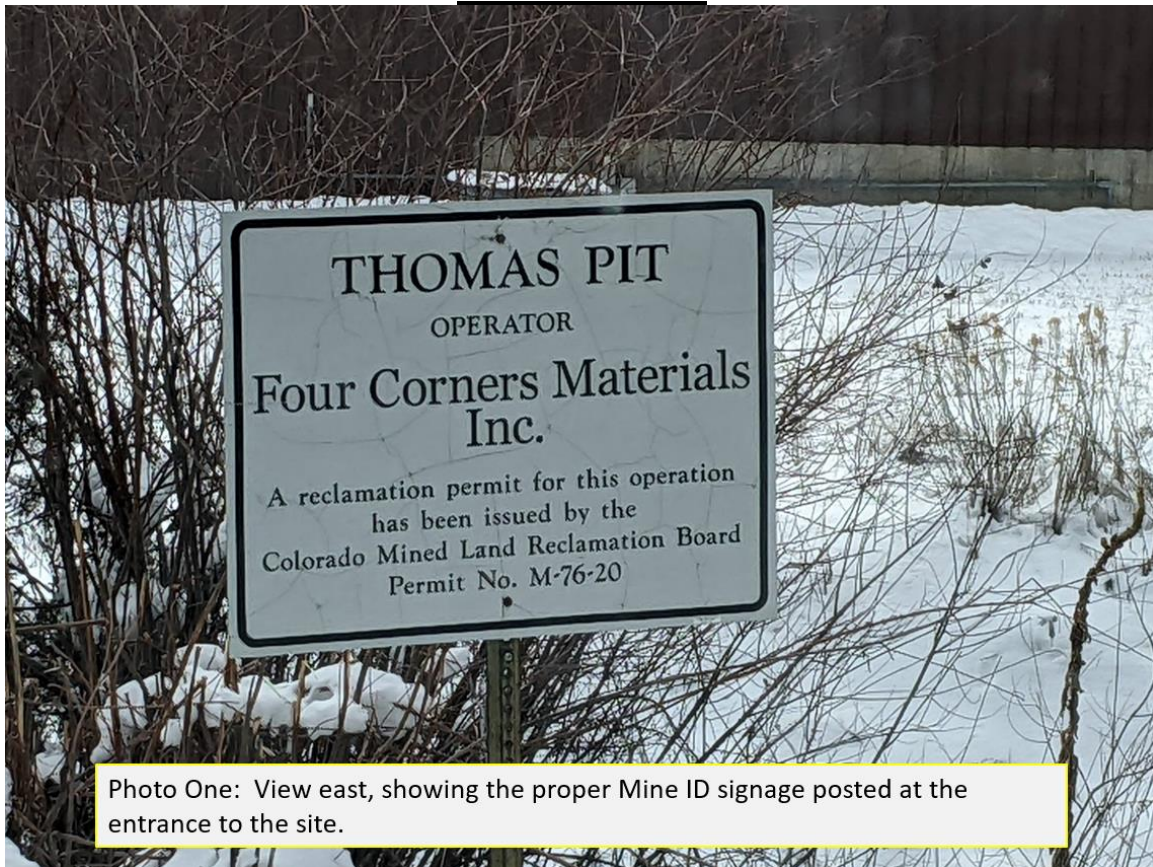
Photo One: View east, showing the proper Mine ID signage posted at the entrance to the site.

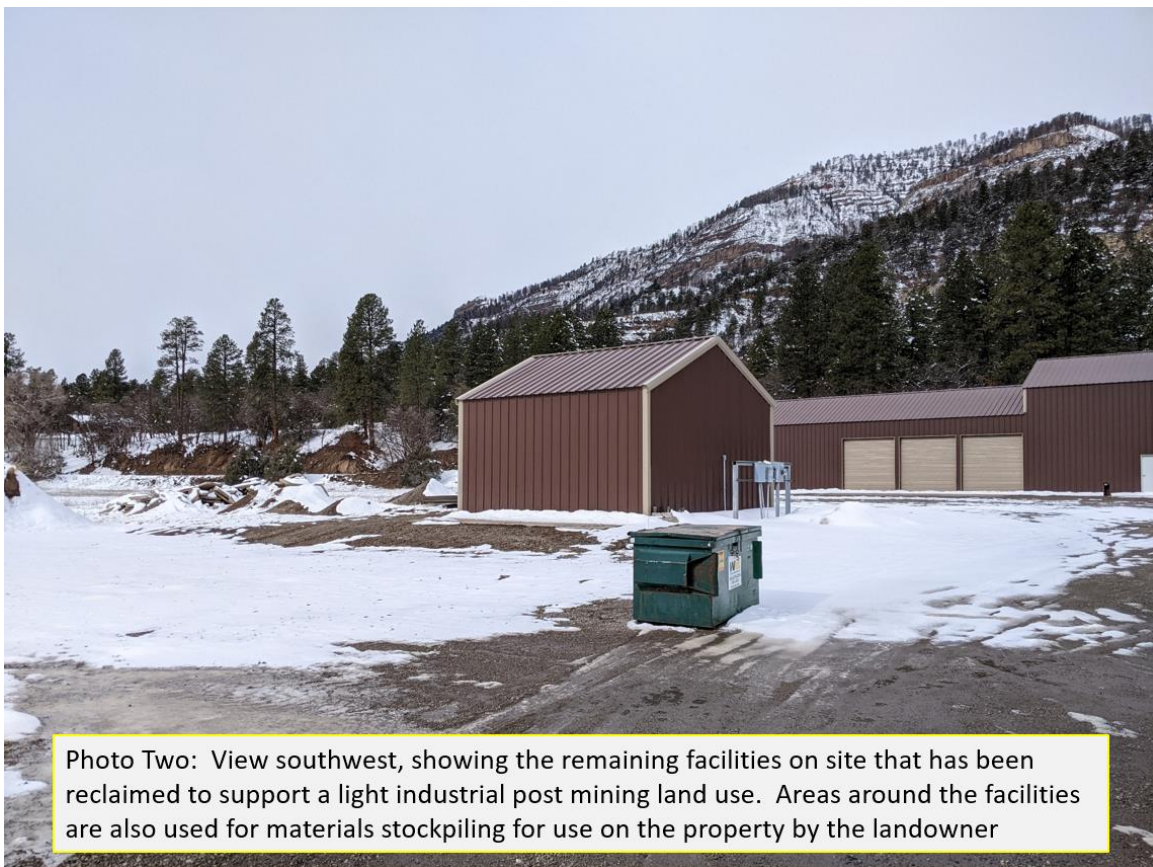
Photo Two: View southwest, showing the remaining facilities on site that has been reclaimed to support a light industrial post mining land use. Areas around the facilities are also used for materials stockpiling for use on the property by the landowner

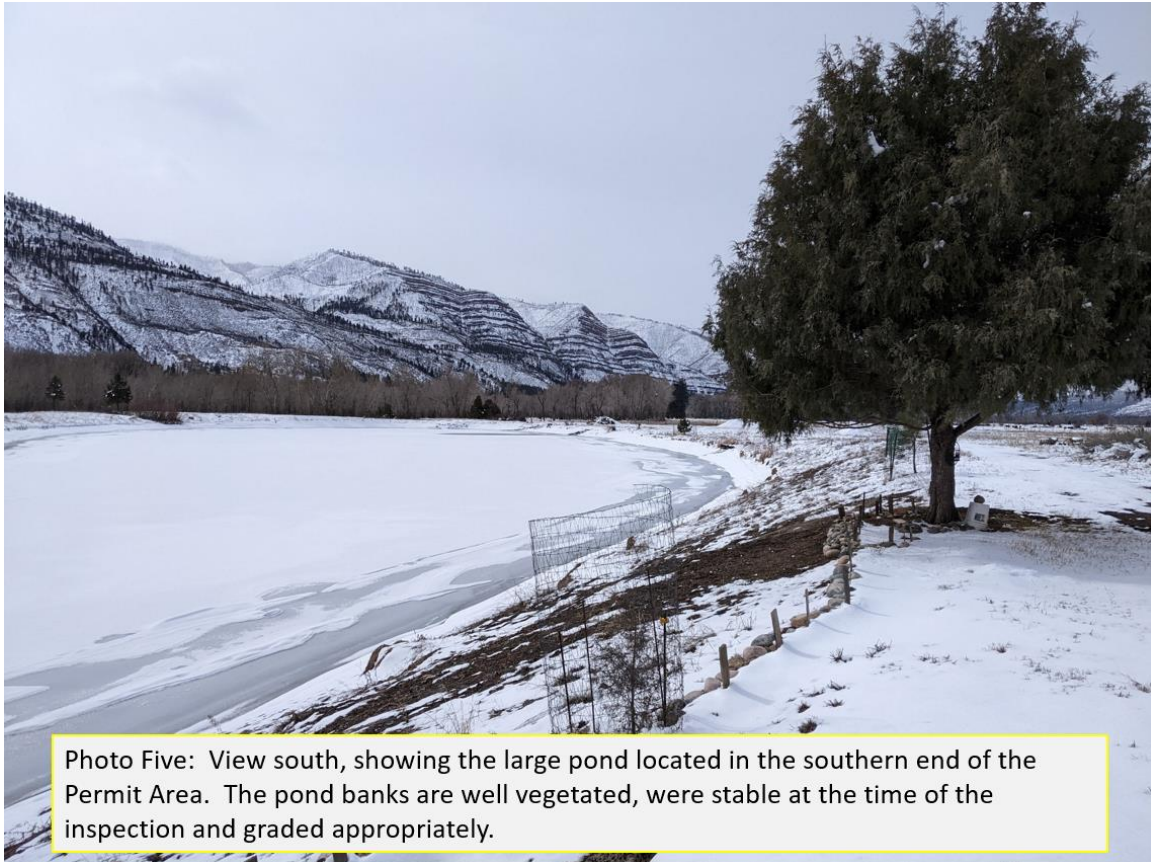
Photo Five: View south, showing the large pond located in the southern end of the Permit Area. The pond banks are well vegetated, were stable at the time of the inspection and graded appropriately.

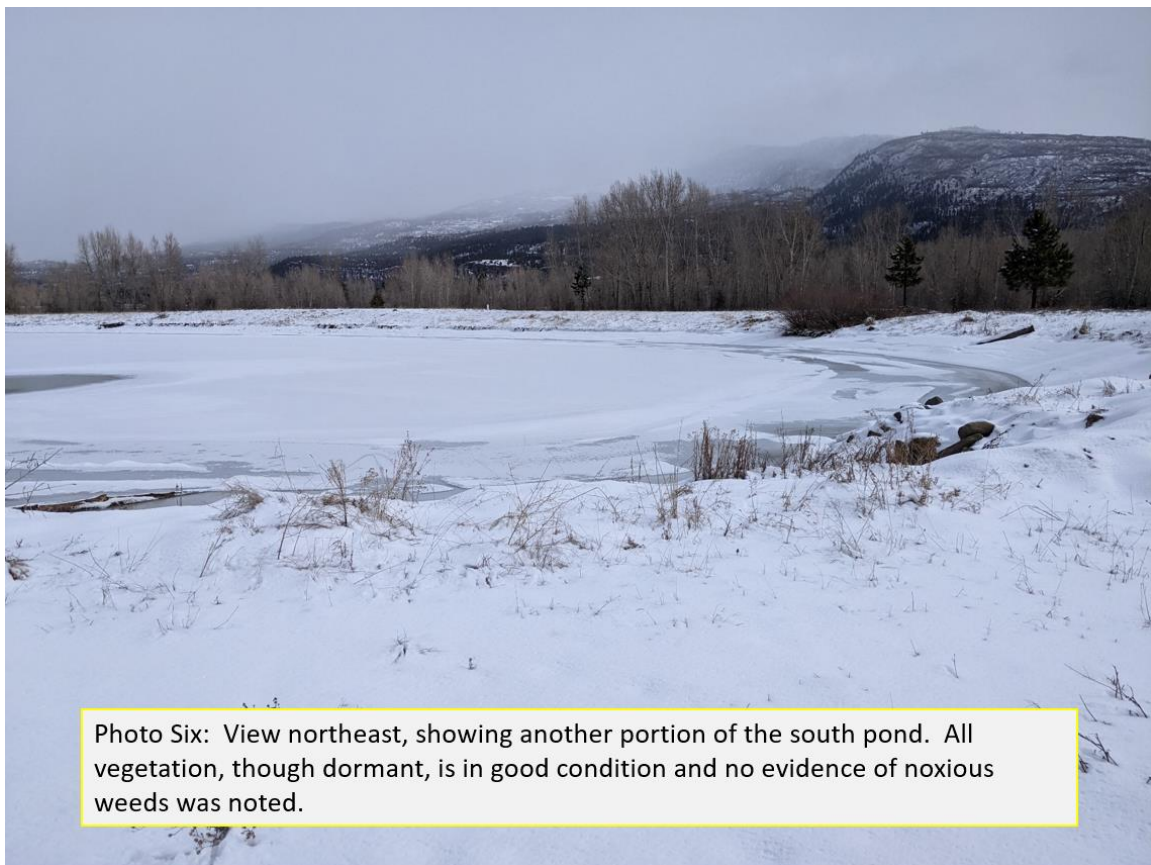
Photo Six: View northeast, showing another portion of the south pond. All vegetation, though dormant, is in good condition and no evidence of noxious weeds was noted.
