MINERALS PROGRAM INSPECTION REPORT
PHONE: (303) 866-3567

MINE NAME: Animas Glacier Gravel (AGG)	MINE/PROSPECTING ID#: M-2011-028	MINERAL: Gravel and sand	COUNTY: La Plata
INSPECTION TYPE: Monitoring	INSPECTOR(S): Lucas West	INSP. DATE: March 9, 2022	INSP. TIME: 12:48
OPERATOR: Oldcastle SW Group, Inc. dba Four Corners M	OPERATOR REPRESENTATIVE: Matt Carnahan	TYPE OF OPERATION: 112c - Construction Regular Operation	
REASON FOR INSPECTION: Normal I&E Program	BOND CALCULATION TYPE: Complete Bond	BOND AMOUNT: \$78,788.37	
DATE OF COMPLAINT: NA	POST INSP. CONTACTS: None	JOINT INSP. AGENCY: None	
WEATHER: Clear	INSPECTOR'S SIGNATURE:

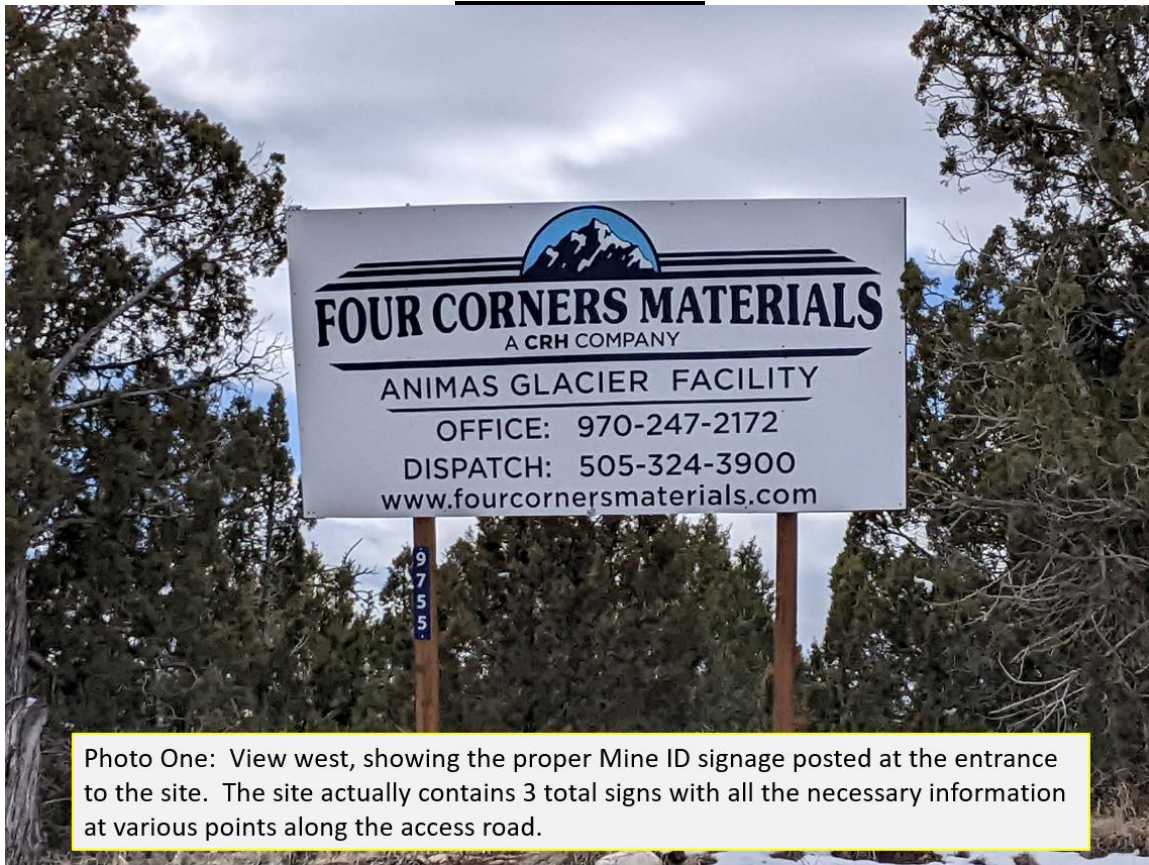
The proper Mine Identification signage was posted where the access road meets La Posta Road shown in Photo One, and the permit boundaries were clearly marked. The site was not active during the day of the inspection however maintenance was being performed on the crusher, and various other pieces of equipment. The active mining area is confined to a small area located in the southwest corner of the pit. The active mining area consists of two highwalls. The first located to the west is approximately 15 feet tall on average and approximately 300 linear feet. A portion of the west highwall can be seen in Photo Two. The east highwall is approximately an average of 20 feet tall with nearly 200 linear feet exposed. The east highwall ranges from near vertical to 2H:1V slopes and can be seen in Photo Three. Both highwalls are in good condition and appears to be stable, showing no signs of settling, slumping, or significant erosion at this time. The previously mined areas that surround the pit floor have been relaxed to approximately a 3H: 1V configuration and revegetated. The vegetation is coming in well, and is providing adequate stability to the slopes as no signs of erosion was observed on the reclaimed areas.

Photo One: View west, showing the proper Mine ID signage posted at the entrance to the site. The site actually contains 3 total signs with all the necessary information at various points along the access road.

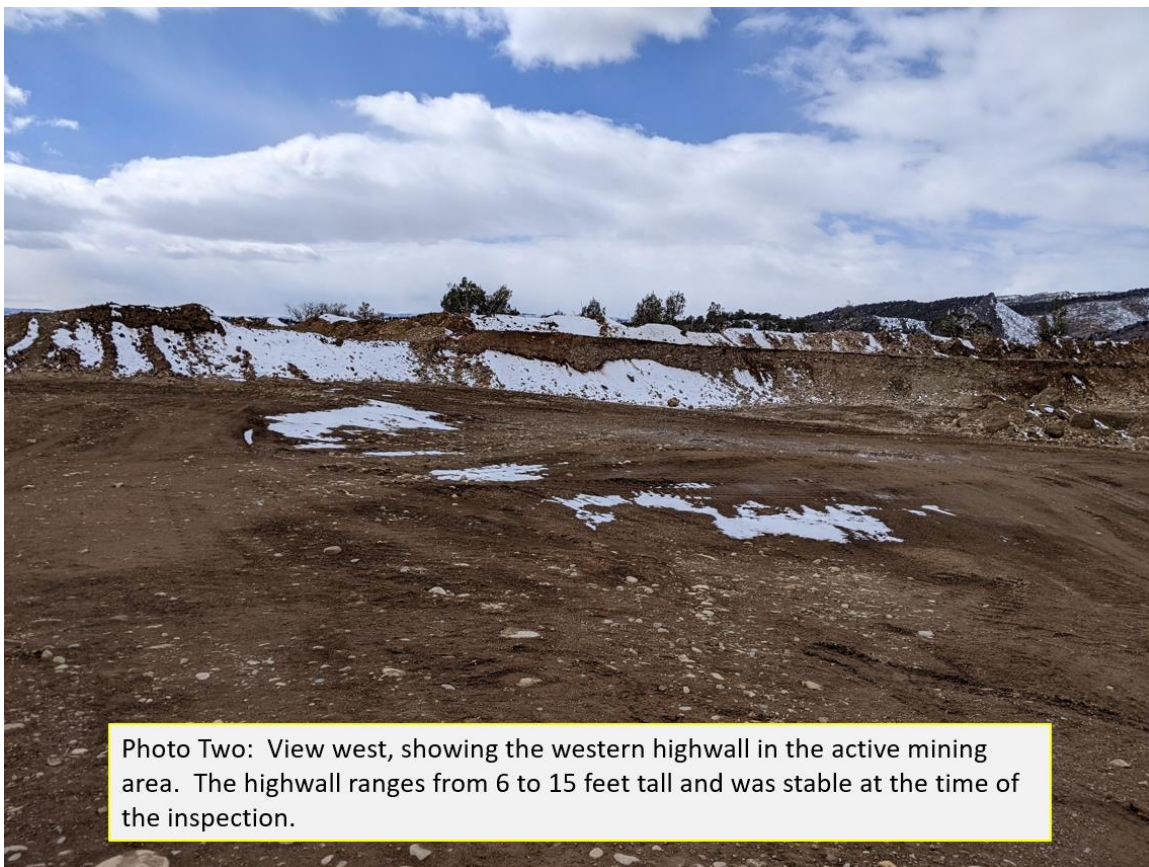
Photo Two: View west, showing the western highwall in the active mining area. The highwall ranges from 6 to 15 feet tall and was stable at the time of the inspection.

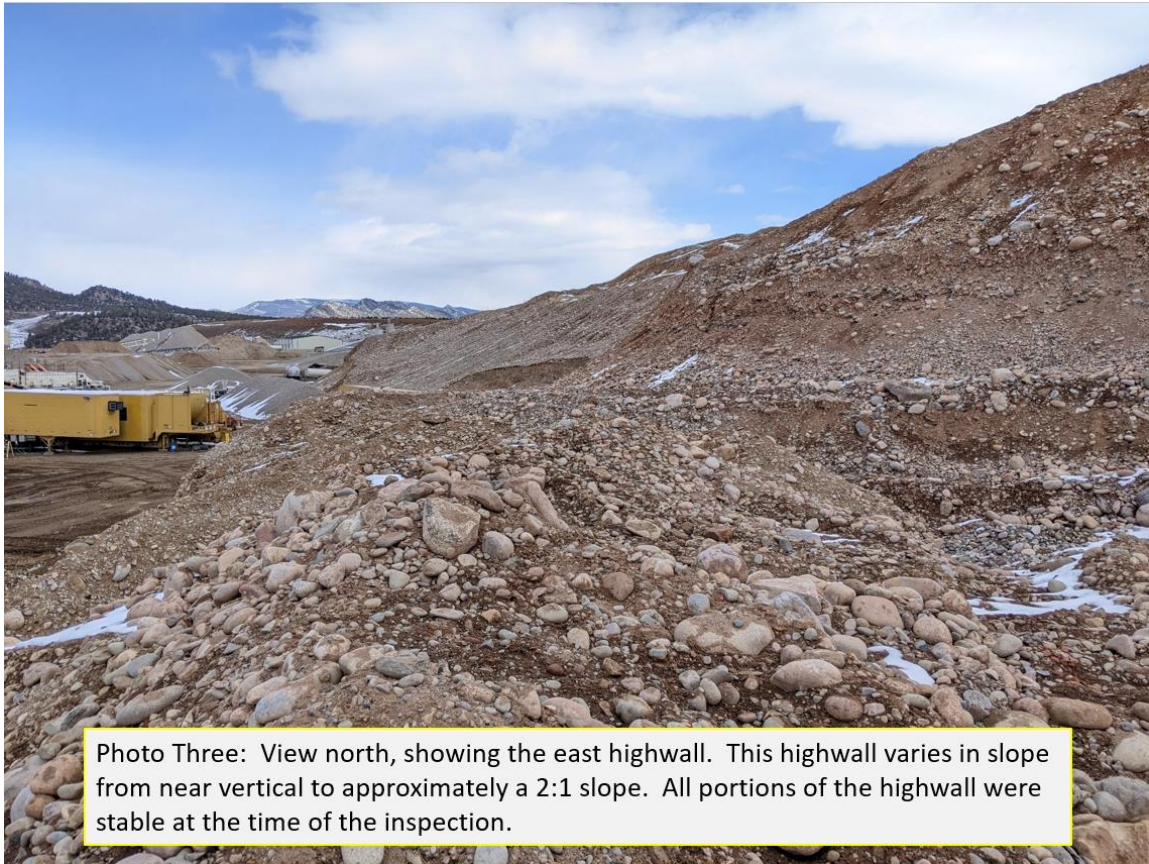
Photo Three: View north, showing the east highwall. This highwall varies in slope from near vertical to approximately a 2:1 slope. All portions of the highwall were stable at the time of the inspection.

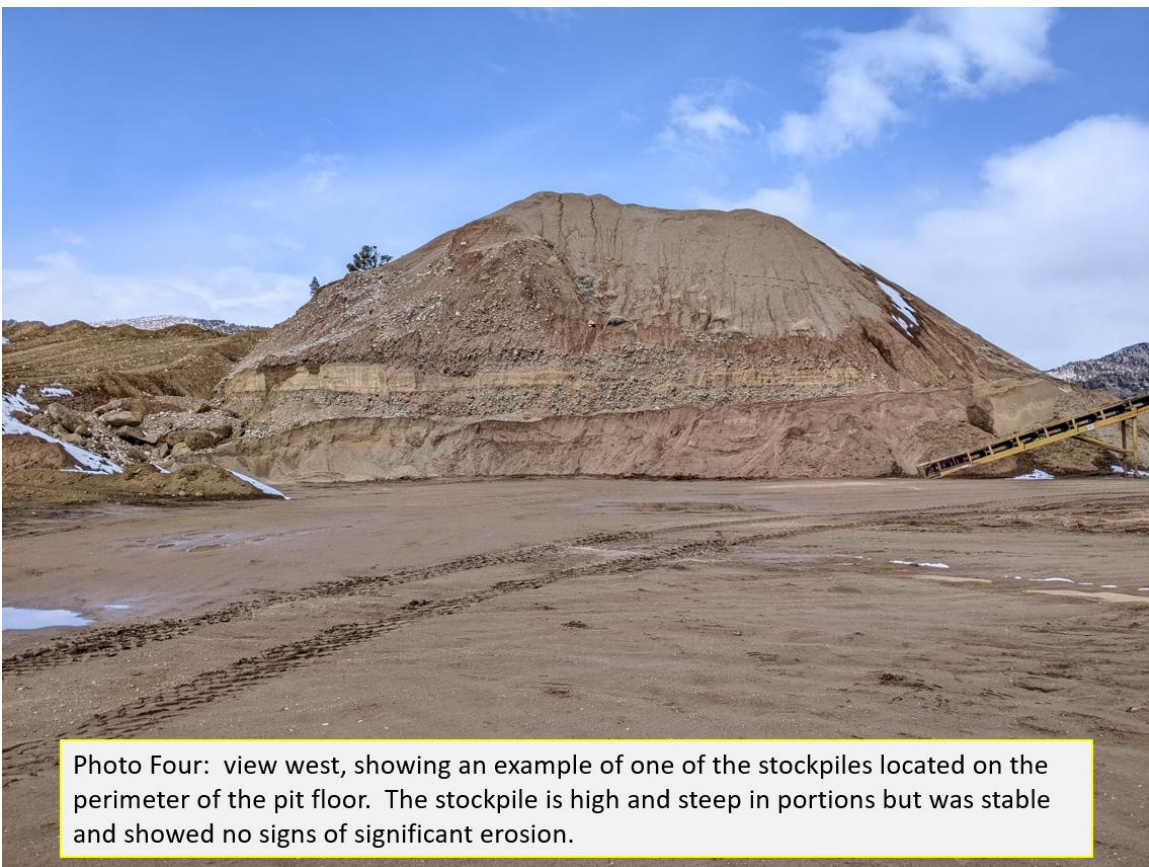
Several large stockpiles of various sized materials were on the pit floor. All stockpiles observed appeared to be in good condition and stable. Examples of the stockpiles can be seen in Photos Four and Five. An overview of the pit floor can be seen in Photo Six. Several facilities exist on the pit floor including the crusher, conveyors, wash plant, concrete batch and asphalt hot plants as well others. All facilities are in excellent condition with all of the ancillary equipment stored in a neat and orderly fashion. Near the asphalt hot plant is a mobile office trailer currently being used as an office as well as a large area being used as a laydown/ storage area. All items being stored in the storage area are in good condition and stored in a neat and orderly fashion. In the storage area are two large double walled above ground fuel storage containers. The proper safety and spill kits are located adjacent to the tanks and because they are double walled with built in secondary containment, no additional containment measures are required.

Photo Four: view west, showing an example of one of the stockpiles located on the perimeter of the pit floor. The stockpile is high and steep in portions but was stable and showed no signs of significant erosion.

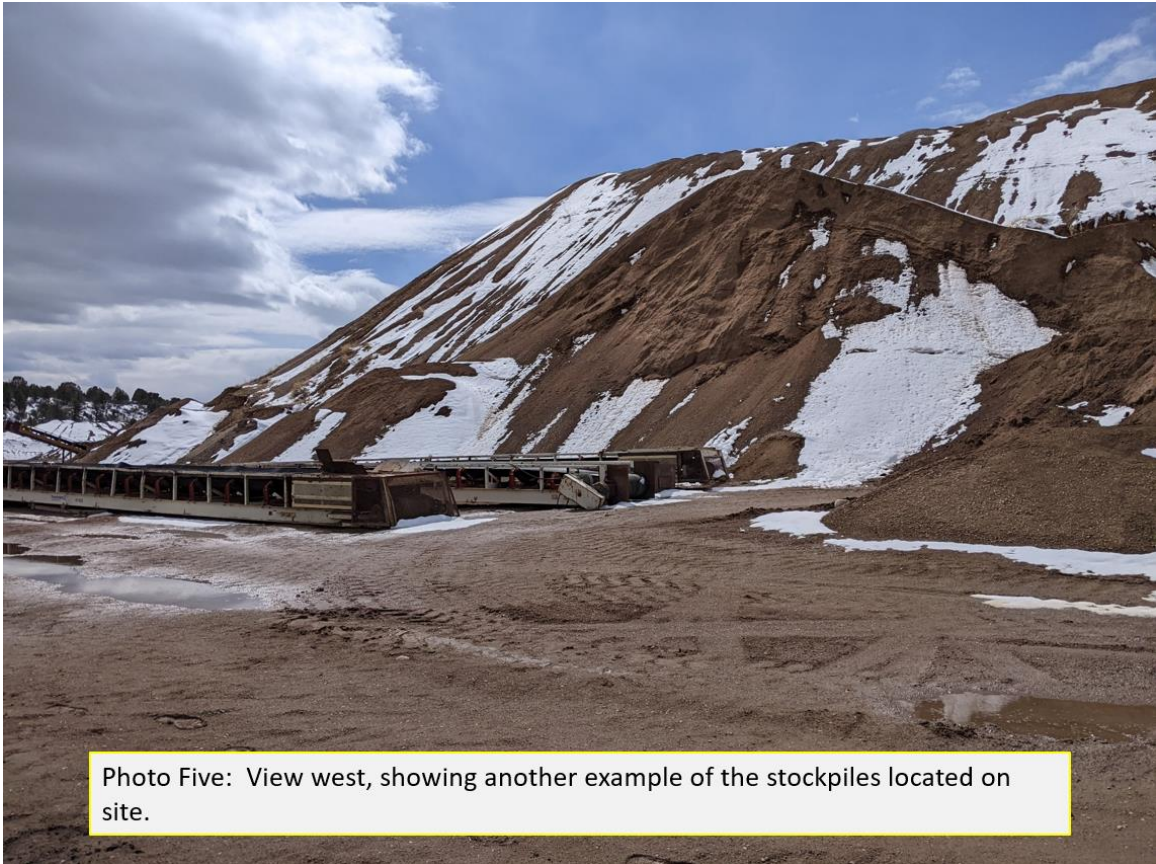
Photo Five: View west, showing another example of the stockpiles located on site.

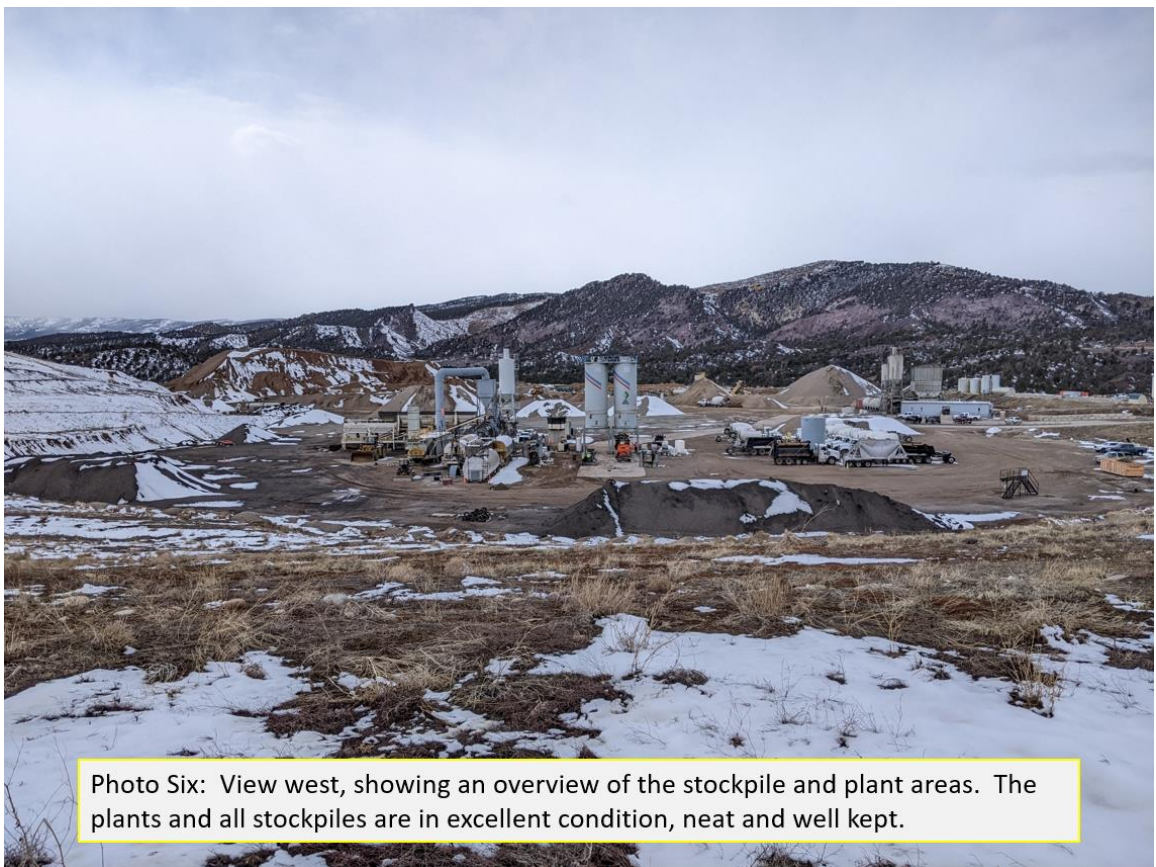
Photo Six: View west, showing an overview of the stockpile and plant areas. The plants and all stockpiles are in excellent condition, neat and well kept.
