MINERALS PROGRAM INSPECTION REPORT
PHONE: (303) 866-3567

MINE NAME: Rock Dog #1	MINE/PROSPECTING ID#: M-2005-045	MINERAL: Sand and gravel	COUNTY: La Plata
INSPECTION TYPE: Monitoring	INSPECTOR(S): Lucas West	INSP. DATE: March 9, 2022	INSP. TIME: 14:00
OPERATOR: Oldcastle SW Group, Inc. dba Four Corners M	OPERATOR REPRESENTATIVE: Matt Carnahan	TYPE OF OPERATION: 112c - Construction Regular Operation	
REASON FOR INSPECTION: Normal I&E Program	BOND CALCULATION TYPE: Complete Bond	BOND AMOUNT: \$137,842.00	
DATE OF COMPLAINT: NA	POST INSP. CONTACTS: None	JOINT INSP. AGENCY: None	
WEATHER: Cloudy	INSPECTOR'S SIGNATURE:

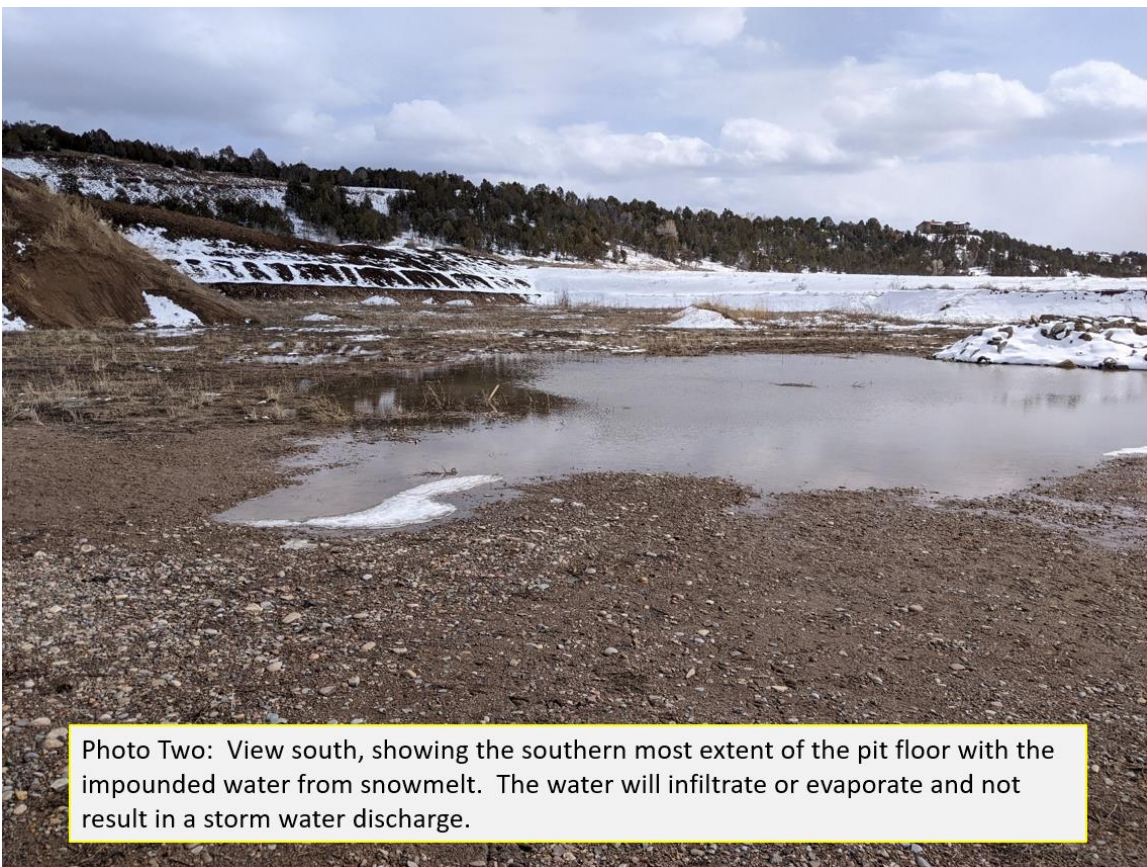
Proper Mine identification signage was not posted at the entrance to the site, however shortly after the date of the inspection the Operator provided photographic evidence that the sign had been replaced. The permit boundaries were clearly outlined with berms, fence lines and T-Posts. The site was not active during the inspection and site conditions remain largely unchanged from the previous inspection. The current mining activity is concentrated in the area identified as Phase B in the mine plan maps. All mining activities were contained within the permit boundaries. An overview of the site can be seen in Photo One. The site consists of 210.9 Acres and currently has approximately 38 Acres disturbed. The pit floor is graded to the south to contain storm water. The southernmost portion of the pit floor contained impounded storm water from snowmelt, however is not considered a problem at this time. The impounded snowmelt can be seen in Photo Two.

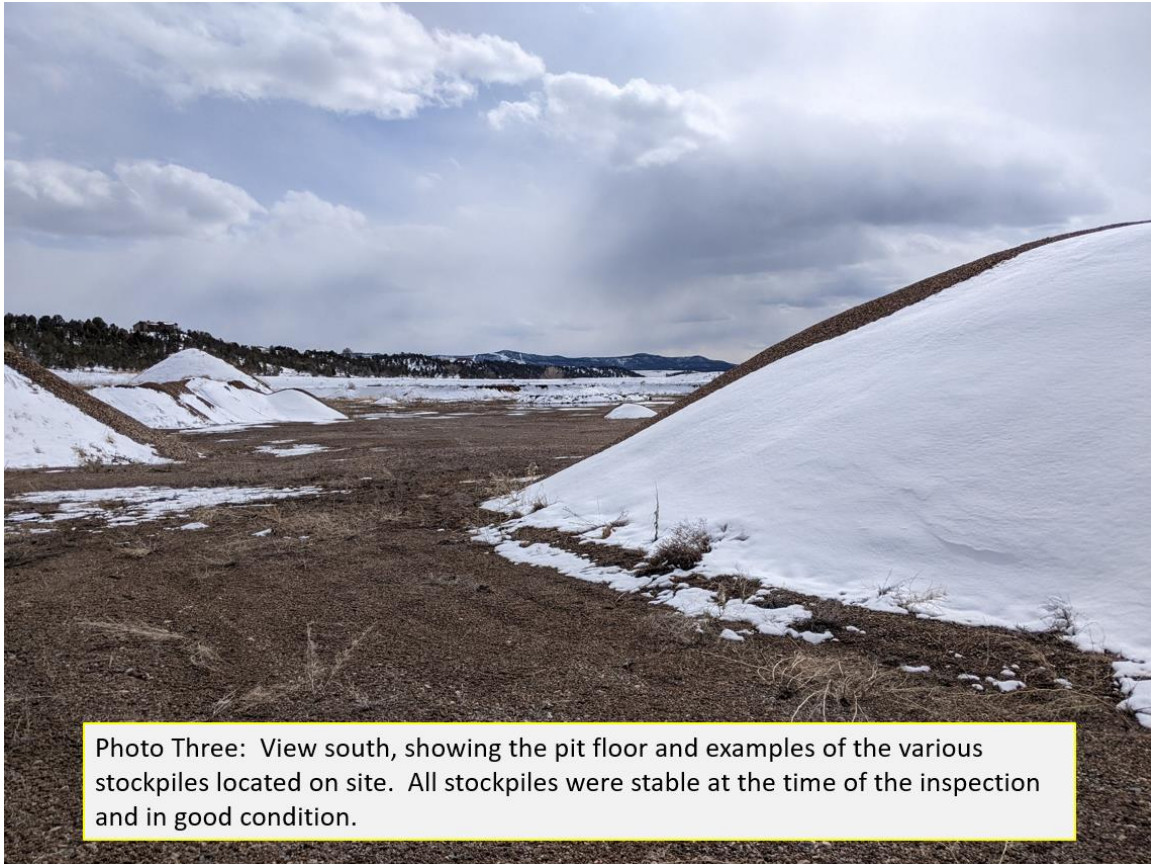
The pit floor and stockpiles appeared stable at the time of the inspection. Examples of the stockpiles can be seen in Photos Three and Four. Some of the stockpiles show evidence of recent hauling but no additional crushing or processing has taken place in quite some time. The topsoil stock pile is large and well vegetated, showing no signs of erosion. No signs of erosion were identified on the entire site. Evidence of last years weed treatment was observed, but no additional issues with state listed noxious weeds were noted. All equipment, fuels and hazardous materials have been removed from the site.
