MINERALS PROGRAM INSPECTION REPORT

MINE NAME: Fountain Pit	MINE/PROSPECTING ID#: M-1982-155	MINERAL: Sand and gravel	COUNTY: El Paso
INSPECTION TYPE: Monitoring	INSPECTOR(S): Timothy Cazier, P.E.	INSP. DATE: March 15, 2022	INSP. TIME: 09:00
OPERATOR: Schmidt Construction Company	OPERATOR REPRESENTATIVE: Mark Heifner & Dan Chavez	TYPE OF OPERATION: 112c - Construction Regular Operation

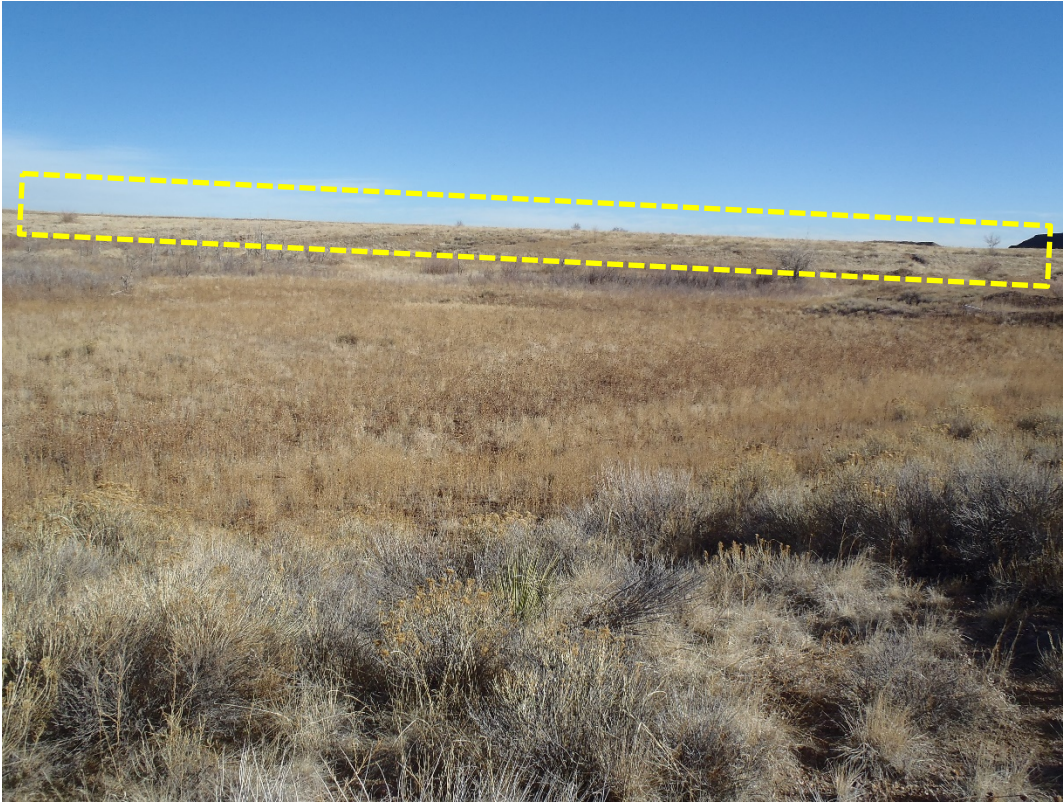
Excess Spoil and Dev. Waste: Overburden piles were observed north of the pit floor (see **Photo 1**) and on the west side of the pit, south of the truck scale (see **Photo 2**).

Photo 1. North overburden stockpile (looking NE from middle sediment basin).

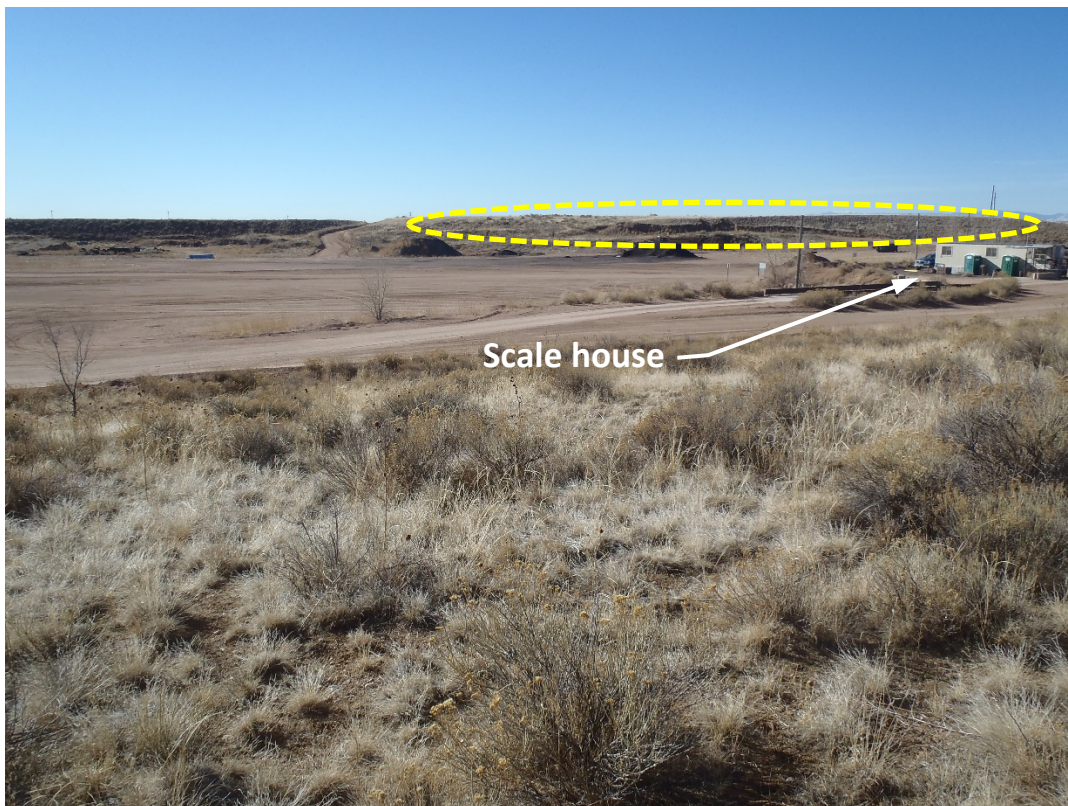
Photo 2. West overburden stockpile (looking south from sediment basins).

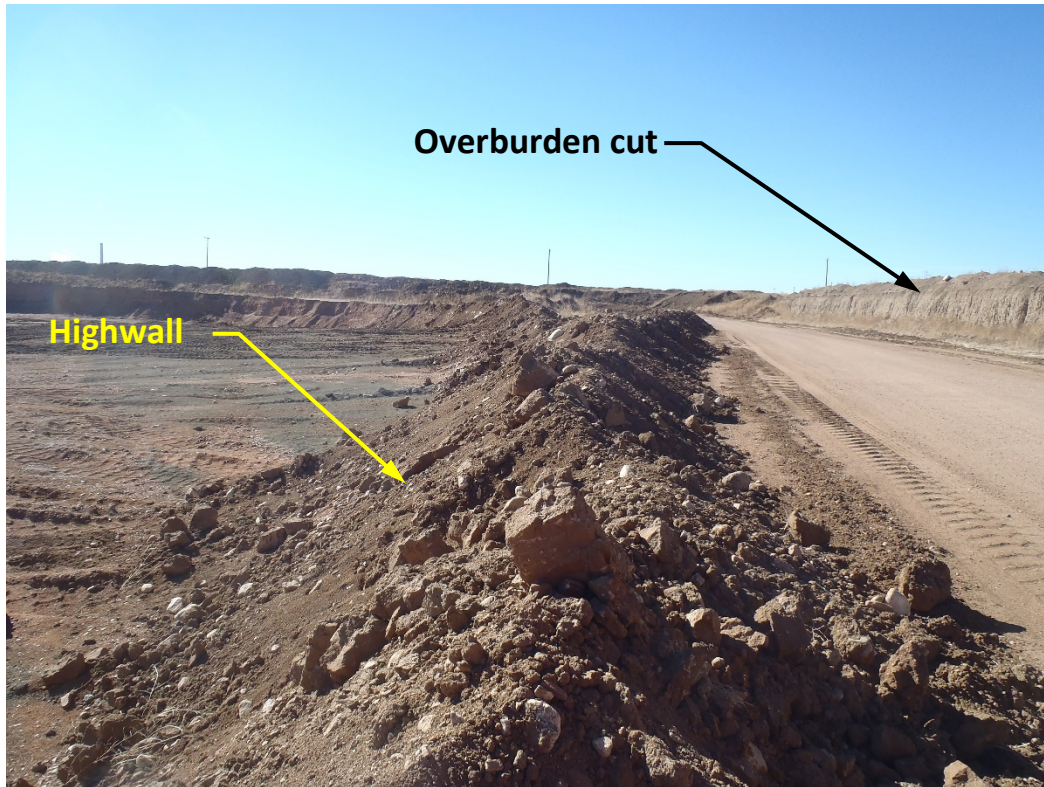
Structures: Powerlines were observed within 200 feet of the south end of the affected area (see **Photo 3**). Mr. Heifner stated the line is owned by Schmidt.

Photo 3. Typical highwall and overburden cut (west side, looking south).

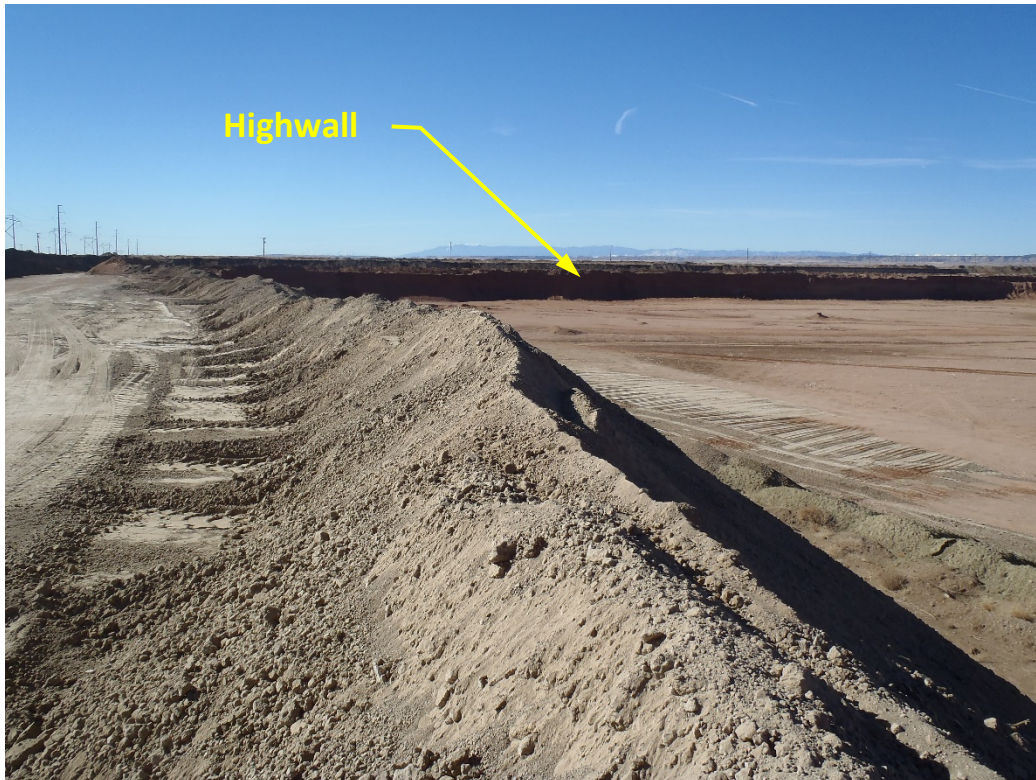
Google Earth was used to measure the disturbed area, which was approximately 300 acres, based on 2020 imagery. This is consistent with the 302.5 acres of disturbance stated in the 2021 annual report. Active Highwalls were estimated to vary between 12 and 15 feet in height and with a somewhat shallower overburden/topsoil removal depth of 8 to 10 feet (see **Photo 3**). Active highwalls were sloped between 1H:1V and vertical (see **Photo 4**), whereas stripped areas had near vertical highwalls (see **Photo 5**).

Photo 4. South highwall (looking south from east side of pit).

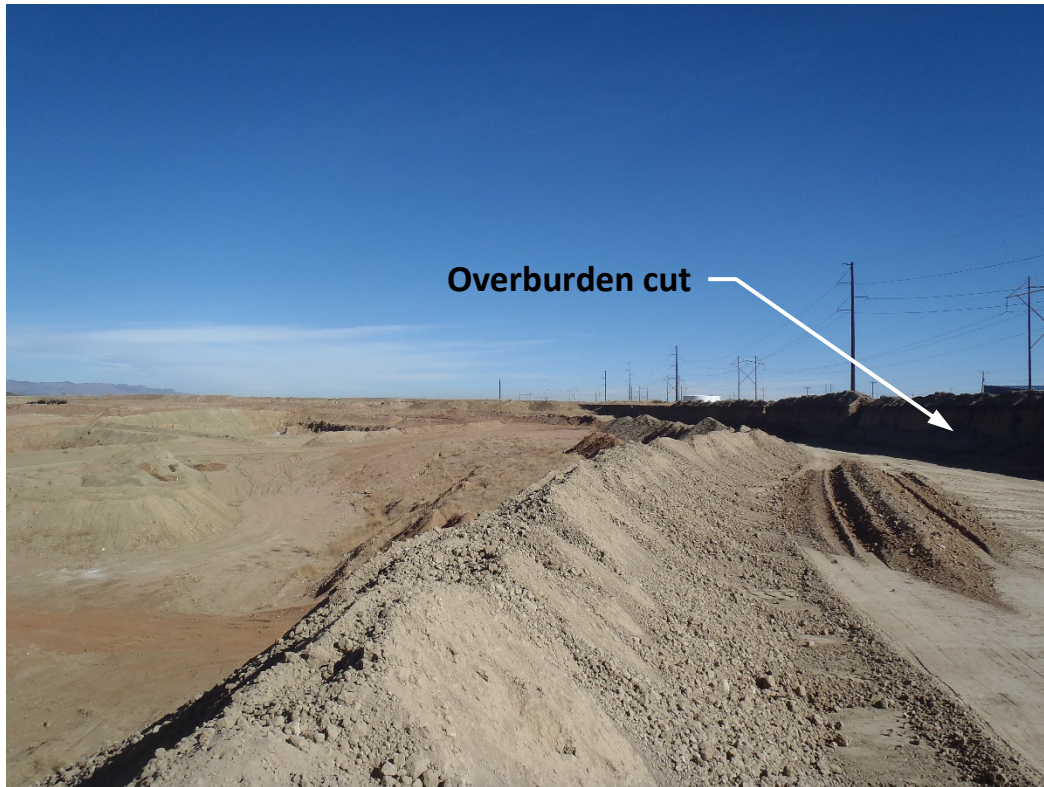
Photo 5. Overburden cut (east side, looking north).

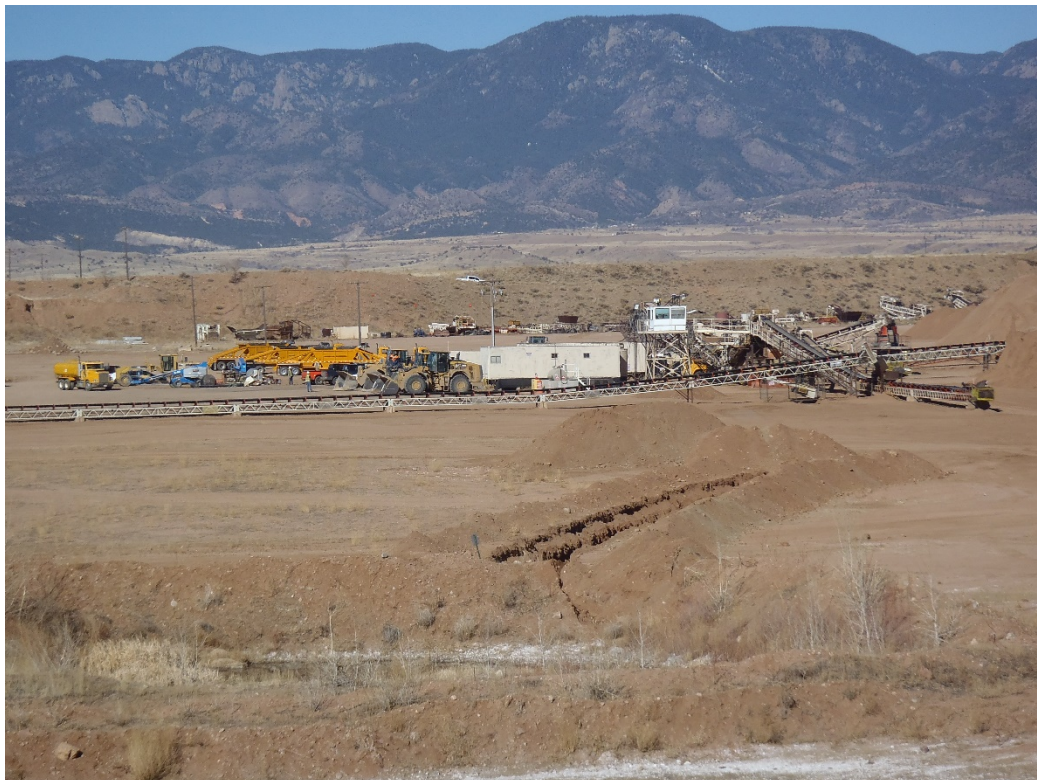
Support Facilities On-site: A screen plant, loaders, and haul truck were observed on site (see **Photo 6**). Mr. Heifner confirmed there is not currently a wash plant.

Photo 6. Screen plant (looking west from east highwall).

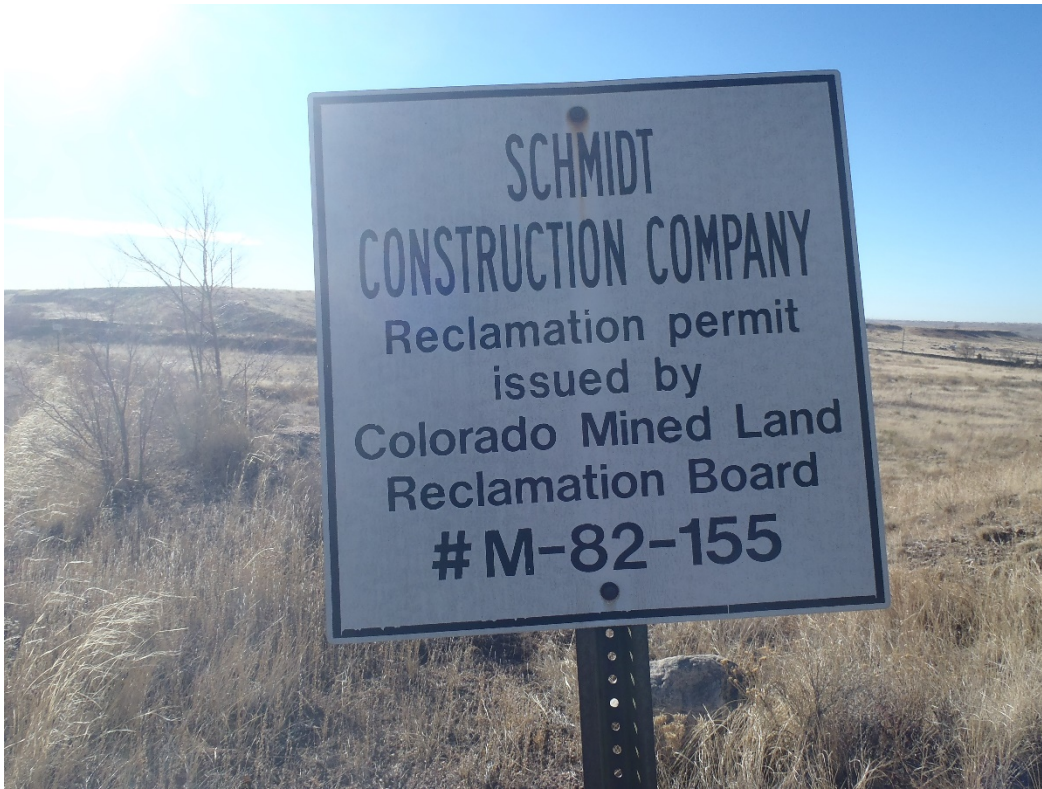
Signs and Markers: The permit sign was properly posted (see **Photo 7**) and boundary markers were observed to delineate the affected area boundary (see **Photo 8**).

Photo 7. Permit sign (at entrance).

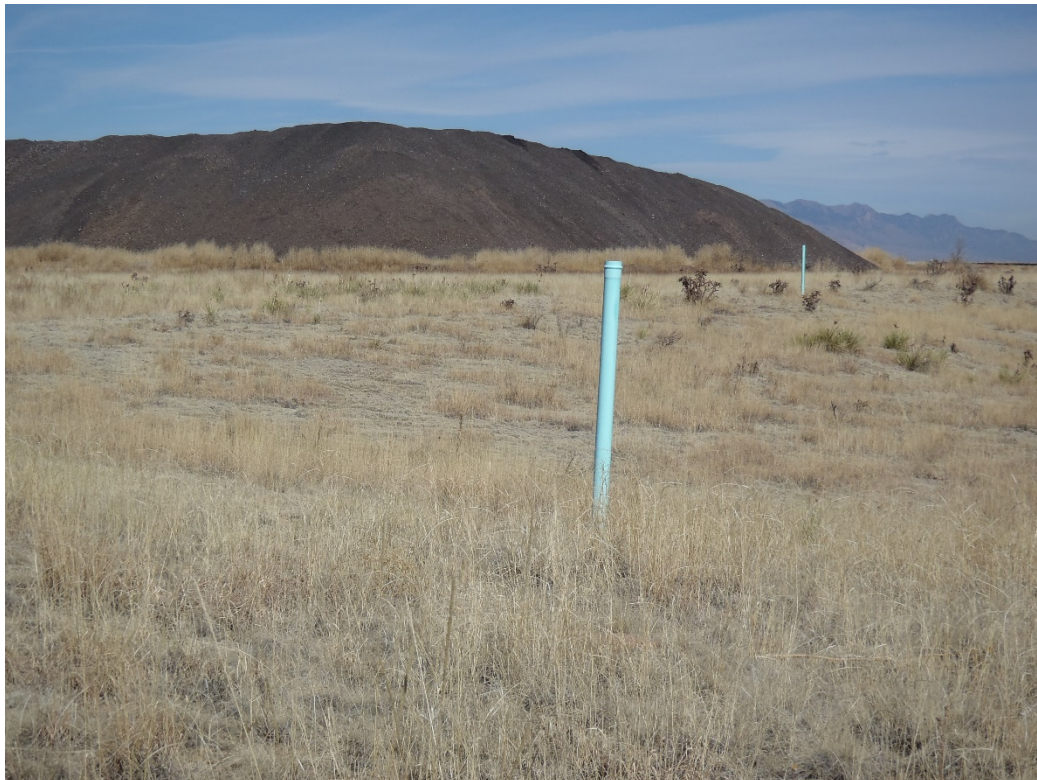
Photo 8. Typical PVC boundary markers (north end looking NW, RAP stockpile offsite).

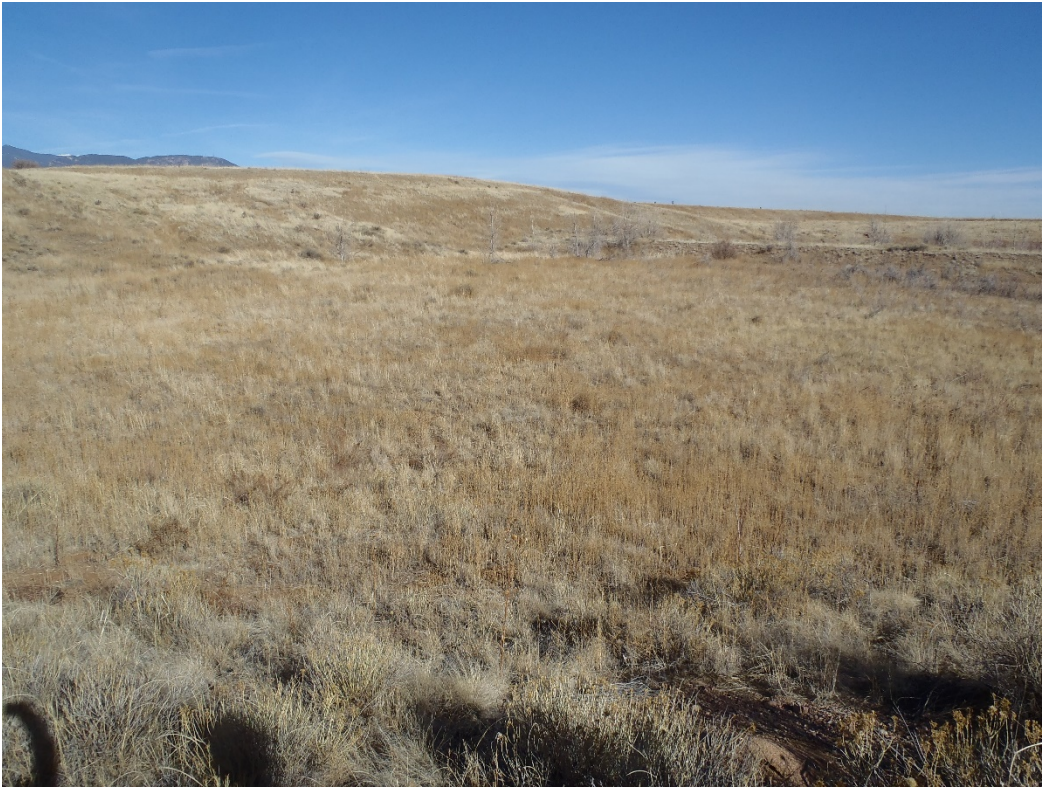
Storm Water MGT Plan: No oil or fuel spills observed. Stormwater not intercepted by the sediment basins (see **Photos 9 and 10**) between the topsoil and overburden stockpiles drains to the pit and infiltrates.

Photo 9. West sediment basin (looking NW from south side).

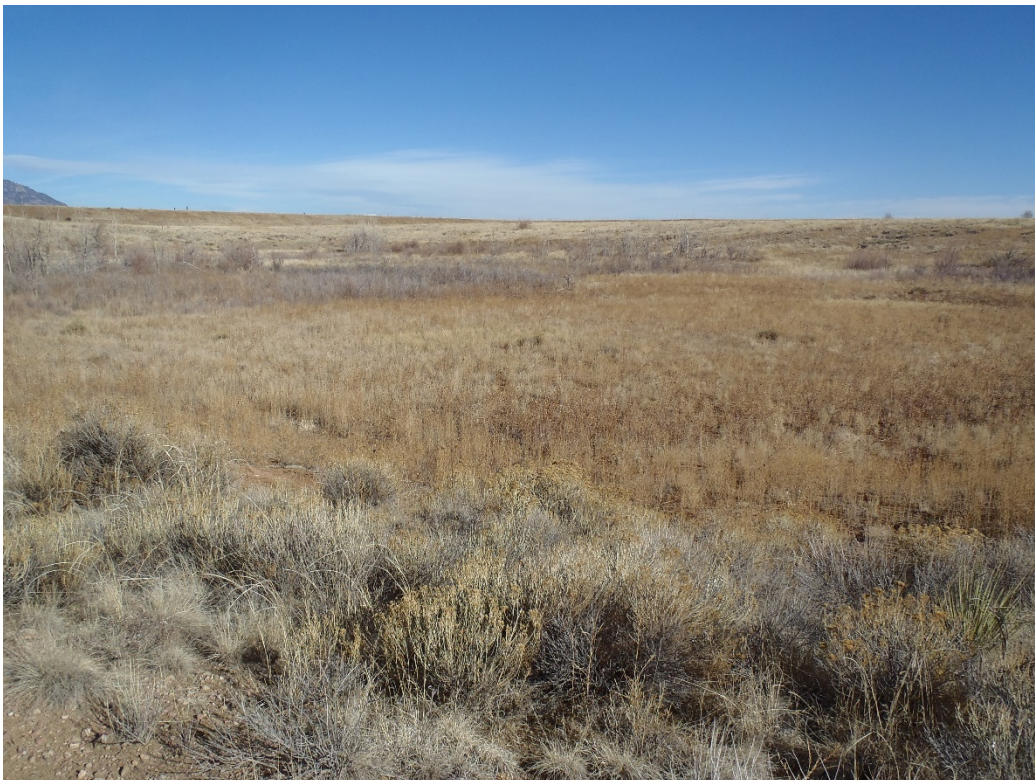
Photo 10. Middle sediment basin (looking north from south side).

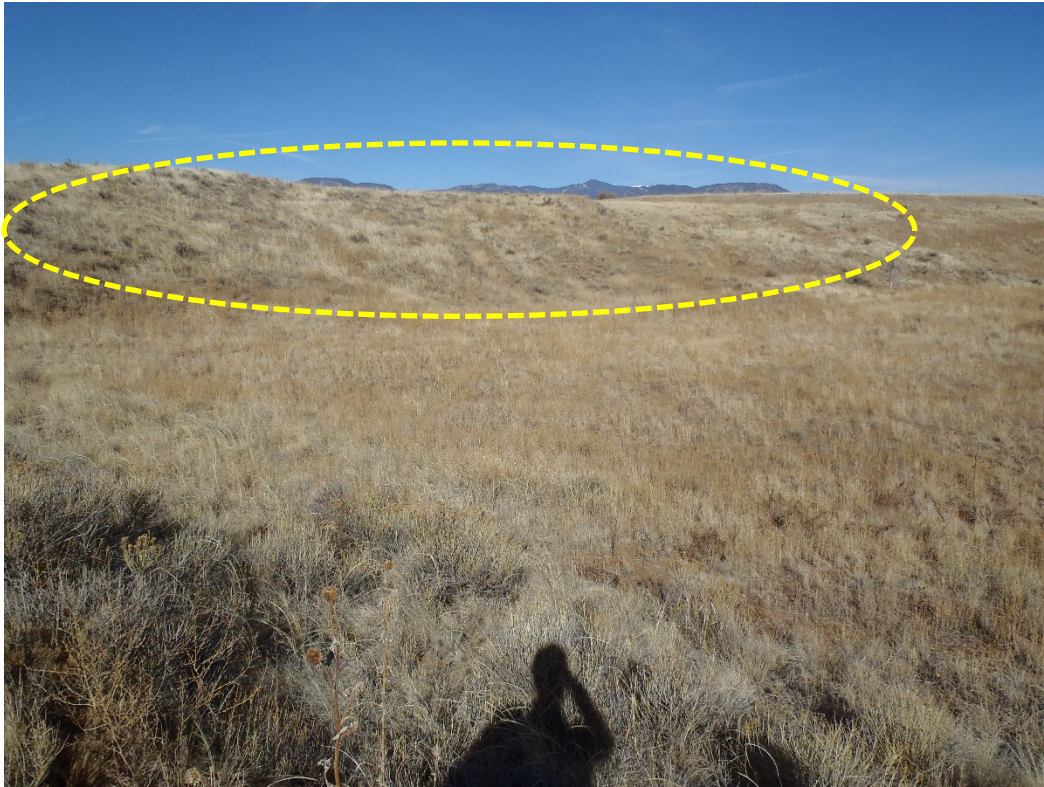
Topsoil: The primary topsoil stockpile is west of the sediment basins (see **Photo 11**).

Photo 11. Topsoil stockpile (looking west from south side of west sediment basin).
