**MINERALS PROGRAM INSPECTION REPORT**  
**PHONE: (303) 866-3567**

| <b>MINE NAME:</b><br>Bayfield Pit No. 1 | <b>MINE/PROSPECTING ID#:</b><br>M-1987-038 | <b>MINERAL:</b><br>Sand and gravel | <b>COUNTY:</b><br>La Plata |
| <b>INSPECTION TYPE:</b><br>Monitoring | <b>INSPECTOR(S):</b><br>Lucas West | <b>INSP. DATE:</b><br>March 9, 2022 | <b>INSP. TIME:</b><br>15:00 |

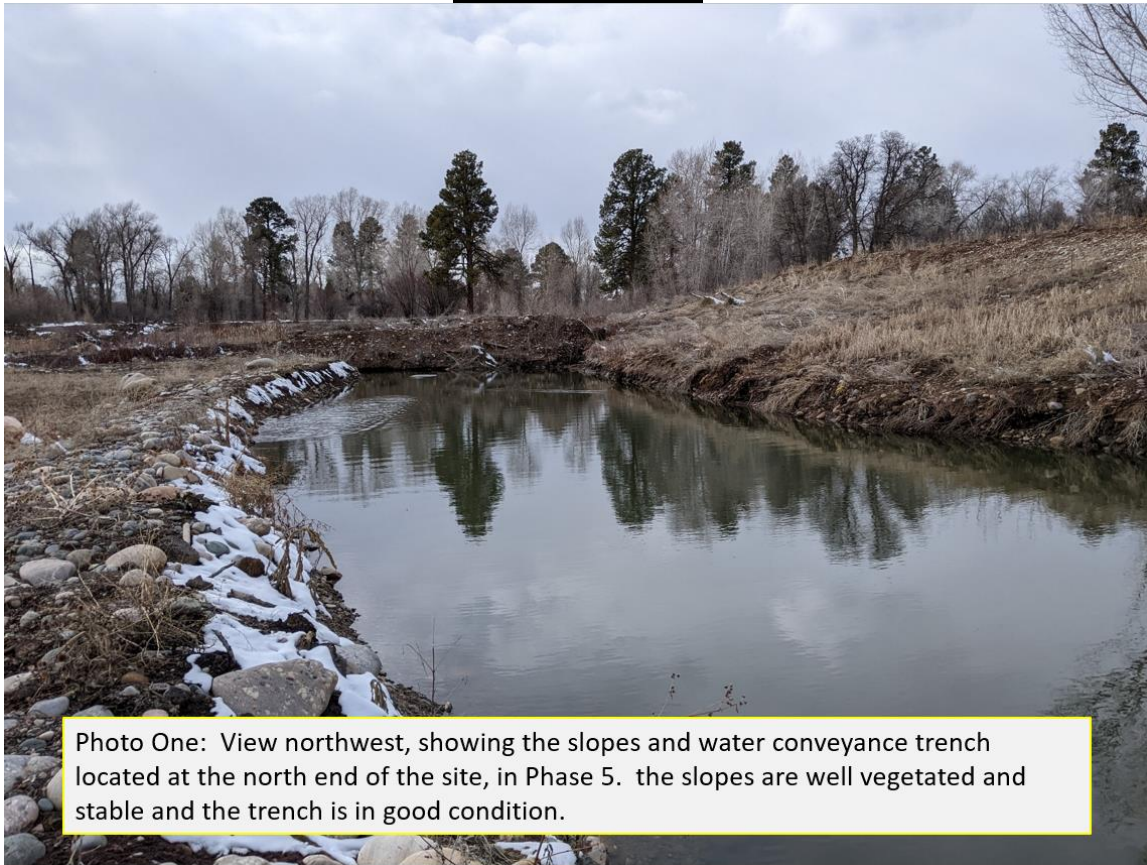
Photo One: View northwest, showing the slopes and water conveyance trench located at the north end of the site, in Phase 5. the slopes are well vegetated and stable and the trench is in good condition.

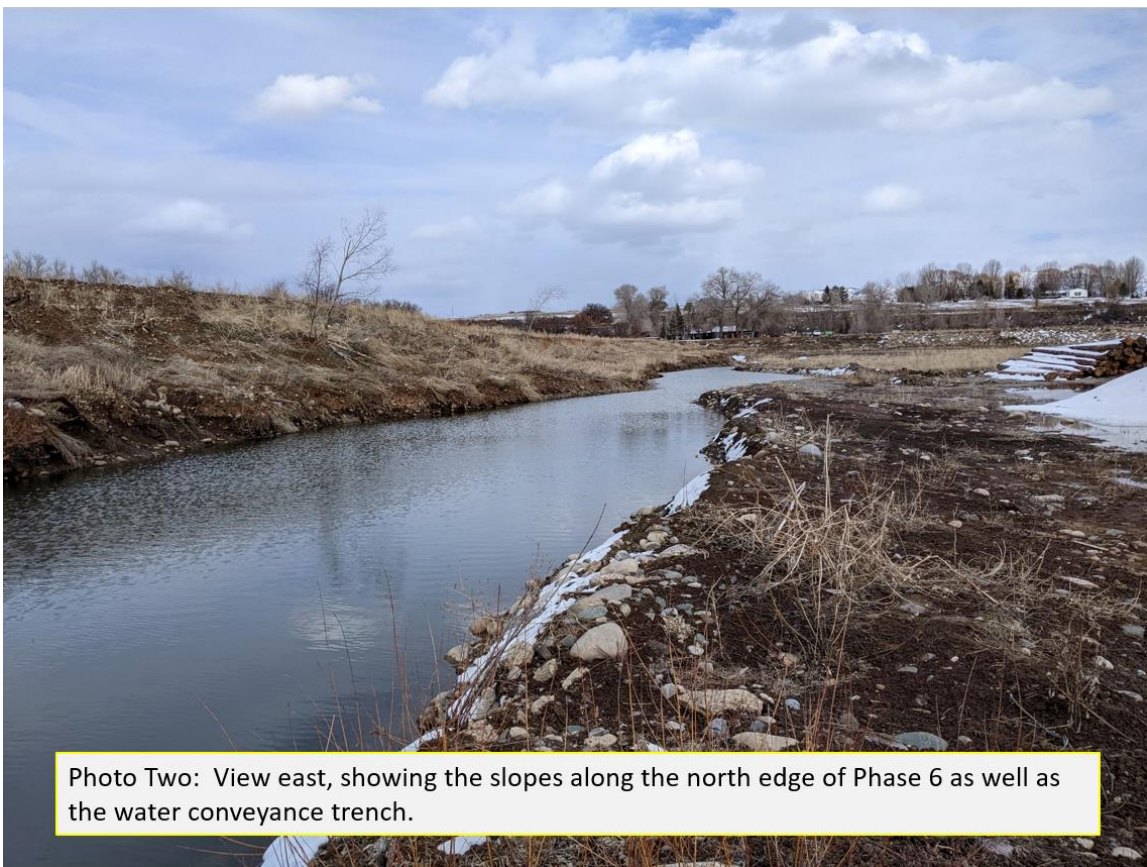
Photo Two: View east, showing the slopes along the north edge of Phase 6 as well as the water conveyance trench.

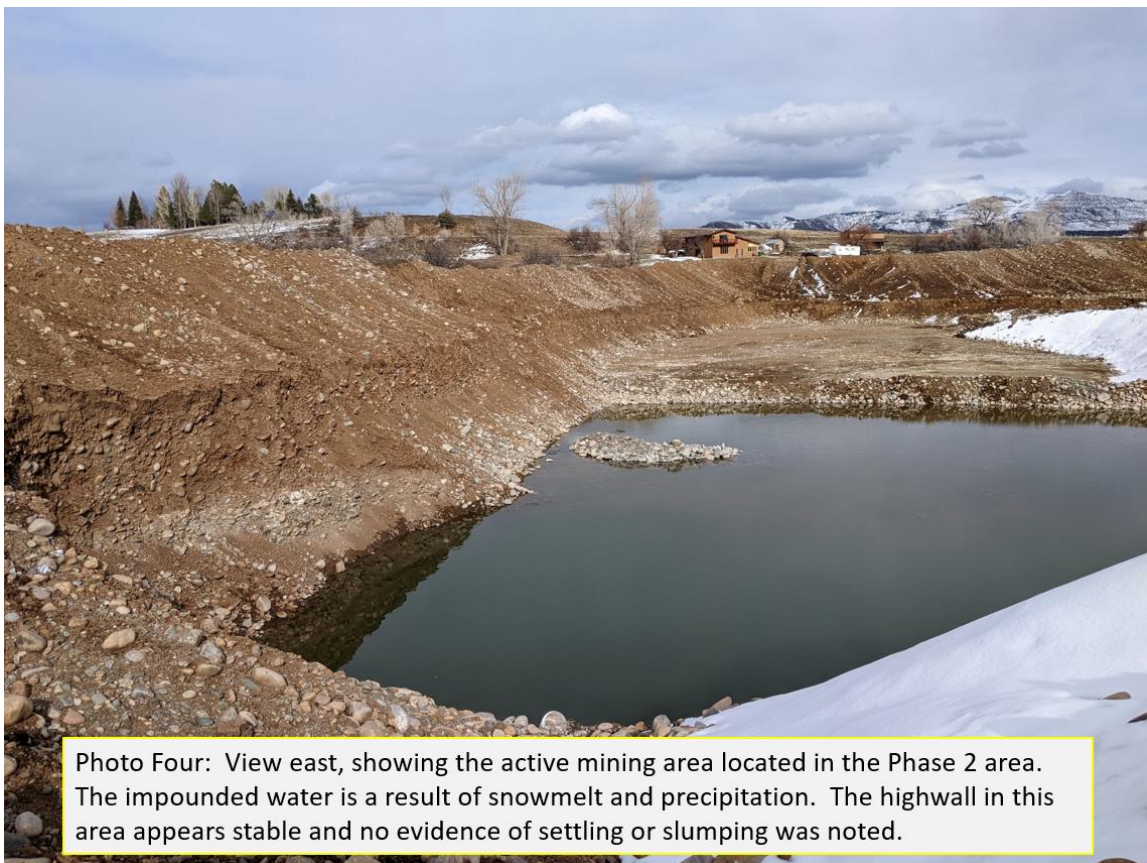
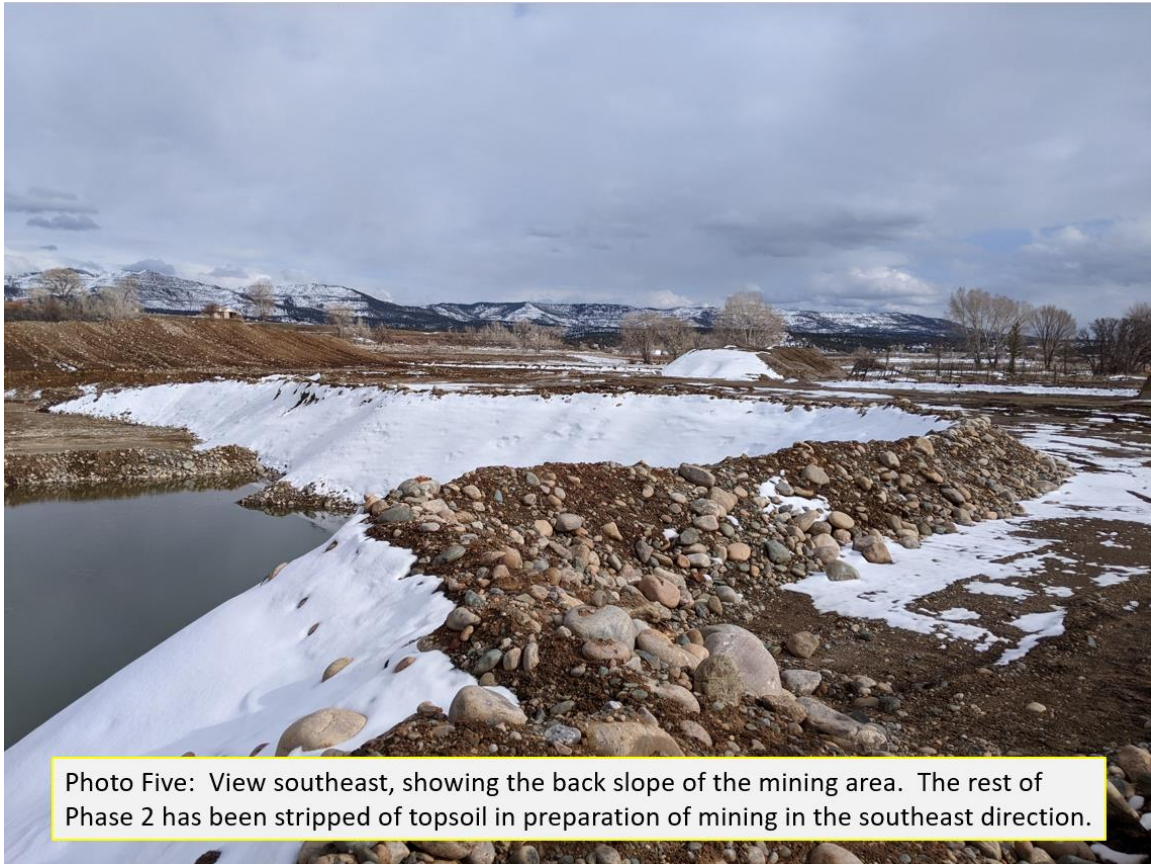
The active mining area is confined to the area referred to as Phase 2, adjacent to the old shop and processing area. The active mining area can be seen in Photos Four and Five. The highwalls that are created by the mining activities appear to be stable and in good condition. When mining reaches the limits of its phase, the slopes will be flattened to create a lay down yard.
