**MINERALS PROGRAM INSPECTION REPORT**  
**PHONE: (303) 866-3567**

<b>MINE NAME:</b> Cresson Project	<b>MINE/PROSPECTING ID#:</b> M-1980-244	<b>MINERAL:</b> Gold	<b>COUNTY:</b> Teller
<b>INSPECTION TYPE:</b> Monitoring	<b>INSPECTOR(S):</b> Patrick Lennberg	<b>INSP. DATE:</b> March 30, 2022	<b>INSP. TIME:</b> 08:00
<b>OPERATOR:</b> Cripple Creek & Victor Gold Mining Co.	<b>OPERATOR REPRESENTATIVE:</b> Maria Bujenovic	<b>TYPE OF OPERATION:</b> 112d-3 - Designated Mining Operation	
<b>REASON FOR INSPECTION:</b> Normal I&E Program	<b>BOND CALCULATION TYPE:</b> None	<b>BOND AMOUNT:</b> \$209,491,188.00	
<b>DATE OF COMPLAINT:</b> NA	<b>POST INSP. CONTACTS:</b> None	<b>JOINT INSP. AGENCY:</b> None	
<b>WEATHER:</b> Snowing	<b>INSPECTOR'S SIGNATURE:</b>

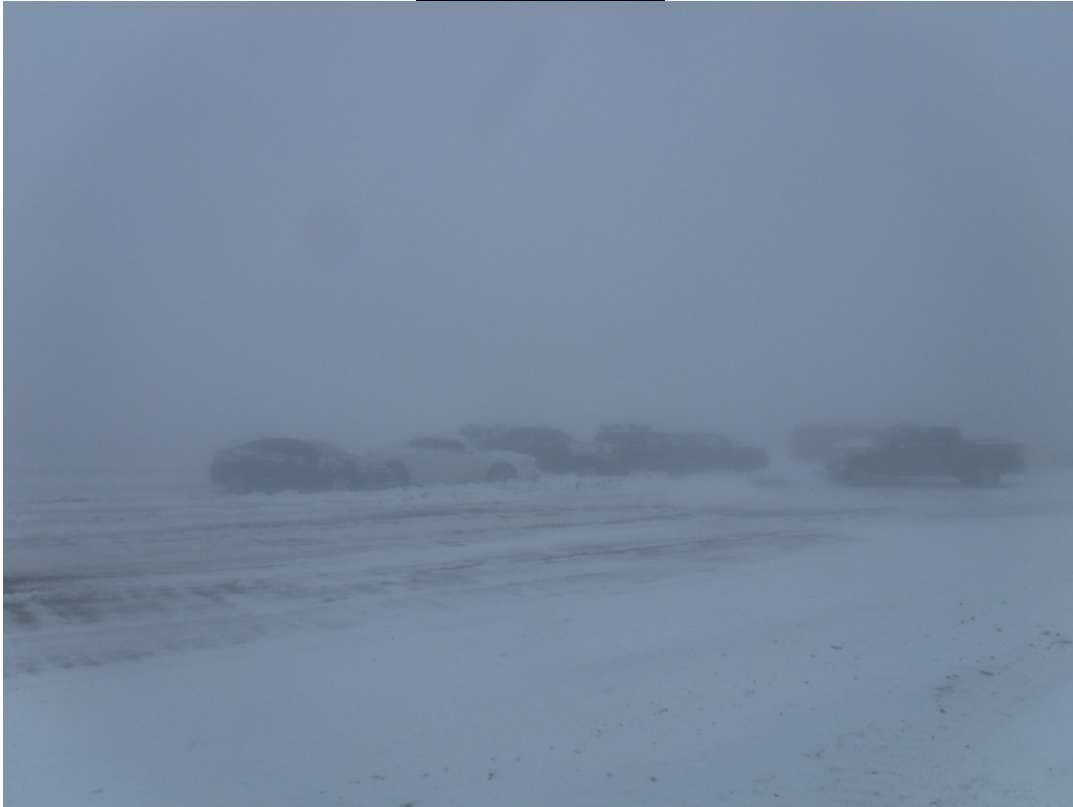
The weather at the site consisted of snow flurries and fog. Due to these weather conditions inspection of the topsoil stockpile, South Cresson Pit, and Schist Island did not occur.

**Photo 1:** Typical site conditions during inspection, Ironclad parking lot

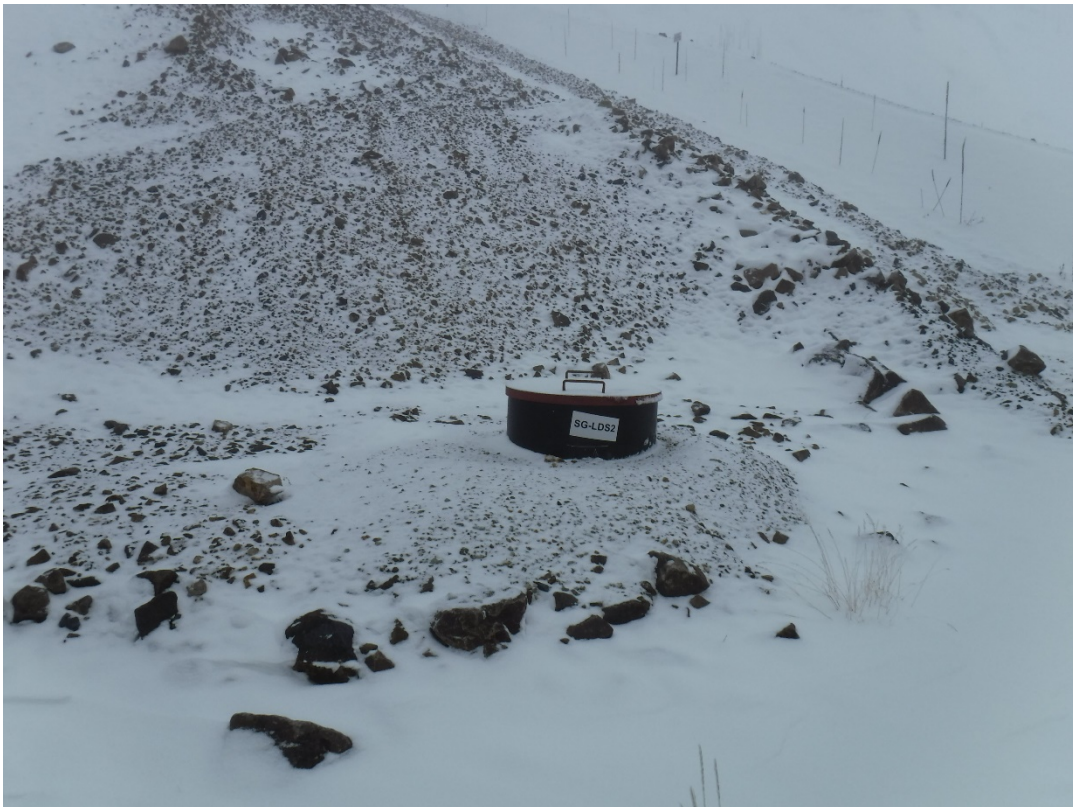
Due to site weather conditions the Division was only able to observe two Leak Detection Sumps (LDS), VLF2-LDS1 and VLF2-LDS2. The sumps were inspected to verify depth indicators had been installed per TR-127. The Division did note there was a strip of red and white reflective tape approximately 12 inches from the bottom of each sump and both sumps were dry. If water were to collect in a sump to the level of the tape the Operator would be required to pump out and collect a sample of the water for analysis of WAD Cyanide and pH. The Operator is to remove as much water as possible to determine if new liquid is present during the next inspection. The sumps are inspected on a weekly basis and an annual summary of the inspections is to be submitted by the end of the first quarter for the following year. The summary table for 2021 was submitted in accordance with TR-127.

**Photo 2:** Leak Detection Sump 2 (VLF2-LDS2)

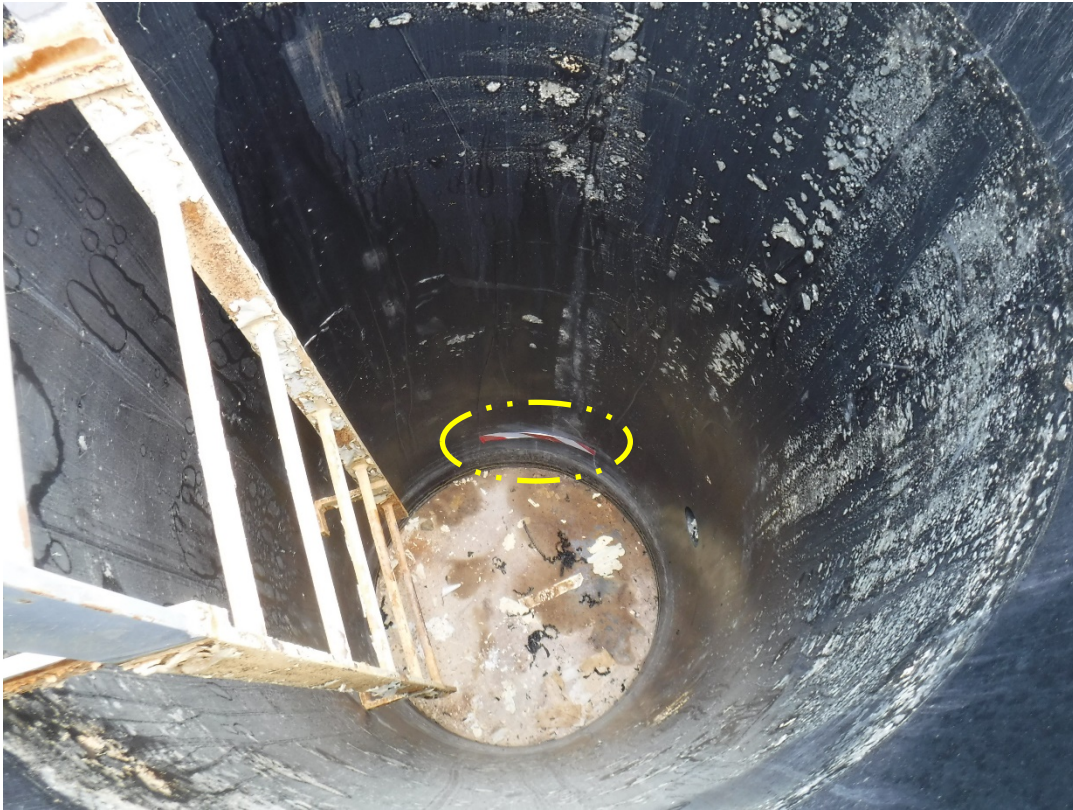
**Photo 3:** Inside view of VLF2-LDS2, reflective tape circled in yellow marks the one foot depth

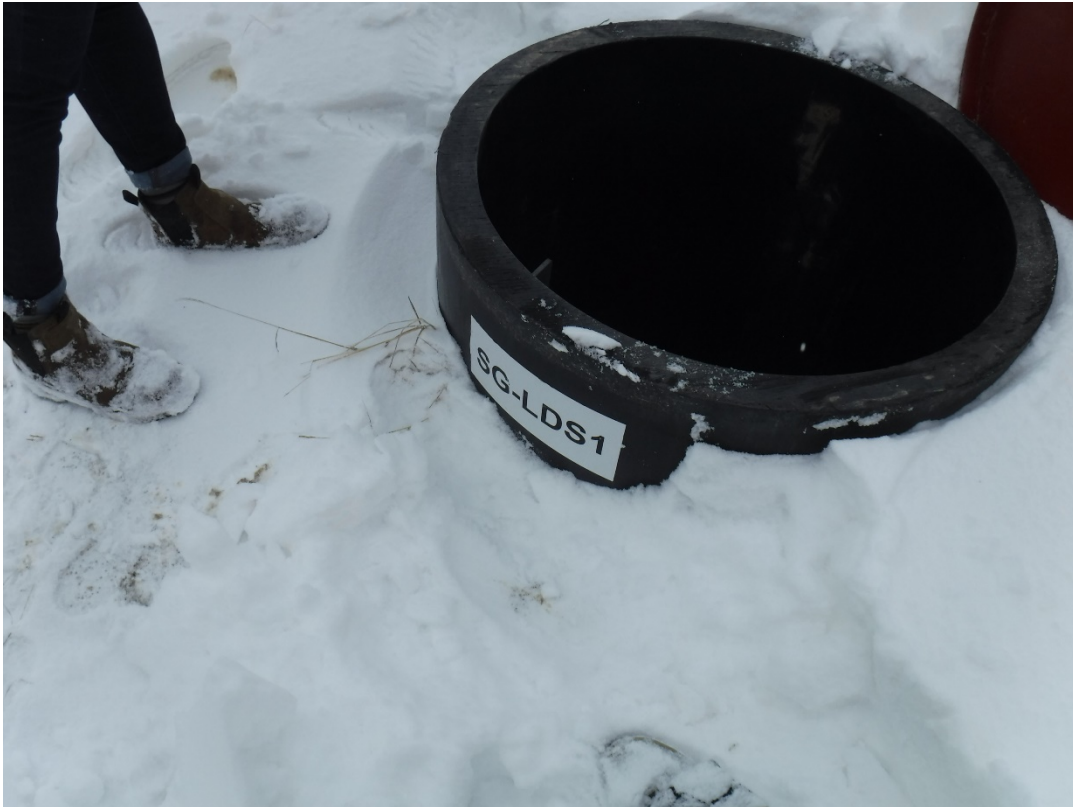
**Photo 4:** Leak Detection Sump 1 (VLF2-LDS1)

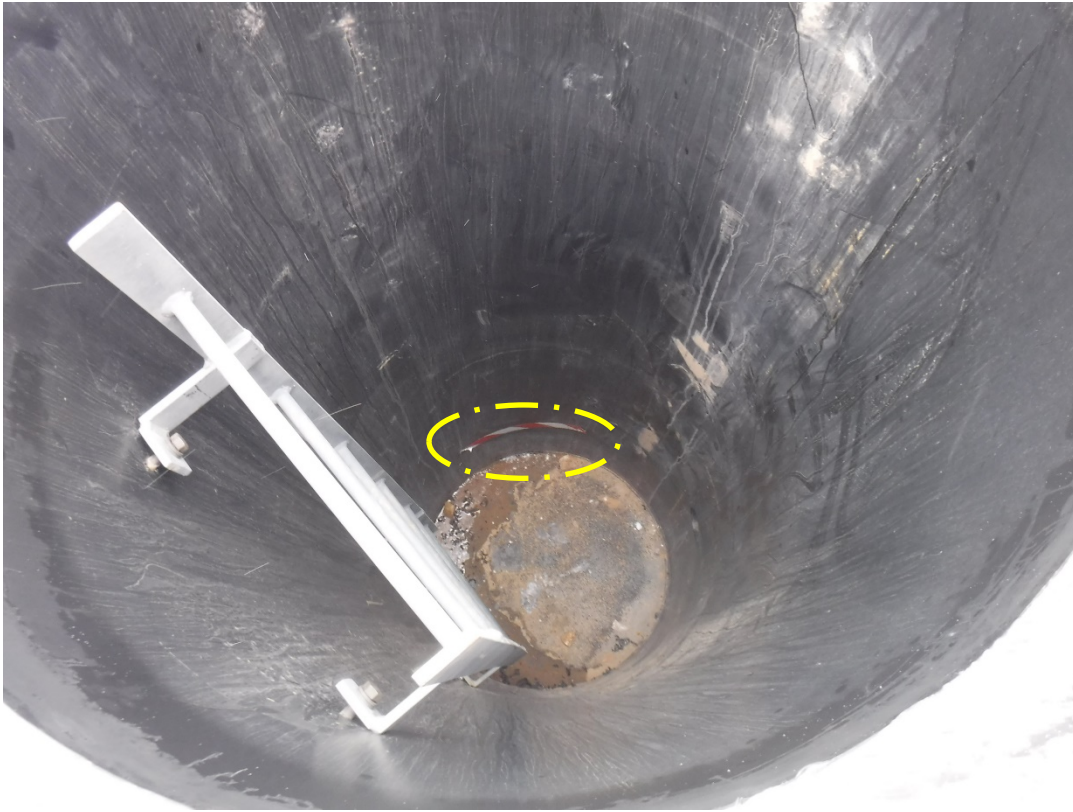
**Photo 5:** Inside view of VLF2-LDS1, reflective tape circled in yellow marks the one foot depth

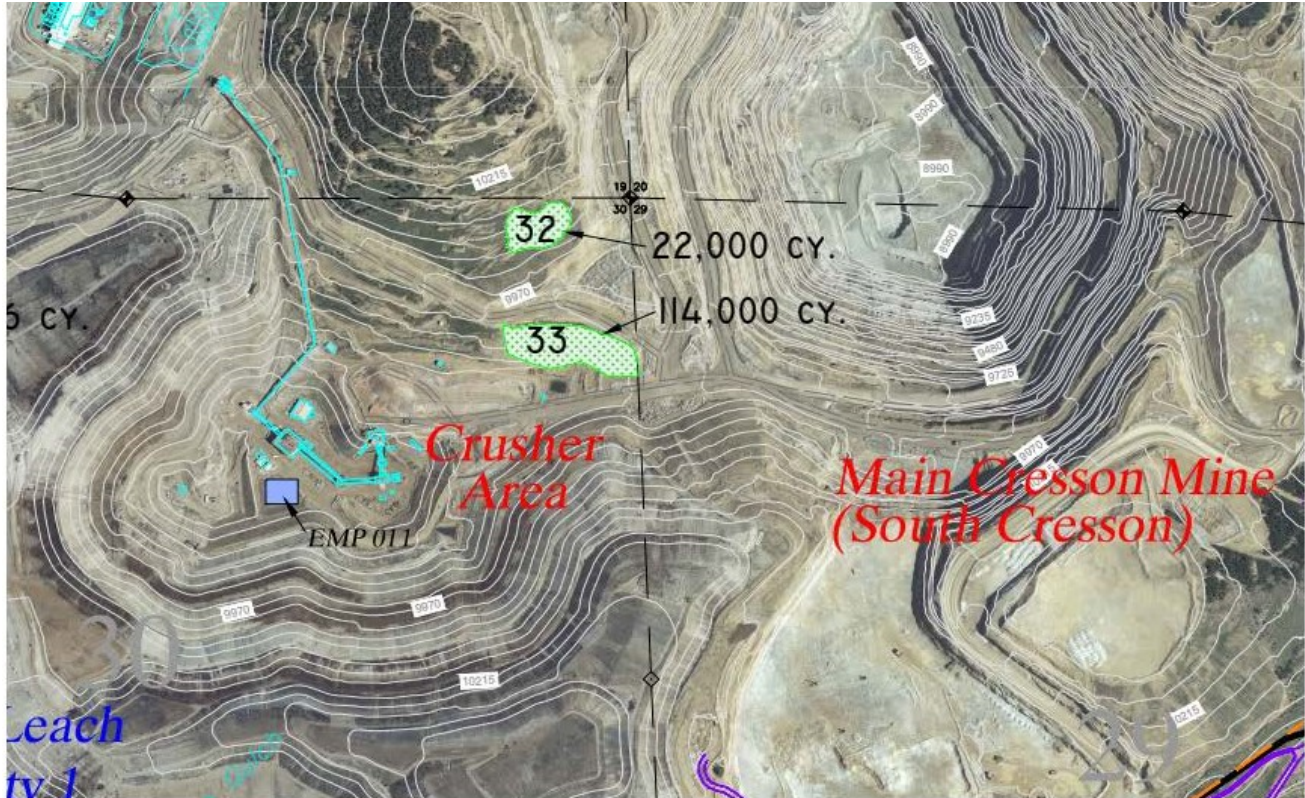
Although the Division was unable to visit topsoil stockpile #32 a conversation about the pile was had with the Mine Operations staff. The staff did state there had been a haul road cut in in the area between topsoil stockpiles #32 and #33. The haul road was constructed to allow for benching and continued mining in the West Cresson Layback area. Reviewing photos from the March 1, 2022 aerial inspection report, issued March 24, 2022, mine staff indicated the slope failure pictured was stable and verified as stable through GPS surveys. The failure was stabilized through over-excavation. While the slope is stable it appears topsoil stockpile #32 is located immediately uphill from the failure and may be subject to material loss in the future. Staff was able to provide documentation of topsoil stockpile #33 being used last year for reclamation of the ECOSA and staging for future reclamation activities. Staff was not familiar with location of stockpile #32. Topsoil stockpile #32 is indicated on AM-13 map C-4b revision 2 and consists of 22,000 c.y (see Map 1). The stockpile will be the subject of a future inspection.

**Map 1:** Excerpt from Map C-4b provided during AM-13 showing the locations of topsoil stockpiles #32 and #33
