TRAPPER MINING INC.
CRAIG, COLORADO

HORSE GULCH FILL
QUARTERLY FILL CERTIFICATION

Horse Gulch Fill Quarterly Inspection Report

First Quarter 2022

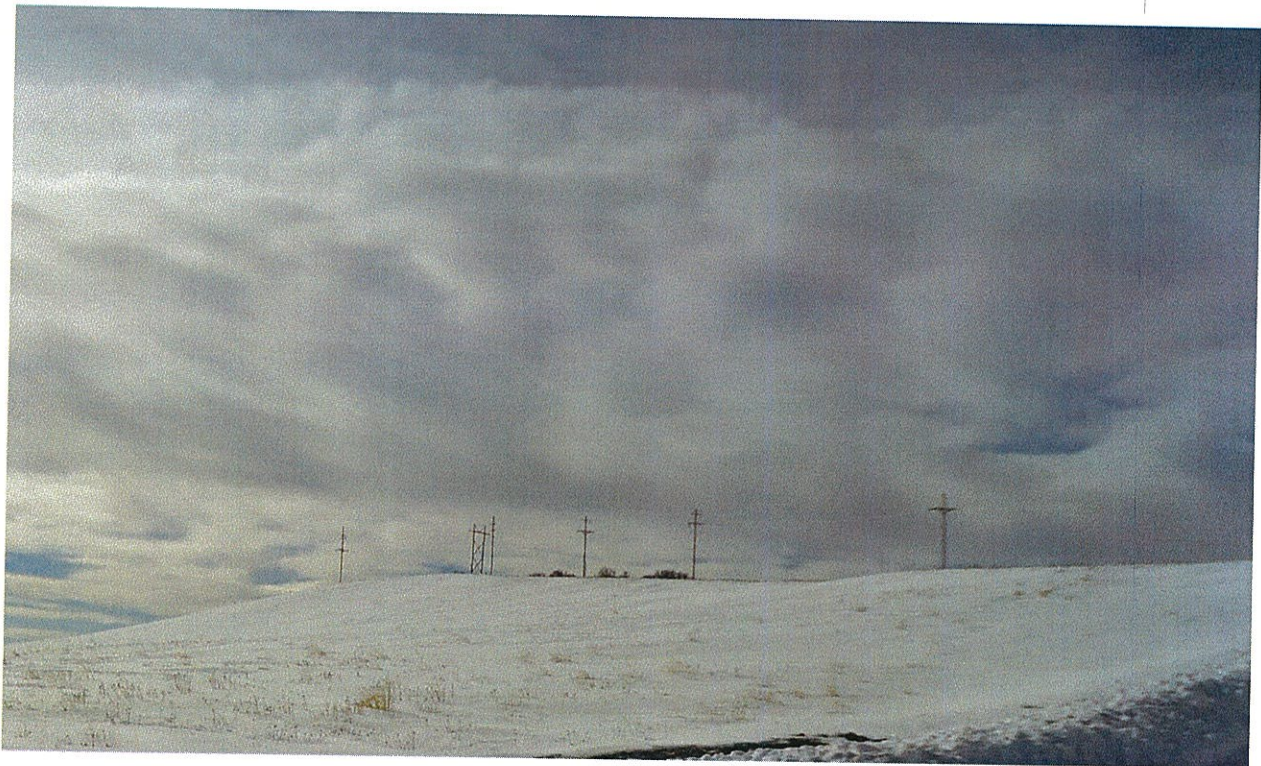
No appearances of instability, structural weakness, or other hazardous conditions were observed. Both the south east side of the fill and the north east side of the fill were inspected this quarter (Photographs 1 and 2). The area where cracks were detected on the top south portion of the dump during the first quarter of 2013 inspection was checked. There was no additional cracking found.

Photograph 1: North East Side Looking South (3/24/2022)

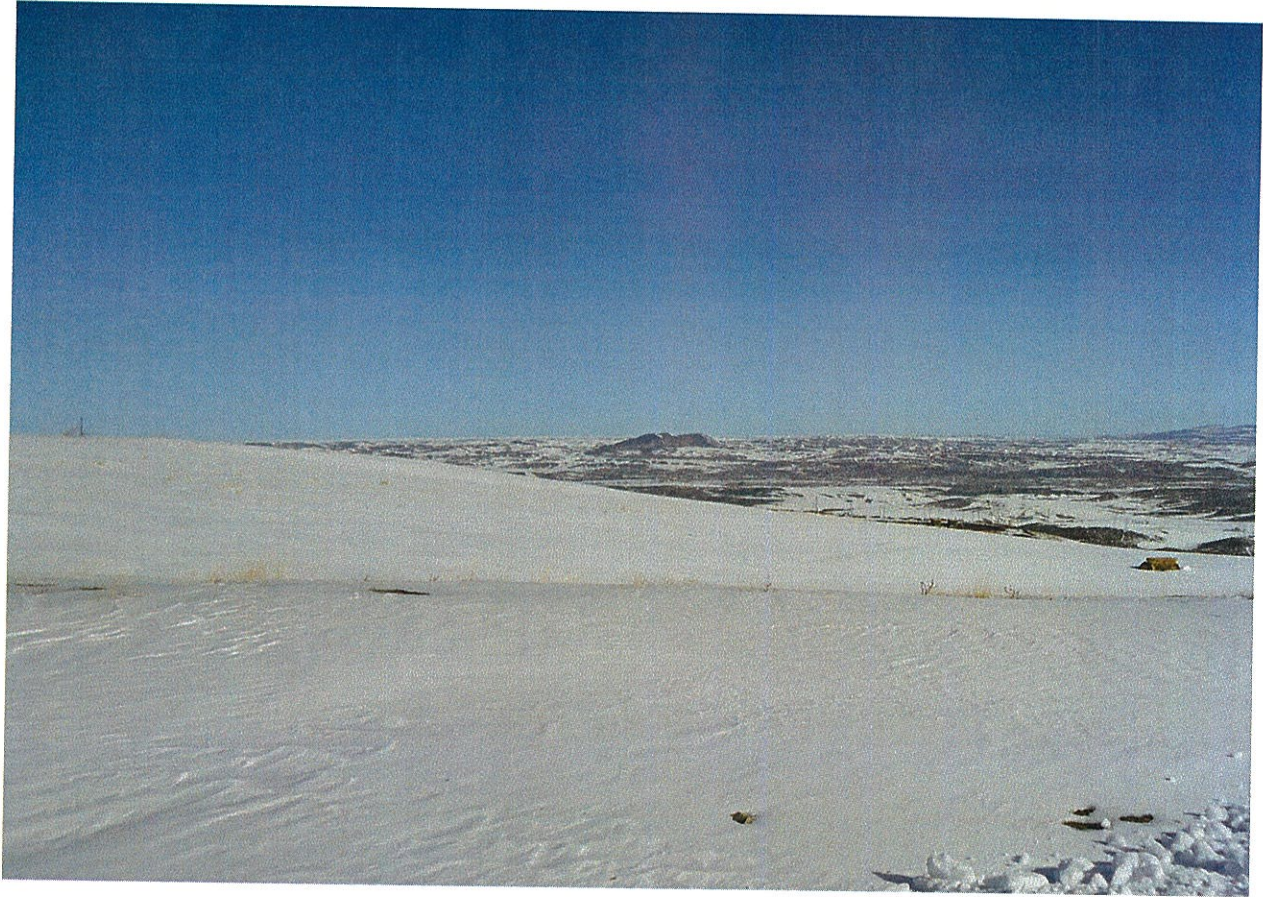
Photograph 2: South East Side Looking North (3/24/2022)

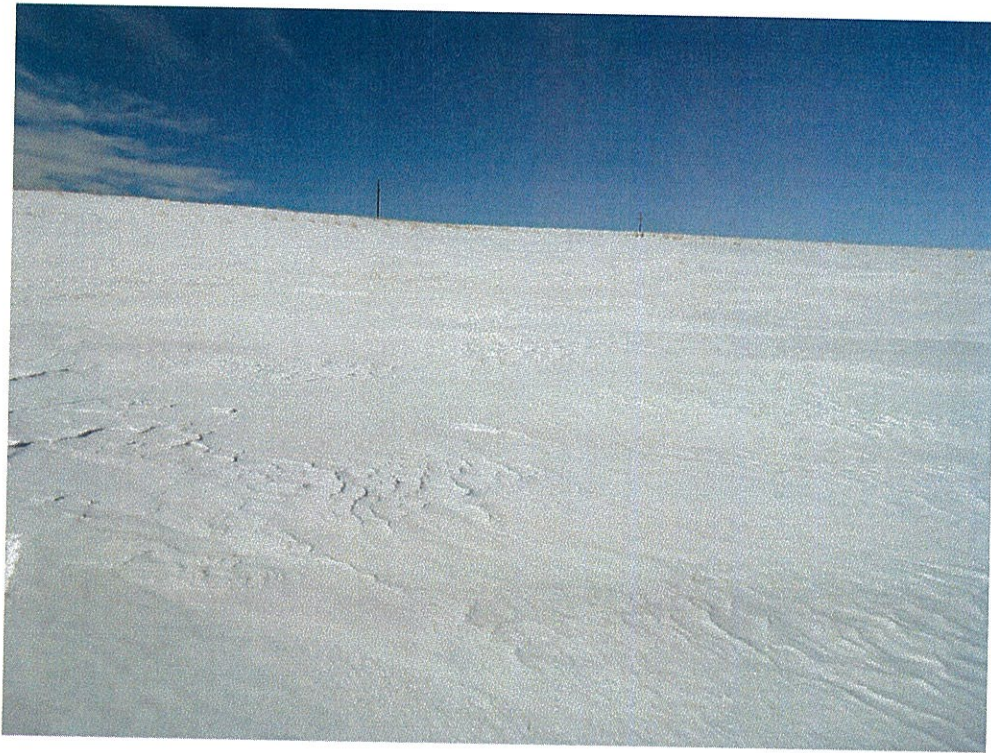
Photograph 3 depicts the east facing slope of the fill.

Photograph 3: East Side of the Fill Looking West (3/24/2022)
