**NEW ELK MINE**  
**Permit No. C-1981-012**

**QUARTERLY COAL WASTE BANK INSPECTION REPORT**  
**March 31, 2022**

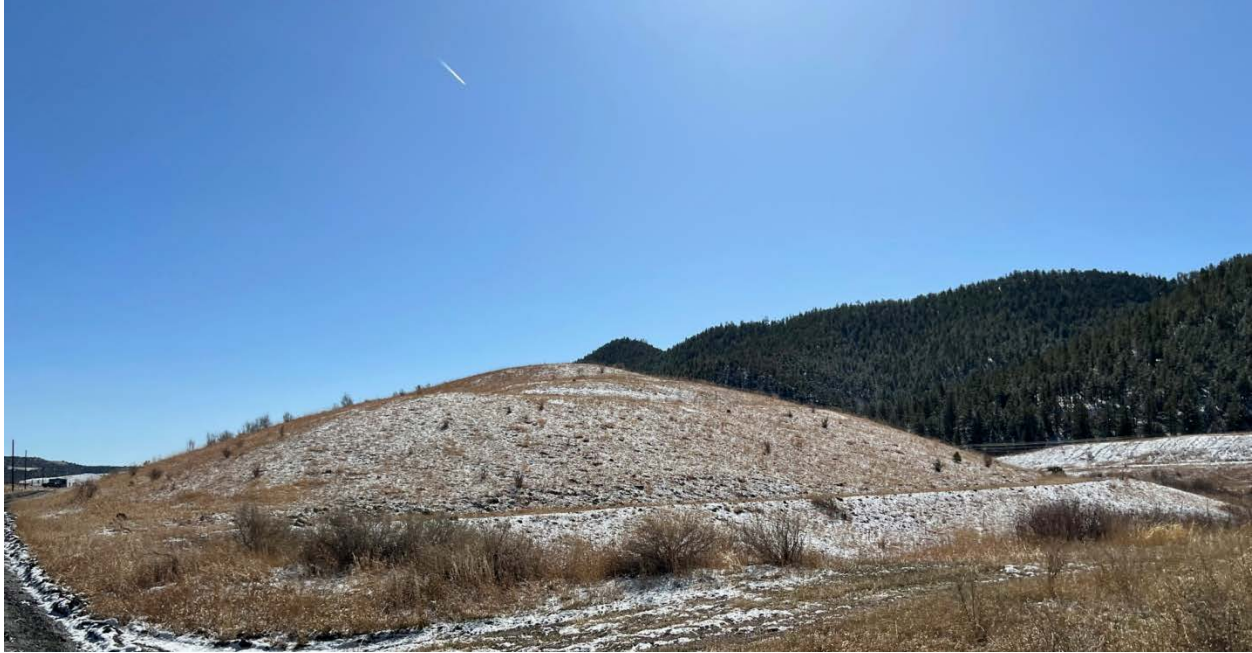
**DWDA #1**

Surface and out slopes of the pile were inspected for visible signs of potential failure or instability. None were observed.

Overall the disposal area is in good condition.

None at this time.

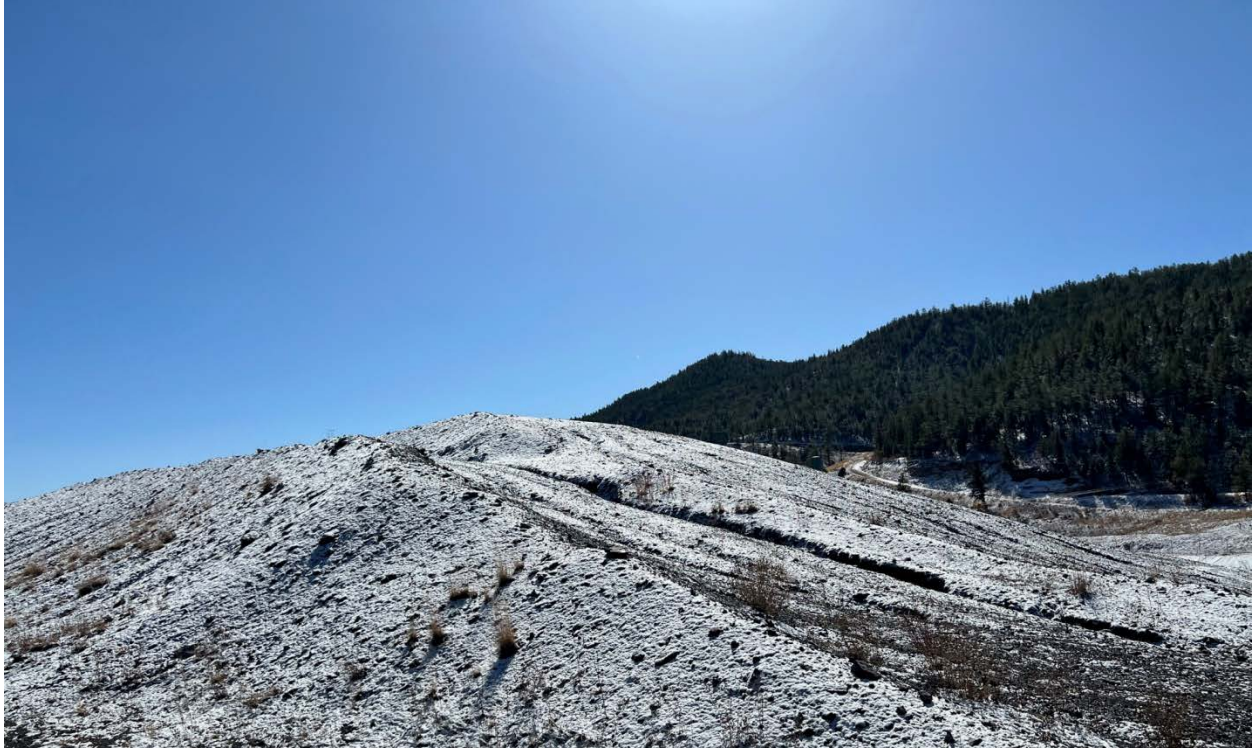
**DWDA #2**

Positive Drainage is maintained on the surface of the DWDA. Sump on East end of pile was being cleaned at time of inspection. Rills on the disposal area are being monitored. No evidence of springs nor seeps were observed.

Surface and out slopes of the pile were inspected for visible signs of potential failure or instability. There was some surface erosion but not enough to make the area unstable. In all no signs of failure or instability were observed.

Overall the disposal area is in good condition. The sign with the name of the area was recently replaced.

The Rills are being monitored and have not gotten any bigger and there is no sediment loading. Operator is evaluating either reclamation of the area or permitting alternative uses of the land north of the Purgatoire River and south of Highway 12. The sump at the end of the area was being cleaned as annual maintenance.

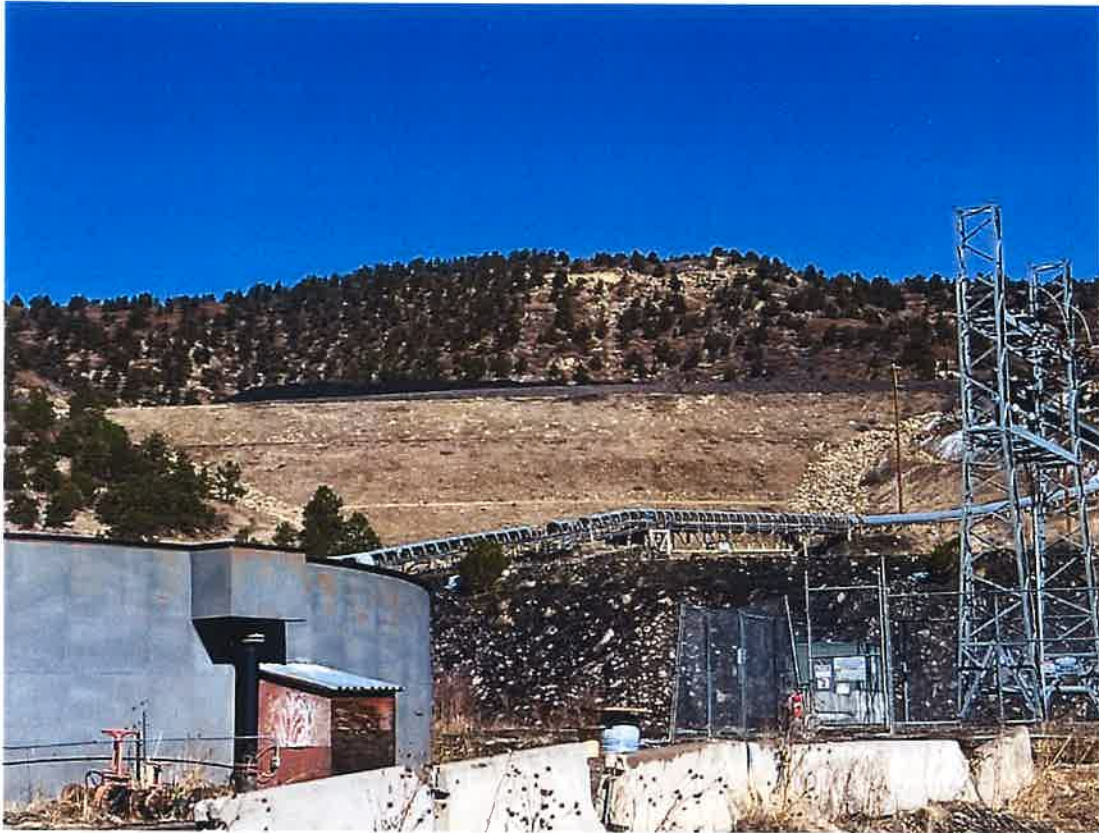
**Face of Refuse Disposal Area**

Refuse is placed in 1-2 foot lifts, allowed to dry and then compacted. Periodically CTL-Thompson, a geotechnical engineering firm, evaluates refuse compaction. The permit requires and testing has demonstrated that the operation has achieved in excess of the required 90% compaction.

Overall the site is in good condition. Compaction test from this quarter is attached.

None required at this time.
