QUARTERLY SEDIMENTATION POND INSPECTION REPORT

Mine: New Elk

Inspection Period: First Quarter 2022

QUARTERLY SEDIMENTATION POND INSPECTION REPORT
New Elk Mine- March 31, 2022

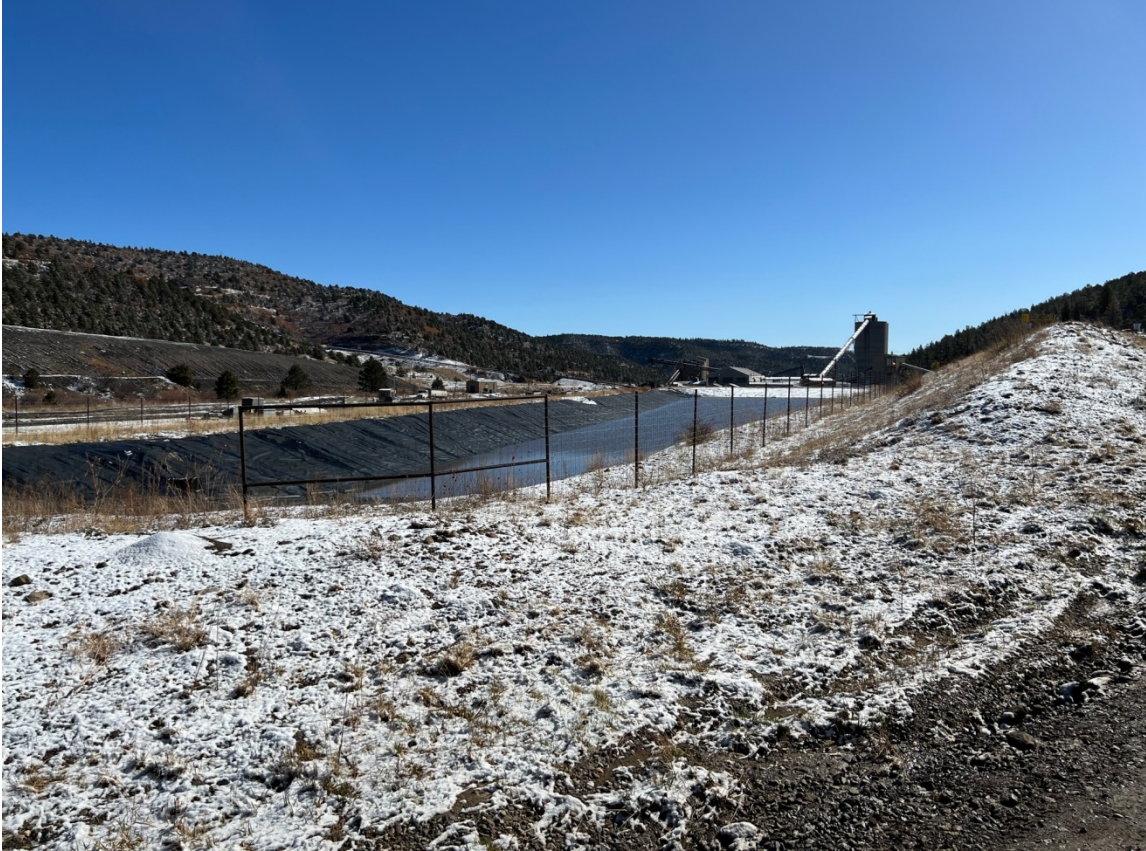
Pond 1

Pond liner is in good working condition at time of inspection. Pond was holding water at time of
inspection. The mine is putting water into the pond. Water is also being pulled through the pond
and being cleaned and reused at the mine site.

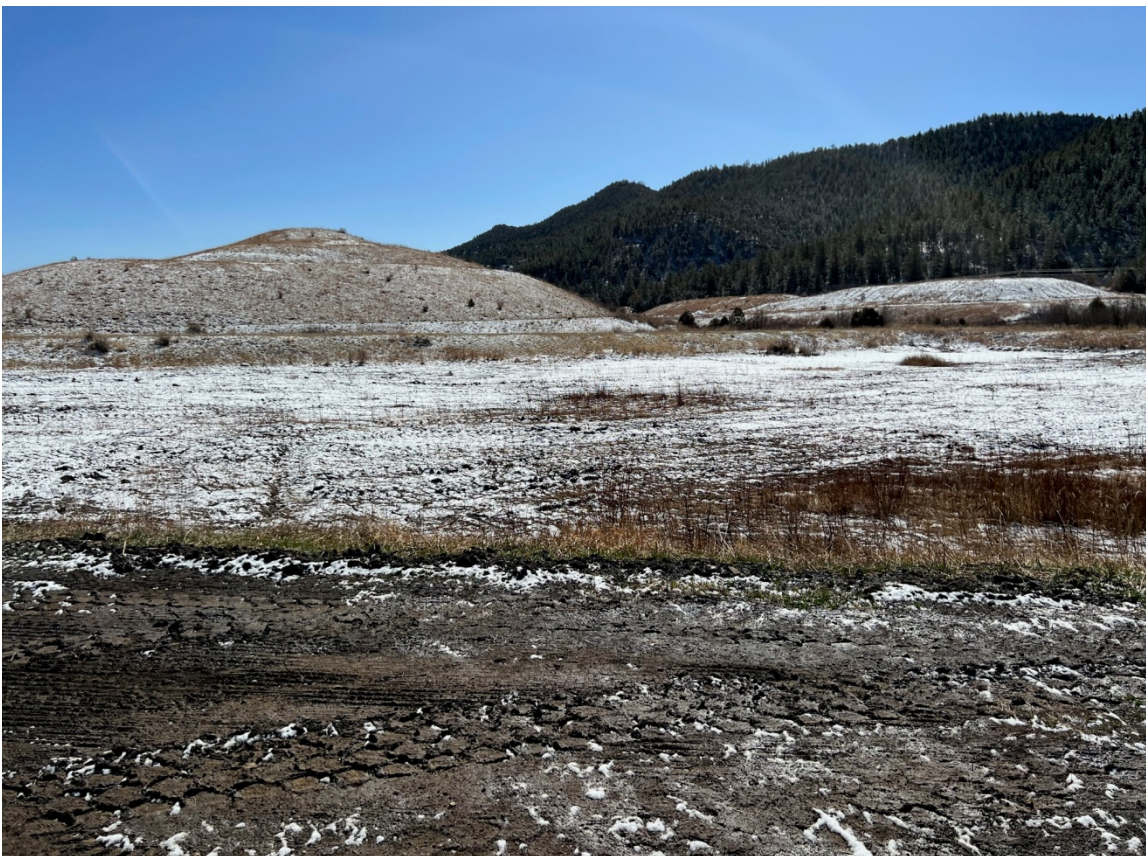
Pond 4

Pond was empty at the time of inspection. Vegetation has been removed from the pond this quarter.

Area around the decant has recently been cleaned of vegetation.

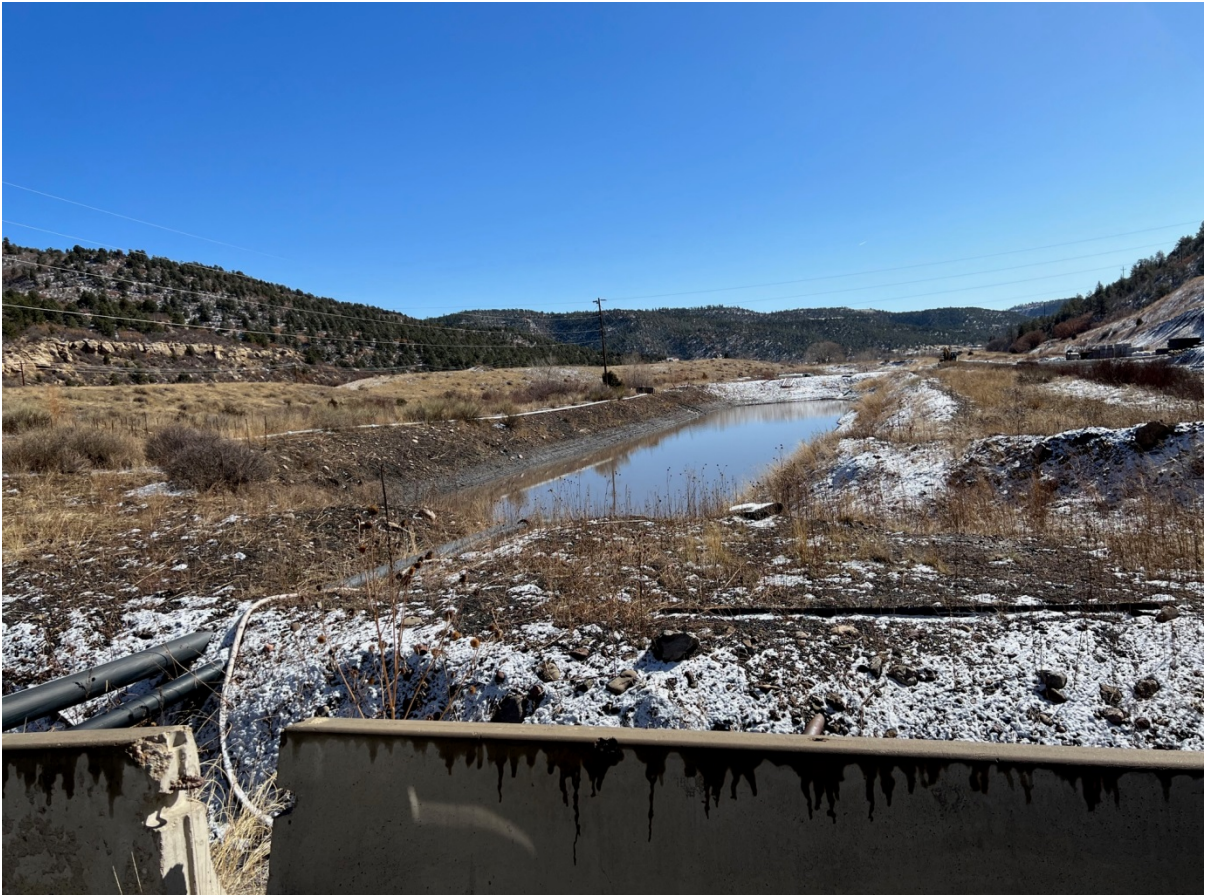
Pond 6

Pond is holding water, but it is not close to full.

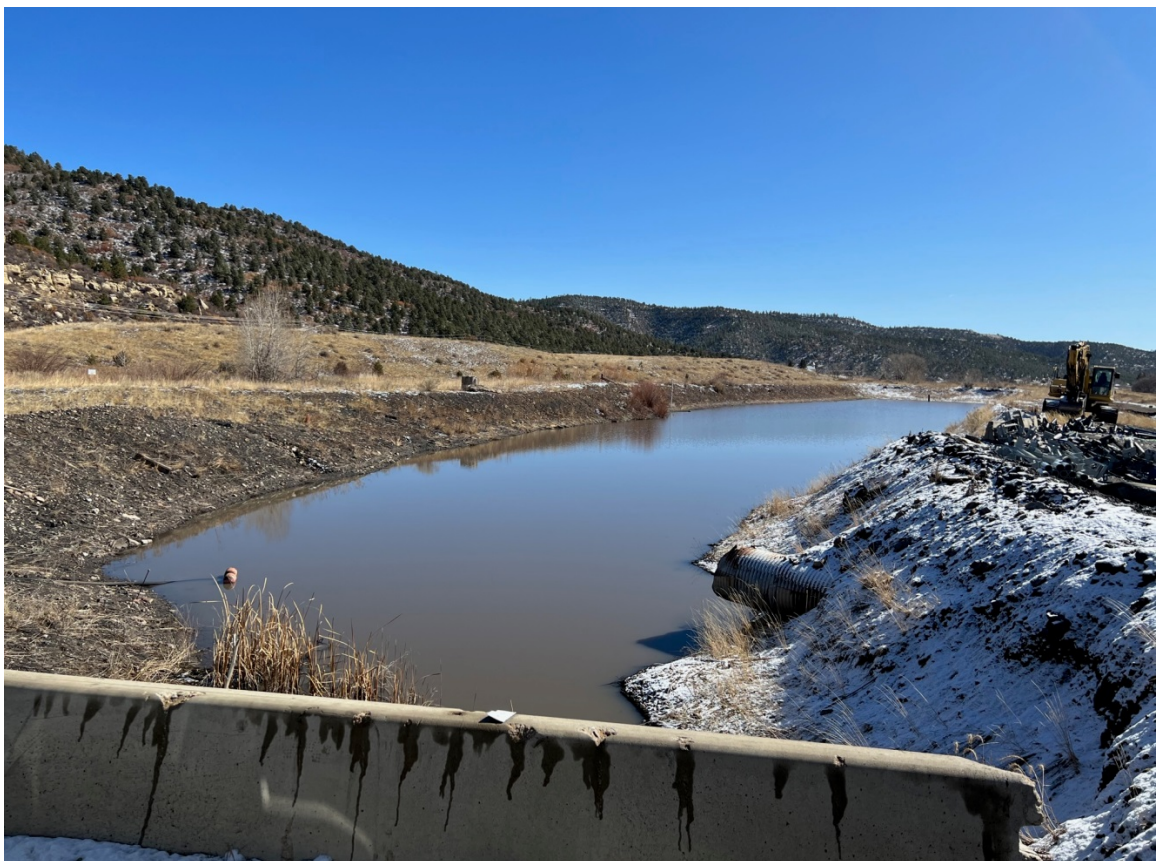
Pond 7

Pond is holding water, just below the level of the decant. The pond and ditches are in good

working condition.

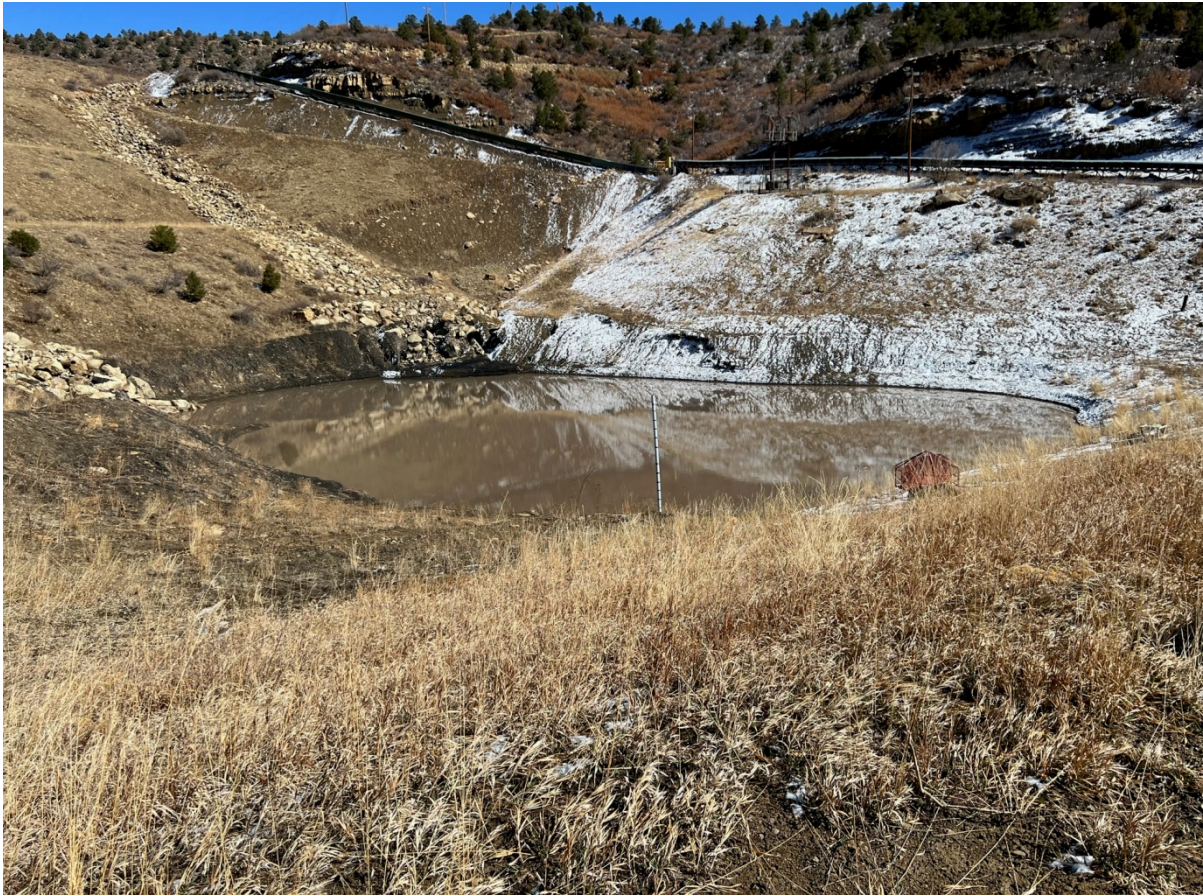
Pond 8

Pond is holding water, not near the decant level. Little new sediment has been deposited since

the pond was last cleaned.

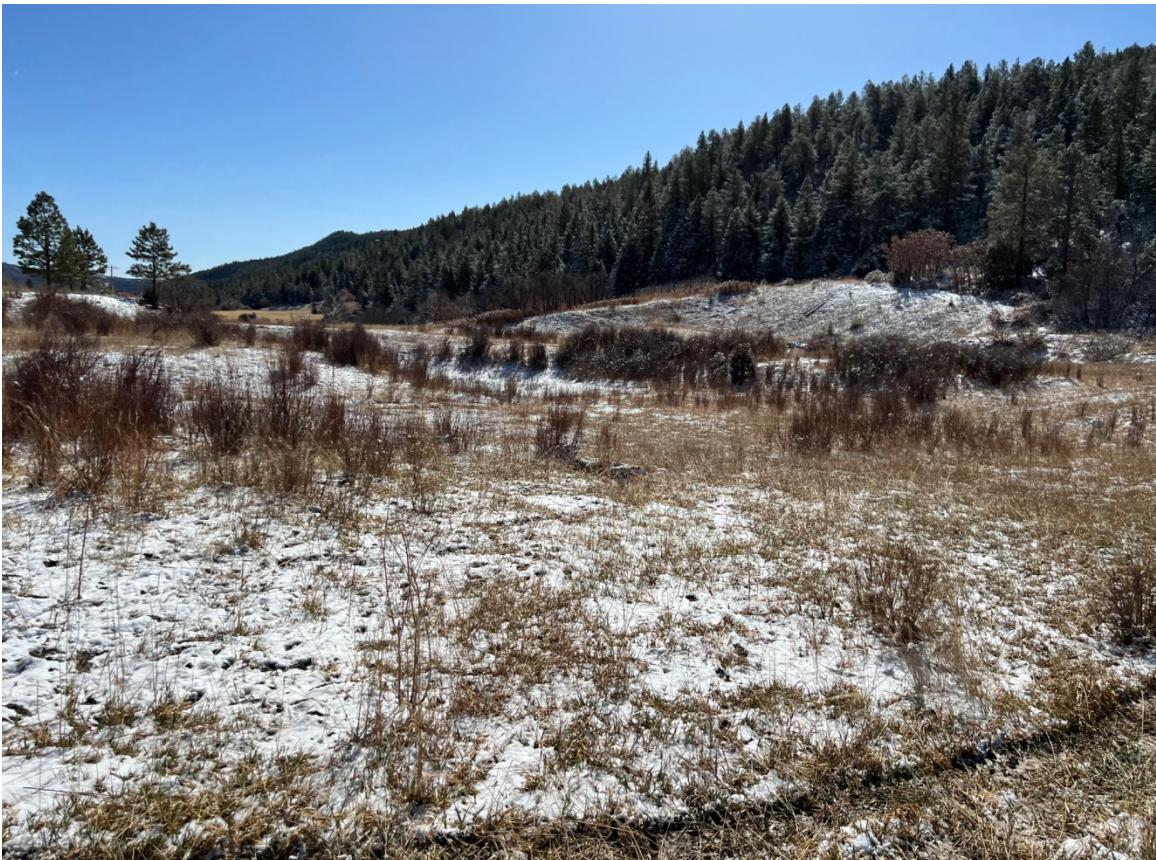
Containment Area #1

Containment was near empty at the time of inspection. Not near top of embankment.

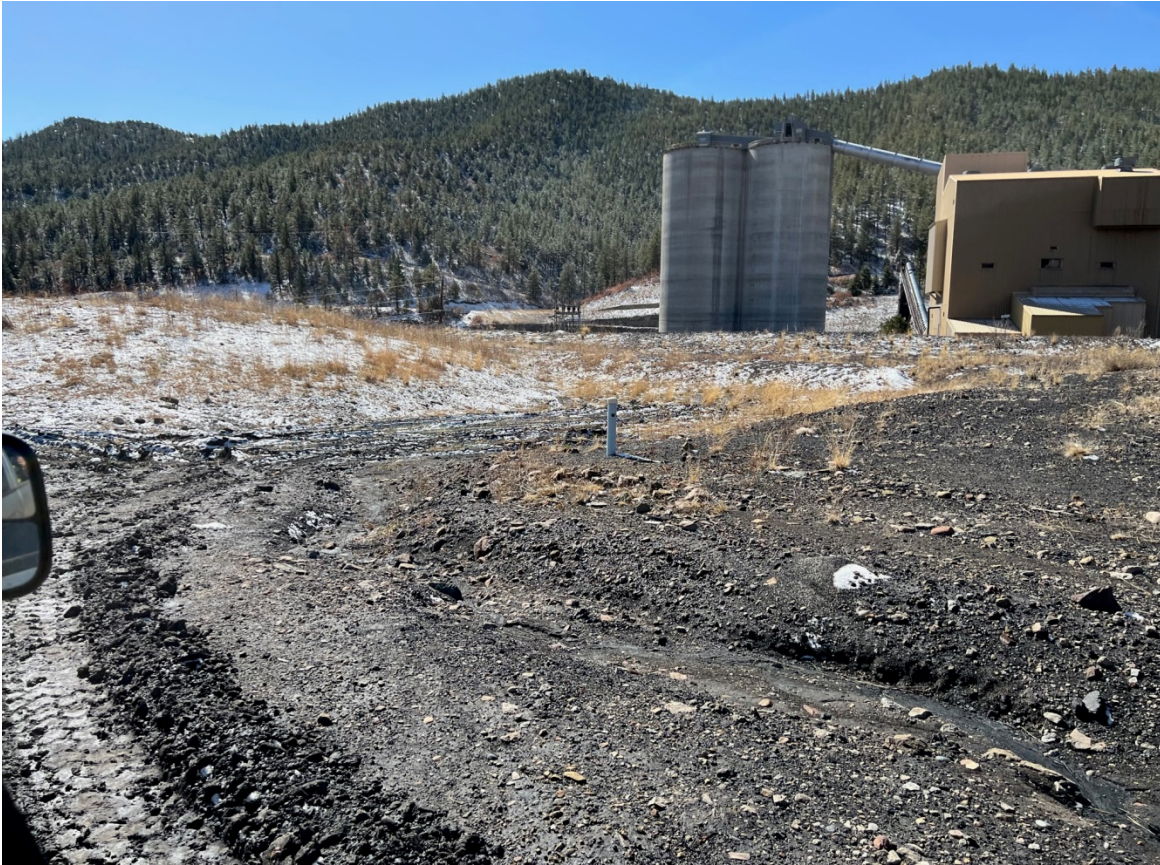
Containment Area #3

Containment Area was dry at time of inspection.

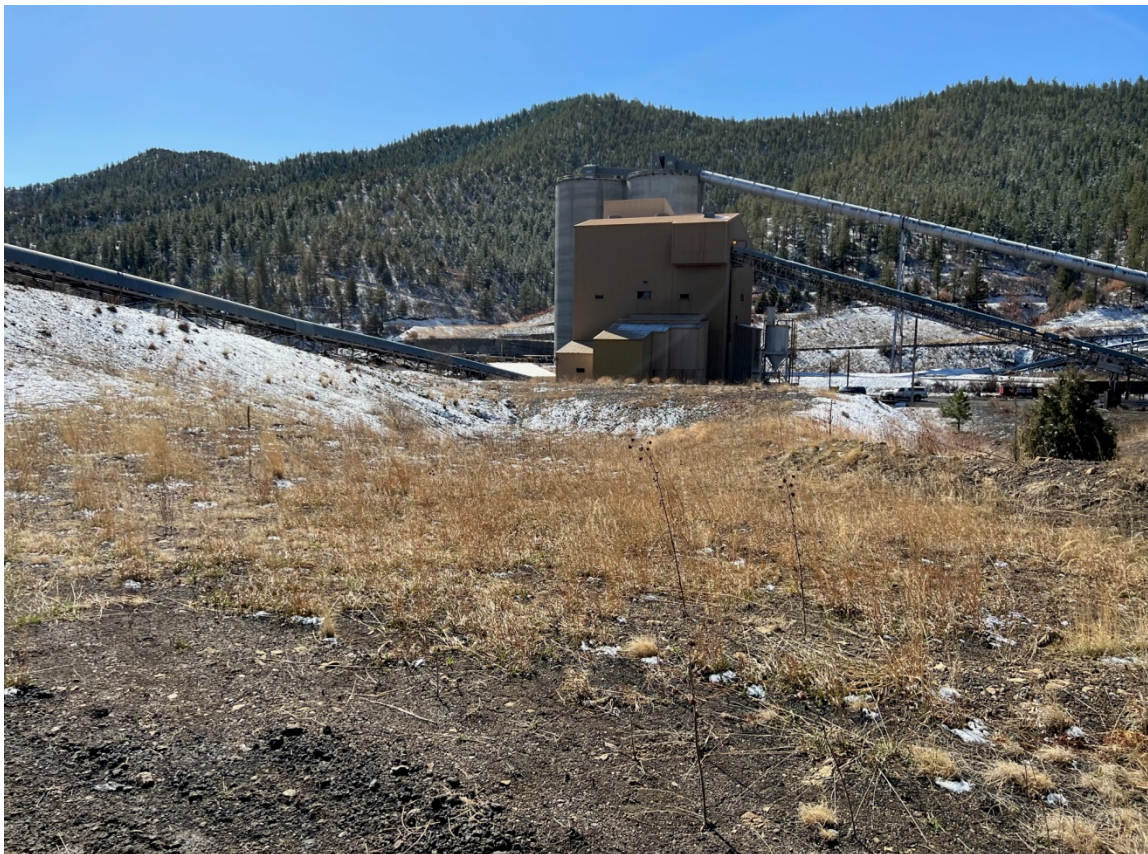
Containment Area #4

Containment Area was dry at time of inspection.

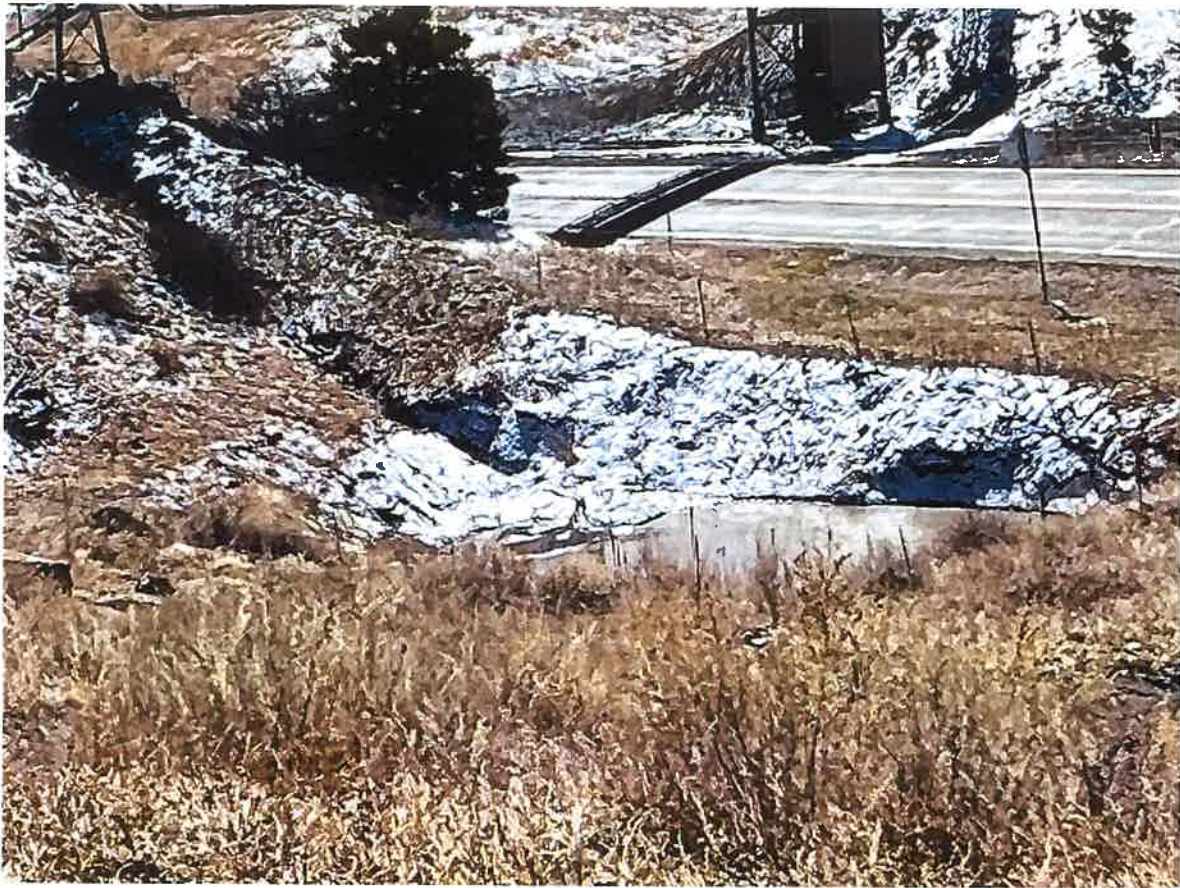
Containment Area #5

Containment Area was holding water. Sediment was cleaned in quarter 2 of 2020.
