**LORENCITO CANYON MINE**  
**Permit No. C-1996-084**

**INSPECTION OF EXCESS SPOIL-FILLS 7, 8, & 9**  
**March 31, 2022**

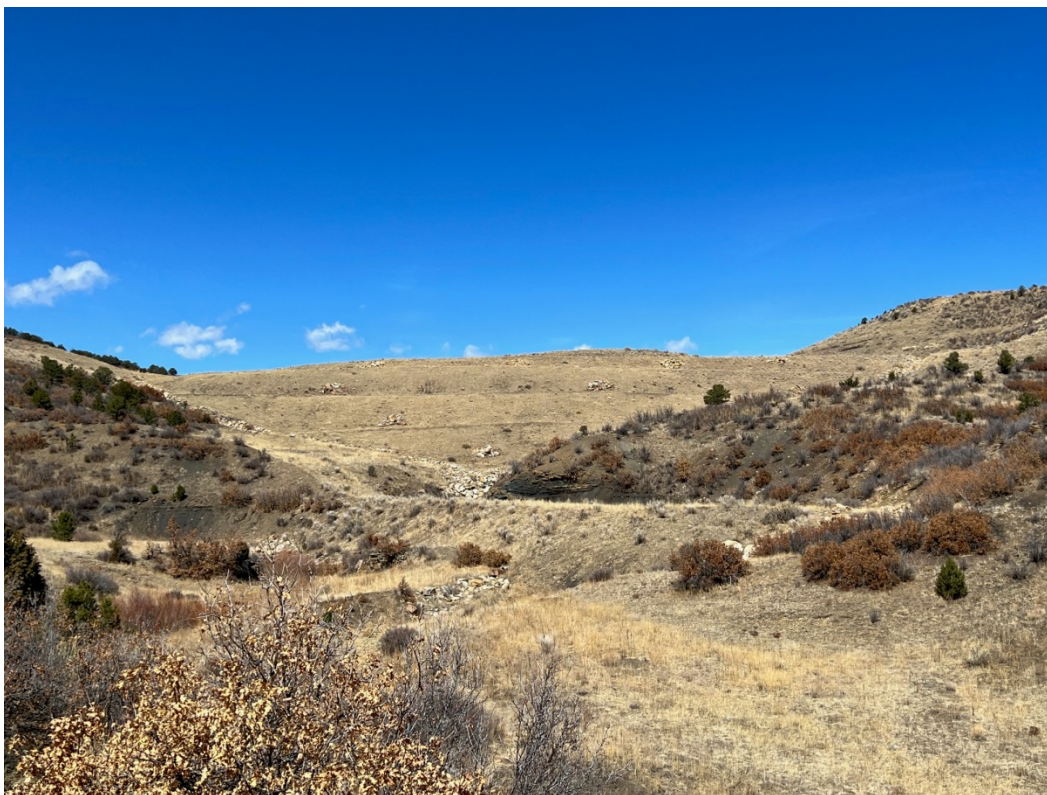
**Fill #7**

Armored Ditches line the east and west boundary of the fill area. Lateral ditches on the fill face direct runoff to these side ditches. A fourth east-west ditch was constructed at the upper most extent of the fill connecting to both armored ditches on the east and west perimeters. No erosional problems were noted at the intersections or along the lateral ditches and the armored ditches. Slopes are well vegetated and no erosional problems were observed.

The entire excess spoil fill facility was examined for signs of failure and instability such as tension cracks, ground movement, springs and seeps, and standing water. There was no indication of potential instability at time of inspection.

Overall the site is in good condition. The vegetation on the fill is encouraging.

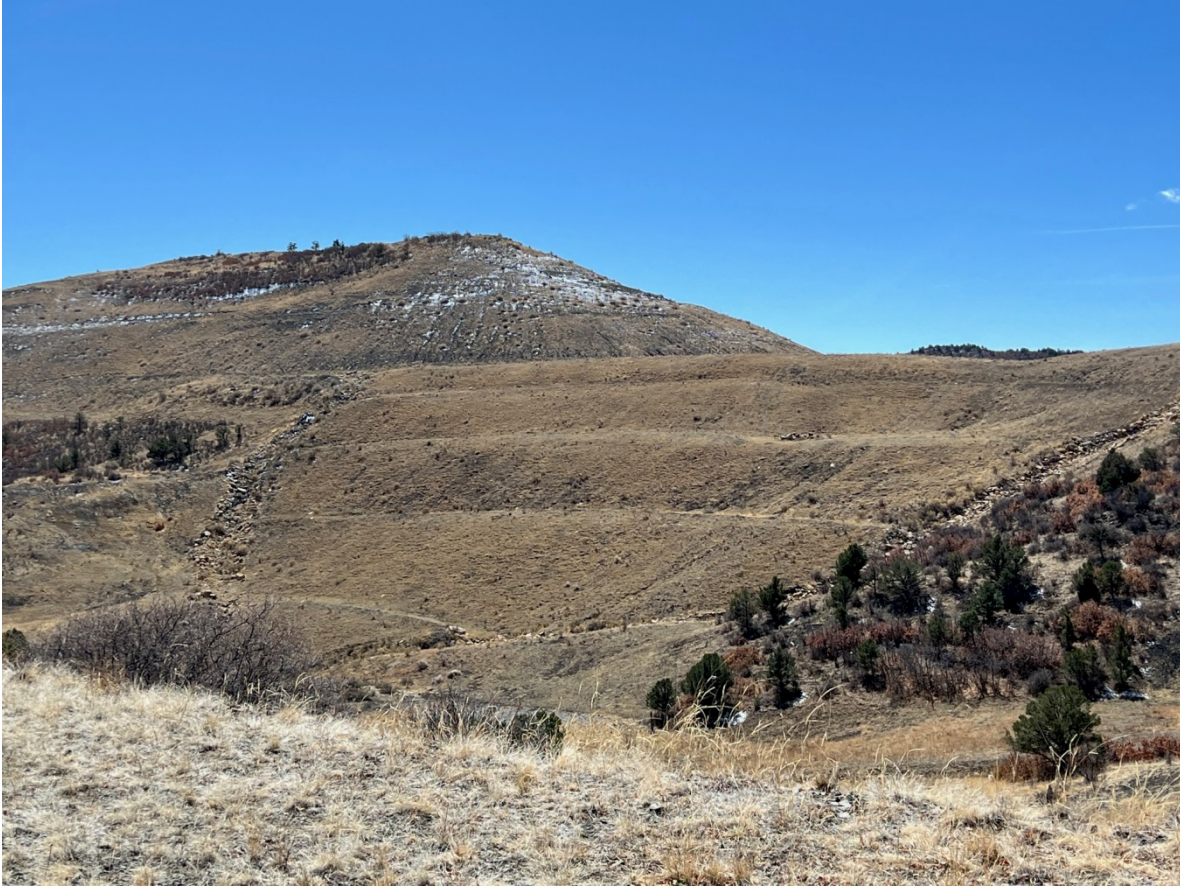
**Fill #8**

Armored Ditches line the east and west boundary of the fill area. Lateral ditches on the fill face direct runoff to these side ditches. No erosional problems were noted at the intersections or along the lateral ditches and the armored ditches. Slopes are well vegetated and no erosional problems were observed.

The entire excess spoil fill facility was examined for signs of failure and instability such as tension cracks, ground movement, springs and seeps, and standing water. There was no indication of potential instability at time of inspection.

Overall the site is in good condition. Vegetation is very good on the fill.

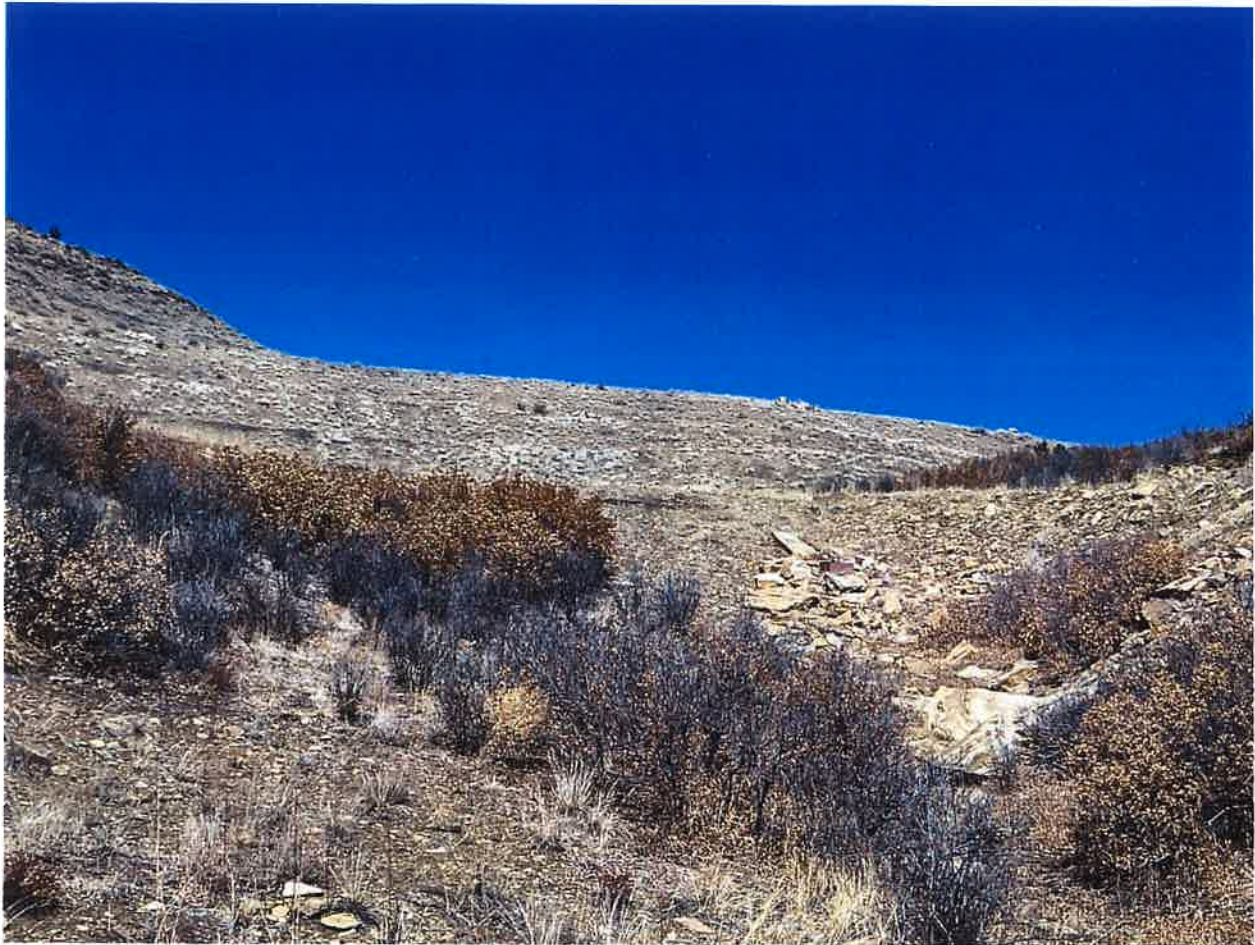
Fill #9

Armored Ditches line the east and west boundary of the fill area. Lateral ditches on the fill face direct runoff to these side ditches. No erosional problems were noted at the intersections or along the lateral ditches and the armored ditches. Slopes are well vegetated and no erosional problems were observed at the time of this inspection.

The entire excess spoil fill facility was examined for signs of failure and instability such as tension cracks, ground movement, springs and seeps, and standing water. There was no indication of potential instability at time of inspection.

Overall the site is in good condition.
