QUARTERLY SEDIMENTATION POND INSPECTION REPORT

Mine: Lorencito

QUARTERLY SEDIMENTATION POND INSPECTION REPORT
Lorencito Canyon Mine- March 31, 2022

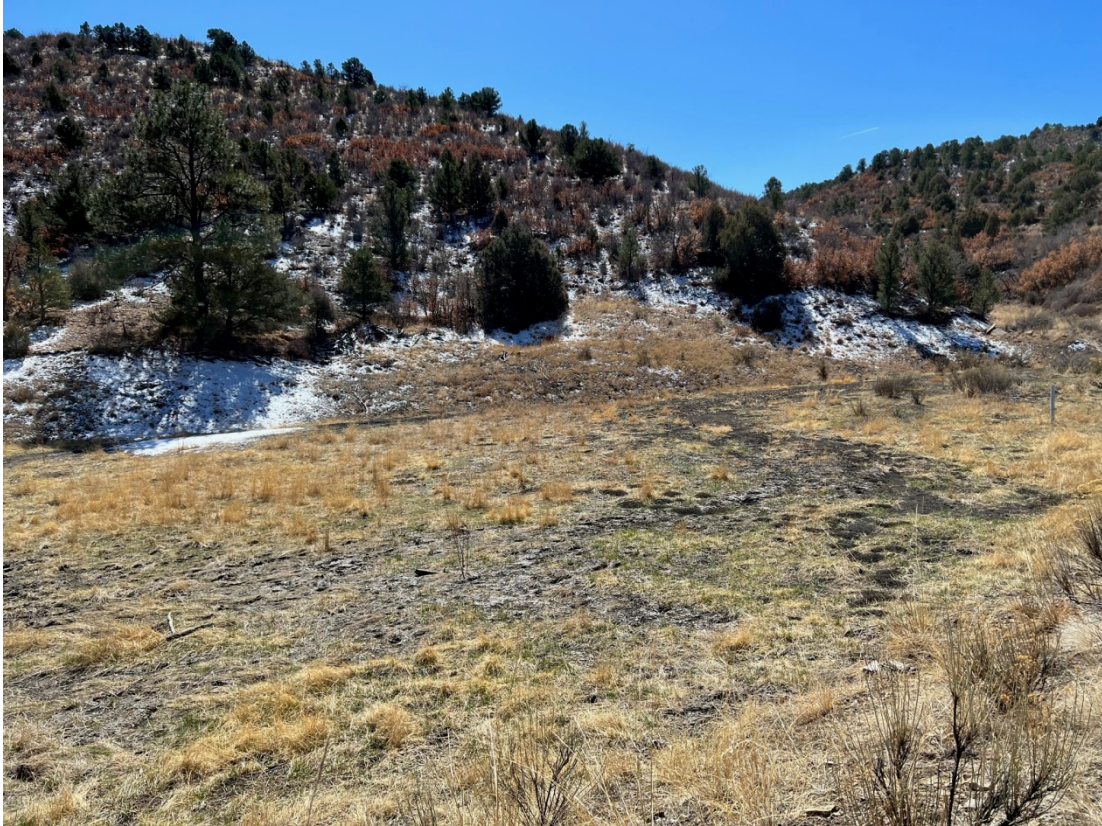
Pond 5

Explain: Sediment in pond does not appear to be over capacity by visual inspection.

Pond was empty at time of inspection.

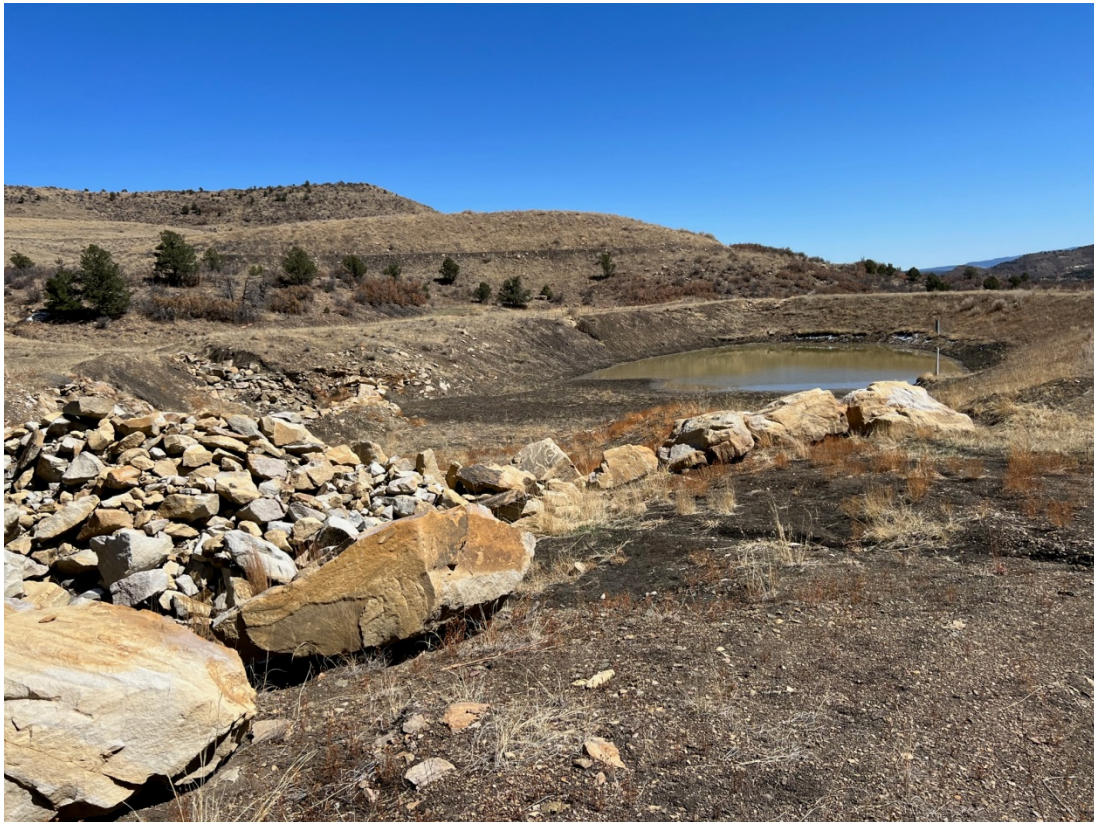
Pond 6

Pond was holding water but not near the level of the decant.

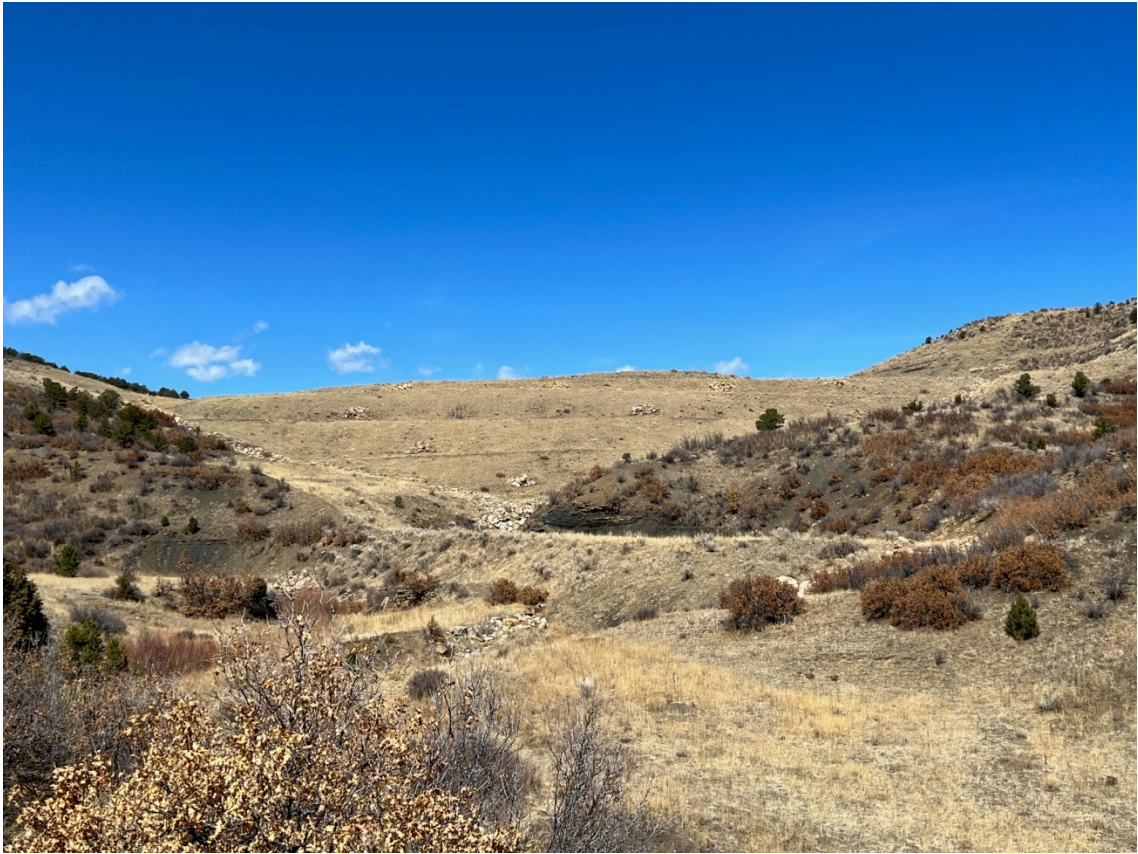
Pond 7 Embankment

Pond was holding some water but not near the level of the decant.

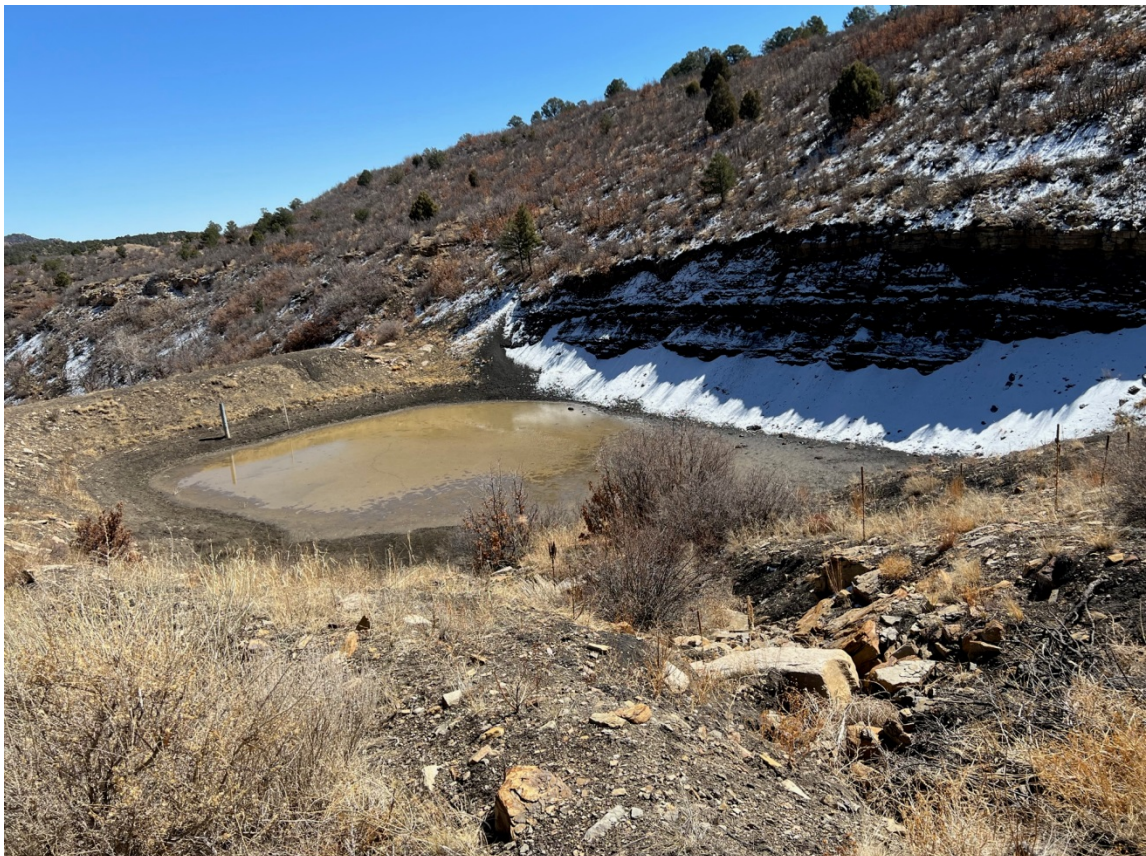
Pond 8

Pond was holding water well below the decant level. No signs of recent discharges.

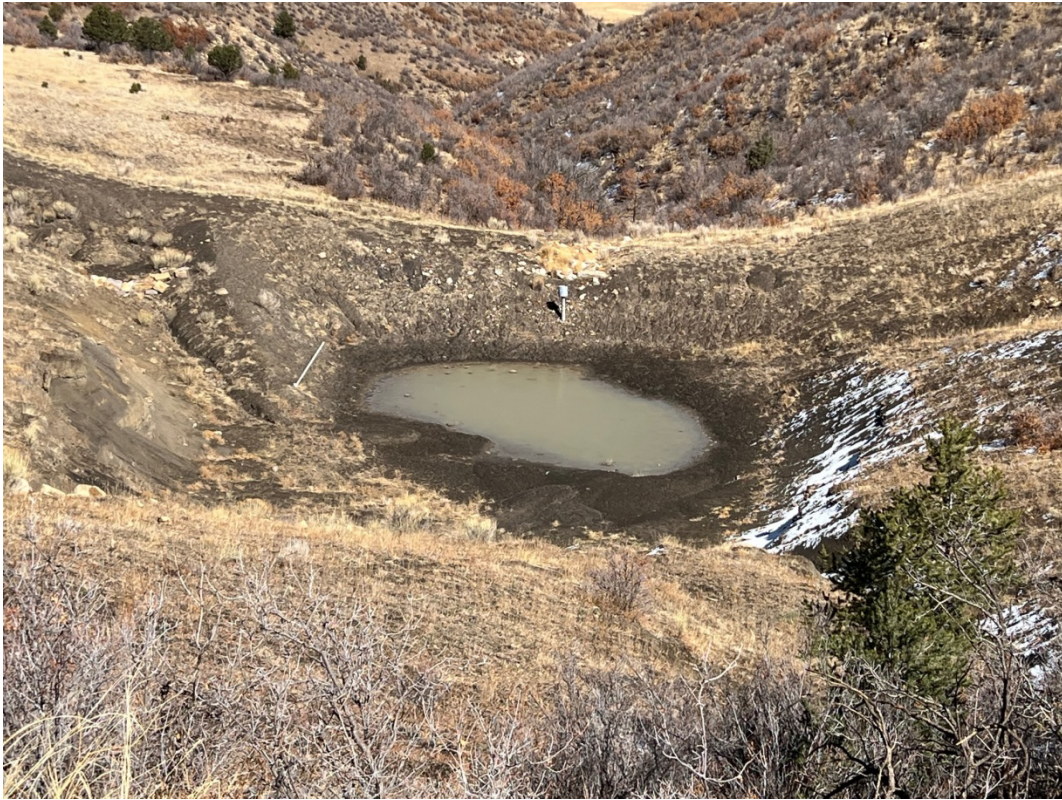
Pond 9

Pond was holding some water but not near discharging at time of inspection.

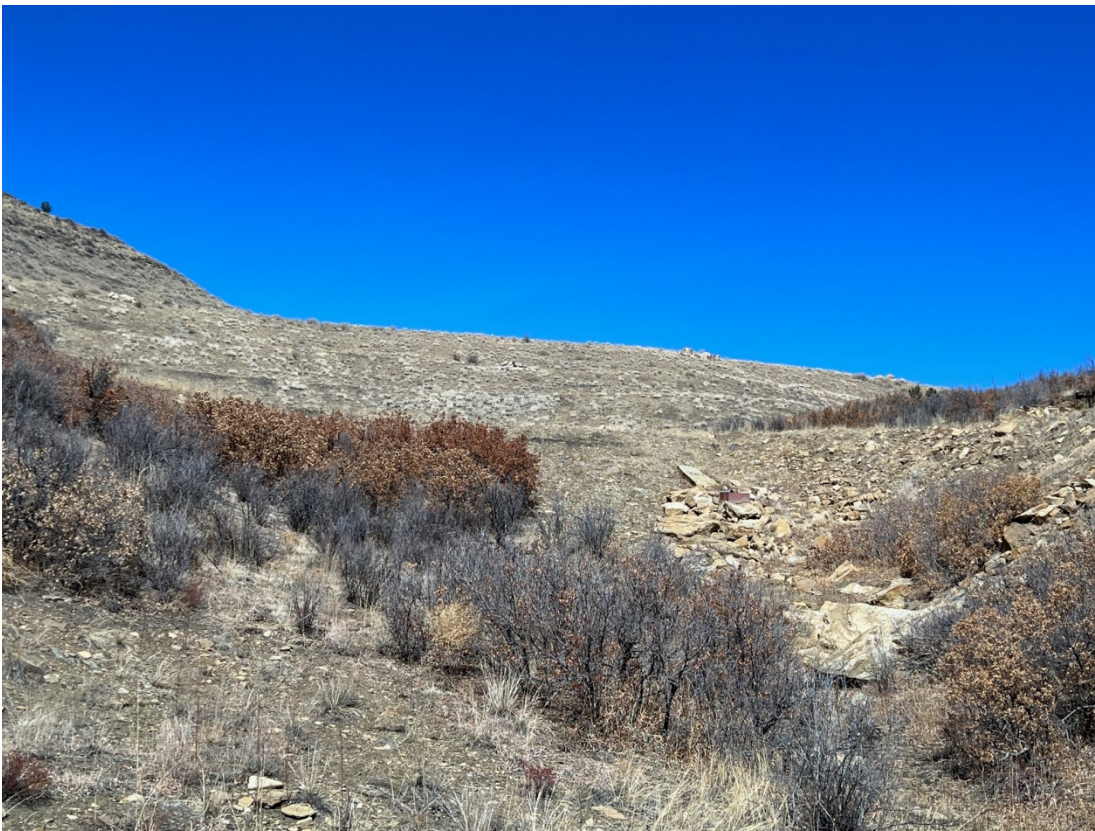
Pond 9a

Pond was little holding water but not near discharging at time of inspection.
