MINERALS PROGRAM INSPECTION REPORT
PHONE: (303) 866-3567

MINE NAME: Table Mountain Quarry	MINE/PROSPECTING ID#: M-1999-004	MINERAL: Silica (quartz, quartz)	COUNTY: Fremont
INSPECTION TYPE: Monitoring	INSPECTOR(S): Timothy Cazier, P.E.	INSP. DATE: March 15, 2022	INSP. TIME: 13:25
OPERATOR: Tezak Heavy Equipment Co. Inc.	OPERATOR REPRESENTATIVE: Lu Toxvard	TYPE OF OPERATION: 112c - Construction Regular Operation	
REASON FOR INSPECTION: Normal I&E Program	BOND CALCULATION TYPE: None	BOND AMOUNT: \$208,171.00	
DATE OF COMPLAINT: NA	POST INSP. CONTACTS: Colo. Land Board	JOINT INSP. AGENCY: None	
WEATHER: Clear	INSPECTOR'S SIGNATURE:

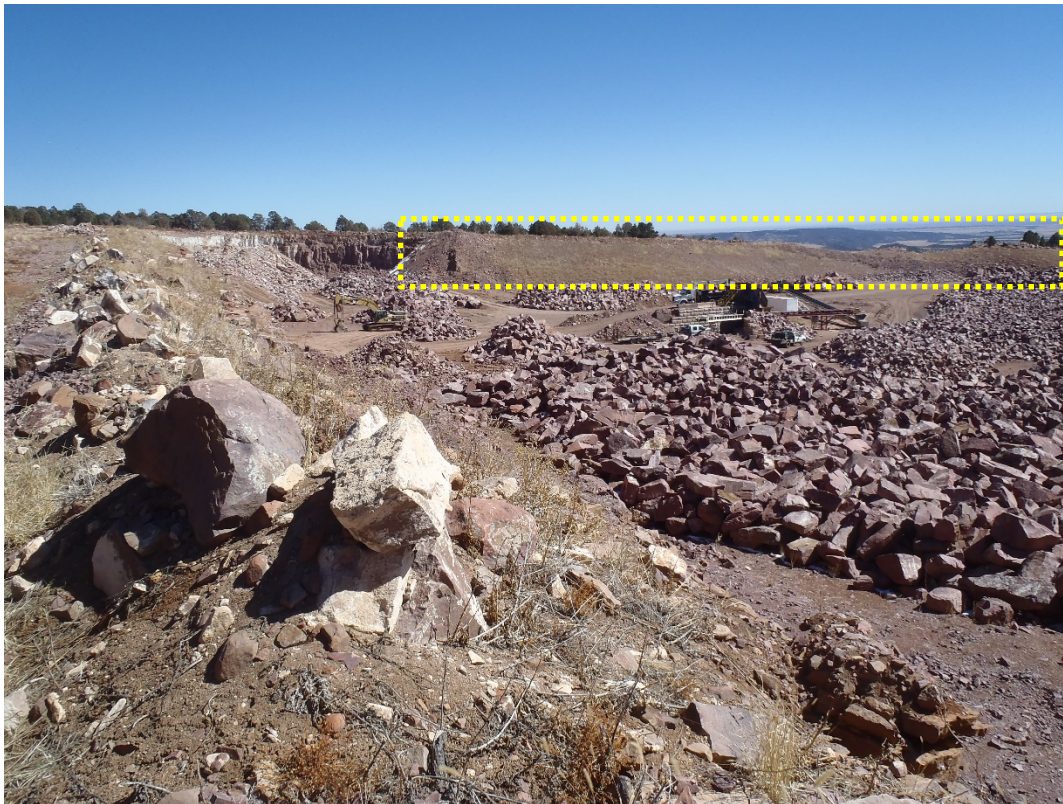
Backfilling and Grading: The mining direction is south to north. The Operator has been backfilling the east (see **Photo 1**) and west highwalls (see **Photo 2**) as the active highwall progresses.

Reclamation Success: As discussed above under "Backfilling and Grading", concurrent reclamation is being performed on the east and west highwalls.

Photo 1. Concurrent reclamation – east highwall backfill & reveg (looking ESE).

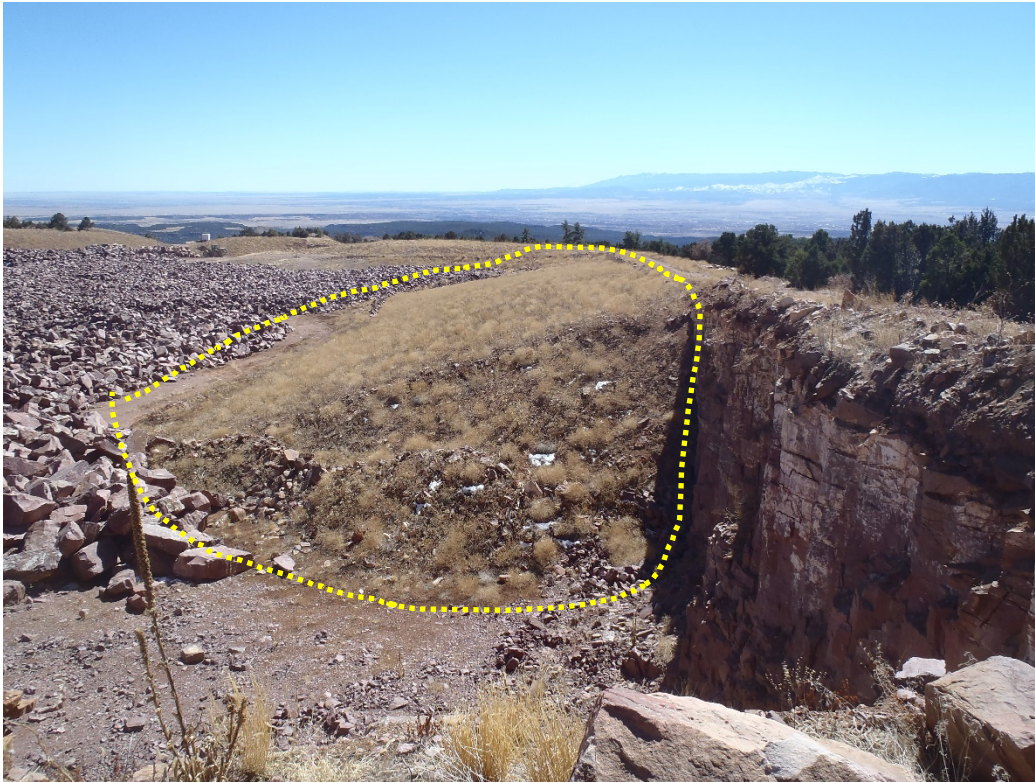
Photo 2. Concurrent reclamation – west highwall backfill & reveg (looking south).

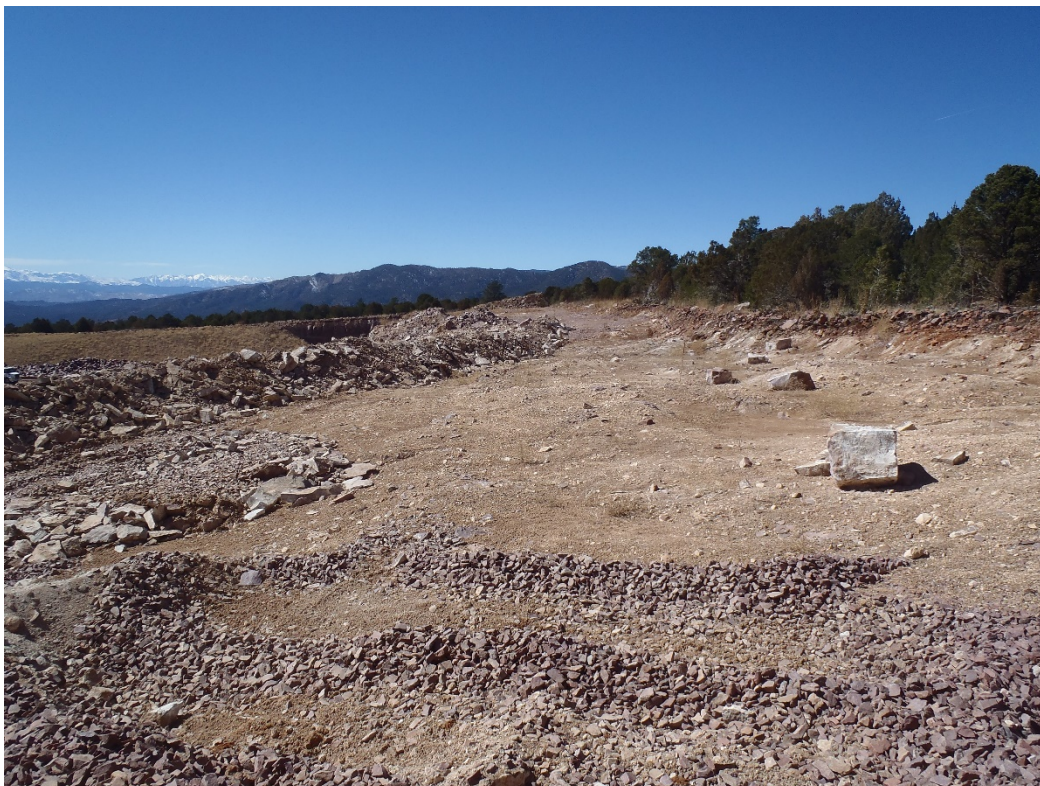
Excess Spoil and Dev. Waste: Overburden north of the active highwall is stripped (see **Photo 3**) ahead of blasting and is stockpiled or immediately used for backfill.

Photo 3. Stripped overburden north of highwall (looking west).

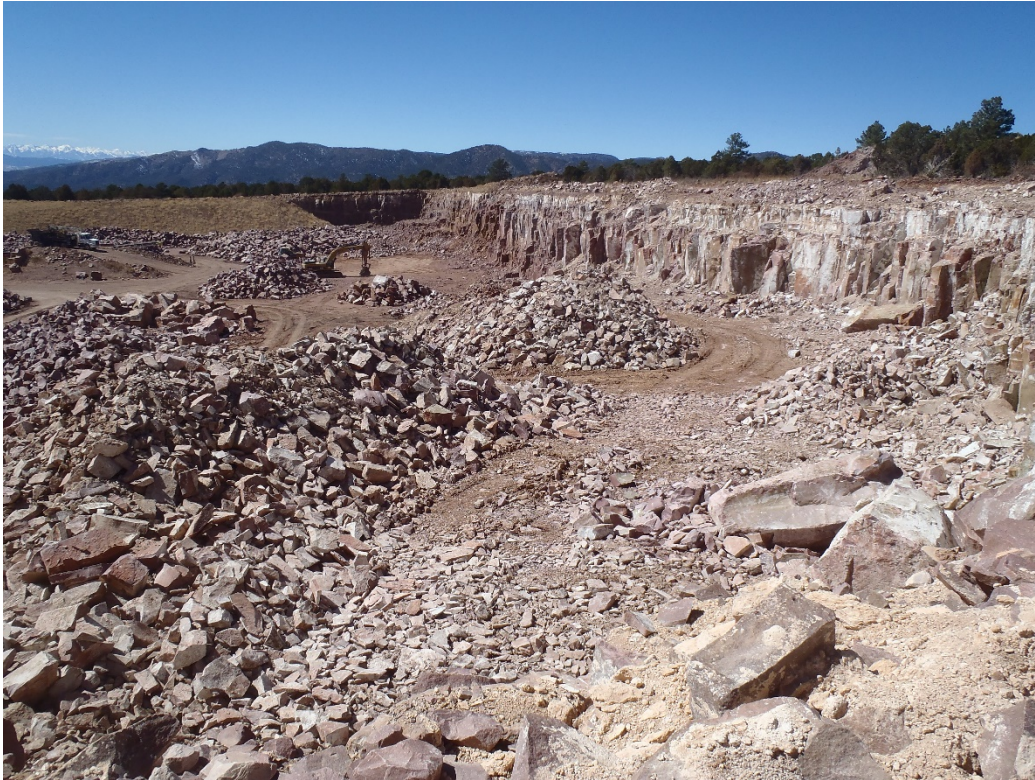
Gen. Compliance with Mine Plan: The operation appeared to be in compliance with the approved mine plan. THE has been mining Area A. The previous Permittee performed some mining in Area B. The maximum allowed disturbed area is 59 acres. Google Earth was used to measure the disturbed area, which was approximately 40 acres, based on 2019 imagery. Highwalls were estimated to vary between 40 and 45 feet in height (see **Photo 4**).

Permit Stipulations: During the AM-01 review process, a commitment was made by the Permittee to limit the highwall to less than 2,000 lineal feet in order to keep the reclamation liability in line with the posted financial warranty. The observed highwall was estimated to be about 1,200 feet, including the unbackfilled portions of the east and west highwall.

Photo 4. Active highwall (looking west).

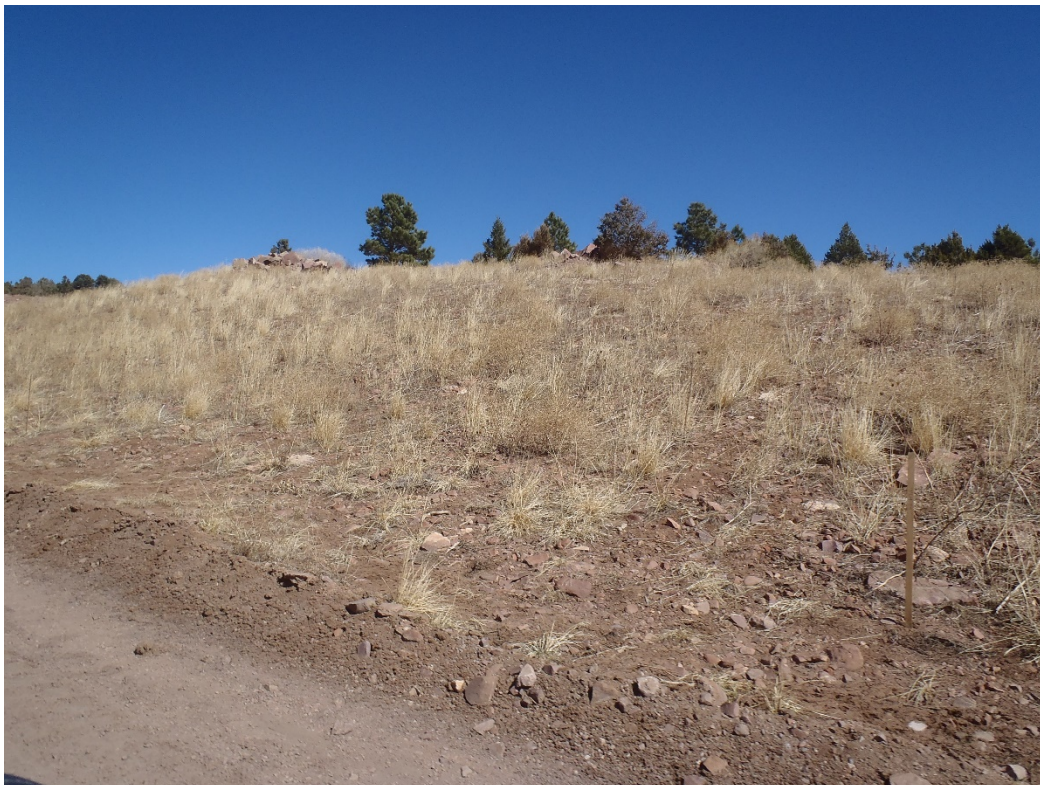
Revegetation: Vegetation is becoming well established on the backfilled east and west highwalls (see **Photo 5**). Mr. Toxvard indicated they had sprayed for knapweed in 2021.

Photo 5. Revegetation on south end of backfilled east highwall (looking NE).

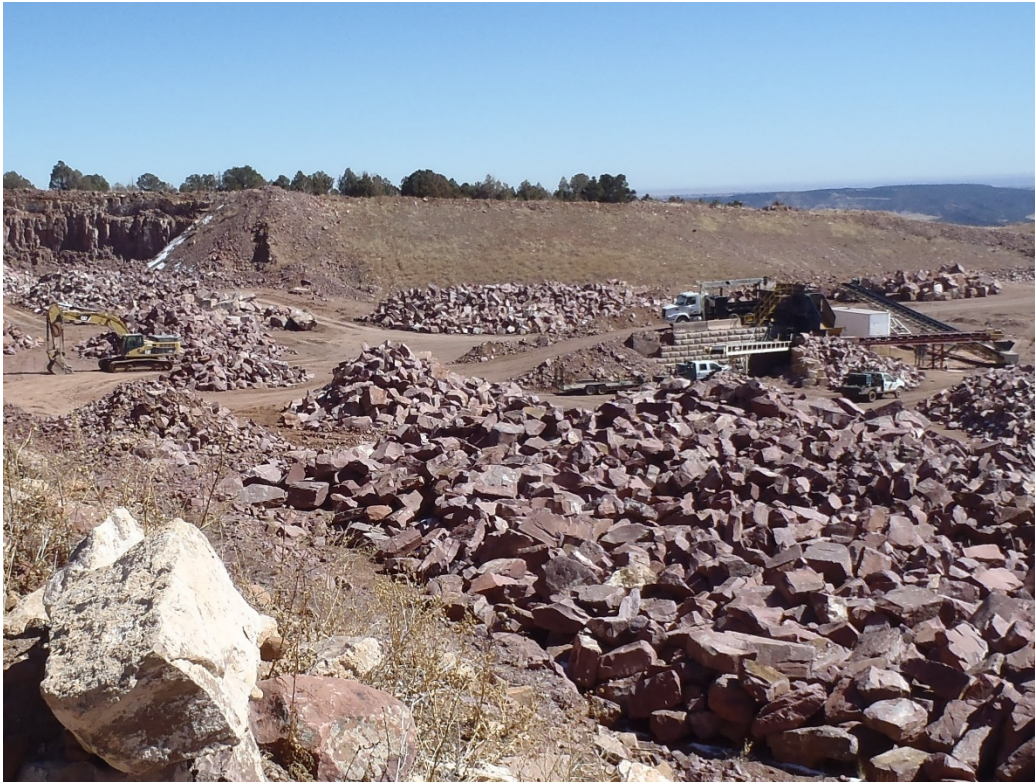
Support Facilities On-site: A screen plant and excavator were observed on site (see **Photo 6**).

Photo 6. Screen plant and excavator.

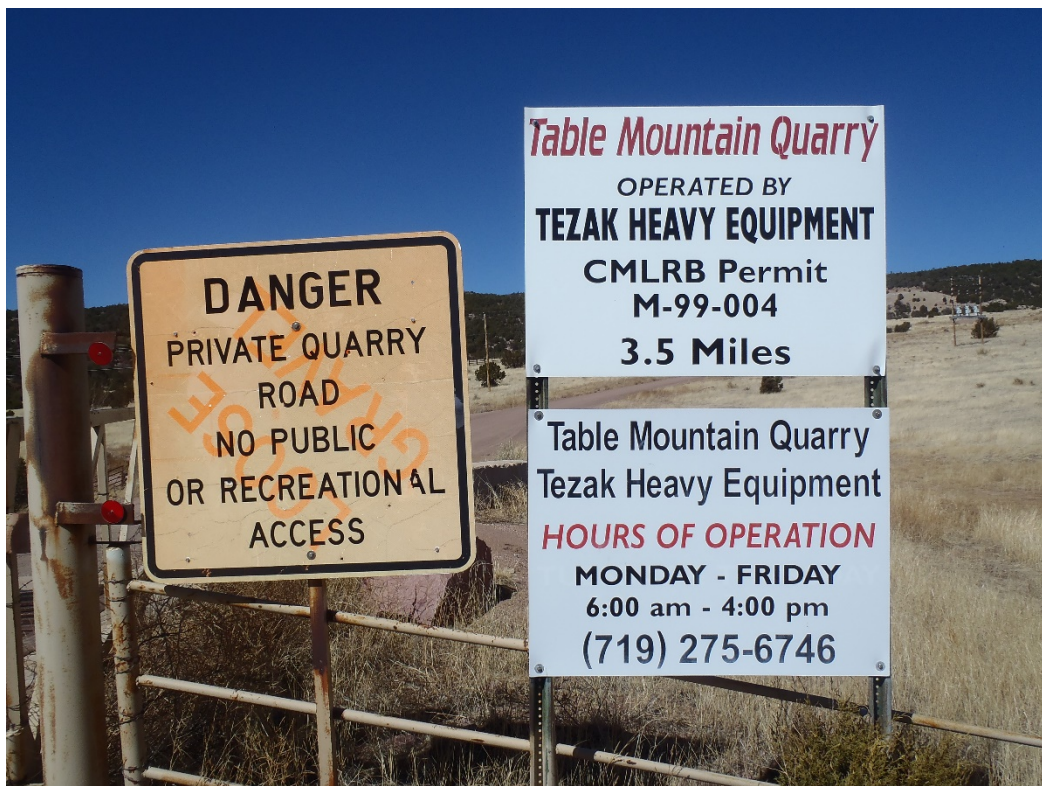
Signs and Markers: The permit sign was properly posted (see **Photo 7**) and boundary markers were observed to delineate the permit boundary (see **Photo 8**).

Photo 7. Permit sign off Hwy 115 entrance.

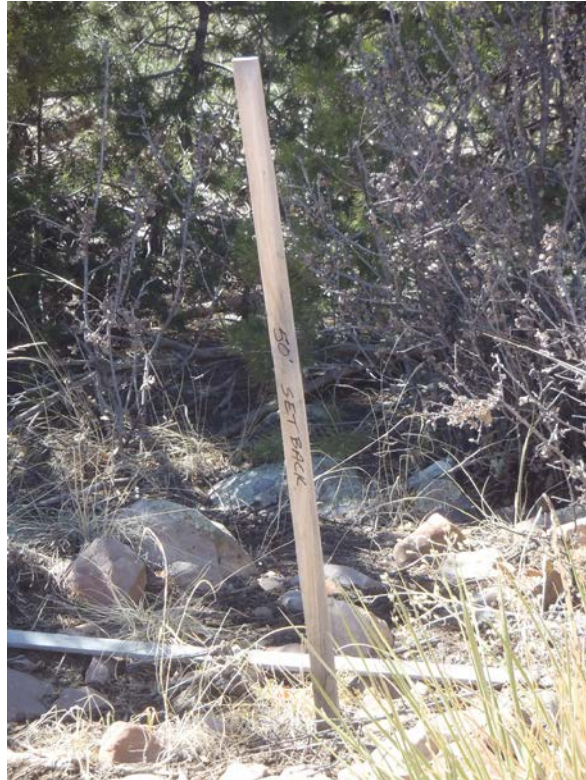
Photo 8. Typical 50-foot boundary offset survey stake (west side) .

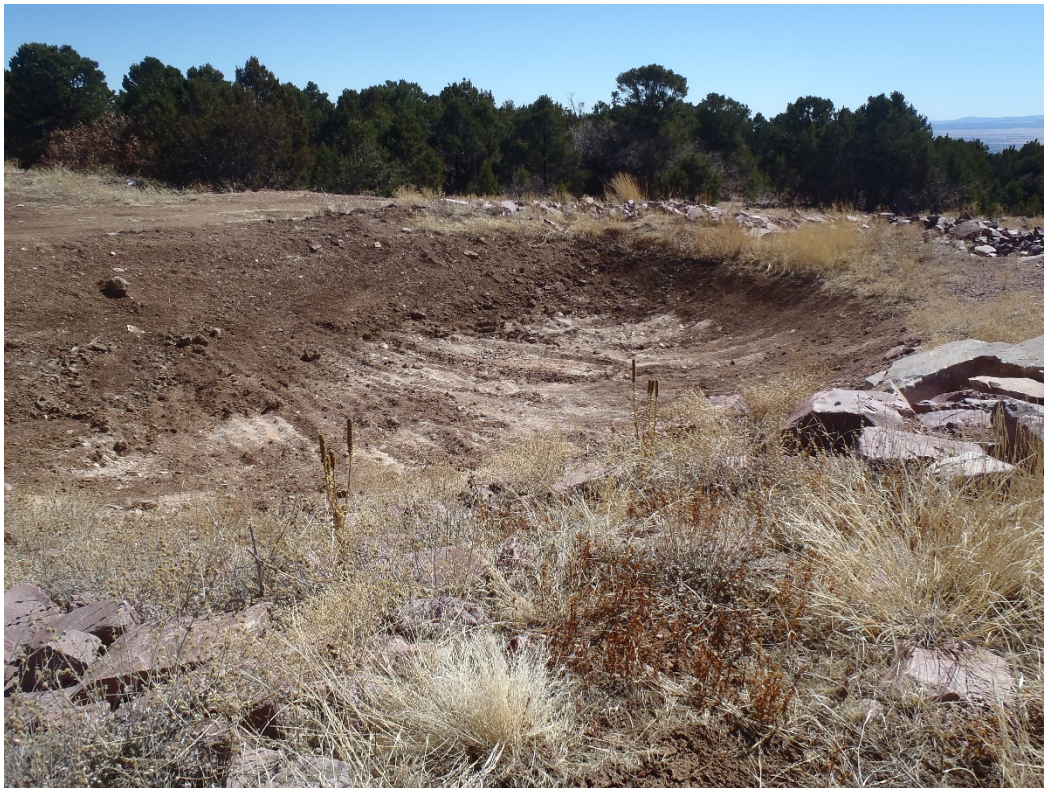
Storm Water MGT Plan: No oil or fuel spills observed. Stormwater drains south to the sediment pond and either discharges when full, or infiltrates. The pond was in good condition (see **Photo 9**).

Photo 9. Sediment pond (south end of site, looking south).
