**MINERALS PROGRAM INSPECTION REPORT**  
**PHONE: (303) 866-3567**

<b>MINE NAME:</b> Cresson Project	<b>MINE/PROSPECTING ID#:</b> M-1980-244	<b>MINERAL:</b> Gold	<b>COUNTY:</b> Teller
<b>INSPECTION TYPE:</b> Monitoring	<b>INSPECTOR(S):</b> Brock Bowles	<b>INSP. DATE:</b> March 2, 2022	<b>INSP. TIME:</b> 09:45
<b>OPERATOR:</b> Cripple Creek & Victor Gold Mining Compar	<b>OPERATOR REPRESENTATIVE:</b> Katie Blake	<b>TYPE OF OPERATION:</b> 112d-3 - Designated Mining Operation	
<b>REASON FOR INSPECTION:</b> Normal I&E Program	<b>BOND CALCULATION TYPE:</b> None	<b>BOND AMOUNT:</b> \$209,491,188.00	
<b>DATE OF COMPLAINT:</b> NA	<b>POST INSP. CONTACTS:</b> None	<b>JOINT INSP. AGENCY:</b> None	
<b>WEATHER:</b> Clear	<b>INSPECTOR'S SIGNATURE:</b>

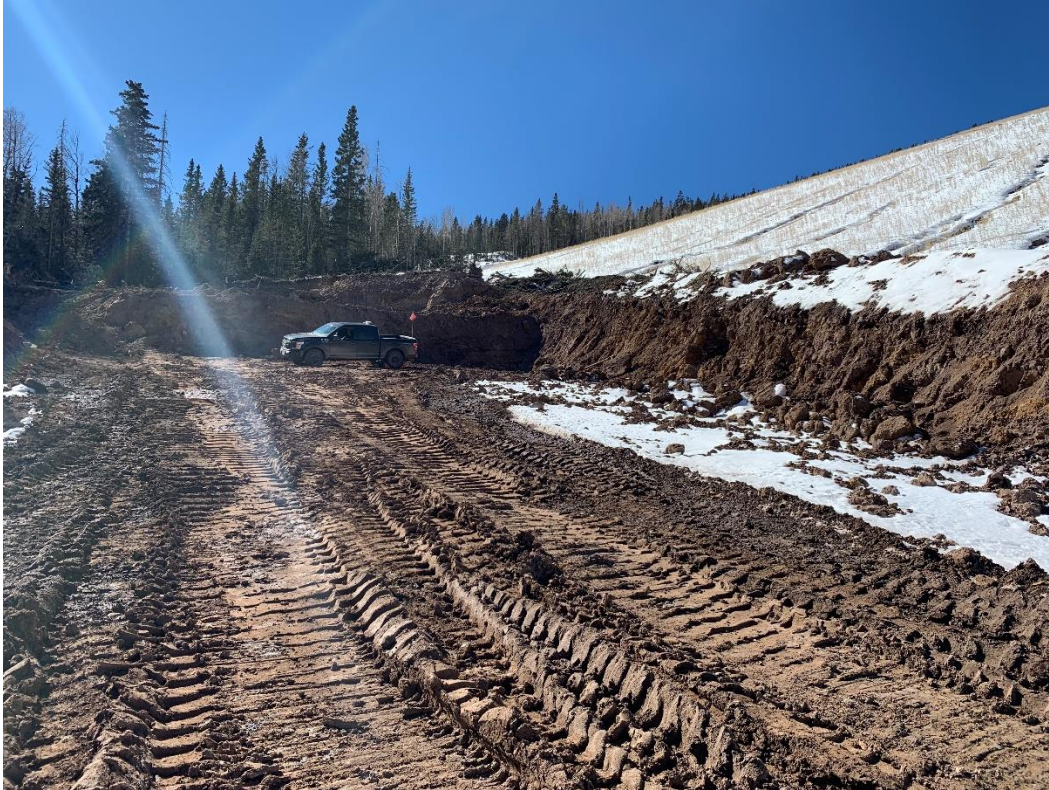
The area is being backfilled to stabilize the toe of the slope. The material being used to backfill is from non-ore processing projects on-site. The area has been graded and sloped to the north (photo 1). The runoff is directed to a large pit on the east side of the access road. The rills and gullies on the reclamation above the clay borrow area have not been repaired. A consultant has been hired to investigate the causes and come up with a new design for the reclaimed area. There is no estimated timeline as to when the repair work will happen. The spring pond was frozen, snow covered and appeared to be very low (photo 2). No discharge was noted and a pump was onsite.

Photo 1 – Clay borrow area graded and sloped to north, photo facing south

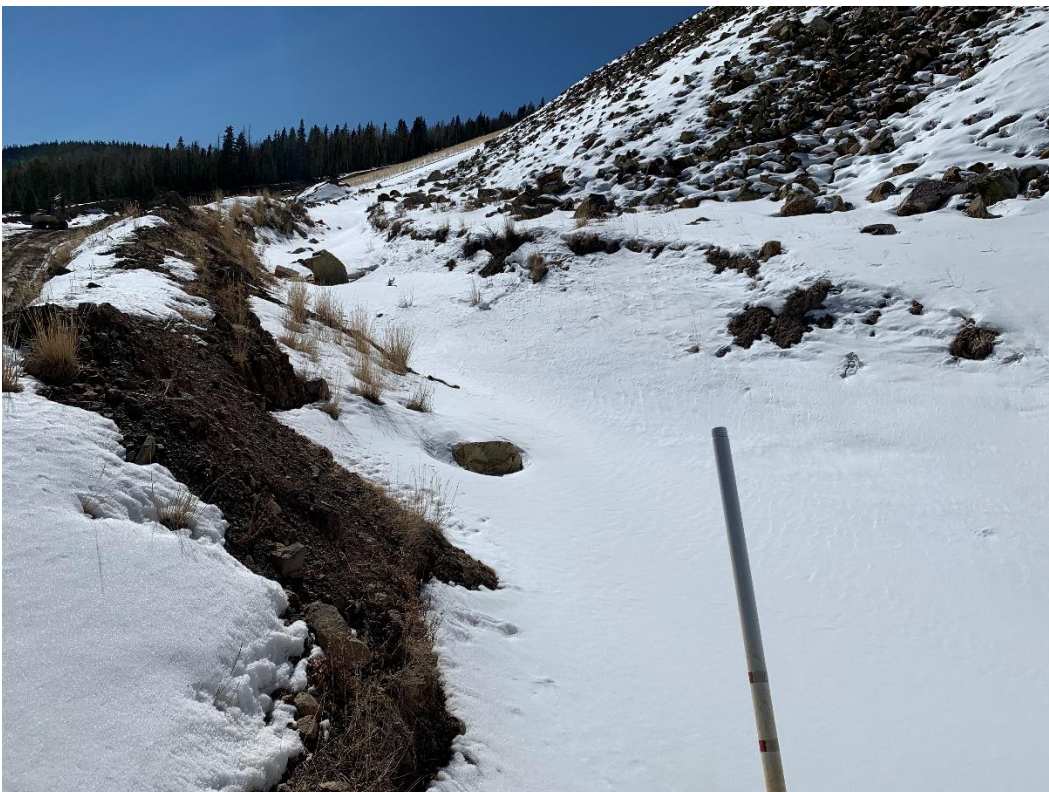
Photo 2 – ECOSA seep pond on west side of access road, facing south

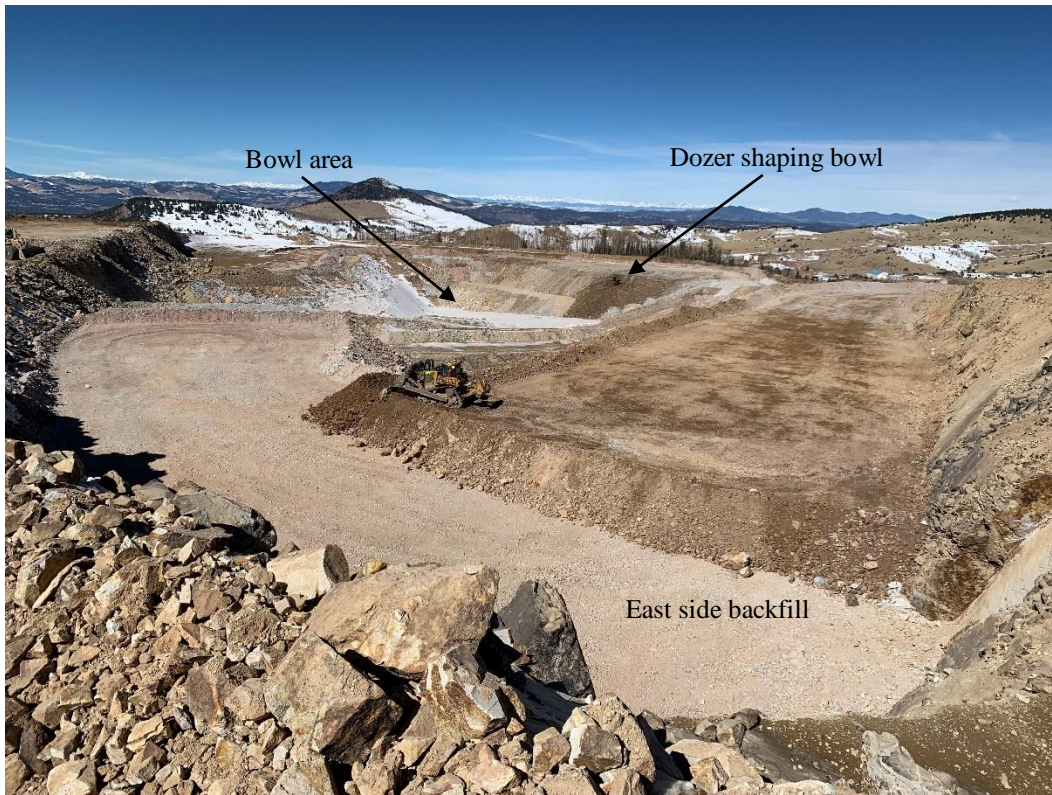
The backfilling of the bowl feature of the Schist Island project was completed. A bulldozer had begun removing the excess material from within the bowl feature to expose the compacted soil (photo 3). The excess material will be removed from the bowl area and used as backfill elsewhere in the project area. The east end of the Schist Island was also being backfilled in (photo 3). This area is not part of the bowl construction.

Photo 3 – Schist Island project area, facing west.

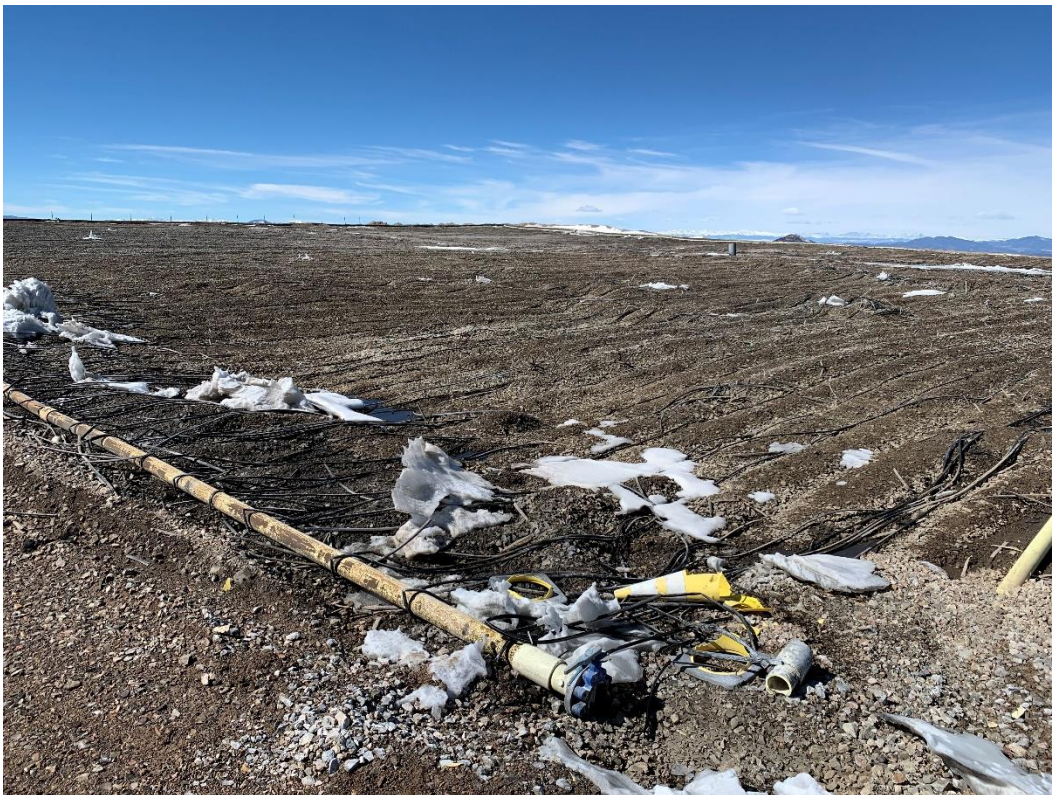
The 10,400 layer was inspected. Solution was being applied through irrigation drip lines. Some small ponding was seen but all the puddles were less than 9 square feet in size (photo 4). There were several patches of snow. The 10,200 layer was observed from the access road. Solution was being applied to this layer as well and no puddles were observed.

Photo 4 – VLF-2, 10,400 layer

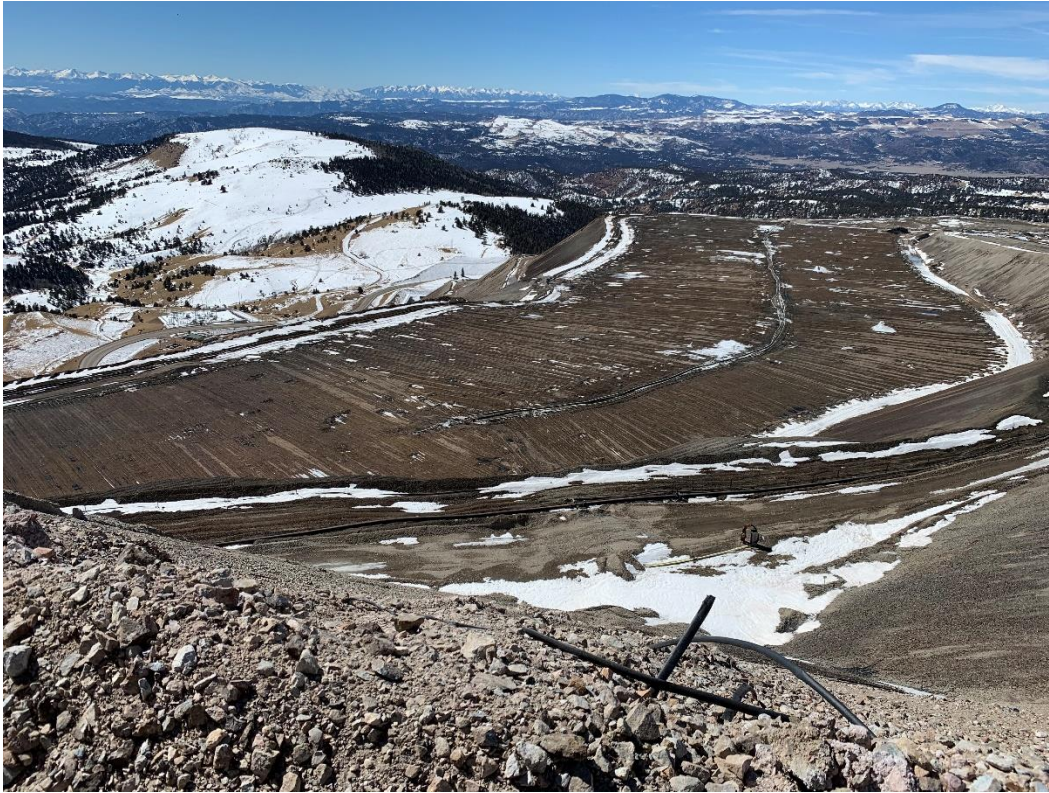
Photo 5 – VLF-2, 10,200 layer
