PERMIT INFORMATION

Permit Number: C-1981-028 Mine Name: Keenesburg Strip Mine Operator: Coors Energy Company Operator Address: Mr. Ben Moline PO Box 4030 Golden, CO 80402 **County:** Weld **Operation Type:** Surface **Permit Status:** Permanent Cessation **Ownership:** Private

INSPECTION INFORMATION

Inspection Start Date: April 6, 2022 Inspection Start Time: 09:50 Inspection End Date: April 6, 2022 Inspection End Time: 11:00			Inspection Type: Coal Partial Inspection Inspection Reason: Normal I&E Program Weather: Windy		
Joint Inspection Agency:		Joint Inspection Contacts:			
None					
Post Inspection Agency:		Post Inspection Contacts:			
None					
Inspector(s):	Inspecto	r's Sig	nature:	Signature Date:	
Robert Zuber, P.E.			Pher	+ D. 24	
			4/9	/2022

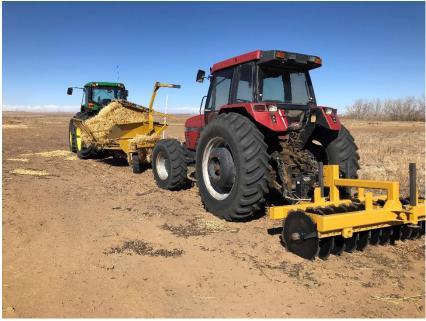
Equipment was seen by the entrance, and large straw bales (and a dozer to move them) were seen at the west end of the Long Term Spoil Area.

Tractor with disking implement and another tractor used for placing straw

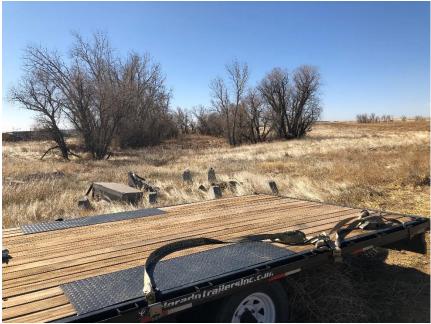
The Dugout Pond contained little to no water (thick vegetation obscures the bottom). It was not discharging during the inspection. There were no signs that it had discharged recently. No problems were observed.

Dugout Pond spillway behind trailer

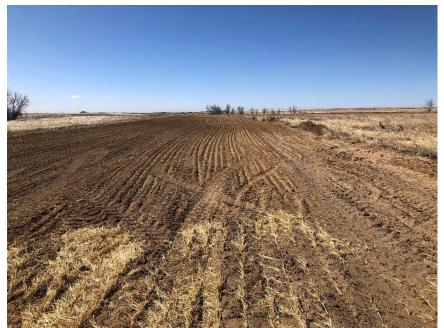
Recently reclaimed road by Dugout Pond

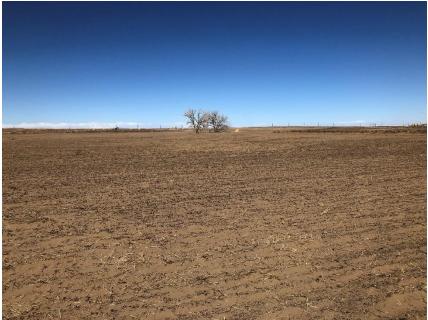
Recent reclamation at Long Term Spoil Area and Area 42

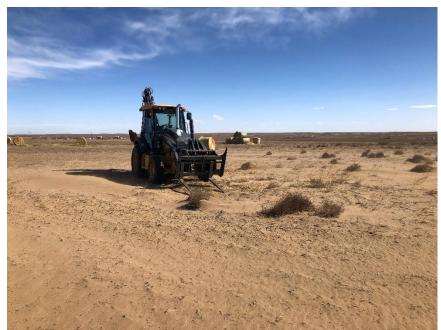
Bales on west side of Long Term Spoil Area

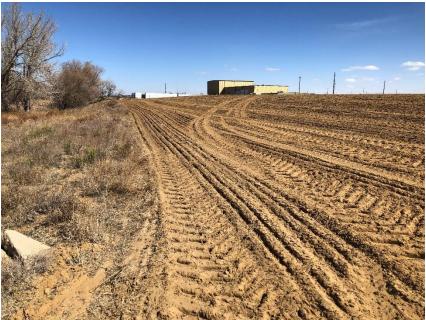
Near the southeast corner of the Dugout Pond, the relatively steep hill (where a topsand pond existed in past years) was stable.

Reclamation southeast of Dugout Pond
