MINERALS PROGRAM INSPECTION REPORT

MINE NAME: Lemoine Gravel Pit	MINE/PROSPECTING ID#: M-1979-140	MINERAL: Sand and gravel	COUNTY: Delta
INSPECTION TYPE: Surety Release Inspection	INSPECTOR(S): Clayton Wein	INSP. DATE: March 22, 2022	INSP. TIME: 11:30
OPERATOR: Delta County	OPERATOR REPRESENTATIVE: Tim McCracken	TYPE OF OPERATION: 112c - Construction Regular Operation

REASON FOR INSPECTION: Surety Release Requested	BOND CALCULATION TYPE: None	BOND AMOUNT: \$0.00
DATE OF COMPLAINT: NA	POST INSP. CONTACTS: None	JOINT INSP. AGENCY: None
WEATHER: Cloudy	INSPECTOR'S SIGNATURE: 	SIGNATURE DATE: April 11, 2022

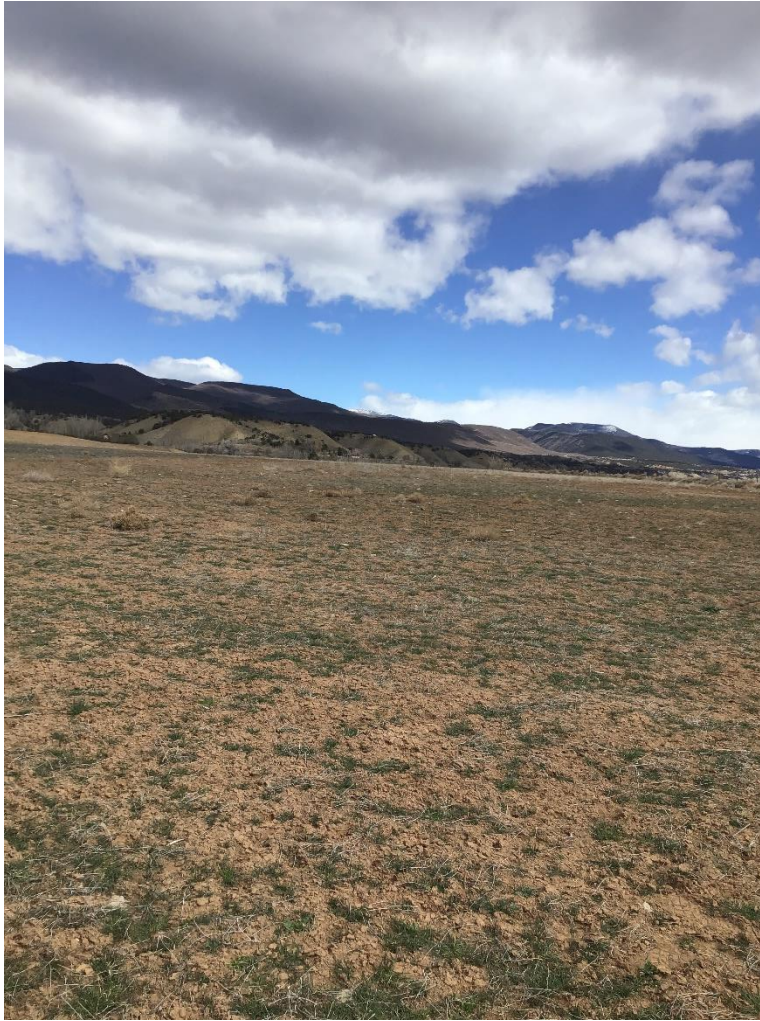
Photo 1: The southwestern portion of the permitted area (reseeded in 2011). The photo was taken looking to the northeast.

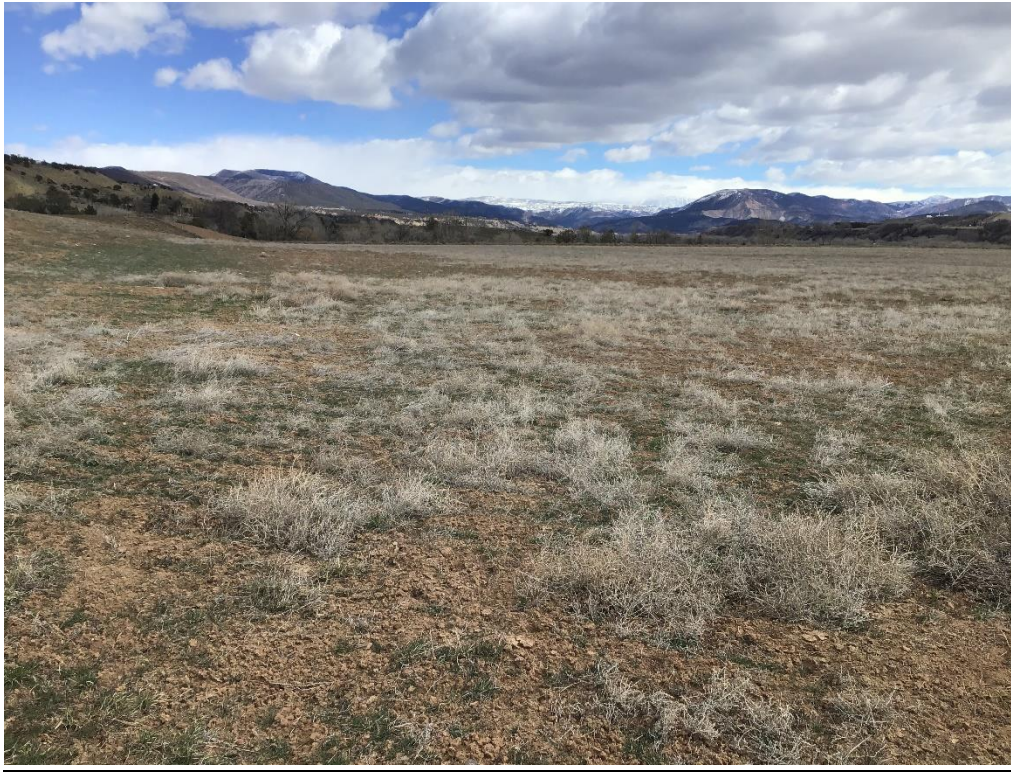
Photo 2: The northeastern portion of the permit area (reseeded in 2019). The photo was taken looking to the northeast. Knapweed was present in this location.

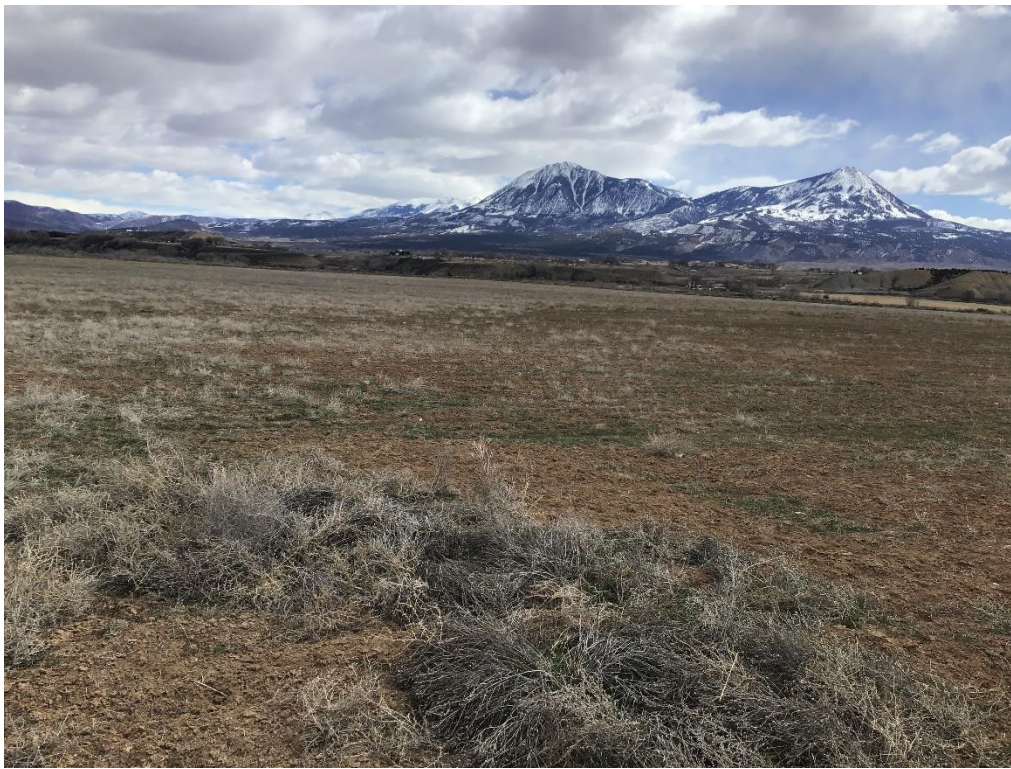
Photo 3: The northeastern portion of the permit area (reseeded in 2019). The photo was taken looking to the east. Knapweed was present in this location.

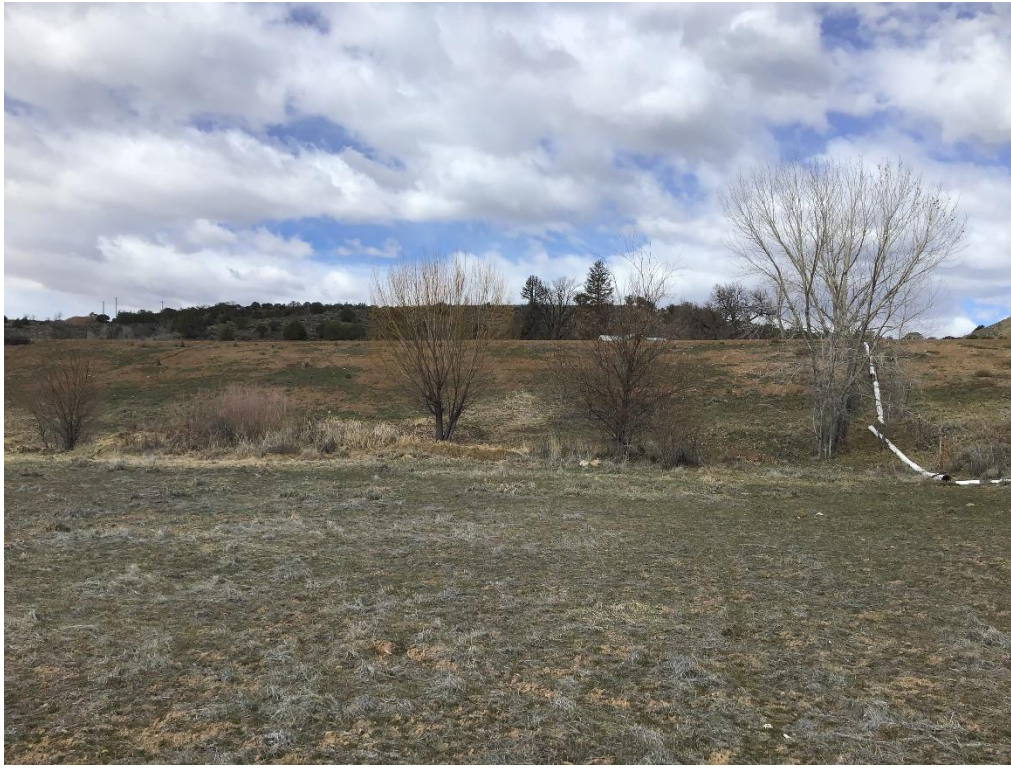
The post mining land use for the Lemoine Pit is pastureland. The mine site has been completely returned to the final contours approved in the reclamation plan. The site has a gentle slope to the south-southwest. The northern portion of the site has a reclaimed slope that was graded to 3:1. Vegetation observed on the southwestern portion of the site was beginning to green; however, not much growth has occurred (Photo 1). The inspection took place at the beginning of the spring. Vegetation at the site has not had time yet to mature. The southwestern portion of the site was reseeded in 2011. There appeared to be consistent vegetative cover in this area from the previous growing season. The site was stable and there were no erosional features observed. **The Division recommends another growing season to allow more time for mature vegetative cover on the western portion of the site.** The northeastern portion of the site was reseeded in 2019. This area was beginning to green for the spring as well. The vegetative cover from the previous growing season was observed to be consistent with its coverage of the reclaimed area. Due to the inspection occurring in the early spring, the vegetation on the northeastern end of the site has not matured (Photo 2 and 3). There were no indications of instability or erosion. **The Division recommends allowing another growing season to allow for mature vegetative cover to establish at the eastern portion of the site.** There was also evidence of knapweed on the eastern portion of the site. **Please use approved weed management practices to control the knapweed on the mine site.** The reclaimed slope at the northern portion of the permitted area had a gradient of roughly 3:1 slopes. The slope was stable with no erosional features observed. The vegetative growth on the slope was observed to be patchy (Photo 4). There were large sections of the reclaimed slope that were barren (Photo 4 and 5). **The Division recommends applying another round of the approved seed mix to the slope. The slope will need to have mature, consistent vegetative cover to meet the requirements of the approved reclamation plan.**

Photo 4: The western end of the reclaimed slope at the northern portion of the permit area. Sections of the slope have patchy vegetative growth.

At this time, from the observations made during the March 22, 2022 Inspection, the Division cannot approve Delta County's request for full and final release of the 33.3 acres and financial warranty of the Lemoine Pit. The Division based this decision on the conditions of the vegetation at the mine site. The vegetation needs additional time to mature and weed control practices need to be implemented to control the knapweed onsite. The reclaimed slope on the northern portion of the permit area needs to be reseeded with the approved seed mix. Consistent vegetative cover on the slope must be established to meet the requirements of the reclamation plan.

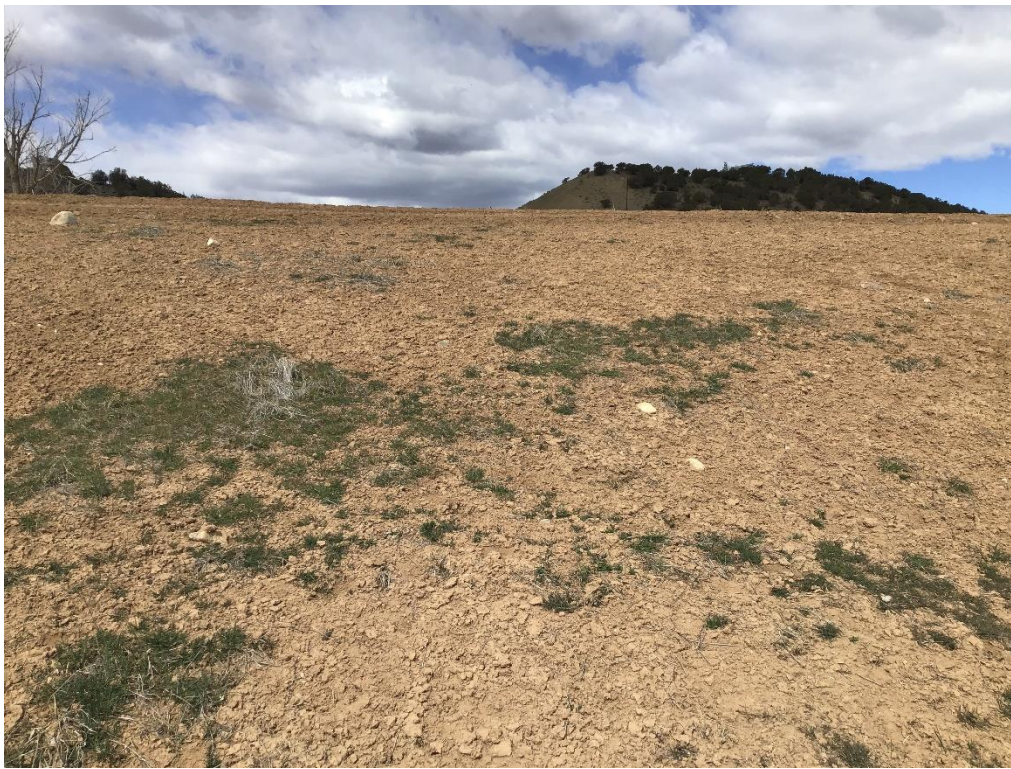
Photo 5: The eastern end of the reclaimed slope at the northern portion of the permit area. Large sections of the slope have barren spots with little to no vegetative cover.
