MINERALS PROGRAM INSPECTION REPORT

MINE NAME: Salt Canyon Project	MINE/PROSPECTING ID#: M-1997-064	MINERAL: Anhydrite, gypsum	COUNTY: Fremont
INSPECTION TYPE: Monitoring	INSPECTOR(S): Timothy Cazier, P.E.	INSP. DATE: March 15, 2022	INSP. TIME: 11:30
OPERATOR: GCC Rio Grande, Inc.	OPERATOR REPRESENTATIVE: Joseph Joshua & Amy Veek	TYPE OF OPERATION: 112c - Construction Regular Operation

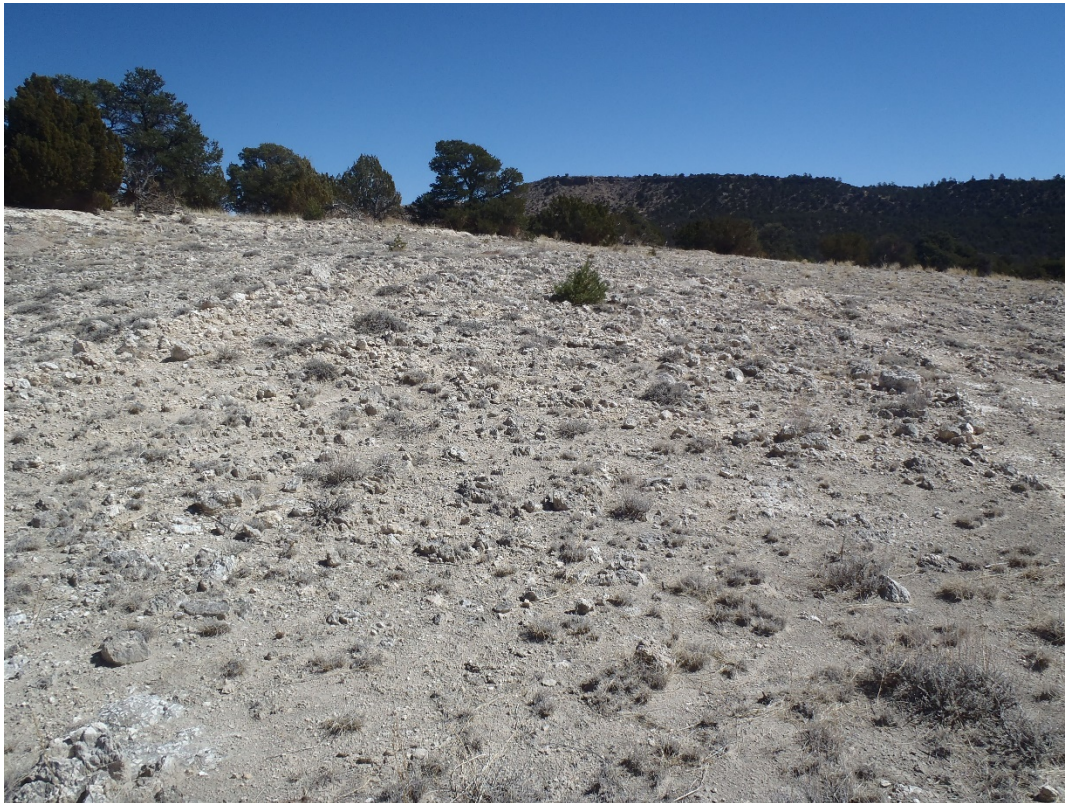
Gen. Compliance with Mine Plan: The operation appears to have exceeded the maximum allowed disturbance of 20 acres at one time. During an onsite discussion, it became clear GCC was not including: the roughly 3.1-acre area disturbed by the previous Permittee (see **Photo 1**) prior to GCC's submittal of the conversion application in 2009; nor the five-acre area designated as reclaimed in their 2021 annual report, as part of the total disturbed area. Mr. Joshua asked about the DRMS definitions for affected, disturbed and reclaimed areas. I emailed these definitions to him on March 22nd. Based on these definition questions, site observations and the 2021 annual report map, the DRMS understands the discrepancies in the reported mine disturbance. However, I explained to GCC while onsite that all past and present disturbed areas are considered disturbed by the DRMS until a formal request for release is received and approved by the DRMS. Mr. Joshua agreed during the inspection to re-measure the disturbed area soon after the inspection, which was provided to the DRMS on April 11th. Based on 2019 Google Earth imagery, the DRMS estimates 15.6 acres had been disturbed by GCC in the northwest and about 3.1 acres (*2.5 acres measured by GCC, which did not include the two access roads into the previously disturbed area*) were disturbed by the previous Permittee just southeast of where newly disturbed area by GCC (*estimated to be 4.9 acres based on a KML file provided by GCC on April 11th and comparing that with the DRMS disturbed area based on 2019 Google Earth imagery*). This totals between 23.2 and 23.8 acres of disturbance. As GCC now understands how the DRMS defines disturbed and reclaimed areas, a technical revision is required to update the mine plan, and subsequently the financial warrantee to account for all current and planned near future disturbance. [The need for an updated mine plan is cited as a problem on p. 1 of this report.](#)

Photo 1. Area disturbed by previous Permittee (looking east from edge of current disturbance).

CORRECTIVE ACTIONS: The operator shall submit a Technical Revision, with the required \$216 revision fee, to update and clarify the current approved mine plan to reflect existing and proposed maximum allowed disturbed area and blasting related activities by the corrective action date.

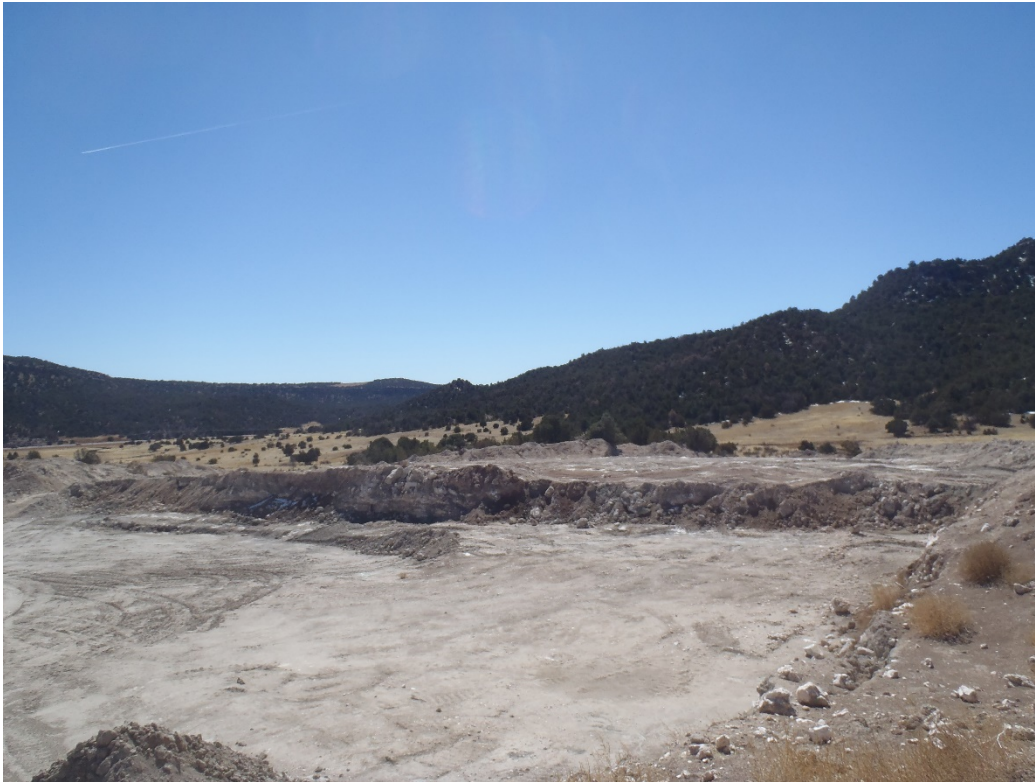
Highwalls were estimated to vary between 8 and 12 feet in height. Some segments were crumbling/sloughing (see **Photo 2**) while others appeared stable (see **Photo 3**).

Photo 2. Active southern highwall (partially crumbling – looking south).

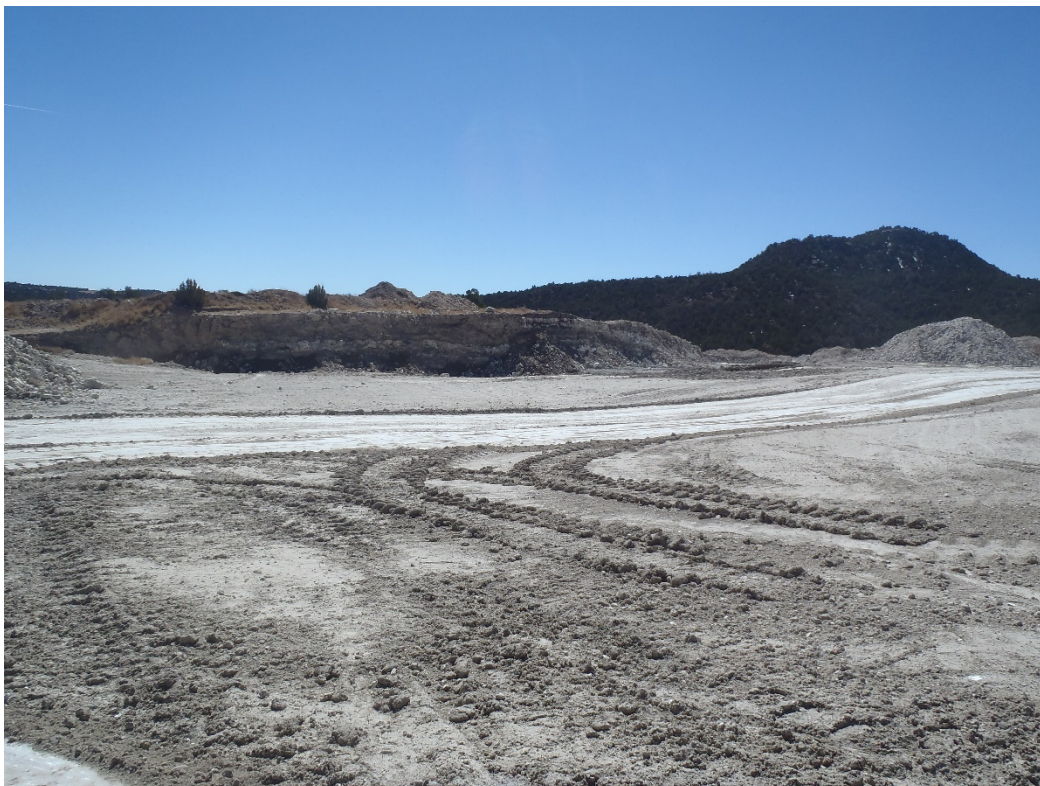
Photo 3. Active eastern highwall (nearly vertical – looking SE from pit floor).

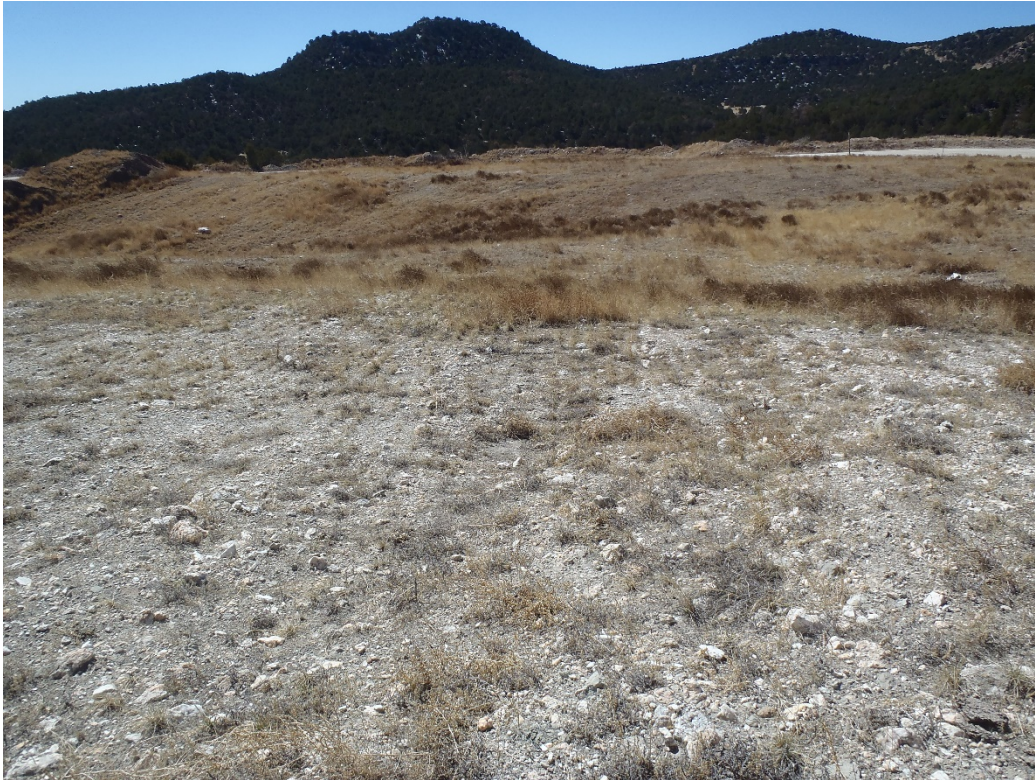
Reclamation Success: Reclamation is well underway in the northwest portion of the affected area. Grading, topsoil replacement and seeding has been completed (see **Photos 4** and **5**).

Photo 4. Northwest reclaimed area (looking south from north side).

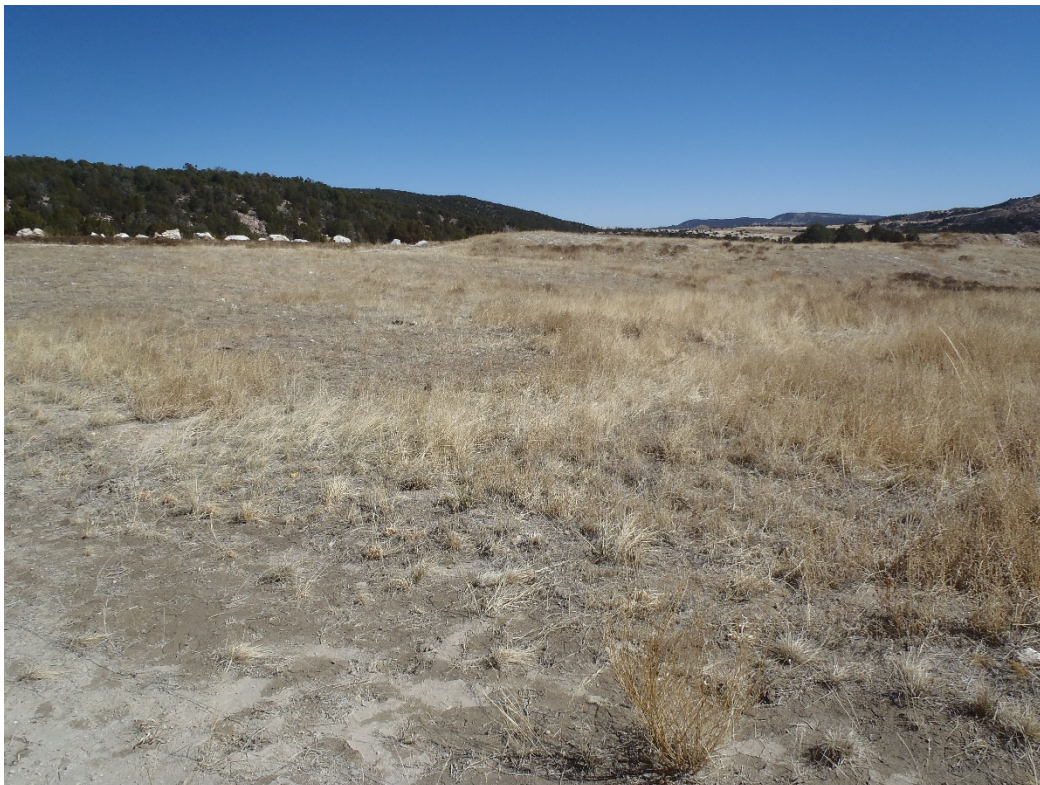
Revegetation: The vegetation in the reseeded northwest area is becoming well established (see **Photo 5**). No noxious weeds were observed.

Photo 5. Northwest reclaimed area (looking SE from west side).

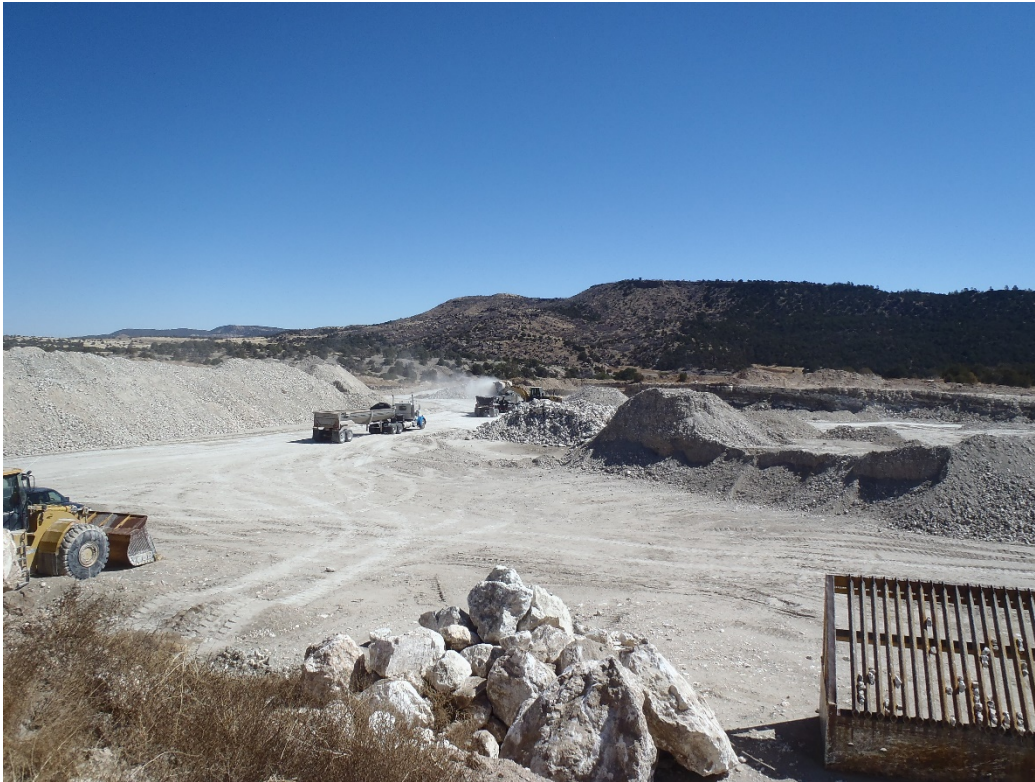
Support Facilities On-site: A grizzly screen, loaders, and dump trucks were observed on site (see **Photo 6**).

Photo 6. Loaders, trucks and grizzly screen on pit floor (looking east).

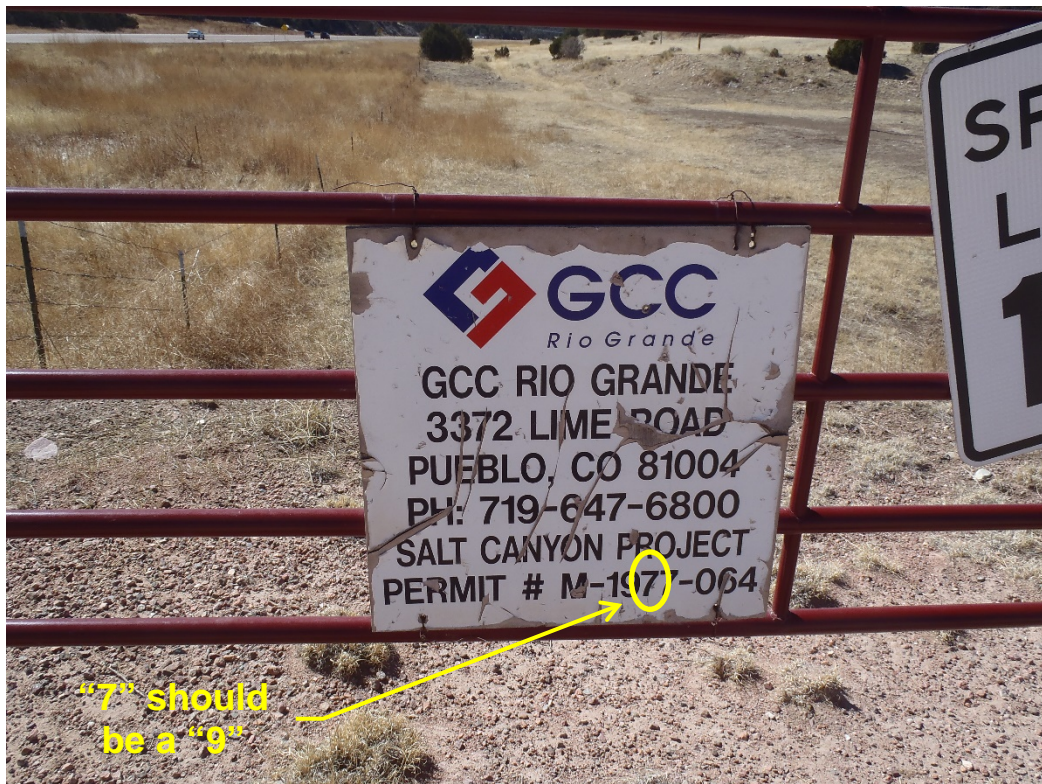
Signs and Markers: The permit sign was properly posted (see **Photo 7**), however the permit number was incorrectly displayed as M-1977-064. It should be M-1997-064. Mr. Joshua emailed the DRMS on March 25th stating a new sign was being procured.

Photo 7. Permit sign at entrance with incorrect ID.
