MINERALS PROGRAM INSPECTION REPORT
PHONE: (303) 866-3567

MINE NAME: Ignacio Pit	MINE/PROSPECTING ID#: M-1977-446	MINERAL: Sand and gravel	COUNTY: La Plata
INSPECTION TYPE: Monitoring	INSPECTOR(S): Lucas West	INSP. DATE: March 9, 2022	INSP. TIME: 16:00
OPERATOR: Hocker Construction, LLP	OPERATOR REPRESENTATIVE: None	TYPE OF OPERATION: 112c - Construction Regular Operation	
REASON FOR INSPECTION: Normal I&E Program	BOND CALCULATION TYPE: Complete Bond	BOND AMOUNT: \$115,646.00	
DATE OF COMPLAINT: NA	POST INSP. CONTACTS: None	JOINT INSP. AGENCY: None	
WEATHER: Clear	INSPECTOR'S SIGNATURE:

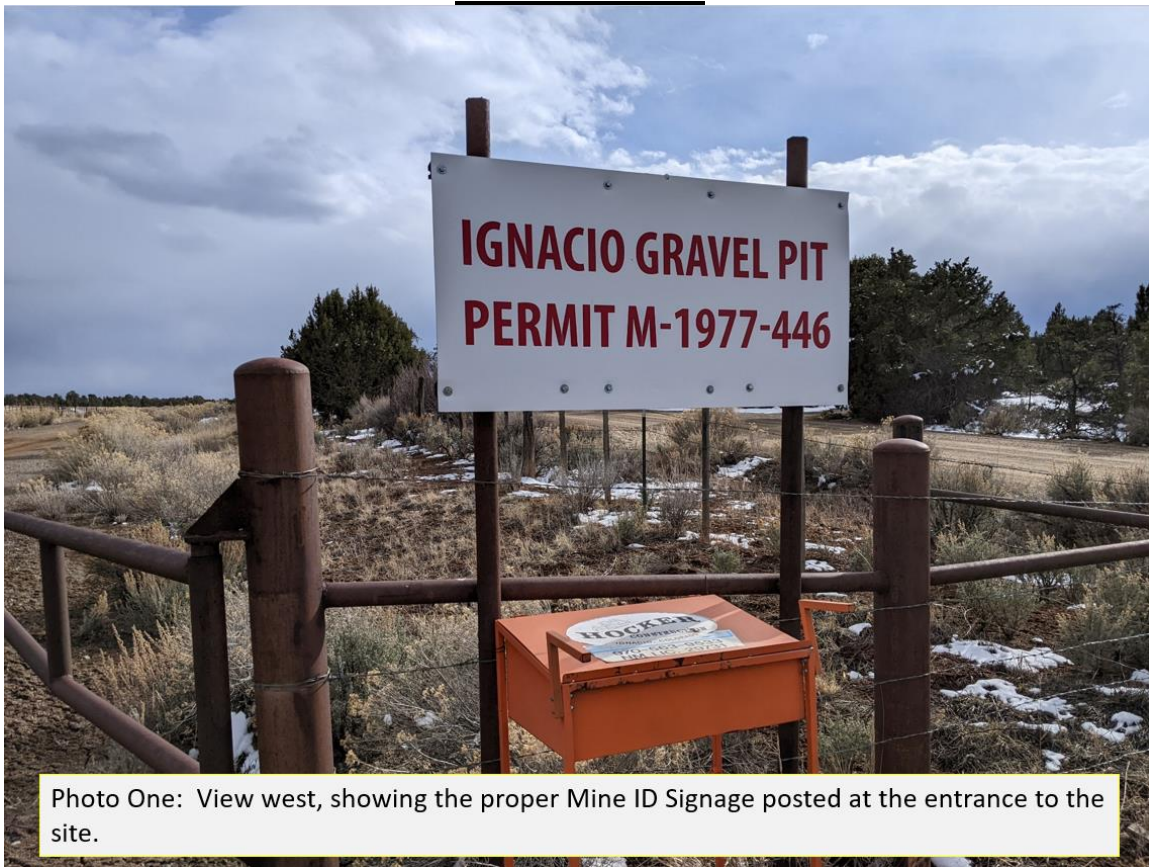
Proper mine identification signage was posted at the entrance to the site, as seen in Photo One. The permit boundaries were clearly outlined with a mixture of T-posts, fence lines and earthen berms. All disturbances are contained within the permitted areas. The condition of the site remains largely unchanged since the Division's previous inspection. The active mining areas consist of a large highwall, which averages approximately 50' tall and is approximately 1200 linear feet in length. Photos Two through Four shows the highwall, which is in good condition and appears to be stable. A significant volume of overburden is stockpiled adjacent to the highwall ready to be used for backfill should the Operator choose to do so. Photo Five shows an example of the large overburden stockpile.

Photo One: View west, showing the proper Mine ID Signage posted at the entrance to the site.

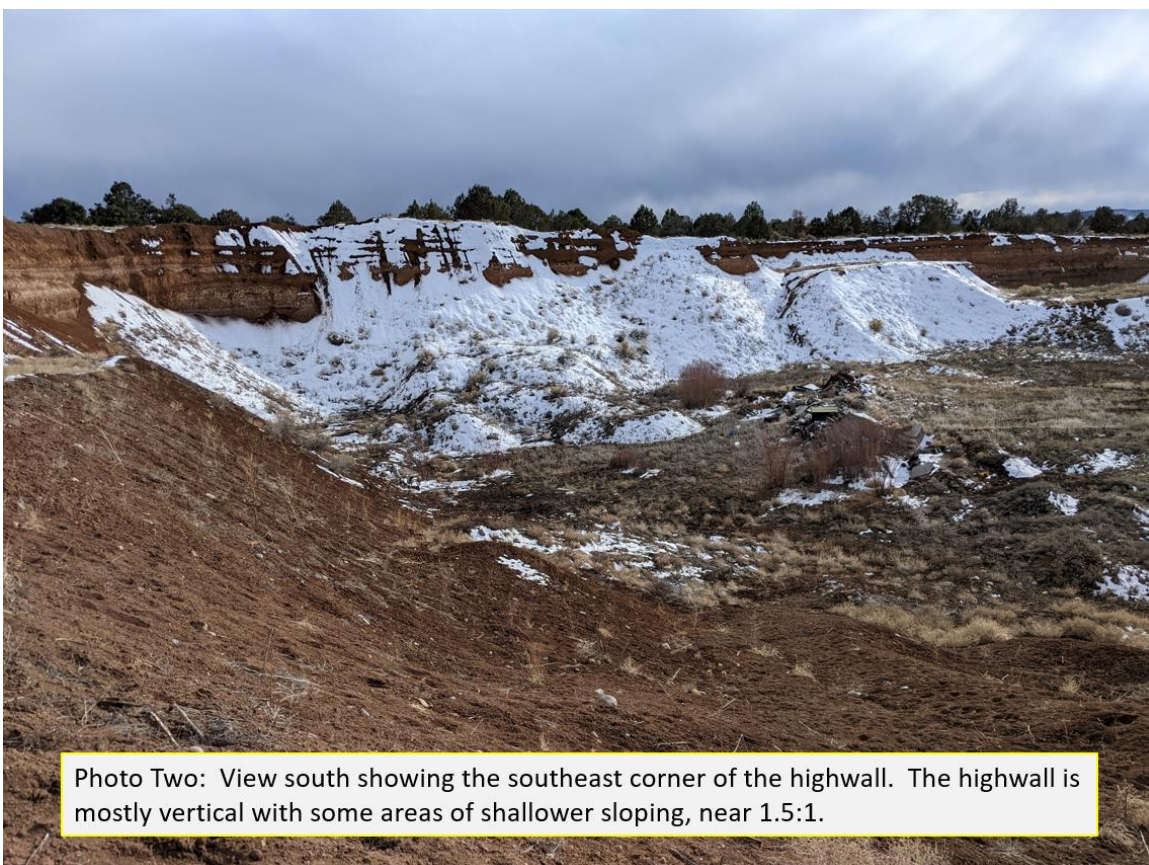
Photo Two: View south showing the southeast corner of the highwall. The highwall is mostly vertical with some areas of shallower sloping, near 1.5:1.

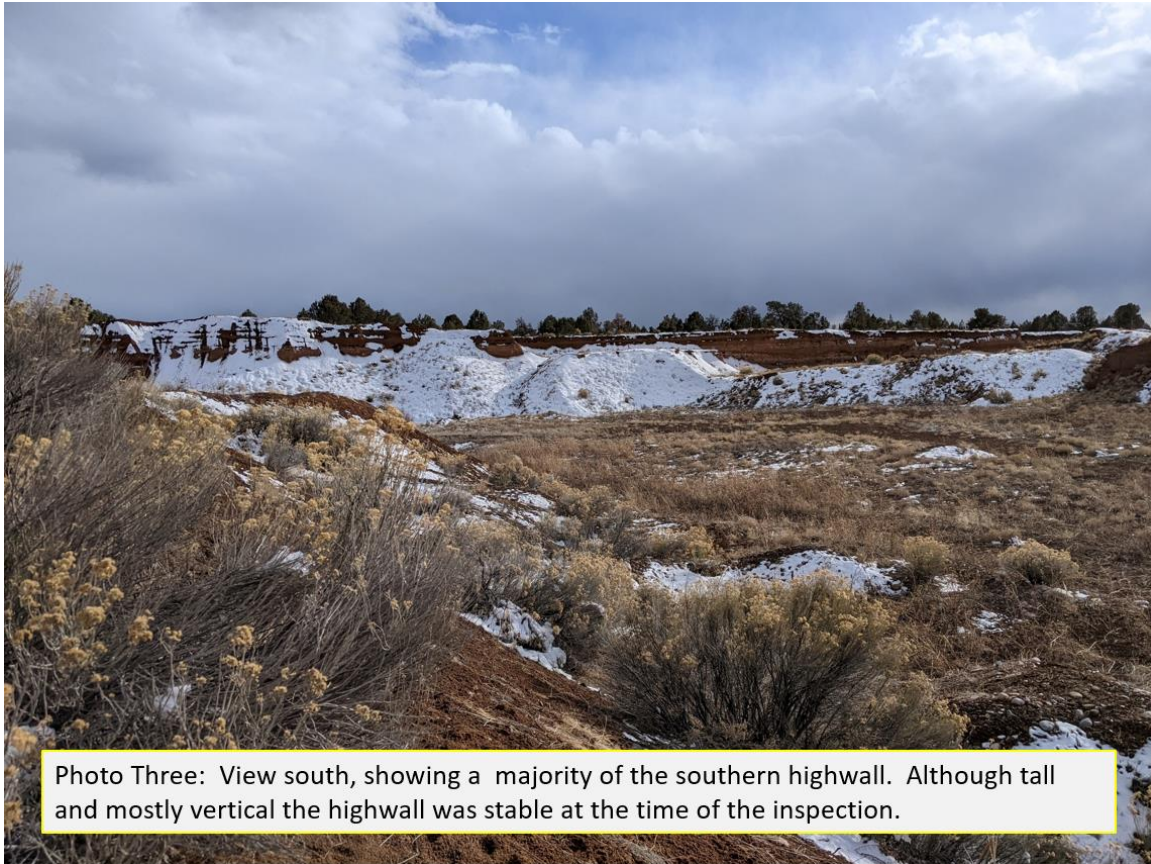
Photo Three: View south, showing a majority of the southern highwall. Although tall and mostly vertical the highwall was stable at the time of the inspection.

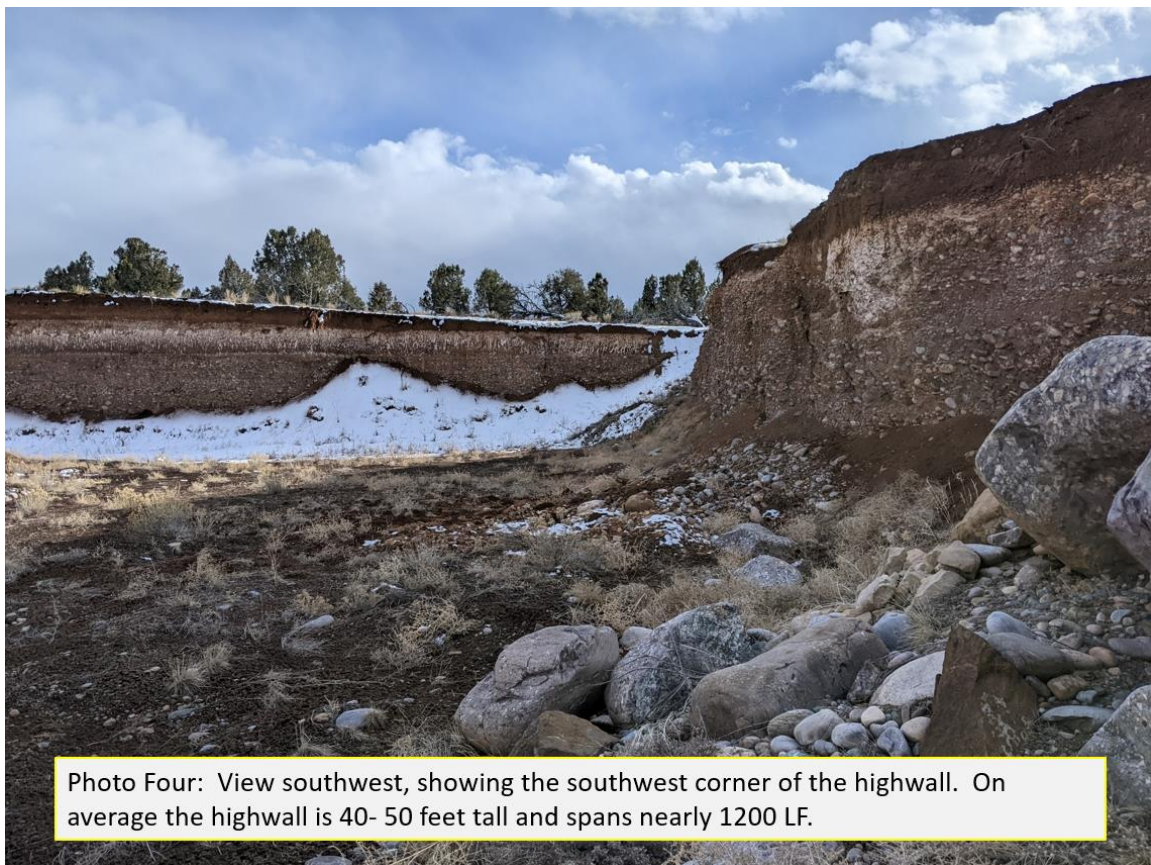
Photo Four: View southwest, showing the southwest corner of the highwall. On average the highwall is 40- 50 feet tall and spans nearly 1200 LF.

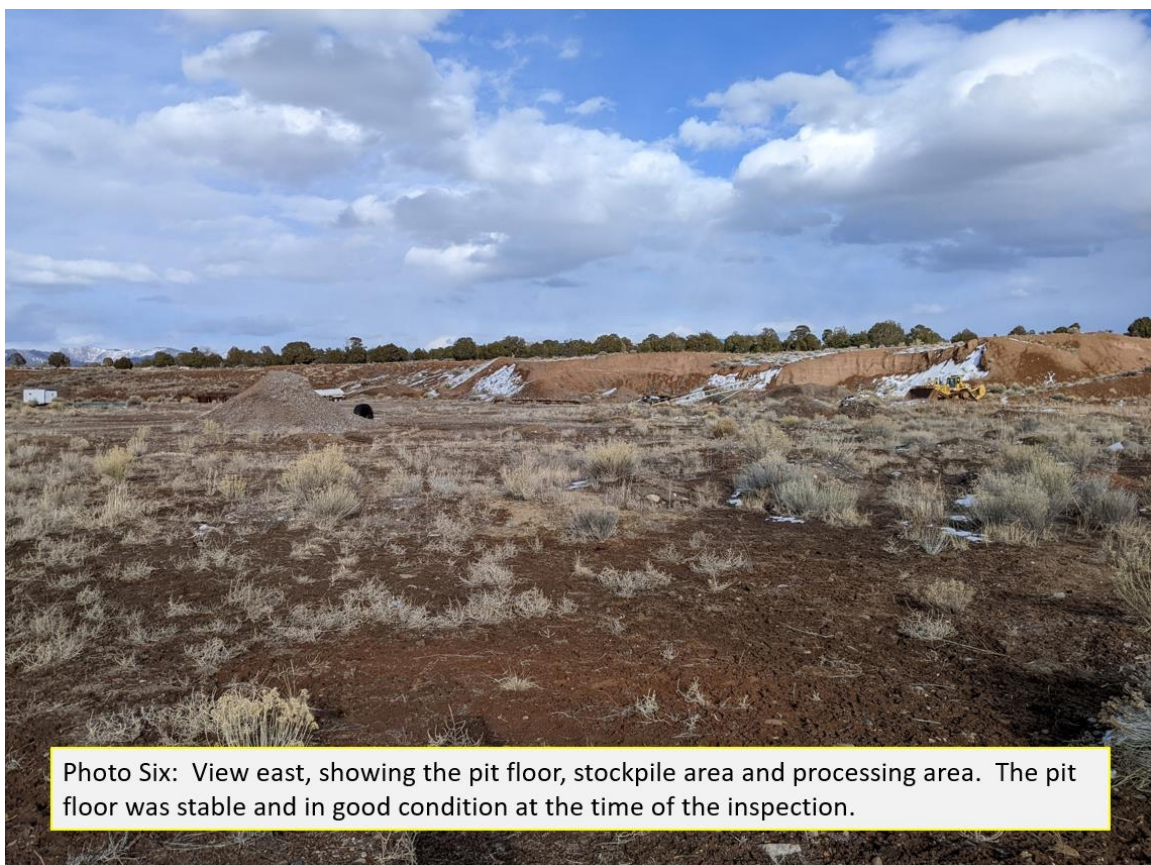
Several stockpiles including topsoil, overburden and various sized material was observed on the pit floor. Evidence of recent hauling from the stockpiles was noted. All stockpiles are in good condition and appear to be stable. . Although the site was not active during the inspection, several pieces of equipment were on site. An area of the site is also being used as storage for trailers and various scrap items, which are being stored in a neat and orderly fashion. This is not being considered a problem at this time. The Pit Floor and stockpile area can be seen in Photo Six.
