MINERALS PROGRAM INSPECTION REPORT
PHONE: (303) 866-3567

MINE NAME: Hocker Gravel Pit	MINE/PROSPECTING ID#: M-2004-063	MINERAL: Sand and gravel	COUNTY: La Plata
INSPECTION TYPE: Monitoring	INSPECTOR(S): Lucas West	INSP. DATE: March 9, 2022	INSP. TIME: 16:42
OPERATOR: Hocker Construction, LLP	OPERATOR REPRESENTATIVE: None	TYPE OF OPERATION: 112c - Construction Regular Operation	
REASON FOR INSPECTION: Normal I&E Program	BOND CALCULATION TYPE: Complete Bond	BOND AMOUNT: \$26,676.00	
DATE OF COMPLAINT: NA	POST INSP. CONTACTS: None	JOINT INSP. AGENCY: None	
WEATHER: Clear	INSPECTOR'S SIGNATURE:

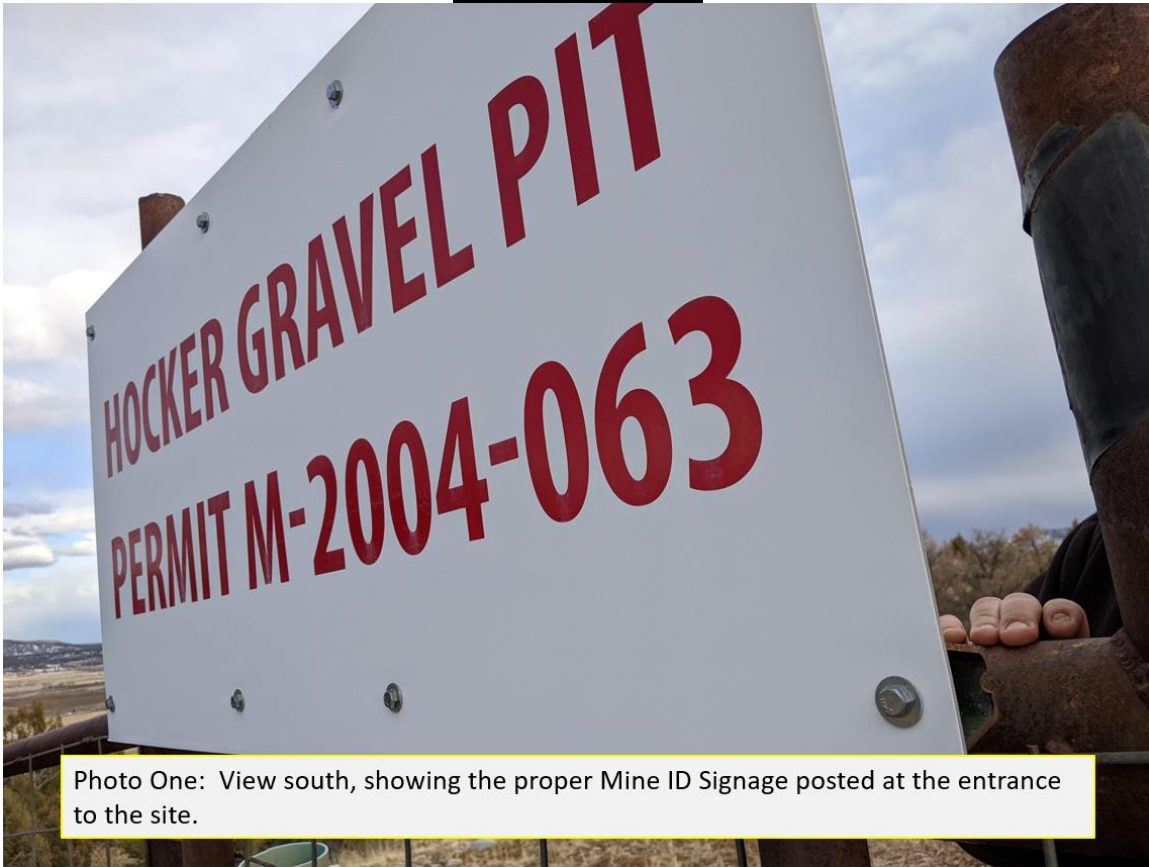
Proper mine identification signage was posted at the entrance to the site, as seen in Photo One. The permit boundaries were clearly outlined with a mixture of T-posts, fence lines and earthen berms. All disturbances are contained within the permitted areas. The site is in similar condition to the Division's Previous Inspection. The active mining area located in phase two appeared to be stable and in good condition. The mining activity has left the slopes at approximately 3H: 1V or shallower and all slopes appear to be stable. Photo Two shows the area of activity. Several stockpiles of overburden was observed on the pit floor. All stockpiles are in good condition and appear to be stable. Photo Three shows some of the stockpiles which are well vegetated with volunteer species. Material stockpiles area noted adjacent to the haul road that runs through the site and topsoil stockpiles are located at various locations throughout the site. Although the site was not active during the inspection, several pieces of equipment were on site. An area of the site is also being used as storage for trailers and various scrap items, which are being stored in a neat and orderly fashion. This is not being considered a problem at this time.

Photo One: View south, showing the proper Mine ID Signage posted at the entrance to the site.

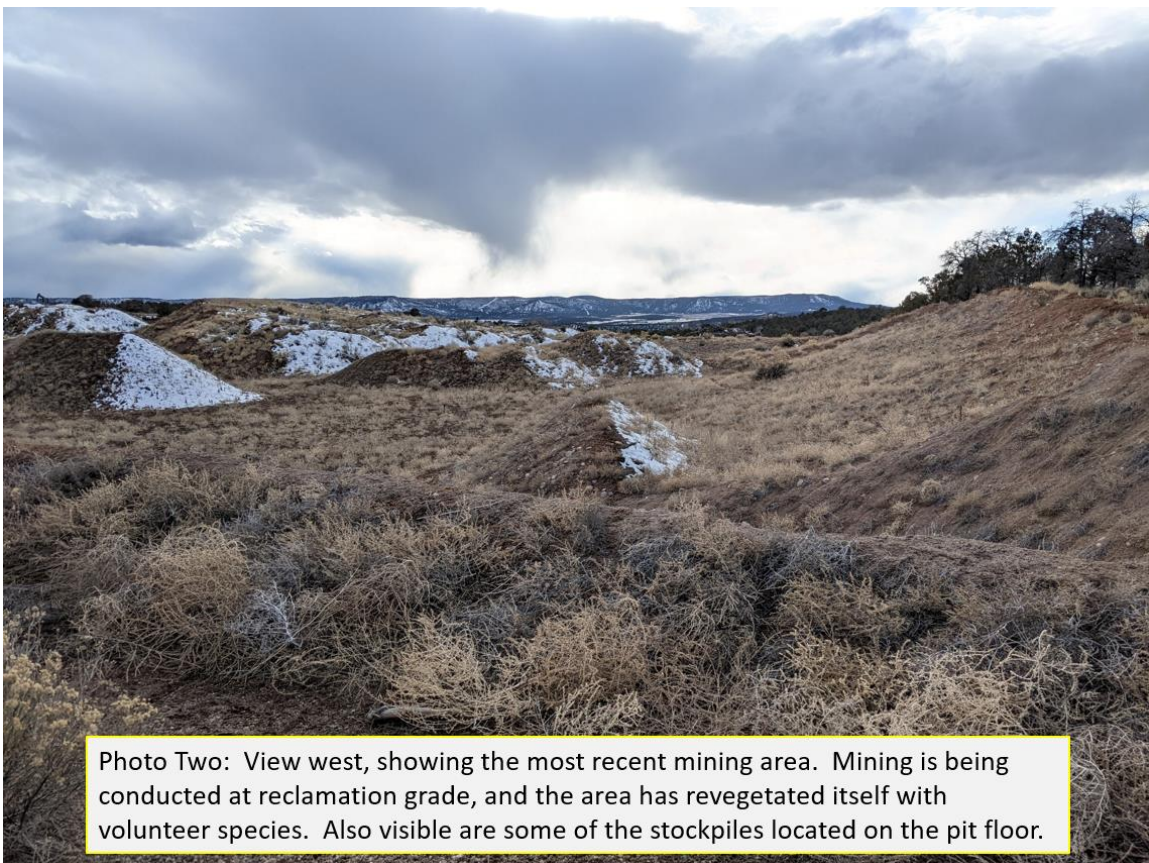
Photo Two: View west, showing the most recent mining area. Mining is being conducted at reclamation grade, and the area has revegetated itself with volunteer species. Also visible are some of the stockpiles located on the pit floor.

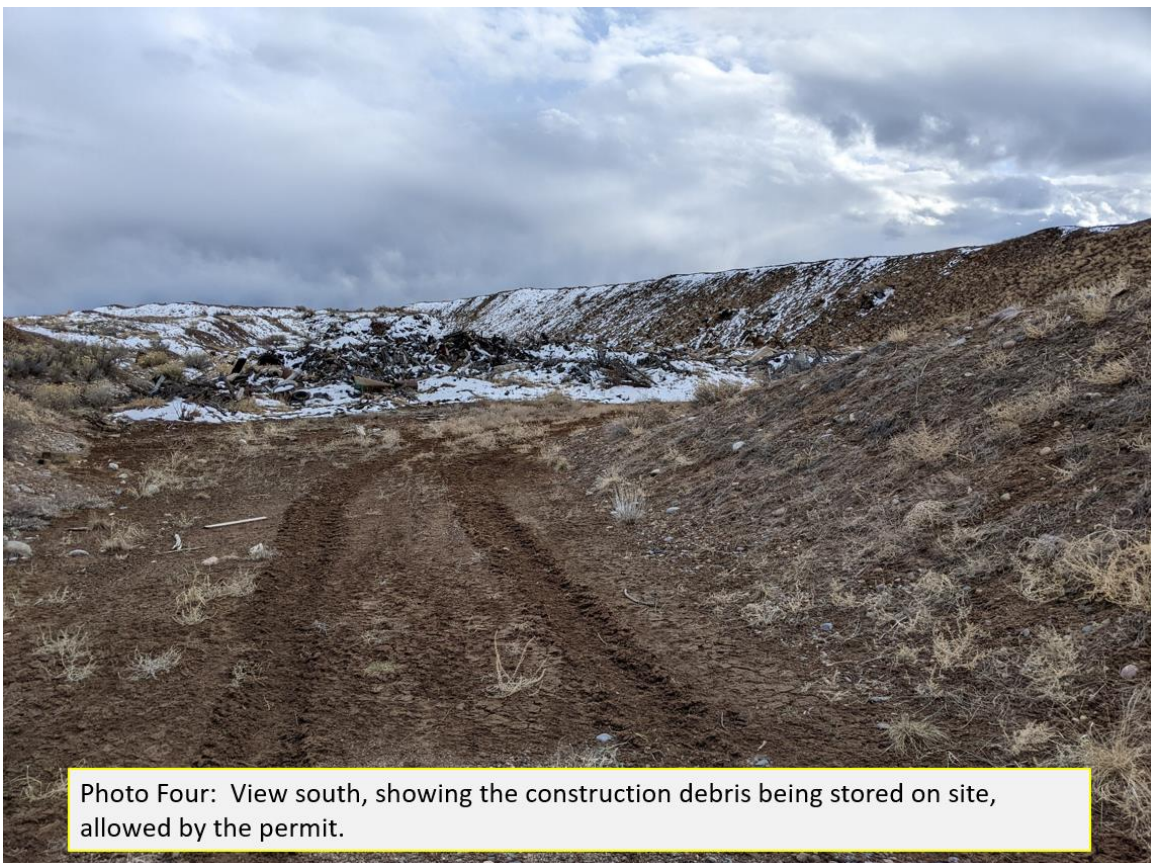
Two areas within the site are being used for storage of construction debris. A Technical Revision was completed to allow for the importation and on site disposal of the material. Photo Four shows the area containing the debris. On site discussions with the operator indicate that he intends to recycle the metal in both areas, which includes protruding rebar from the concrete, prior to covering the piles with an earthen cap. The earthen cap will also be top soiled and revegetated upon final reclamation.
