## MINERALS PROGRAM INSPECTION REPORT

<b>MINE NAME:</b> Hubbs Pit	<b>MINE/PROSPECTING ID#:</b> M-1987-088	<b>MINERAL:</b> Sand and gravel	<b>COUNTY:</b> La Plata
<b>INSPECTION TYPE:</b> Monitoring	<b>INSPECTOR(S):</b> Lucas West	<b>INSP. DATE:</b> March 16, 2022	<b>INSP. TIME:</b> 14:35
<b>OPERATOR:</b> Hubbs III, LLC	<b>OPERATOR REPRESENTATIVE:</b> Leslie Jakoby	<b>TYPE OF OPERATION:</b> 112c - Construction Regular Operation	
<b>REASON FOR INSPECTION:</b> Normal I&E Program		<b>BOND CALCULATION TYPE:</b> Complete Bond	
<b>DATE OF COMPLAINT:</b> NA		<b>BOND AMOUNT:</b> \$59,905.00	
<b>POST INSP. CONTACTS:</b> None		<b>JOINT INSP. AGENCY:</b> None	
<b>WEATHER:</b> Clear	<b>INSPECTOR'S SIGNATURE:</b>

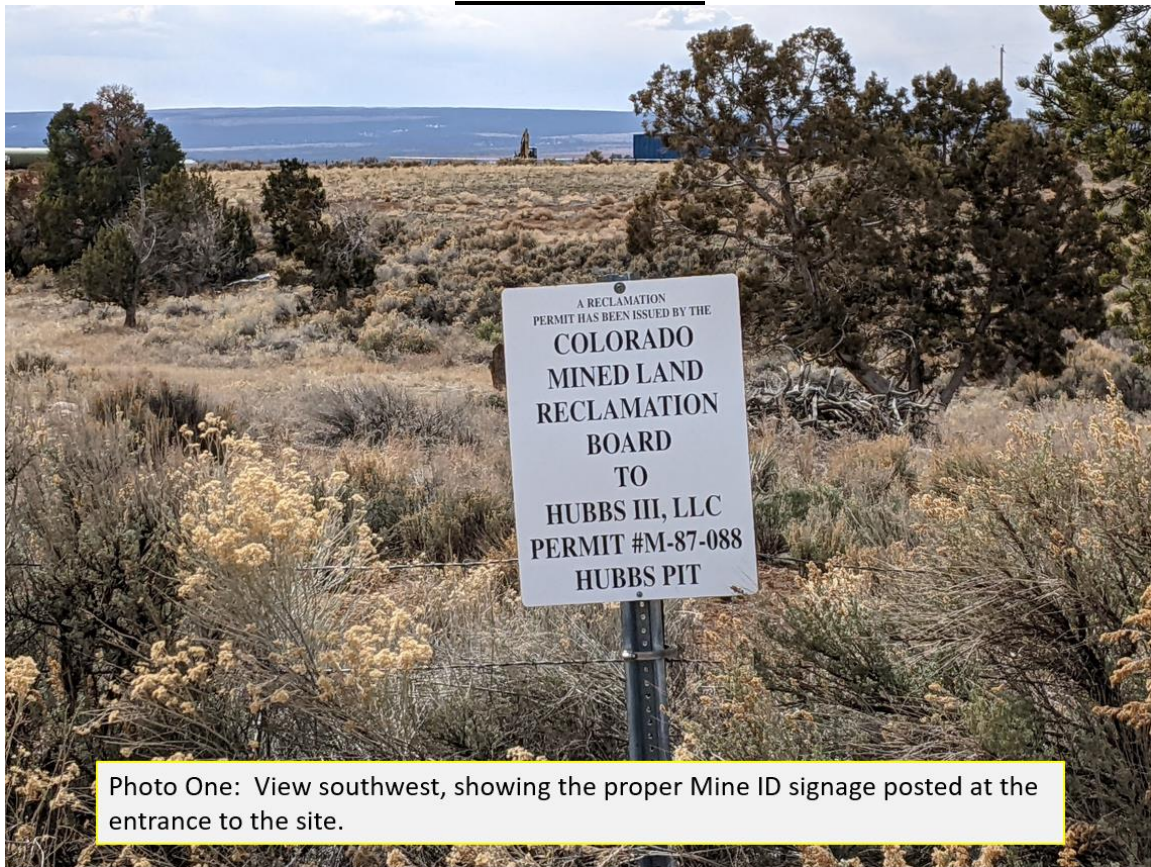
Proper mine identification signage was posted at the entrance to the site and is shown in Photo One. The permitted area was clearly outlined with a barbed wire fence encompassing the entire site. All disturbances were confined within the permitted boundaries. The permitted area is split up into three phases of mining. Phases one, two and part of three have been mined out with the majority of the mining activity taking place in the northern section of phase three. Photos two and Three shows the active mining area of phase three which consists of a highwall approximately 10 feet tall on average and stretching an estimated 1,000 linear feet in a semicircle shape at the north end of the pit. The highwall appears to be stable and is in good condition. Several stockpiles were located on the pit floor including a reject fines, overburden and topsoil stockpiles. Examples of the stockpiles are shown in Photos Four and Five. All stockpiles observed appeared to be stable and in good condition.

Photo One: View southwest, showing the proper Mine ID signage posted at the entrance to the site.

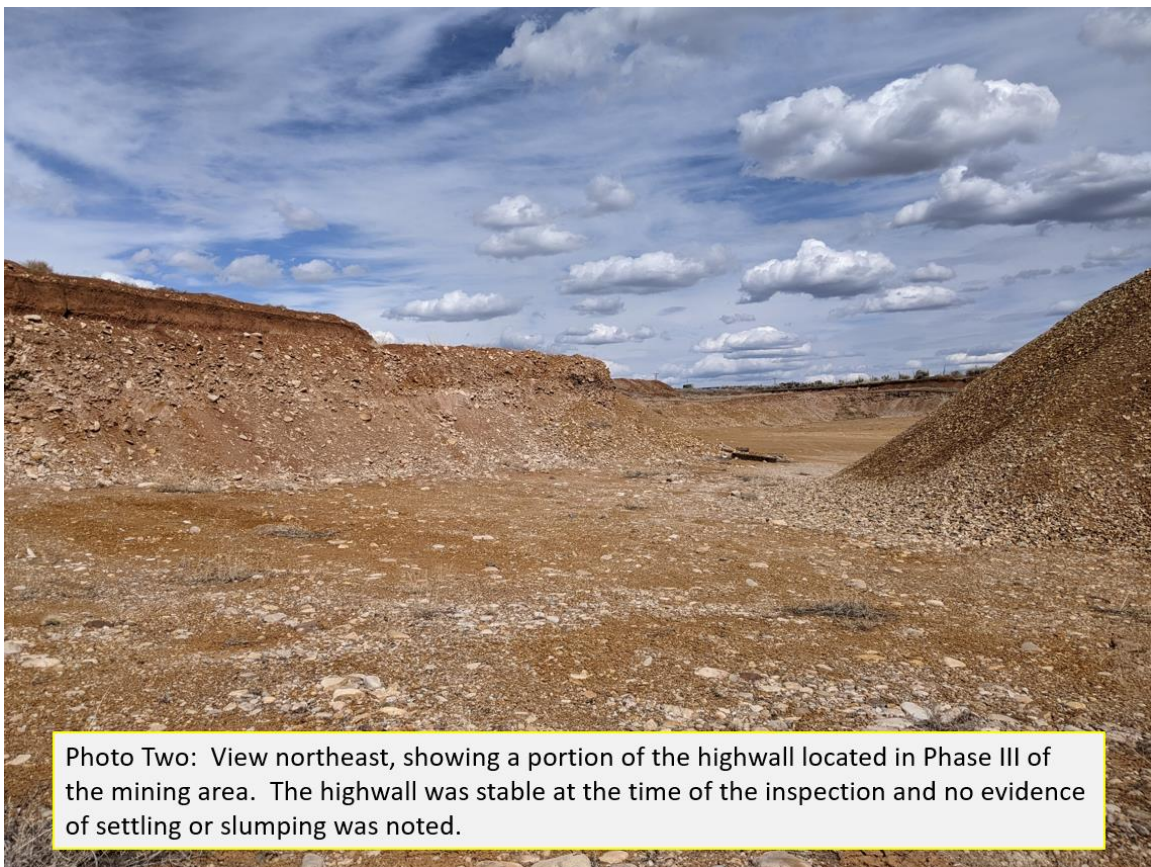
Photo Two: View northeast, showing a portion of the highwall located in Phase III of the mining area. The highwall was stable at the time of the inspection and no evidence of settling or slumping was noted.

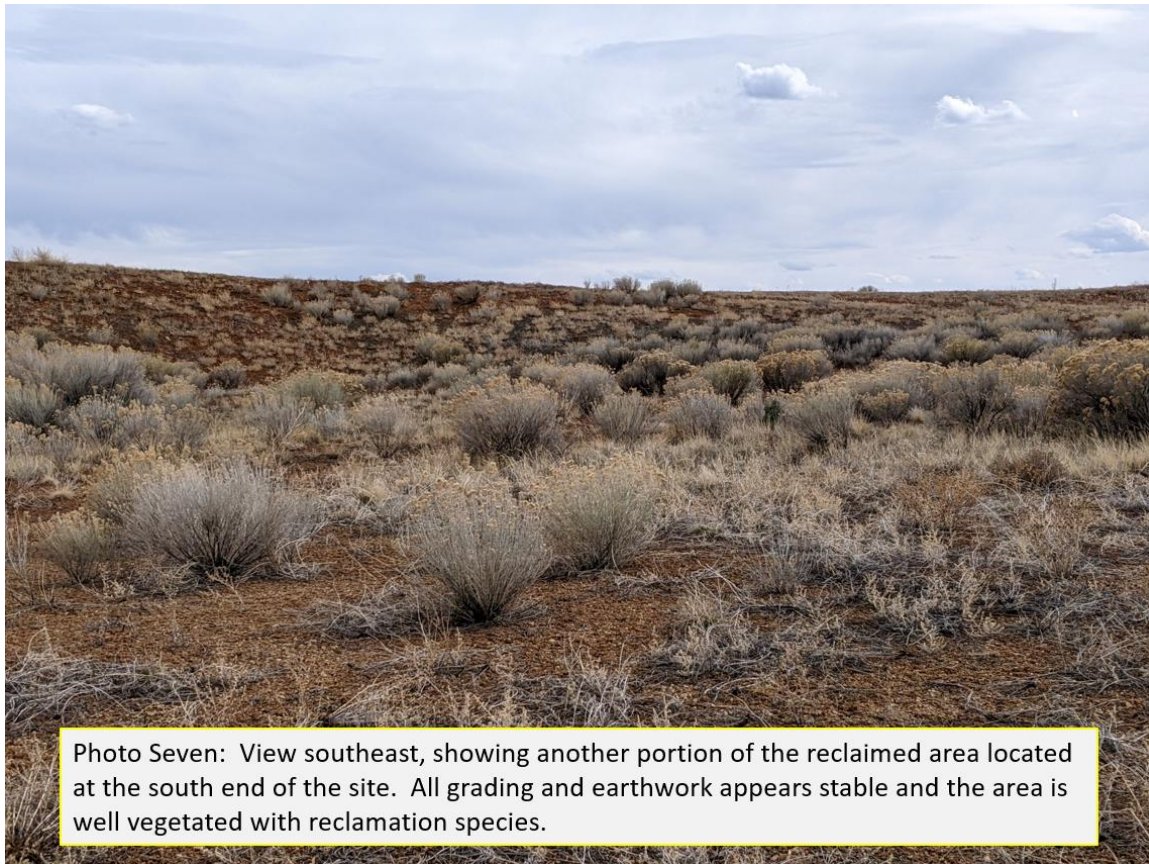
Photo Seven: View southeast, showing another portion of the reclaimed area located at the south end of the site. All grading and earthwork appears stable and the area is well vegetated with reclamation species.
