MINERALS PROGRAM INSPECTION REPORT
PHONE: (303) 866-3567

MINE NAME: Marvel Pit	MINE/PROSPECTING ID#: M-1977-575	MINERAL: Sand and gravel	COUNTY: La Plata
INSPECTION TYPE: Monitoring	INSPECTOR(S): Lucas West	INSP. DATE: March 16, 2022	INSP. TIME: 13:47
OPERATOR: La Plata County	OPERATOR REPRESENTATIVE: Leslie Jakoby	TYPE OF OPERATION: 110c - Construction Limited Impact	
REASON FOR INSPECTION: Normal I&E Program	BOND CALCULATION TYPE: None	BOND AMOUNT: \$0.00	
DATE OF COMPLAINT: NA	POST INSP. CONTACTS: None	JOINT INSP. AGENCY: None	
WEATHER: Clear	INSPECTOR'S SIGNATURE:

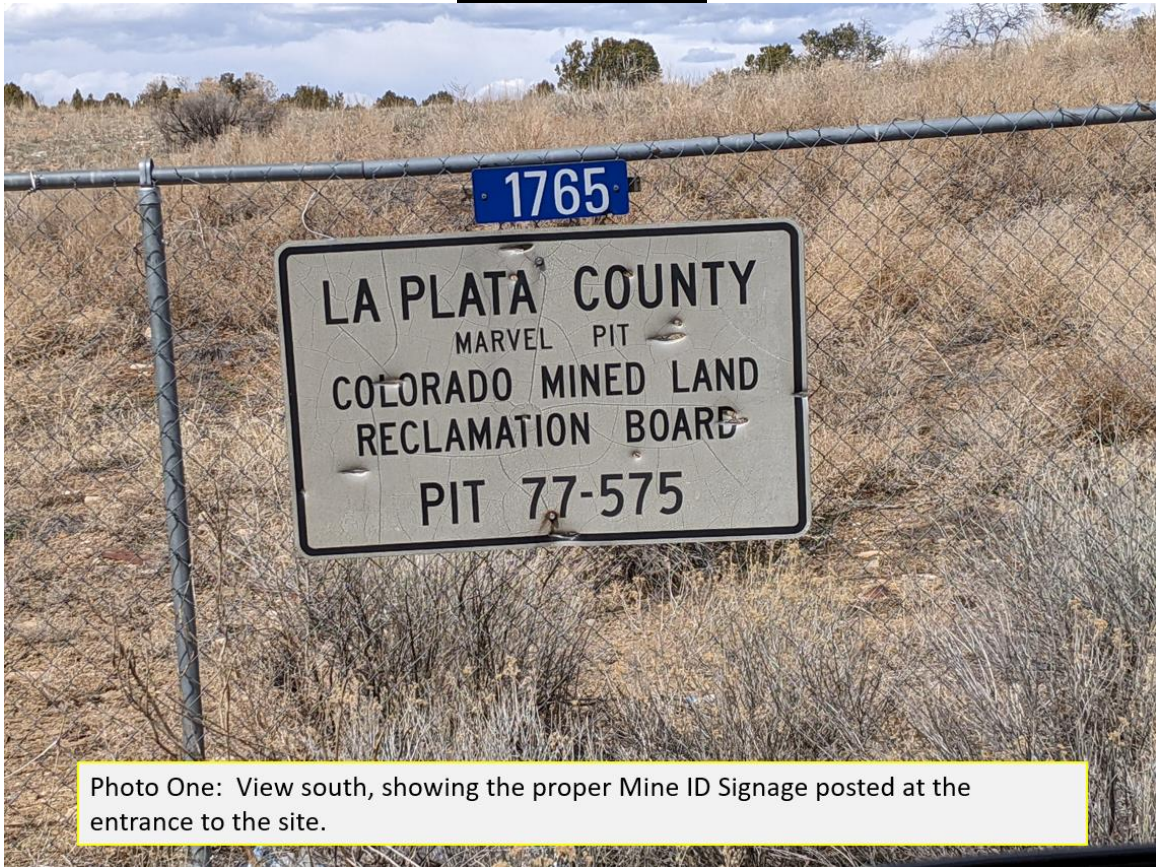
Proper mine identification signage was posted at the entrance to the site, as shown in Photo One. The permit boundaries were clearly marked with fences and earthen berms. Of the 6 permitted acres approximately three acres have been disturbed. All disturbances are within the permitted boundaries. The site was not active during the inspection and no equipment was on site. The site is operated on an as needed basis. Various small stockpiled material was observed on the pit floor. All stockpiles are small and appear to be stable. The topsoil and overburden stockpiles are located in the Southwest corner of the permitted area and are well vegetated and appear to be stable as well. Photo Two shows the topsoil stockpile. The active mining area, shown in Photo Three, consists of a highwall approximately 12 feet tall and 300 feet in length and appears to be stable.

Photo One: View south, showing the proper Mine ID Signage posted at the entrance to the site.

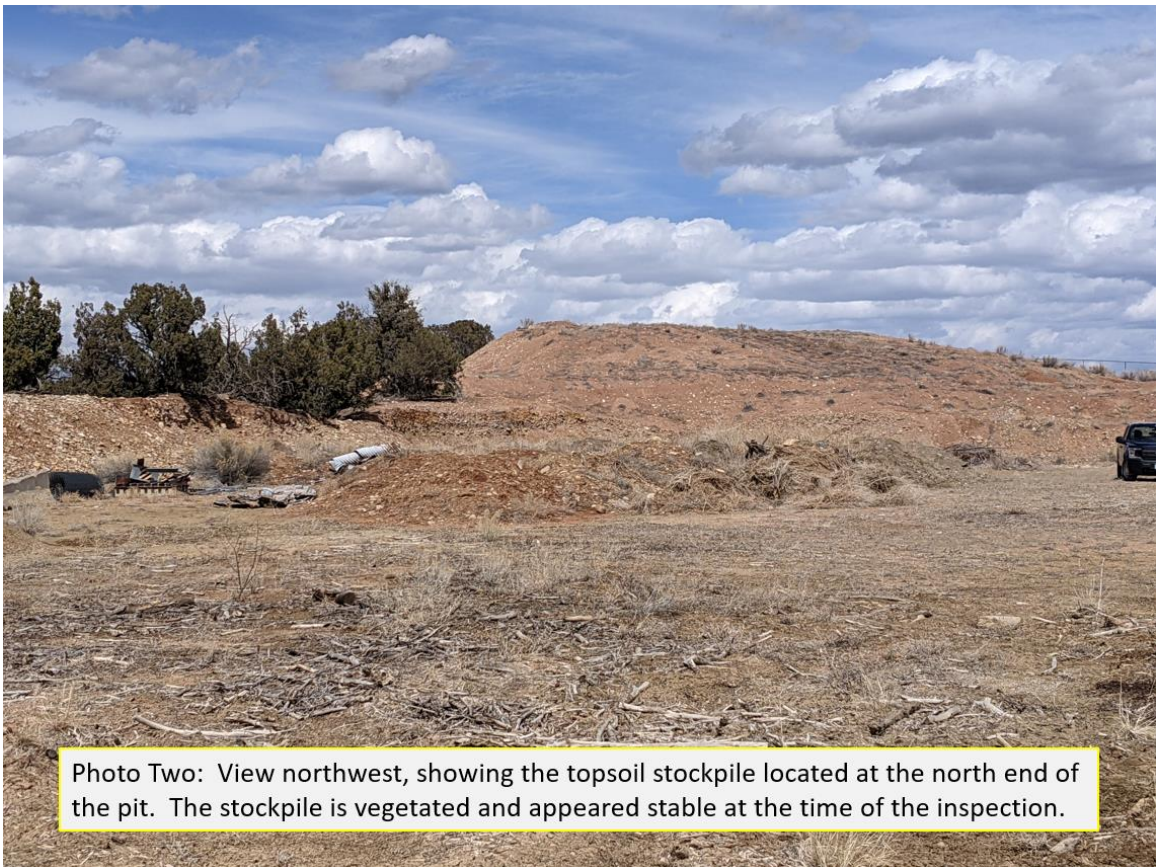
Photo Two: View northwest, showing the topsoil stockpile located at the north end of the pit. The stockpile is vegetated and appeared stable at the time of the inspection.

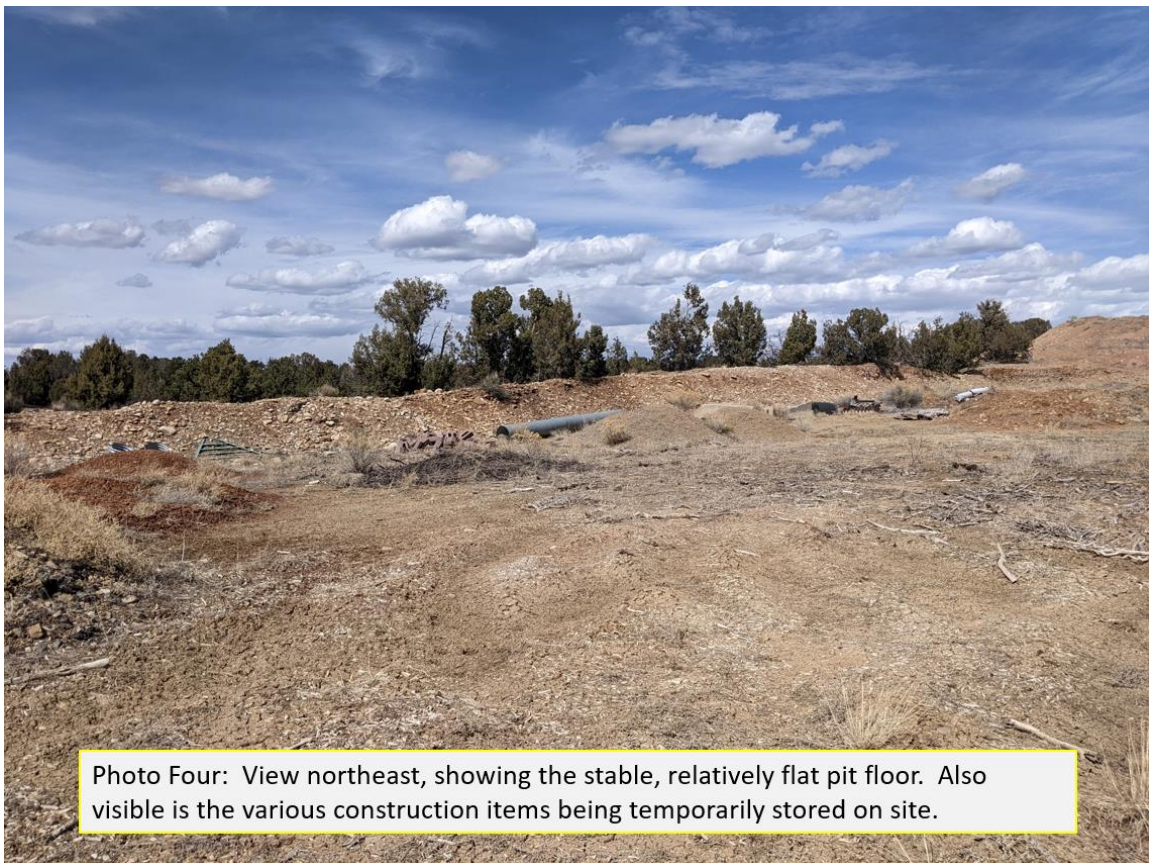
The pit floor is relatively flat and appears to be stable as shown in Photo Four. Several small piles of brush and other deleterious material is located on the pit floor. The operator expressed that they temporarily store brush here until the chipping crew can process and remove the material or the material can be burned on site. A small area of the pit floor is being used as a storage area, items being stored there include scrap and various construction items. The items are stored in neat and orderly fashion and are not considered a problem at this time. The operator expressed that all items are stored there temporarily.
