## MINERALS PROGRAM INSPECTION REPORT

| <b>MINE NAME:</b><br>Pikeview Quarry | <b>MINE/PROSPECTING ID#:</b><br>M-1977-211 | <b>MINERAL:</b><br>Limestone (general),<br>granite, granite gneiss<br>and dolomite | <b>COUNTY:</b><br>El Paso |
| <b>INSPECTION TYPE:</b><br>Monitoring | <b>INSPECTOR(S):</b><br>Timothy Cazier, P.E. | <b>INSP. DATE:</b><br>April 6, 2022 | <b>INSP. TIME:</b><br>10:00 |

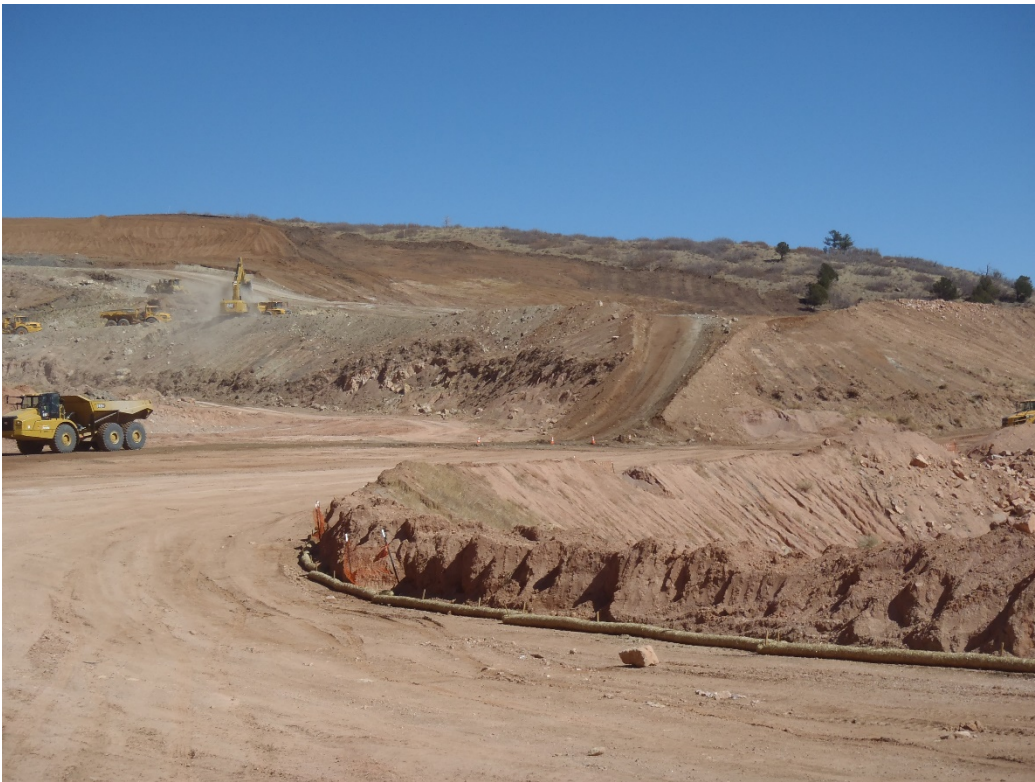
Backfill material was primarily being excavated from the north end (see **Photo 3**) and hauled to the pit floor for placement. Some backfill was also coming from the south end (see **Photo 4**). Backfill was being placed in one-foot lifts, with dozers using GPS systems (see **Photo 5**) to maintain lift thickness. A compactor was observed working the finished lifts (see **Photo 6**). The exception to the one foot lift thickness, as allowed by the approved reclamation plan was within 30 feet of the face of the slide. Dozers and haul trucks were observed placing material in this 30-foot zone by operating perpendicular to the face (see **Photo 7**) as required for safety in the approved specifications. Site representatives indicated between 8 and 20 feet of compacted fill (depending on location) have been placed since construction began in late February and that ground control survey methods were also being used to monitor lift thickness. Site representatives reported some material is still being imported from offsite as allowed by the approval of TR-19.

Photo 3. Excavation and hauling from the north end (looking north from future toe of slope).

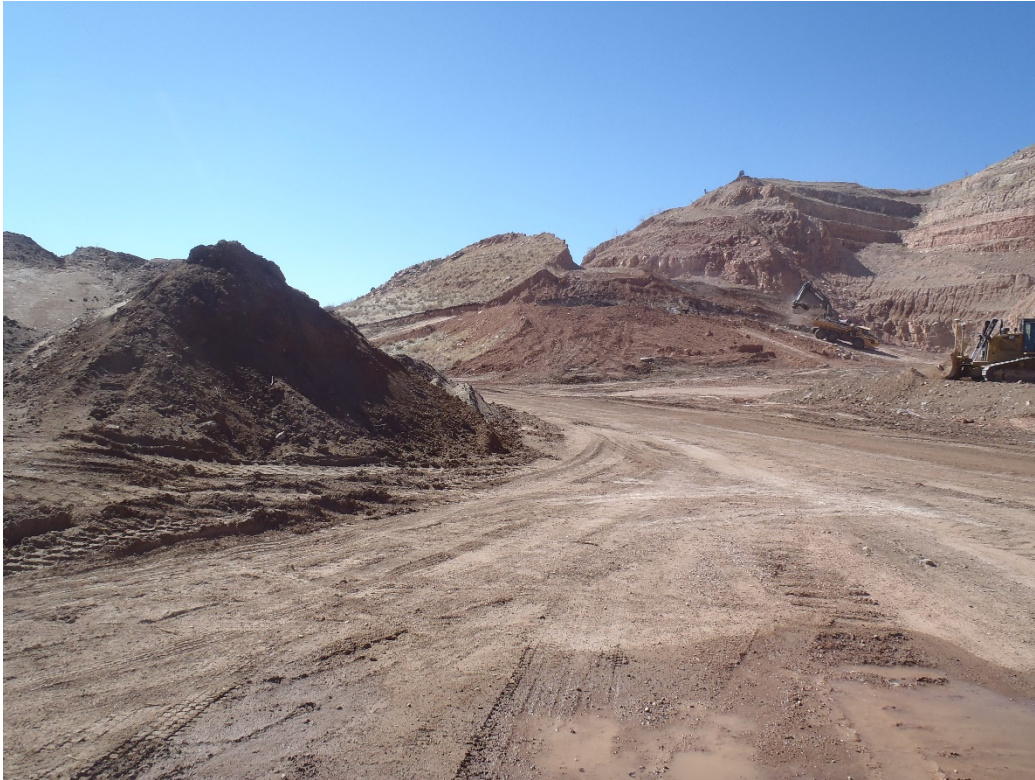
Photo 4. Excavation and hauling from the south end (looking south from future toe of slope).

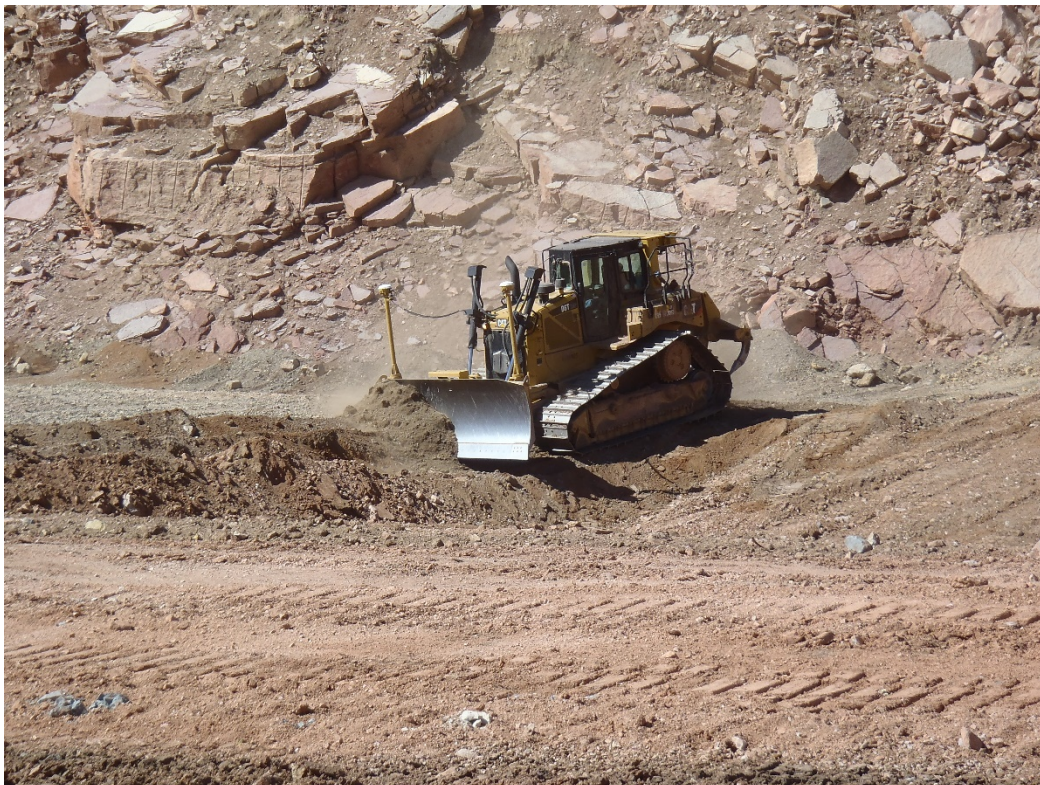
Photo 5. CAT D6 with GPS controls grading for lift thickness.

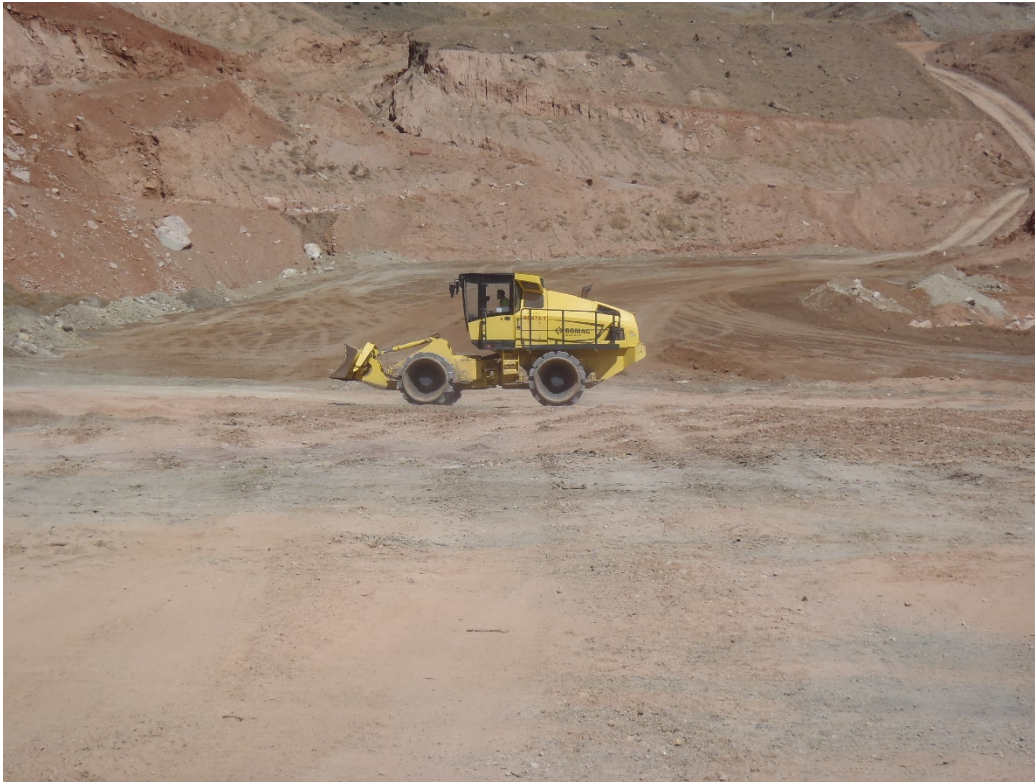
Photo 6. Compactor working latest lift (looking north from pit floor).

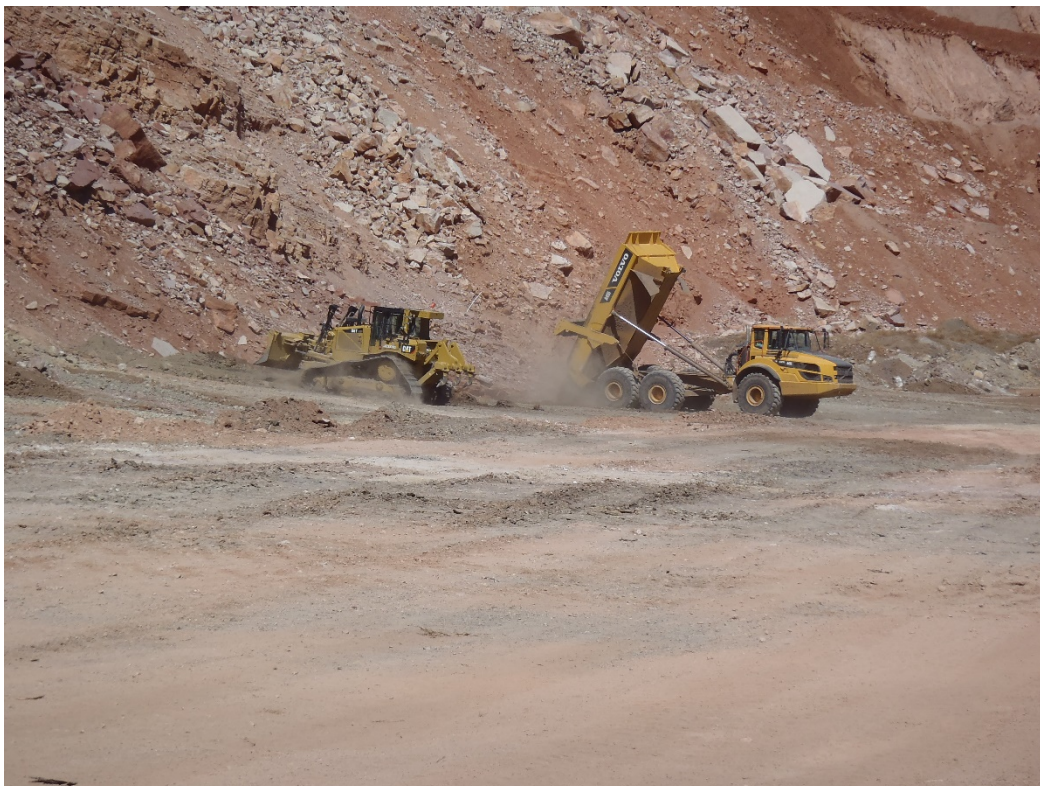
Photo 7. Dozer and haul truck working perpendicular to slide area.

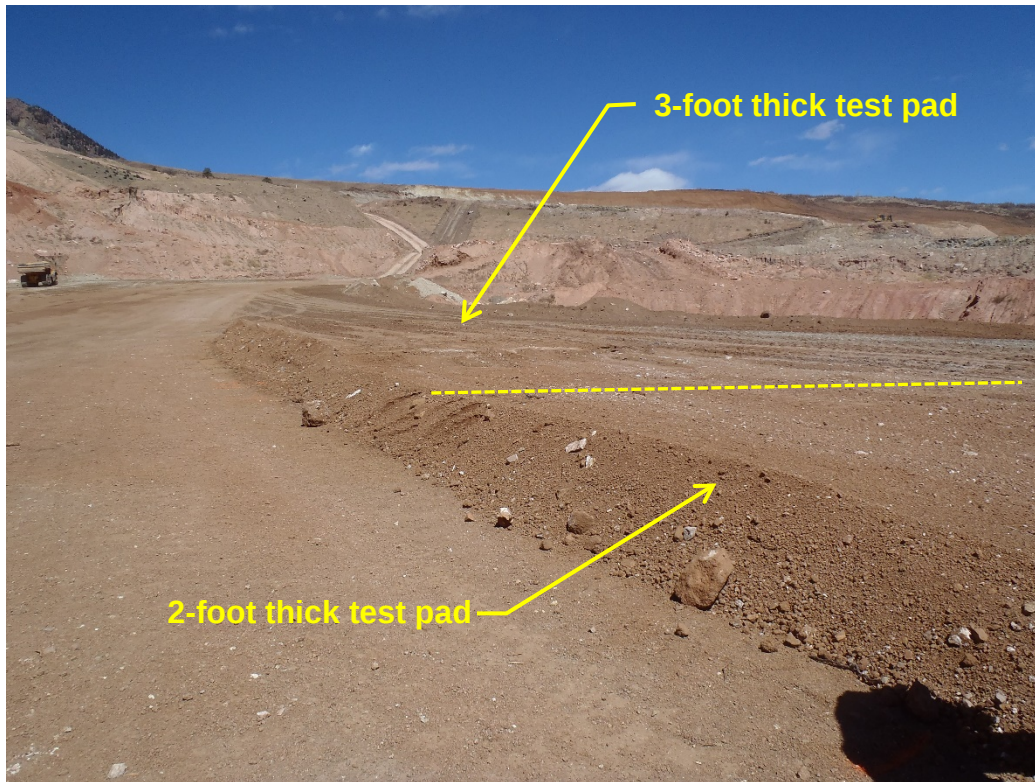
A test pad (see **Photo 8**) had been constructed on the pit floor for the purpose of exploring the effectiveness of placing backfill in thicker lifts – up to three feet maximum. The test pad consisted of a roughly 100 x 50 foot area on which three feet of fill was placed, then compacted. A dozer was used to scrape off one foot of material (leaving a two-foot lift) in the mid-section and two feet off (leaving a one-foot lift) the southern end. The north end of the test pad was left with a three-foot lift. All three sections were tested for compaction. Preliminary results indicated the 90% compaction specification was met or exceeded in all cases. Brice (construction contractor) planned to deconstruct the test pad immediately after it was inspected in order to comply with the approved specifications.

Photo 8. Test pad for investigating thicker lifts (looking north).
