MINERALS PROGRAM INSPECTION REPORT
PHONE: (303) 866-3567

MINE NAME: Crader Gravel Pit	MINE/PROSPECTING ID#: M-1981-114	MINERAL: Sand and gravel	COUNTY: La Plata
INSPECTION TYPE: Monitoring	INSPECTOR(S): Lucas West	INSP. DATE: March 16, 2022	INSP. TIME: 15:50
OPERATOR: La Plata County	OPERATOR REPRESENTATIVE: Leslie Jakoby	TYPE OF OPERATION: 112c - Construction Regular Operation	
REASON FOR INSPECTION: Normal I&E Program	BOND CALCULATION TYPE: None	BOND AMOUNT: \$0.00	
DATE OF COMPLAINT: NA	POST INSP. CONTACTS: None	JOINT INSP. AGENCY: None	
WEATHER: Clear	INSPECTOR'S SIGNATURE:

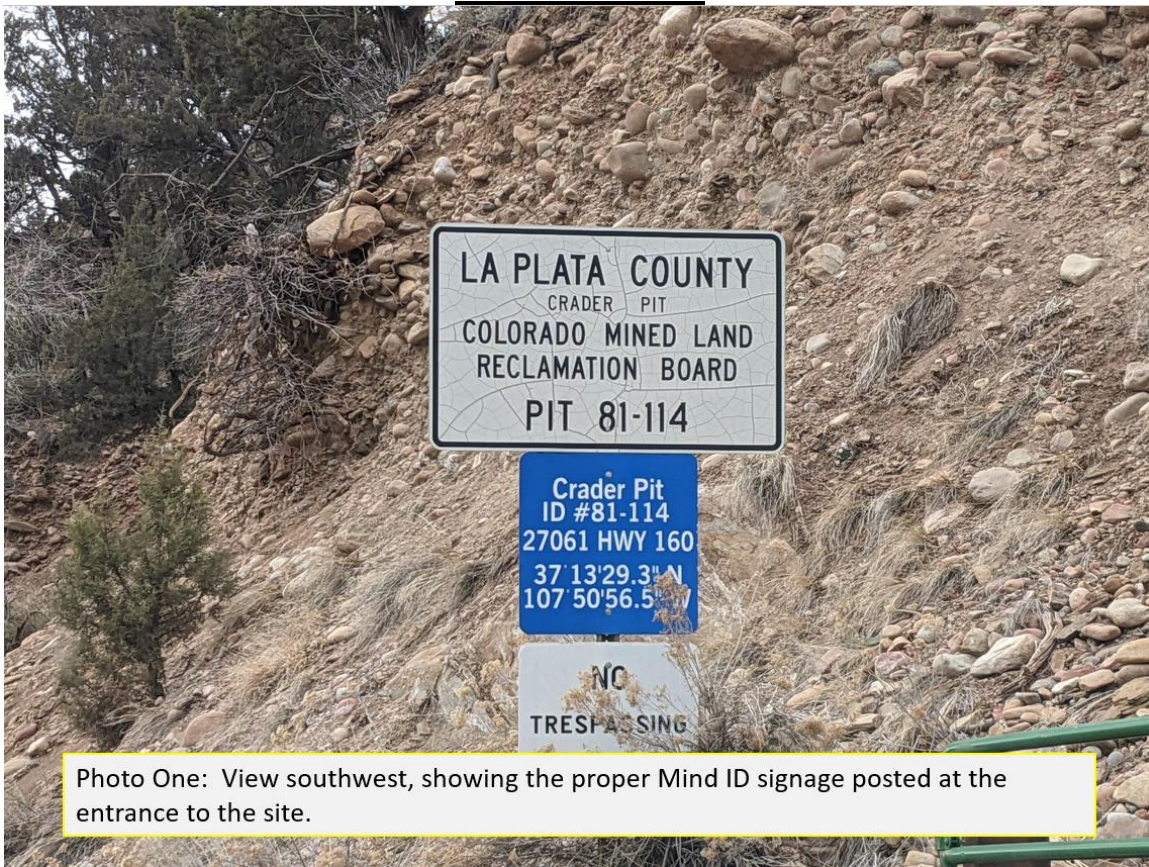
Proper mine identification signage was posted at the entrance to site and is shown in Photo One. The permit boundaries are clearly marked with signs and earthen berms around the site. The site was not active during the inspection and the only equipment noted on site was a Front End Loader. The mining activity is being carried out in phases with all of the active mining being located in Phase One. The active highwall is approximately 40 feet tall on average and stretches between 100 and 150 linear feet. The highwall is in good condition and appears to be stable as seen in Photo Two. The boundary between the Crader pit and the adjacent Montoya pit operated by C & J Gravel has been mined out and the boundary is marked by a suspended cable. The boundary can be seen in Photo Three.

Photo One: View southwest, showing the proper Mind ID signage posted at the entrance to the site.

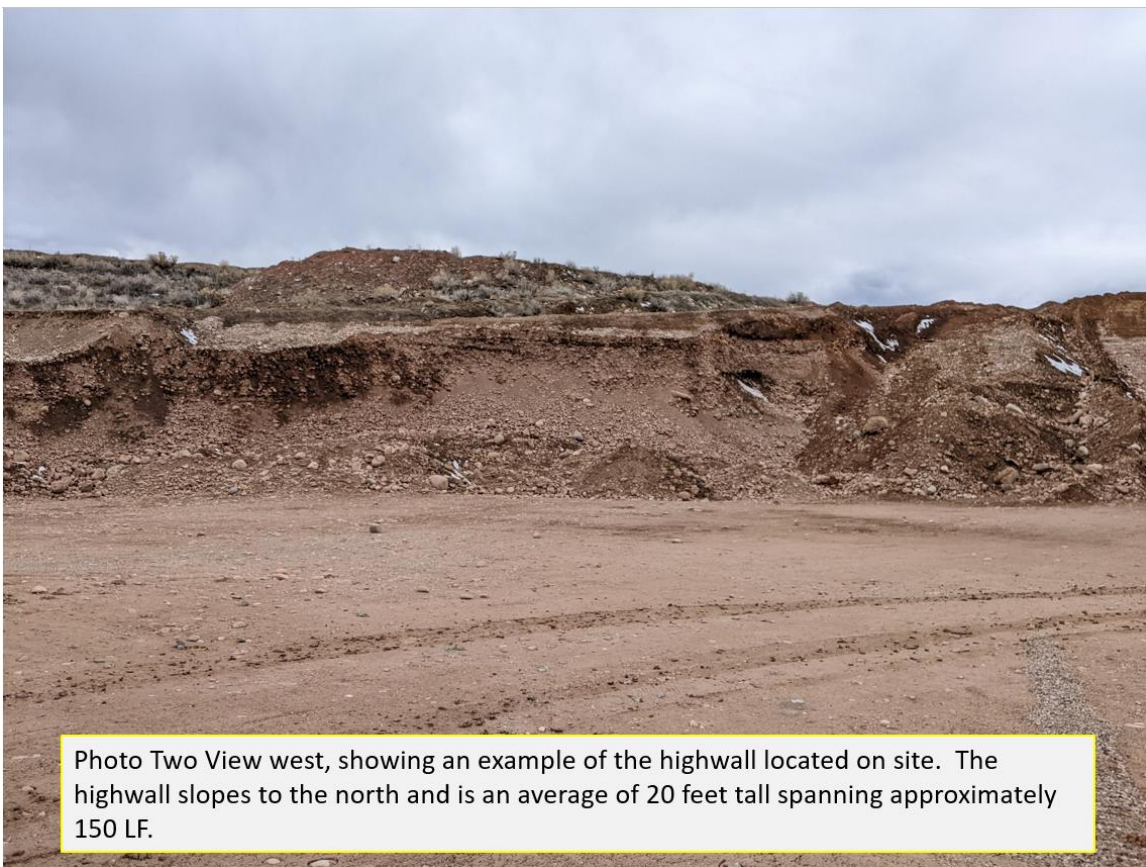
Photo Two View west, showing an example of the highwall located on site. The highwall slopes to the north and is an average of 20 feet tall spanning approximately 150 LF.

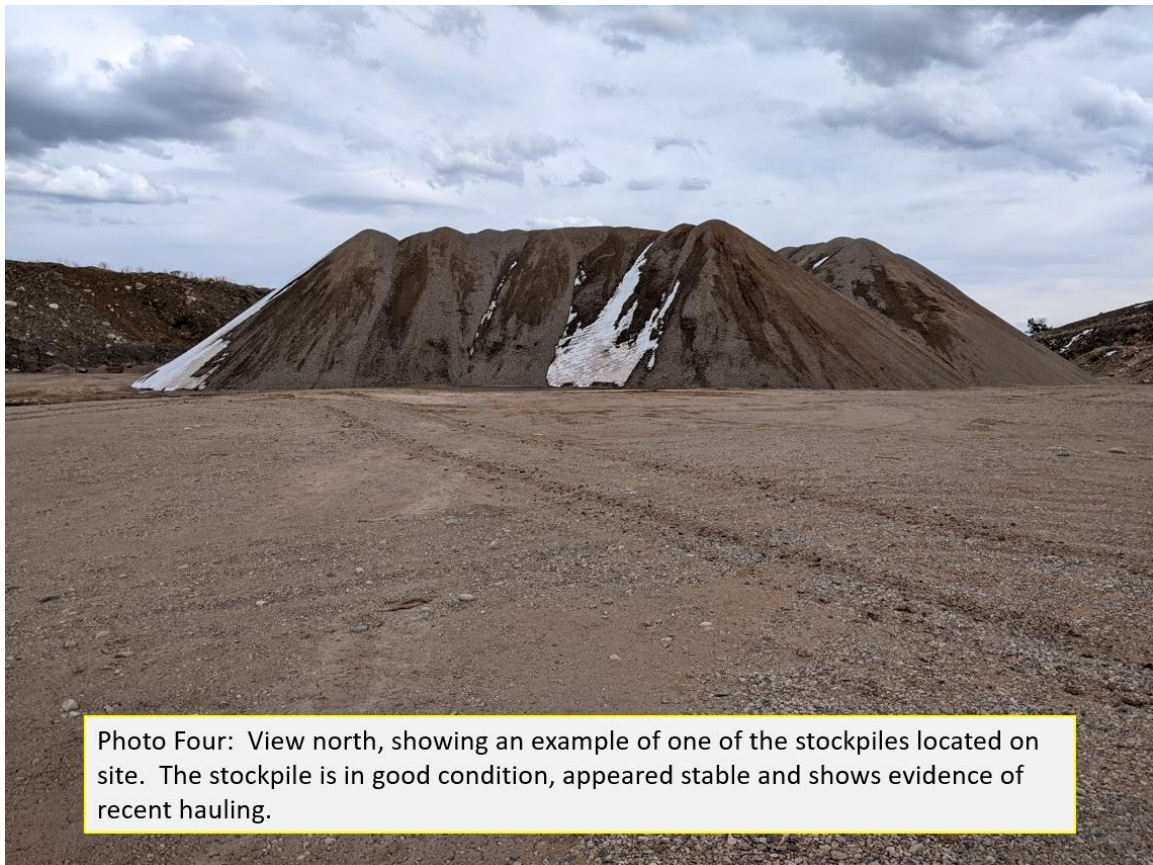
Several stockpiles were observed on site, some being located on the pit floor shown in Photos Four and Five. All stockpiles were in good condition and appear to be stable. The un-mined areas of Phase 2 and Phase 8, which are adjacent sections, are being used as a materials storage area and fenced in facility. All materials and items being stored both in and out of the fenced area are in a neat and orderly fashion and are not considered a problem. The site exhibits positive drainage and no erosional issues were noted during this inspection. No noxious weeds were observed, and the operator indicated that the site undergoes ongoing weed management by the County weed department.

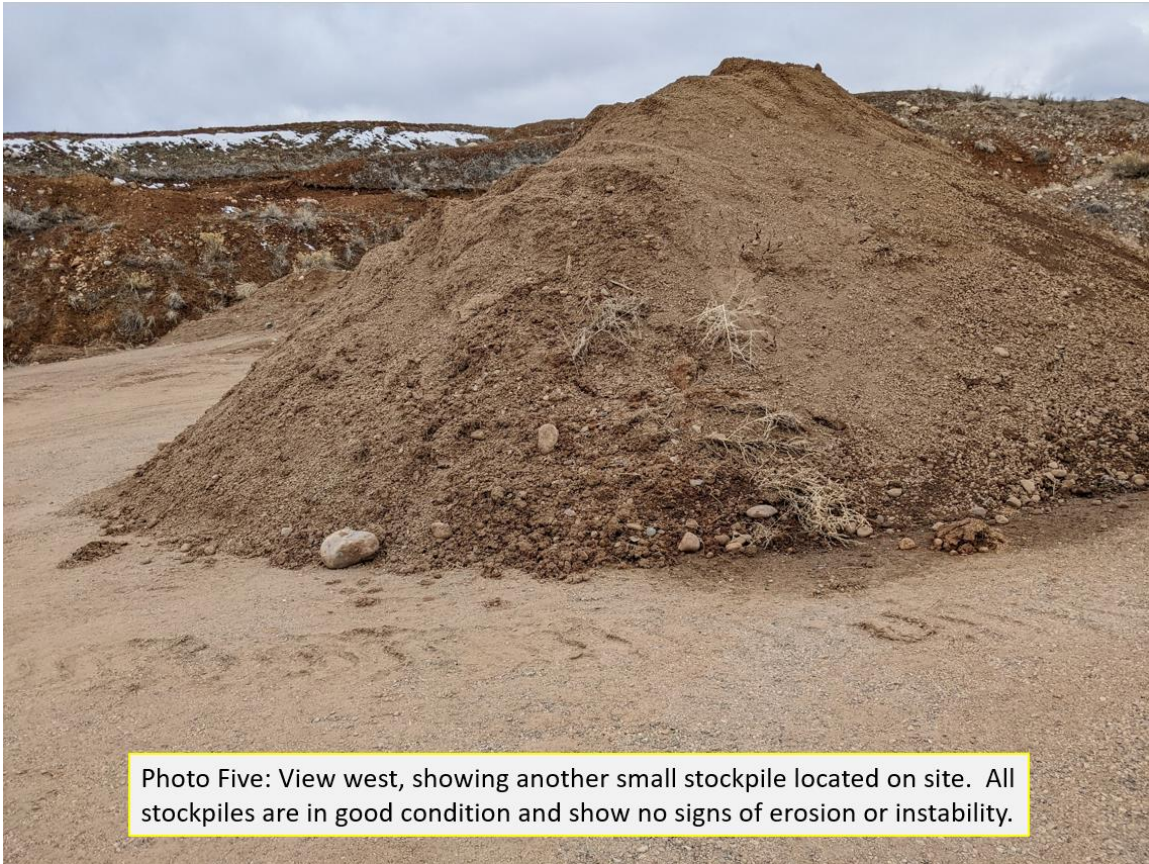
Photo Five: View west, showing another small stockpile located on site. All stockpiles are in good condition and show no signs of erosion or instability.
