**PITCH RECLAMATION PROJECT**  
**COLORADO MINED LAND RECLAMATION BOARD**  
**2021 ANNUAL RECLAMATION REPORT**

RECLAMATION PERMIT NUMBER M-1977-004

*April 2022*

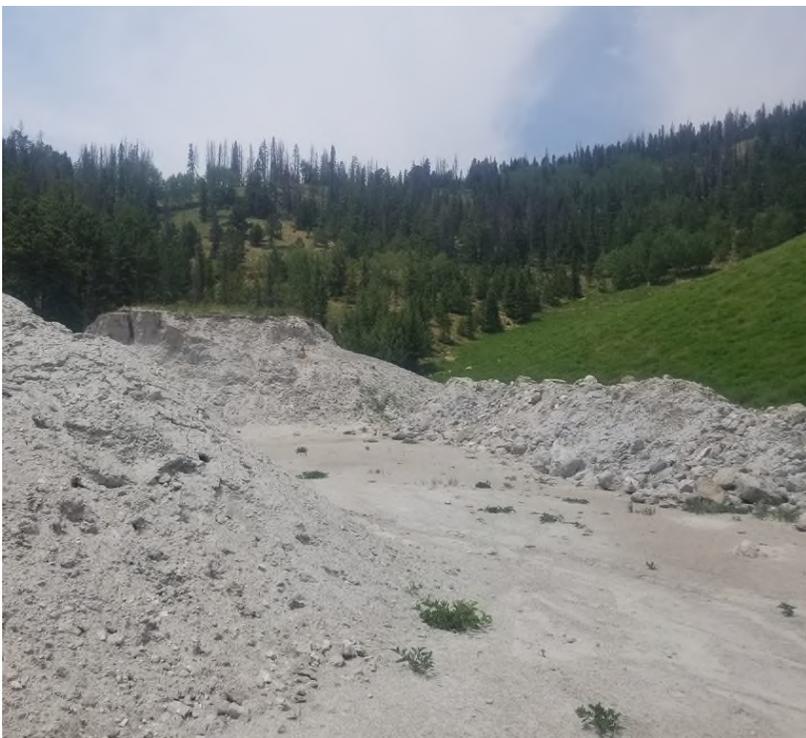
**Description:**  
IRD earthwork

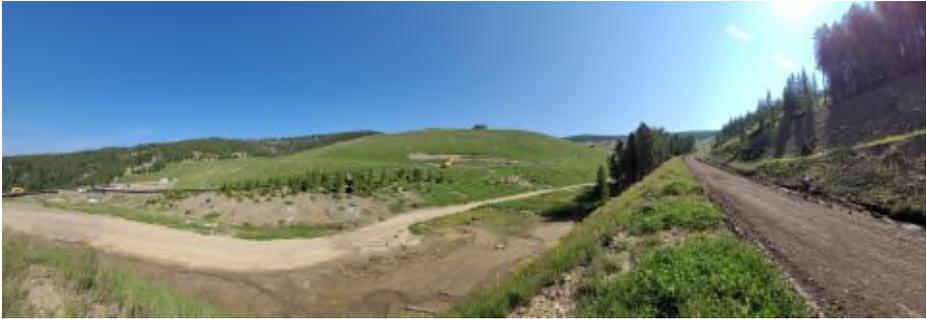
<p><b>Photograph: 7</b></p> <p><b>Description:</b> North Pit Diversion (right) maintenance area and constructed marsh areas.</p> <p><b>Location:</b> NPL</p> <p><b>Date:</b> 8/13/2020</p>

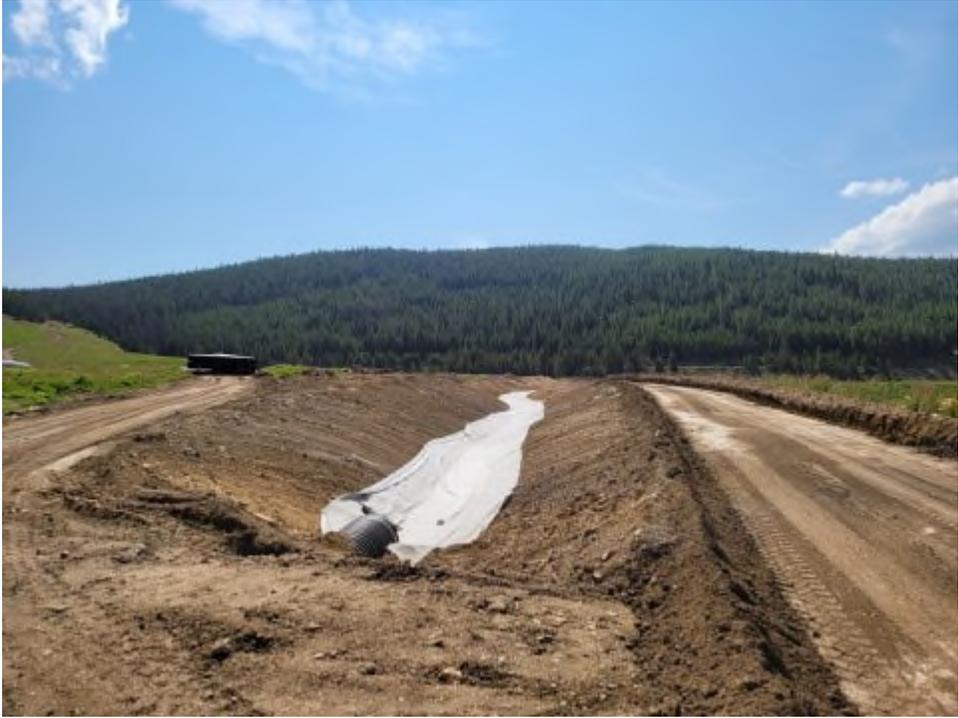
<p><b>Photograph: 8</b></p> <p><b>Description:</b> Tie Camp stormwater control modification</p> <p><b>Location:</b> Tie Camp Disposal area</p> <p><b>Date:</b> 8/13/2020</p>

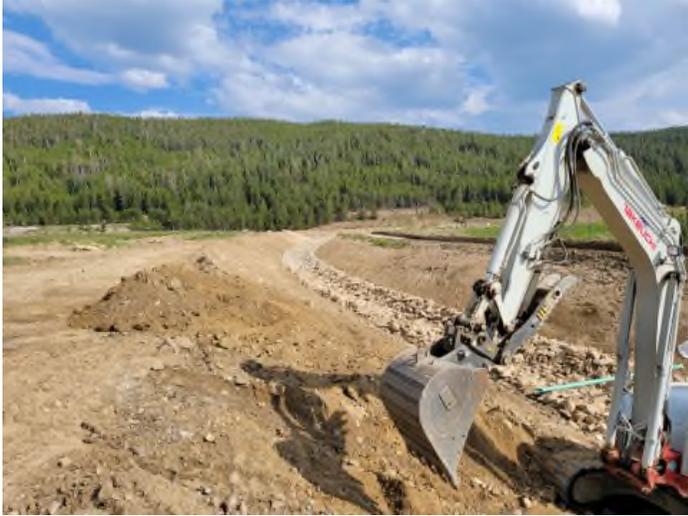
<p><b>Photograph: 10</b></p> <p><b>Description:</b> Tie Camp stormwater control modification</p> <p><b>Location:</b> Tie Camp Disposal area</p> <p><b>Date:</b> 8/18/2020</p>

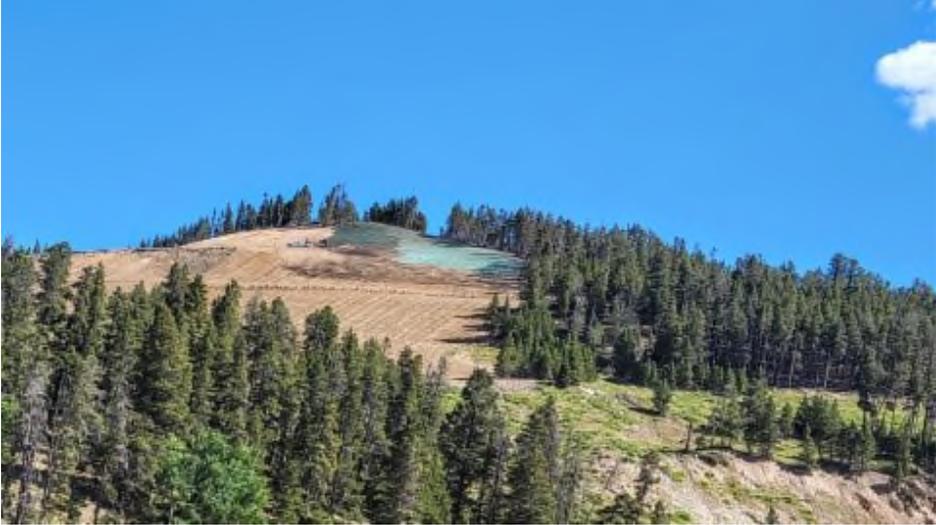
<p><b>Photograph: 11</b></p> <p><b>Description:</b> South mine reseeding</p> <p><b>Location:</b> South mine area</p> <p><b>Date:</b> 9/14/2020</p>

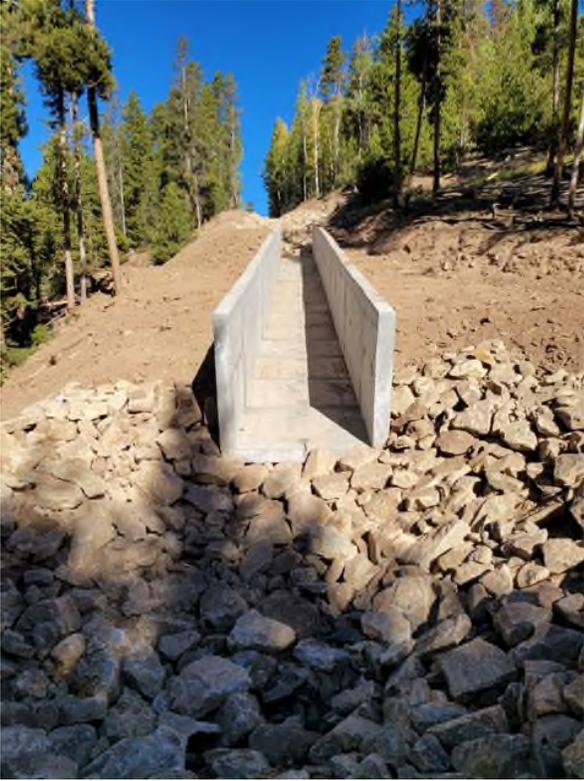
<p><b>Photograph: 12</b></p> <p><b>Description:</b> New area of disturbance. Tie Camp Drainage concrete modification.</p> <p><b>Location:</b> Tie Camp Drainage</p> <p><b>Date:</b> 9/23/2020</p>

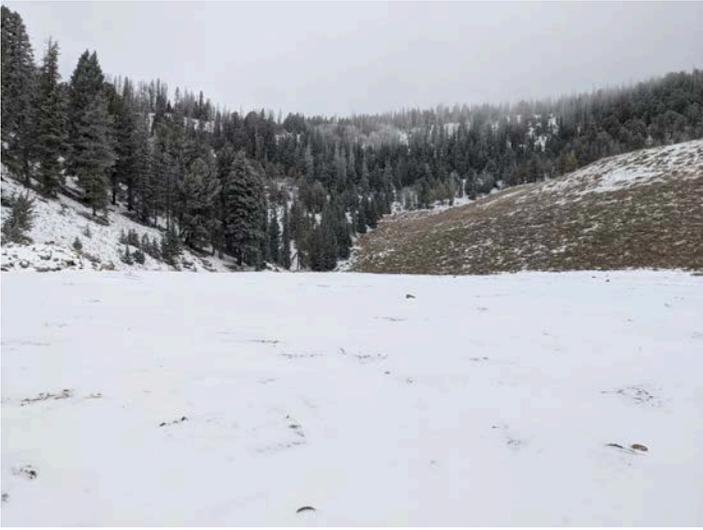
The laydown area above the Tie Camp Rock dump has been regraded and reseeded. The reclamation work looks good. No problems were noted.

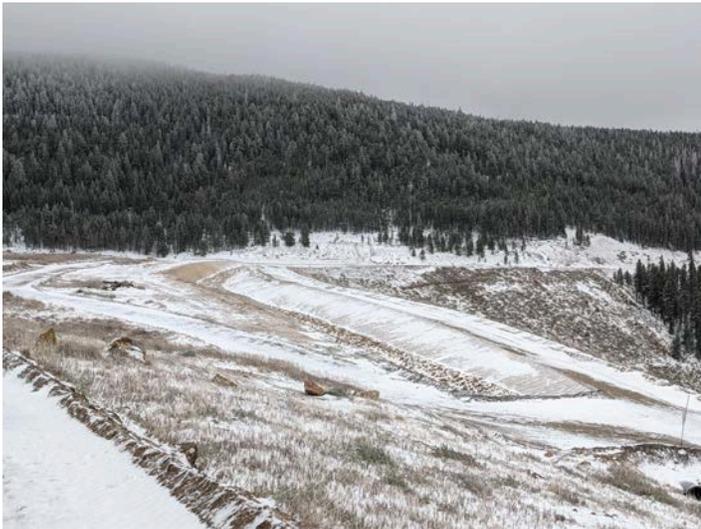
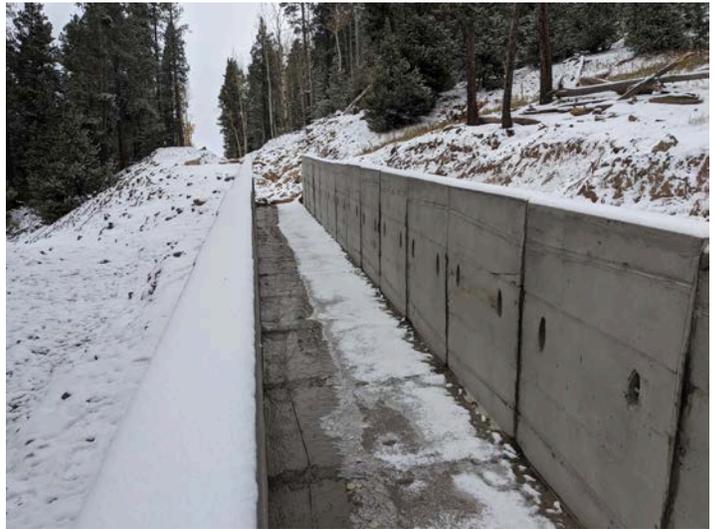
A significant amount of drainage work has been completed at the site. The channel above the north pit has been improved and constructed with rip-rap. A rip-rap drainage channel above the Tie-Camp rock dump has been constructed. 36" HDPE pipe has been installed along the road below the shop area and the channel has been improved down to the concrete structures above the sediment pond area.
