## MINERALS PROGRAM INSPECTION REPORT

<b>MINE NAME:</b> Schwartzwalder Mine	<b>MINE/PROSPECTING ID#:</b> M-1977-300	<b>MINERAL:</b> Uranium	<b>COUNTY:</b> Jefferson
<b>INSPECTION TYPE:</b> Monitoring	<b>INSPECTOR(S):</b> Amy Eschberger	<b>INSP. DATE:</b> March 22, 2022	<b>INSP. TIME:</b> 09:00
<b>OPERATOR:</b> Colorado Legacy Land, LLC	<b>OPERATOR REPRESENTATIVE:</b> Elizabeth Busby	<b>TYPE OF OPERATION:</b> 112d-2 - Designated Mining Operation	
<b>REASON FOR INSPECTION:</b> Normal I&E Program	<b>BOND CALCULATION TYPE:</b> None	<b>BOND AMOUNT:</b> \$7,674,022.00	
<b>DATE OF COMPLAINT:</b> NA	<b>POST INSP. CONTACTS:</b> None	<b>JOINT INSP. AGENCY:</b> None	
<b>WEATHER:</b> Clear	<b>INSPECTOR'S SIGNATURE:</b>

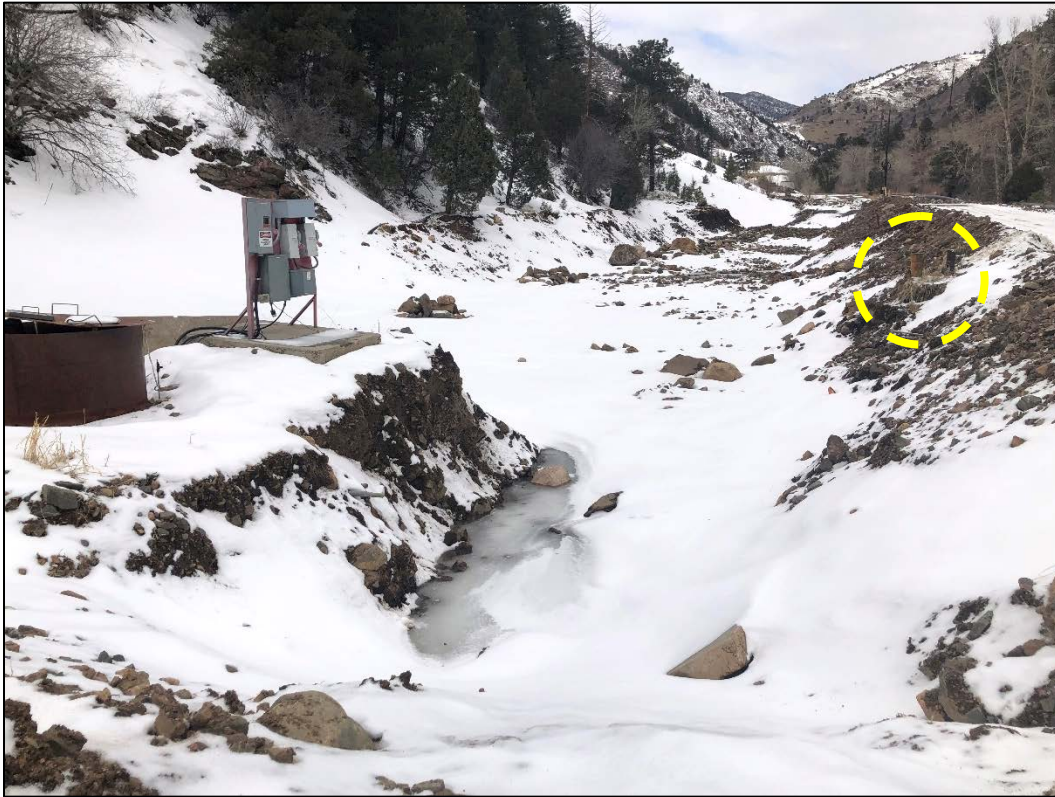
**Photo 1.** View looking northwest across excavation area located in southeastern portion of project area. Note alluvial groundwater monitoring well MW-7 (circled) which will need to be abandoned for the excavation project. Also note Master Sump #1 (at left), the last functional sump on site which may also become redundant.

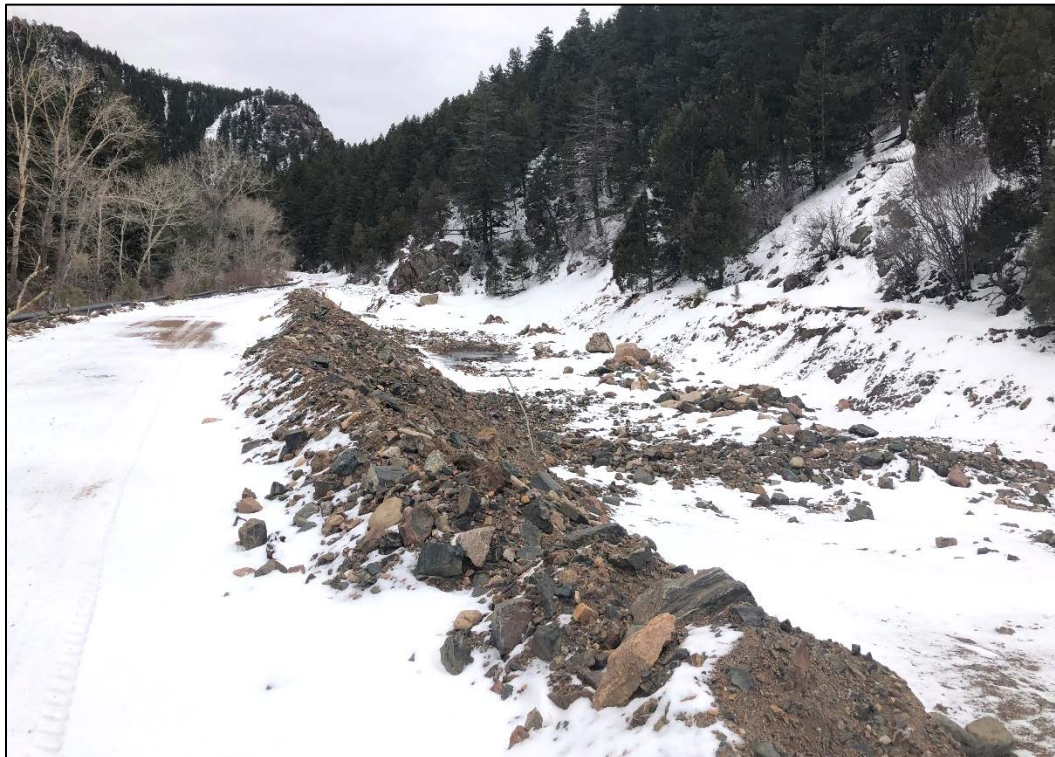
**Photo 2.** View looking southeast across excavation area located in southeastern portion of project area. Note Glencoe Valley Road (at left) located adjacent to excavation area.

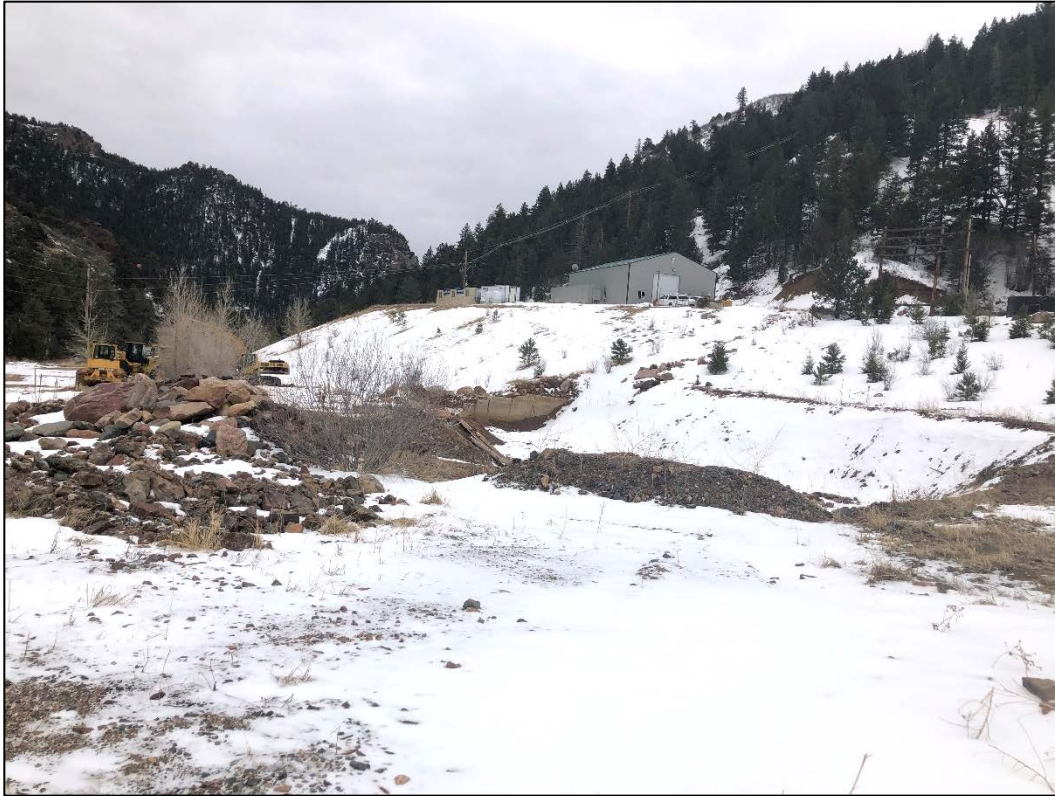
**Photo 3.** View looking southeast across excavation area located in central portion of project area at base of mesa with water treatment plant (visible in background).

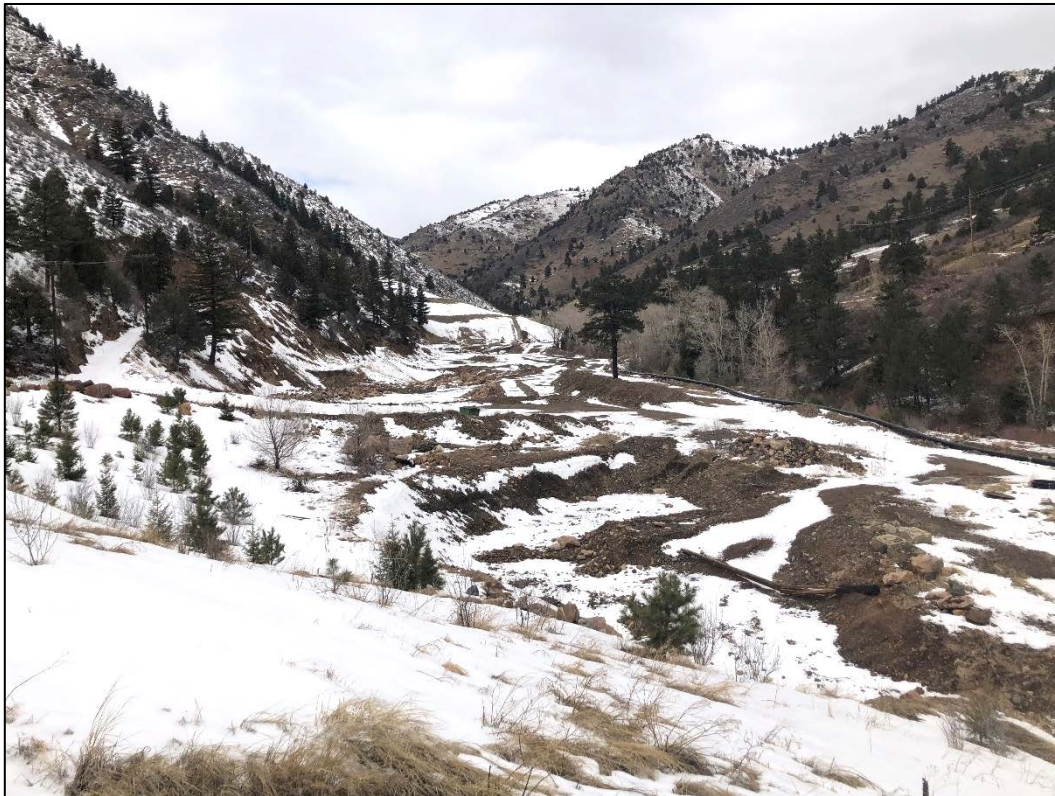
**Photo 4.** View looking northwest across excavation area located in northern portion of project area.

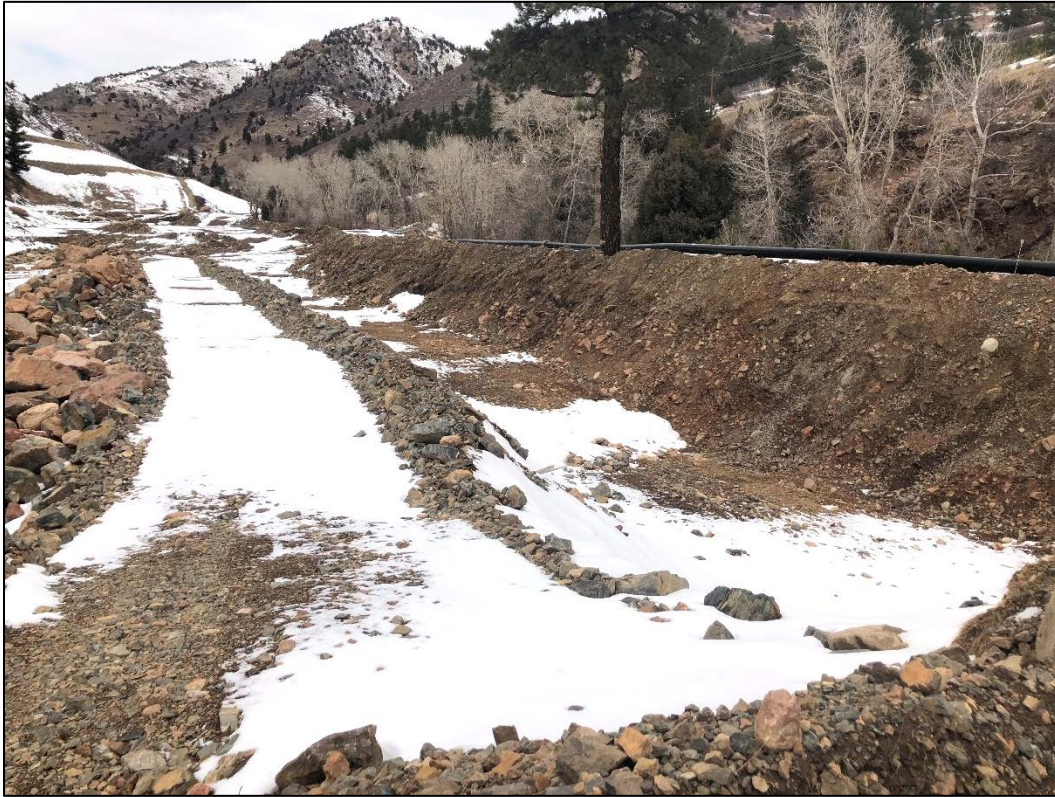
**Photo 5.** Closer view of excavation area located in northern portion of project area. Ralston Creek is located at eastern edge of valley (at right; not visible in this photo).

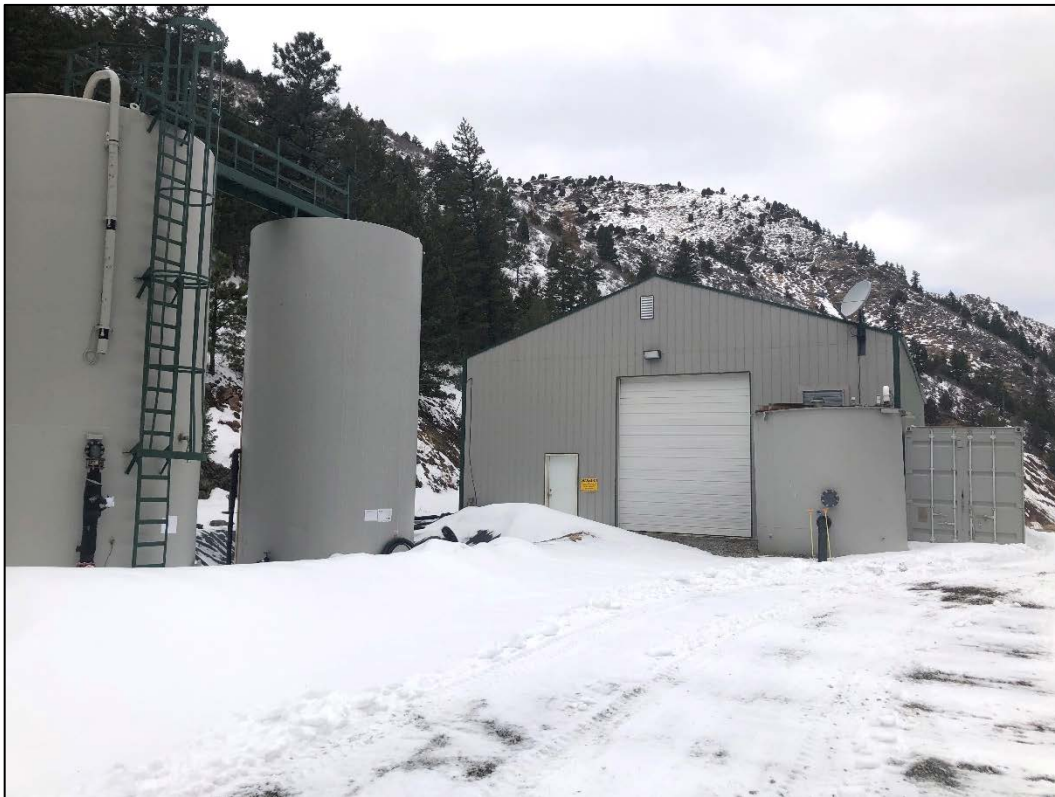
At the time of the inspection, the weather was cold and windy and the ground was covered with snow. The mine pool was reported at 224 feet below Steve Level, which is 74 feet below the required 150 foot depth. The water treatment plant was shut down for the winter in September of 2021. An in-situ treatment (the 5<sup>th</sup> treatment conducted since 2013) was conducted during the last week of September 2021. Phosphoric acid was injected into the mine pool on September 24, 2021 and ethanol was injected into the mine pool on September 29, 2021. After the last in-situ treatment was conducted in January of 2020, the operator did not observe a significant decrease in uranium concentrations in the mine pool as was observed after previous in-situ treatments. The operator does not expect the 2021 treatment to produce similar results as the 2020 treatment because different chemicals were used and the in-situ injection will have a longer treatment period this time. The operator plans to bring the water treatment plant back online in early May of 2022.

**Photo 6.** View looking north/northwest at water treatment plant which was offline for the winter.

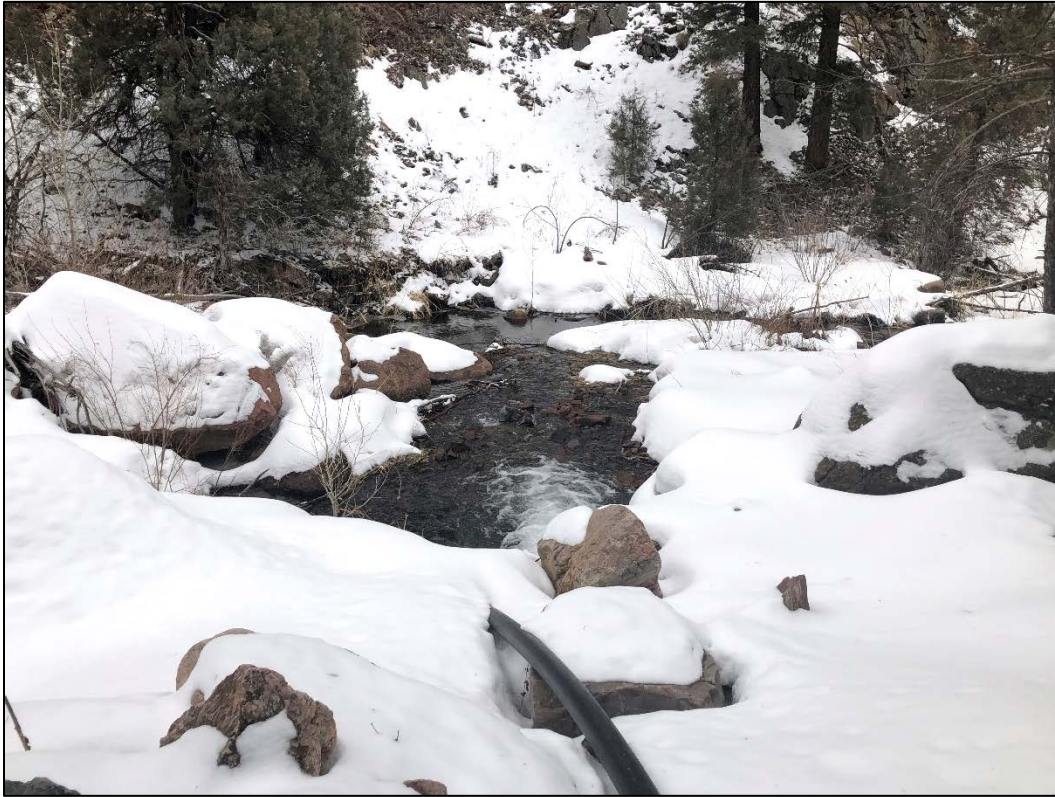
During the inspection, creek flows were being captured above the upgradient cutoff wall and routed around the mine site via the bypass pipeline. While the upgradient cutoff wall was not observed during the inspection, the Division did observe the permitted outfall location downstream of the mine site (SW-BPL) at which water routed around the mine via the bypass pipeline and treated water from the plant are discharged into the creek.

During the inspection, only the bypass pipeline was discharging water into the creek (since the plant was offline).

**Photo 7.** View looking north at permitted outfall in Ralston Creek (SW-BPL) at which, creek flows captured upstream of mine were discharging into creek via bypass pipeline. No discharge was occurring from the water treatment plant since it was still offline for the winter.
