Daniels Sand Pit 2, Permit No. M-1973-007-SG: Monthly Monitoring Report

April 12, 2022
Project No.: 19125

Regarding: Daniels Sand Pit 2, Permit No. M-1973-007-SG
Slope Stability Monthly Monitoring Report

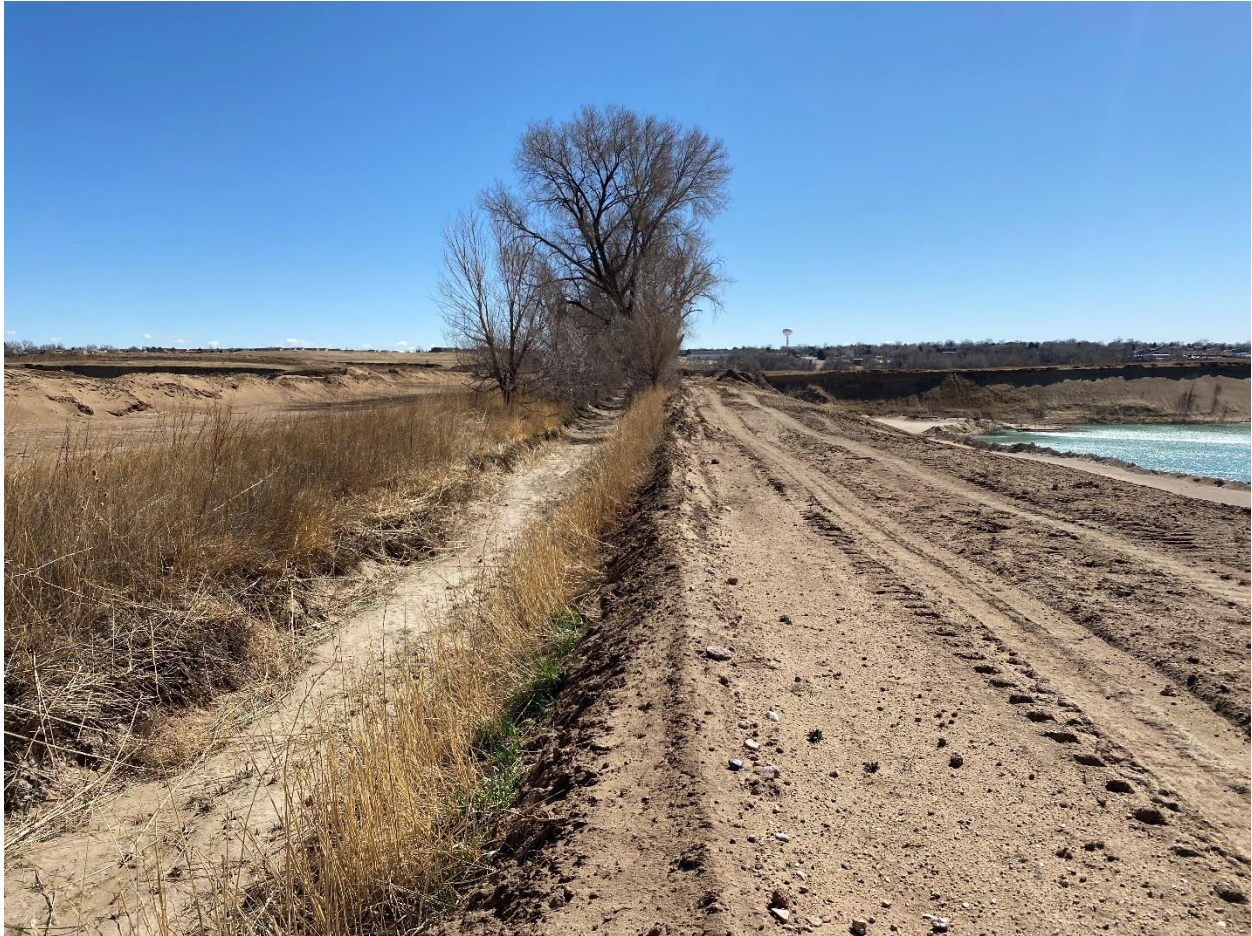
Photo 1. Fountain Mutual Ditch looking east with butterslope

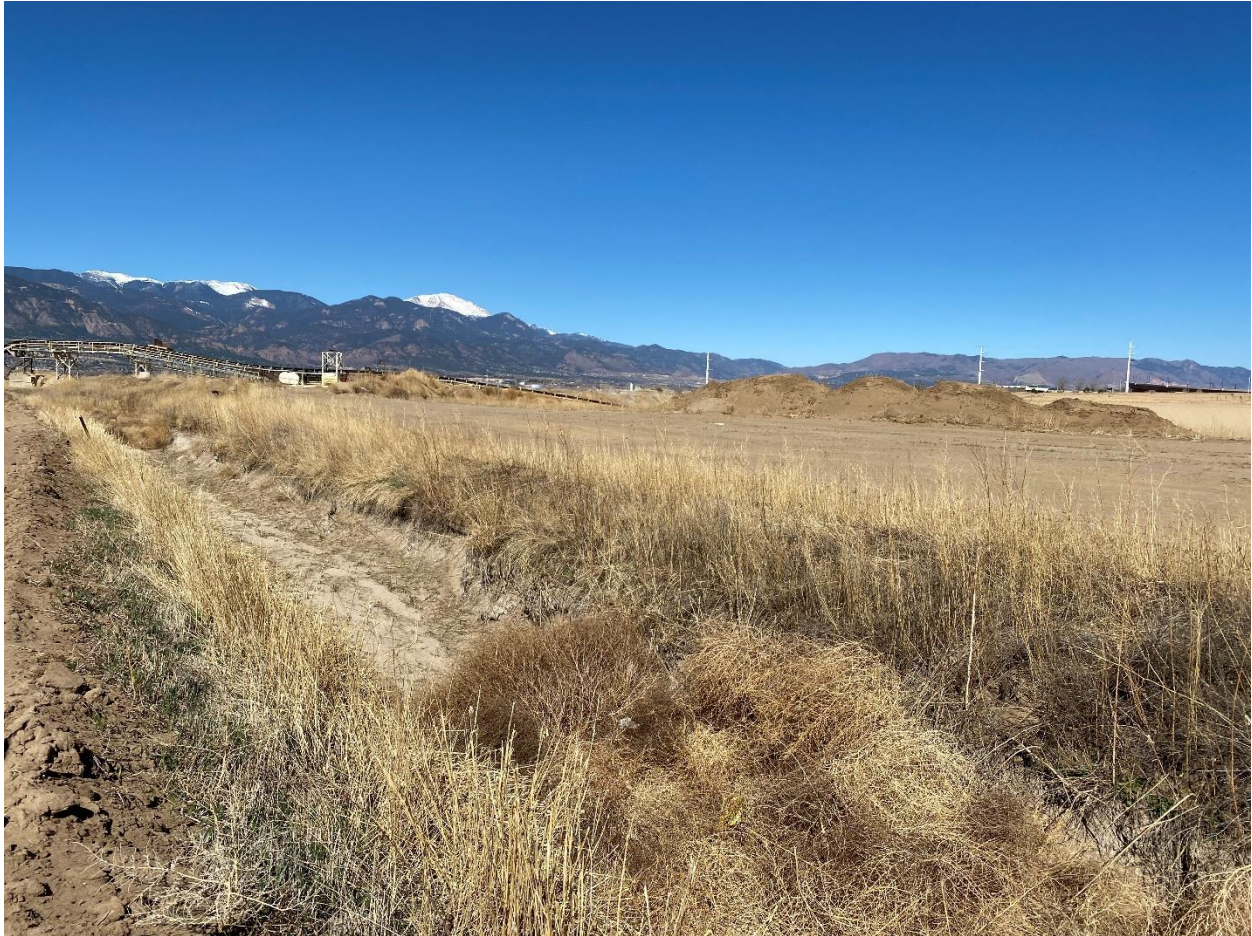
Photo 2. Fountain Mutual Ditch looking west

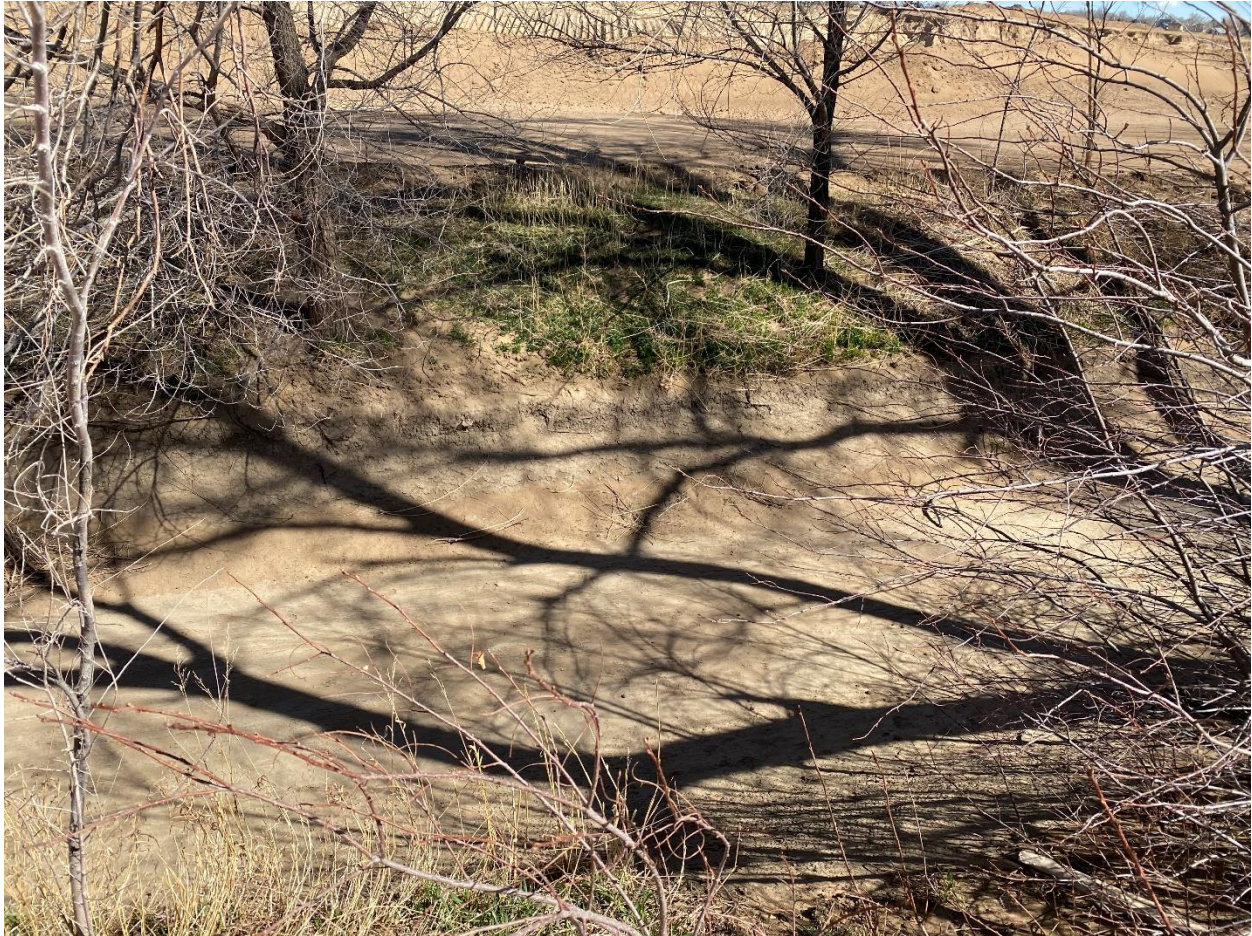
Photo 3. Fountain Mutual Ditch looking north

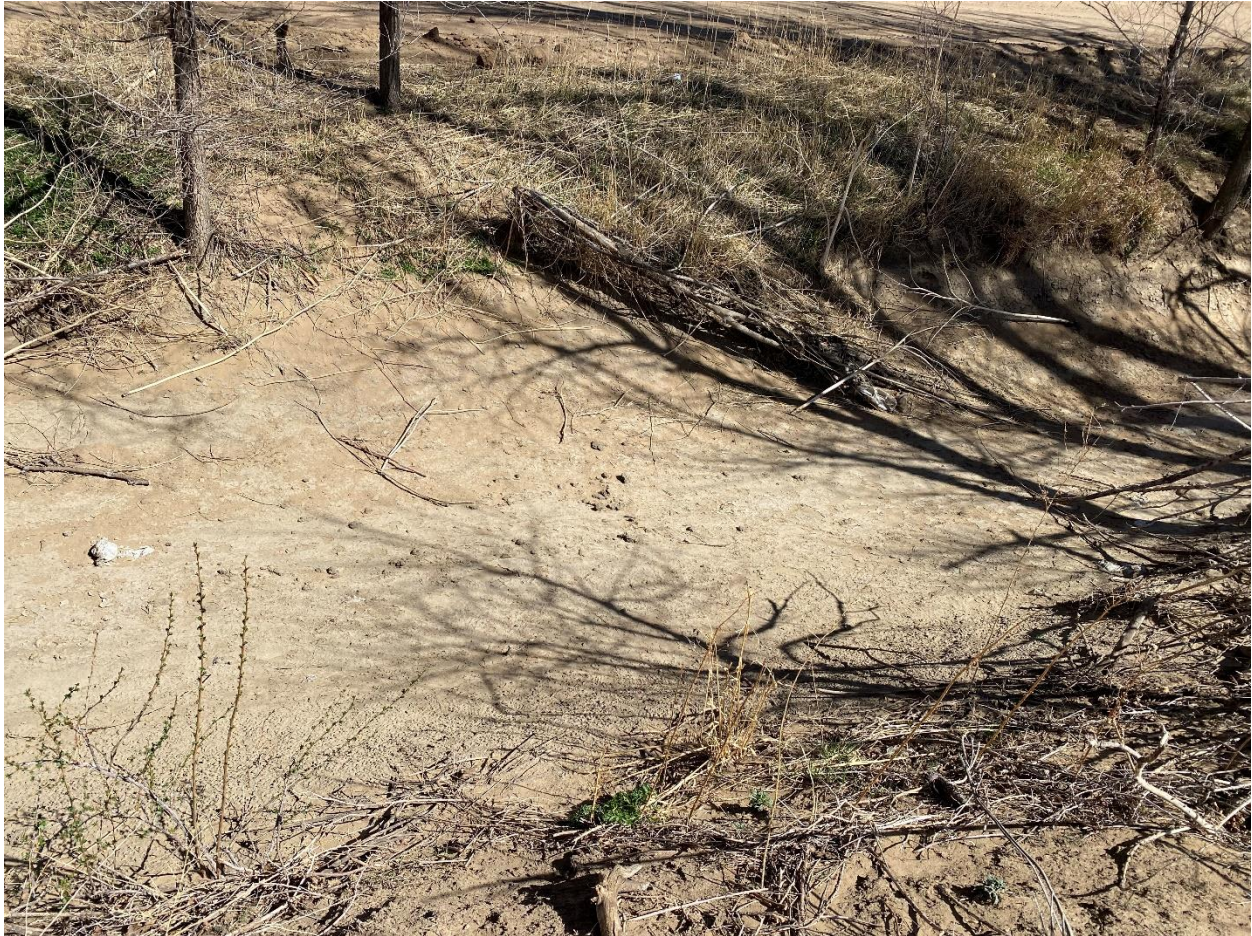
- Weather: 29-55°, sunny with gusty winds, winds 20-30 mph
- Visual observation of the Fountain Mutual Ditch:
 - No tension cracks
 - No toe erosion that was visible
 - No water flowing in the ditch
 - No sloughed slope surfaces
 - Several broken branches near crest
 - The condition of the ditch is stable

Photo 4. Fountain Mutual Ditch invert with branches

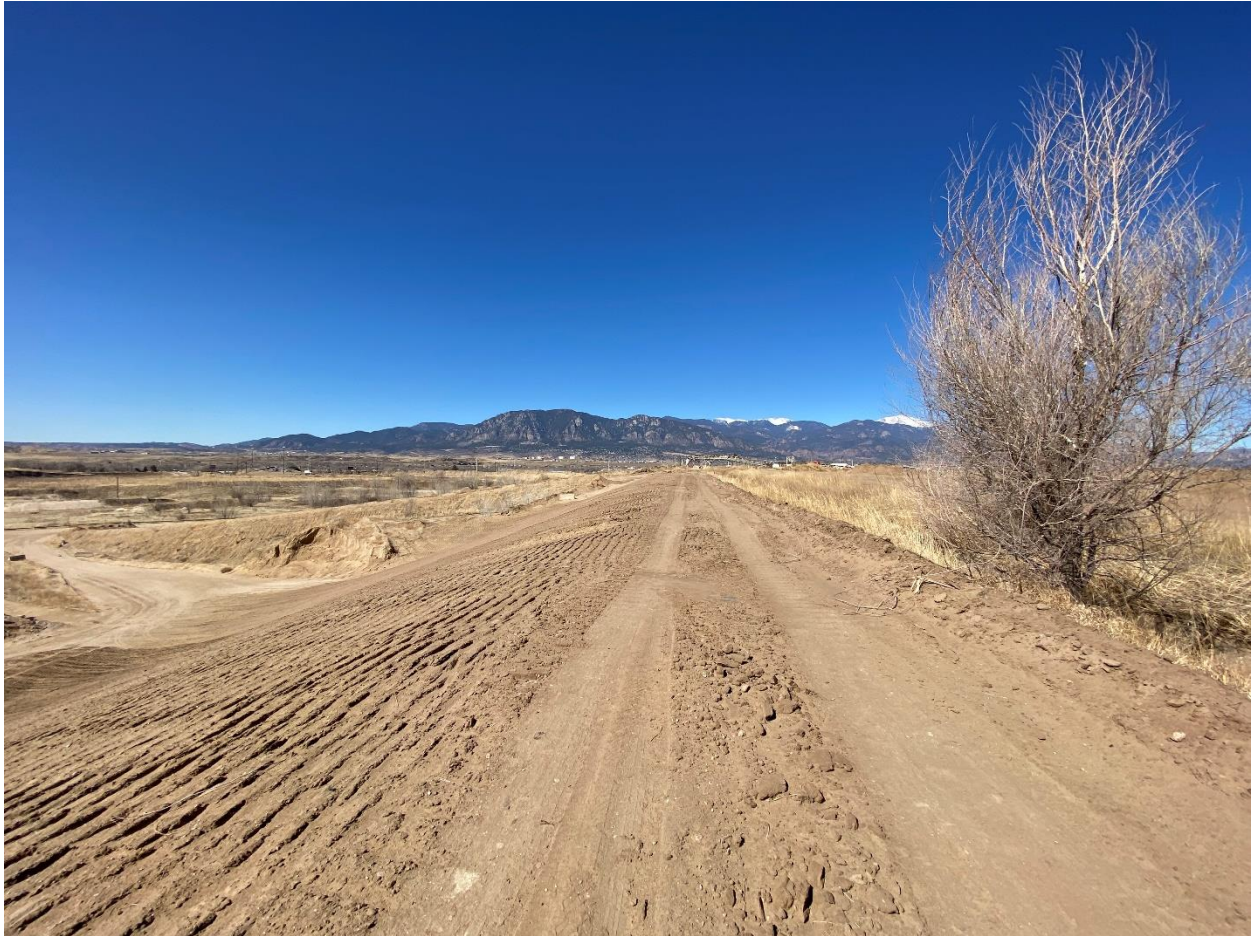
Photo 5. Butterslope, access road and ditch (looking west)

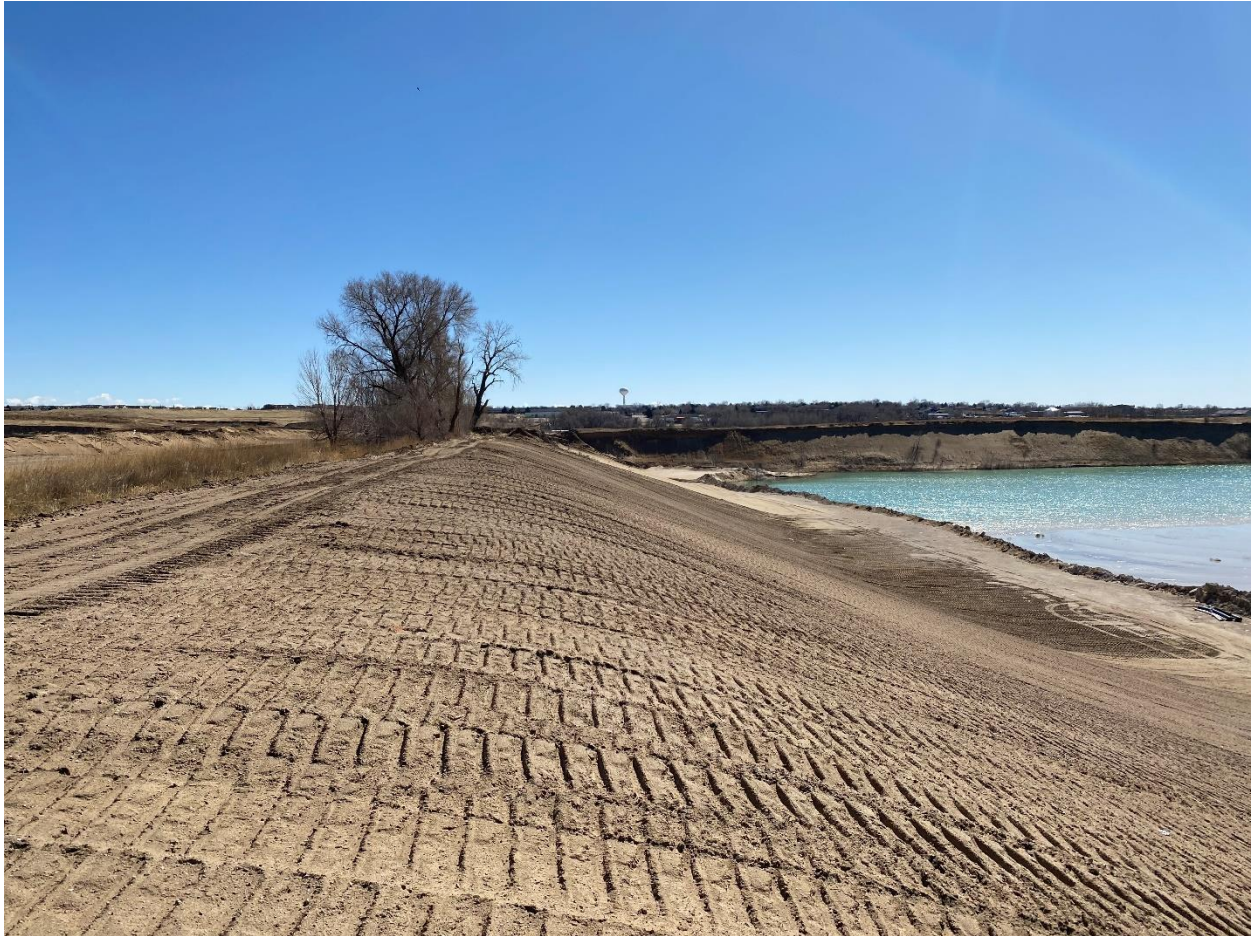
Photo 6. Buttress slope looking east from crest

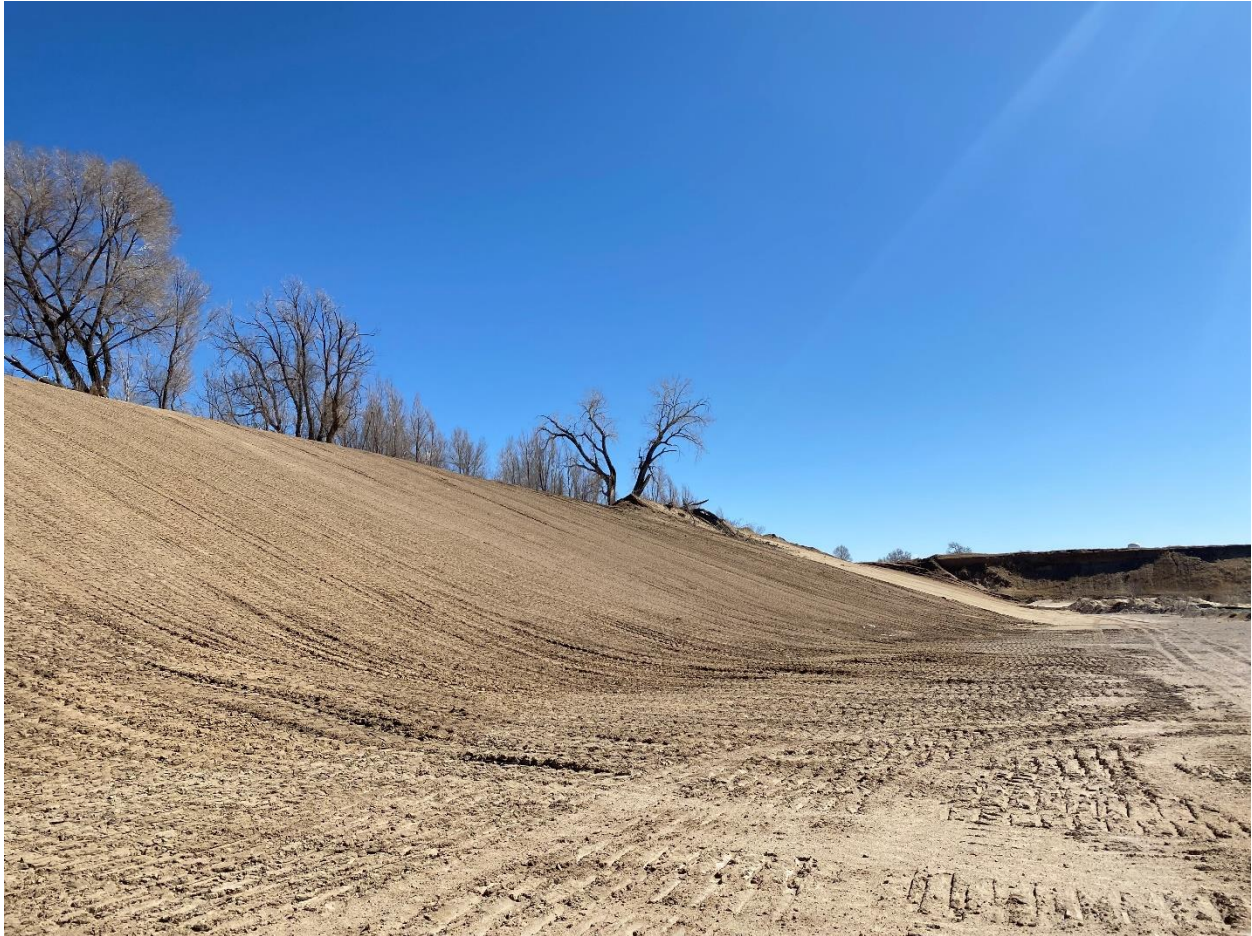
- Construction sequence
 - At this time, the buttress slope varies from 3H:1V to 4H:1V
 - Approximately 50 LF from the east needs to be placed for the final lift
 - Due to a recent wind storm, a tree has fallen on the stockpile material and part of the buttress on the eastern end (top of embankment)
 - Approximately 40 LF needs to be regraded near the fallen tree

Photo 7. Buttress slope looking east from toe (note fallen tree)

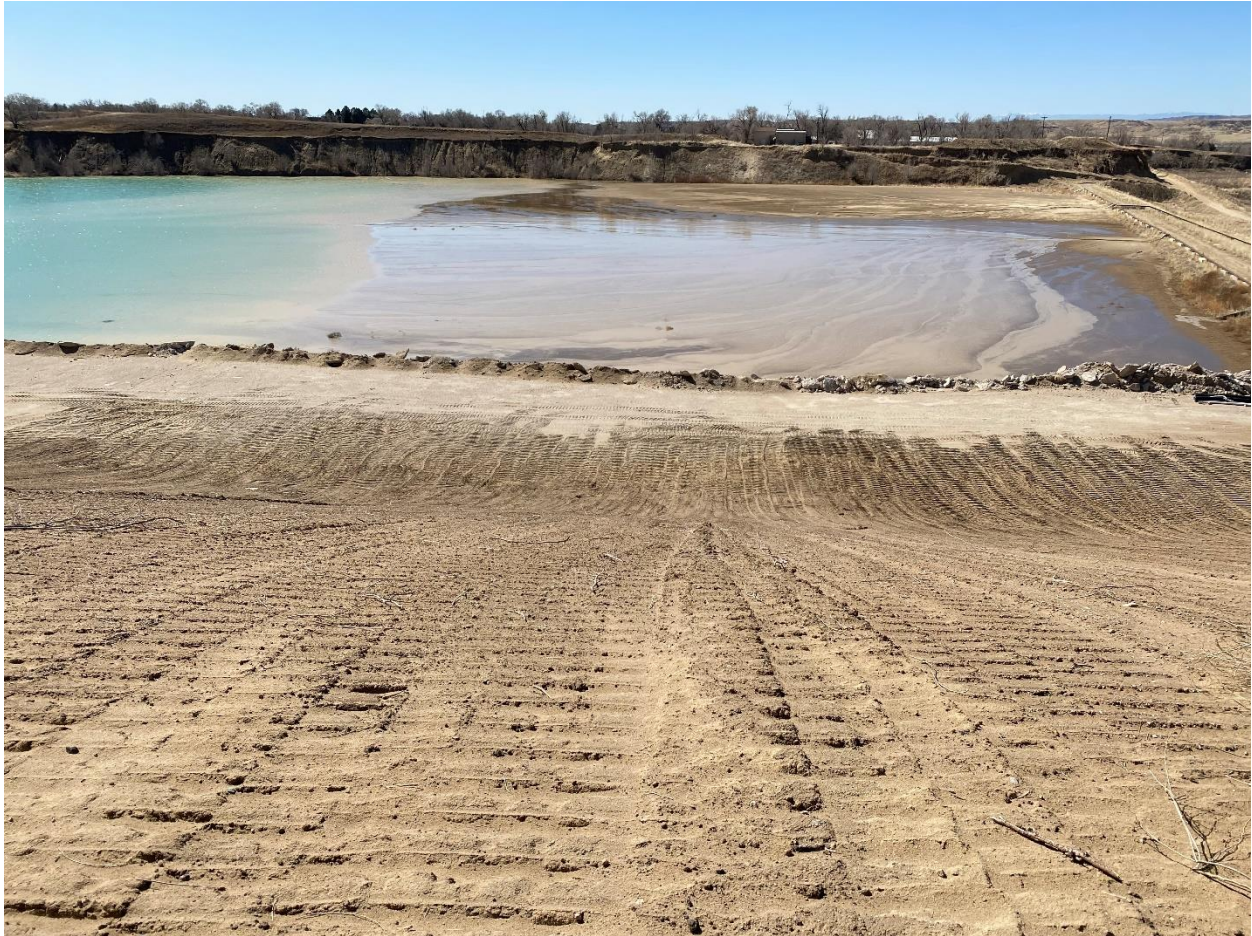
Photo 8. Buttress slope looking south

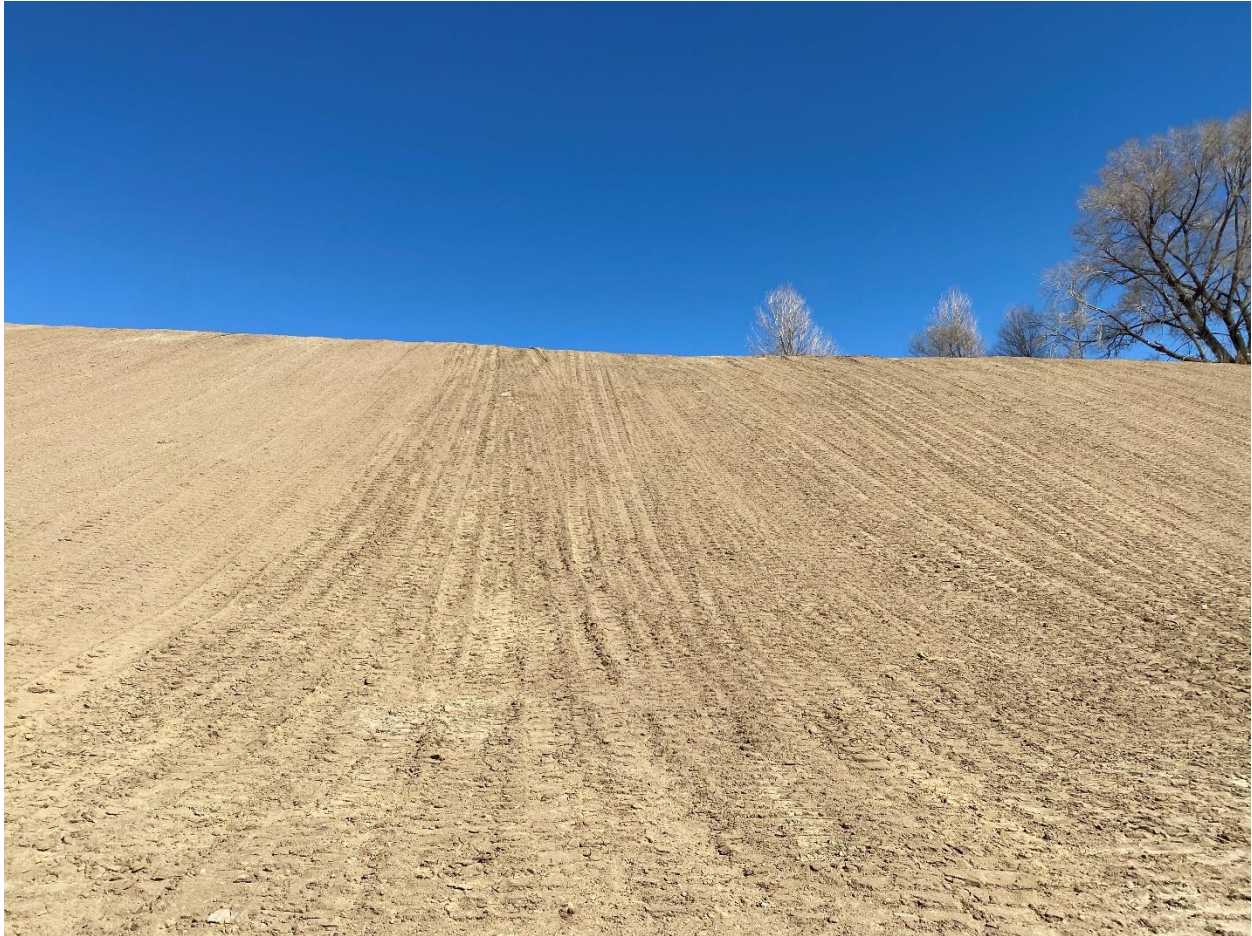
Photo 9. Buttress slope looking north

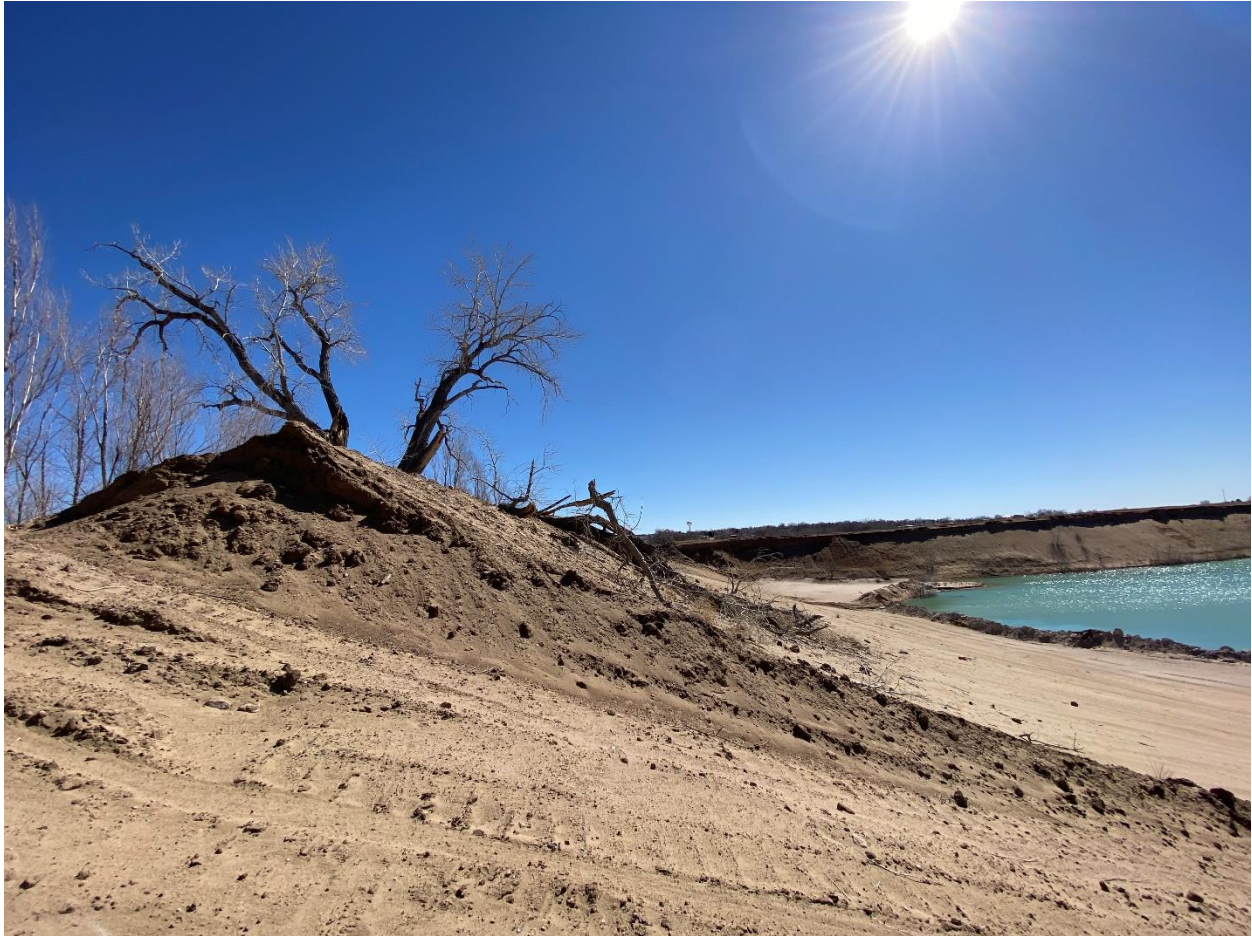
Photo 10. Buttress slope looking east, fallen tree within stockpiled material and buttress slope

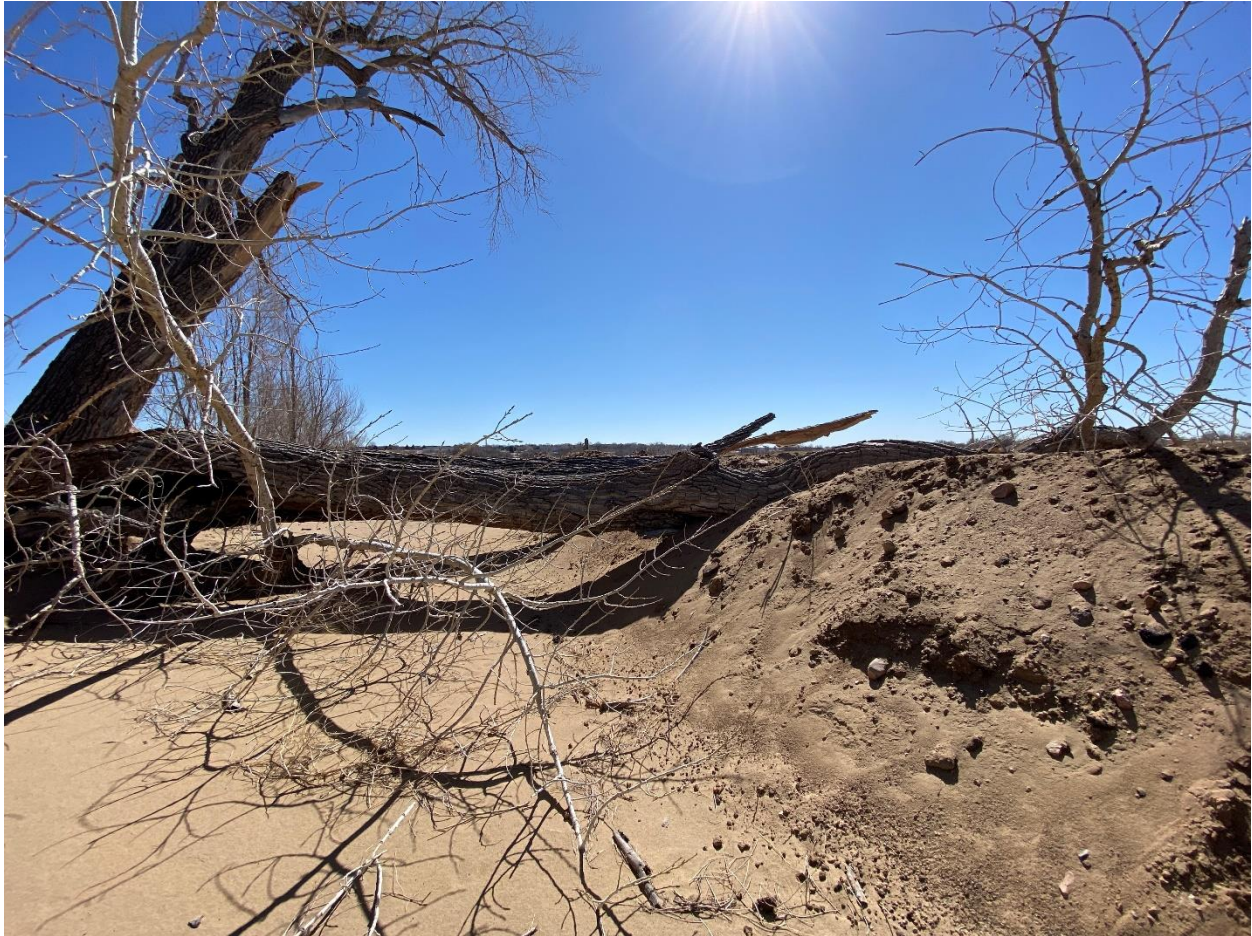
Attached is the Daniels Pit 2 monthly slope stability monitoring report for April, 2022. Please note that due to the recent windstorms, a tree fell (from the FMIC property) on the stockpiled material and partially on the buttress slope, presenting safety hazards and access to the work area of final lift placement. Fountain Mutual Irrigation Company removed some of the fallen branches away from the ditch and is currently tending to the remainder. I will keep you posted.

Photo 11. Fallen tree on stockpiled material for final lift and blocking access road
