## Elk Creek Mine - April 2022 Partial Inspection Report

## Denver Field Branch Inspection Narrative

Permittee:	Oxbow Mining, LLC
Facility:	Elk Creek Mine
Permit No:	C-1981-022
Date of Inspection:	April 5, 2022
Inspection Type:	Partial oversight
Weather:	Partly cloudy, mild, and windy
Representative(s):	Doug Smith
DRMS:	Leigh Simmons
OSMRE Official(s):	Dan MacKinnon (Badge #554) and Brook Zeller

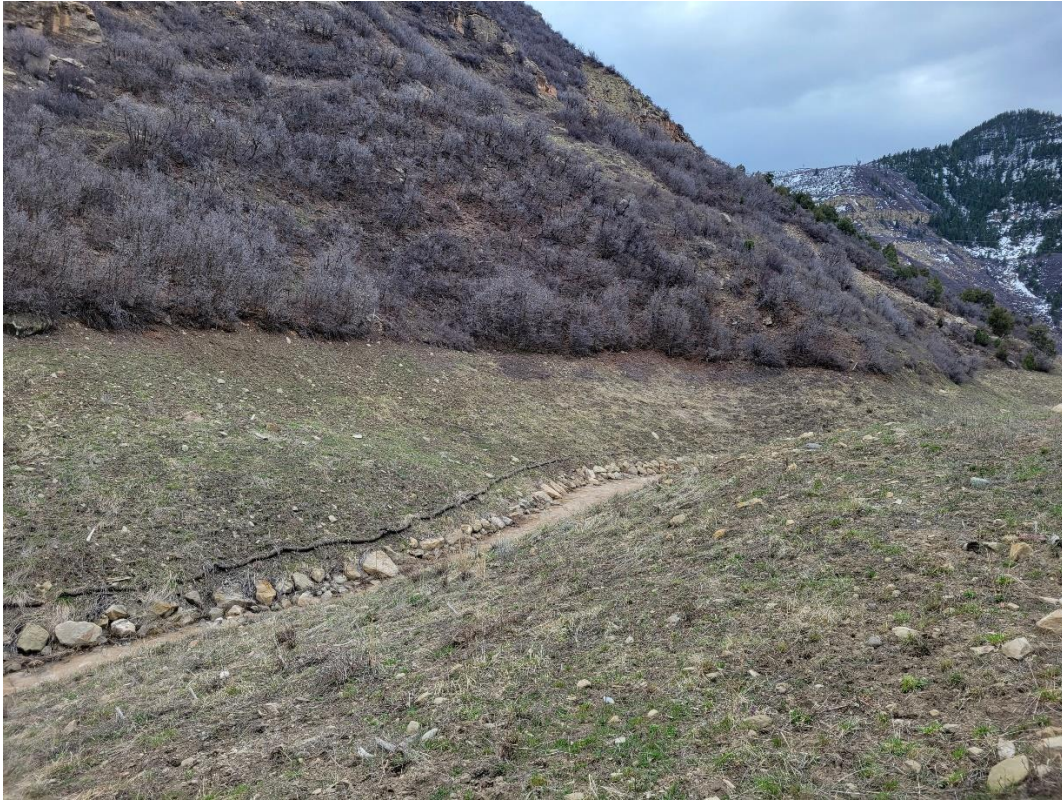
**Upper and lower reclaimed Elk Creek channel.** Both the upper and lower portions of the reclaimed Elk Creek channel was stable at the time of inspection. See figures 1-3. Vegetation was beginning to fill in, though much had been browsed by wildlife. Vegetation sufficiently controlled erosion with no erosional features identified. Work had been recently done to mitigate undercutting of the culvert in a lower portion of the Elk Creek channel, and it was fully functional at the time of inspection. See figure 4.

figure 1 – Upper portion of reclaimed Elk Creek Channel looking southeast.

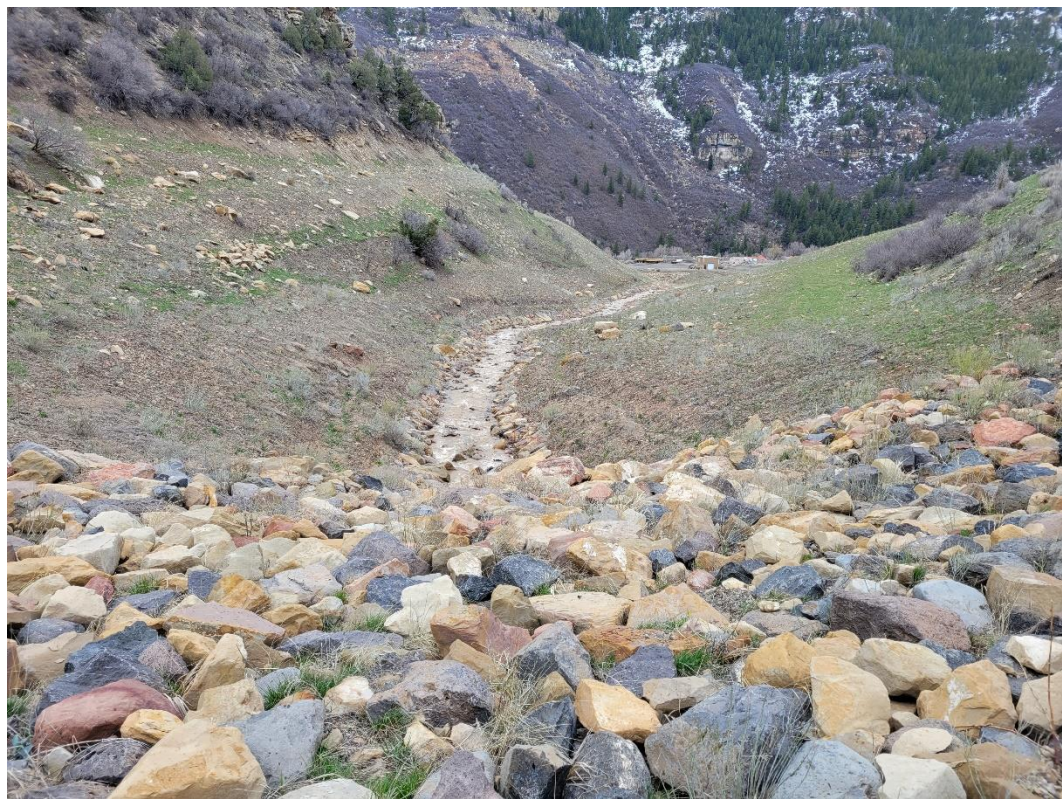
figure 2 – Lower portion of reclaimed Elk Creek channel looking south.

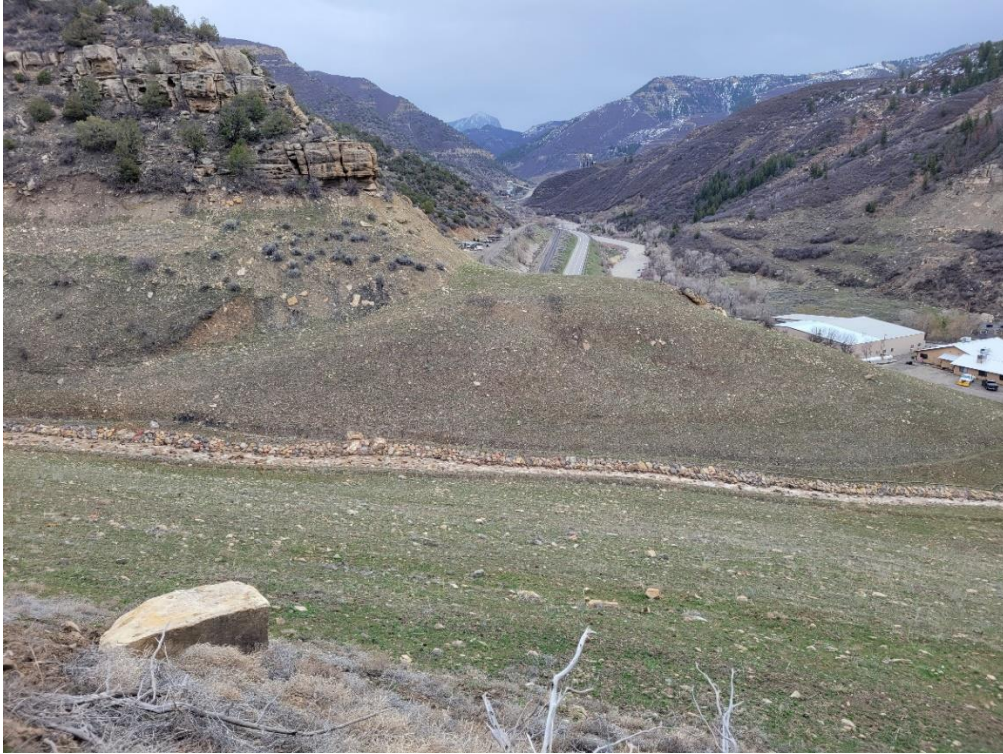
figure 3 – Lower portion of reclaimed Elk Creek channel looking east.

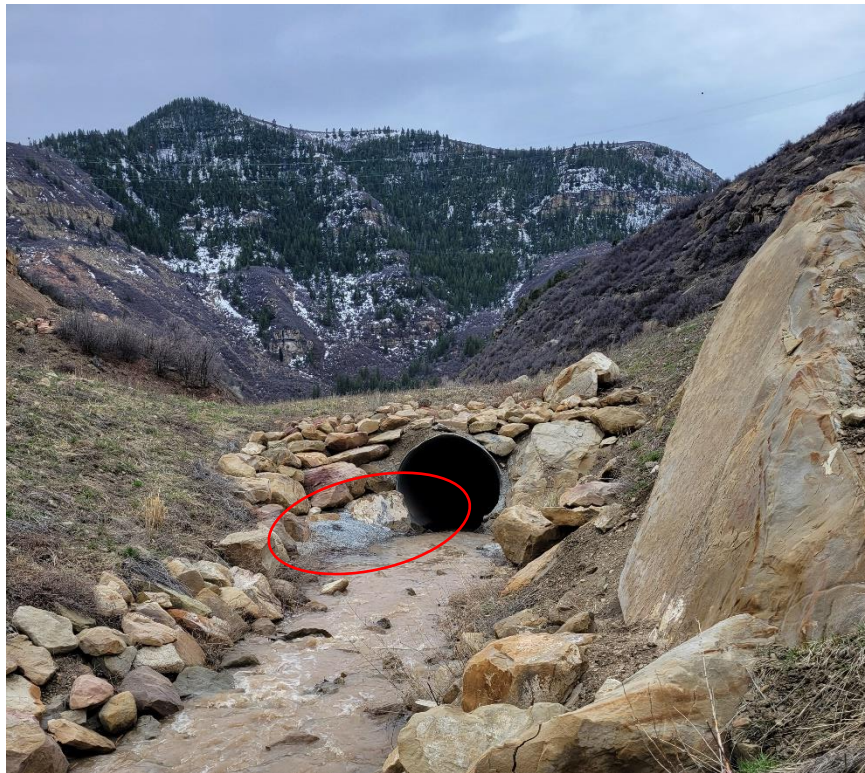
figure 4 – Mitigation of culvert undercutting with concrete on the upper portion of the reclaimed Elk Creek channel.

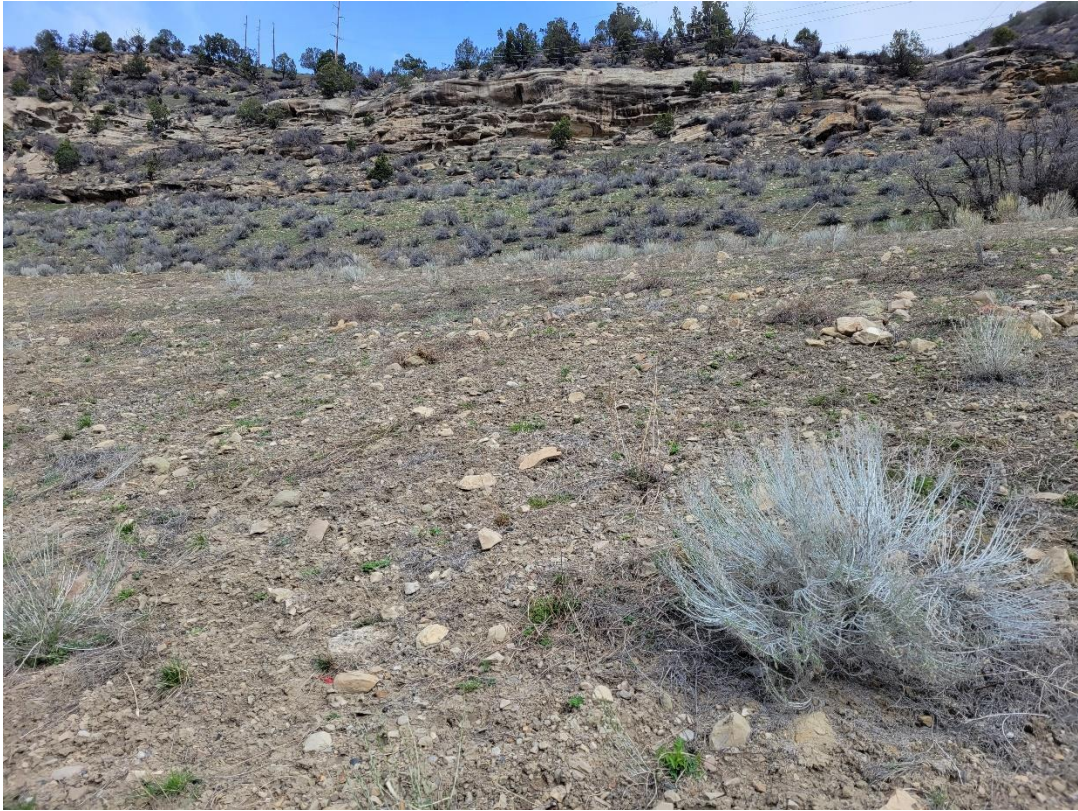
**East yard coal waste pile.** The East Yard was stable at the time of inspection with no signs of erosion. Vegetation was slightly sparse in some areas due to heavy wildlife browsing and it being early in the growing season; however, it appeared sufficient to control erosion and consistent with the vegetation mix of surrounding phase III released areas. See figure 5.

figure 5 – East Yard looking north.

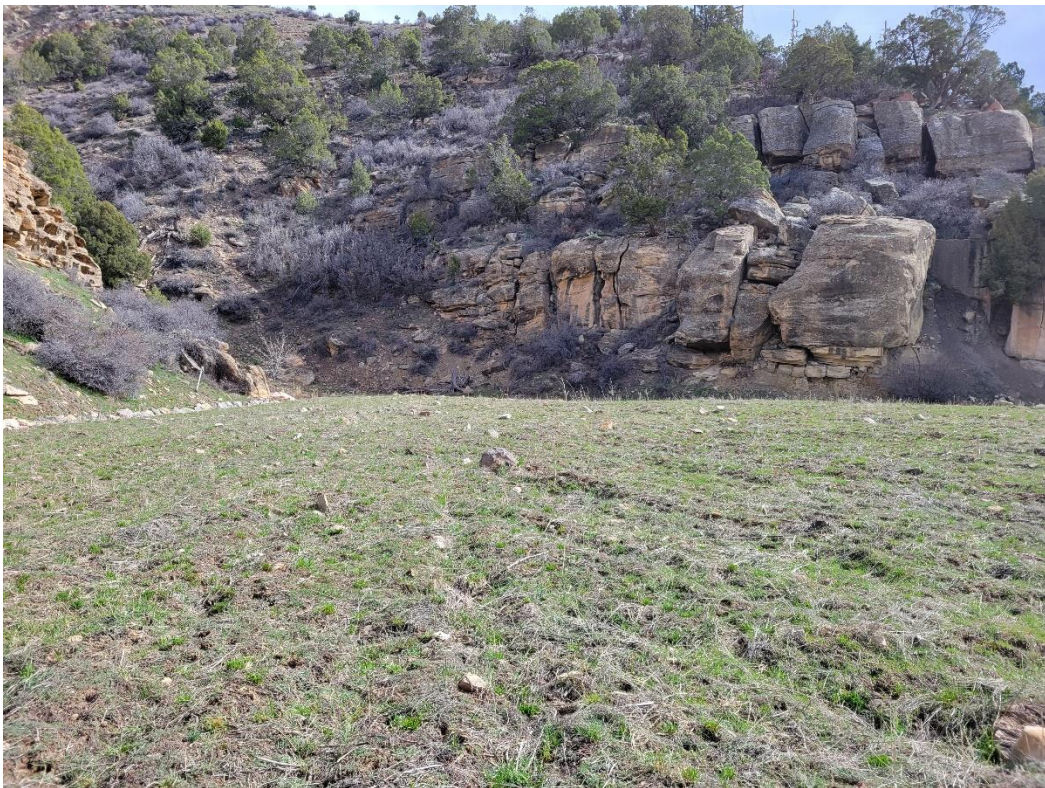
**Upper and lower portions of west valley fill.** Both the upper and lower portions of the west valley fill waste pile were stable and well vegetated with no erosional features. There were signs of heavy wildlife browsing and deer were seen nearby. See figures 6 and 7.

figure 6 – Upper portion of west valley fill looking north.

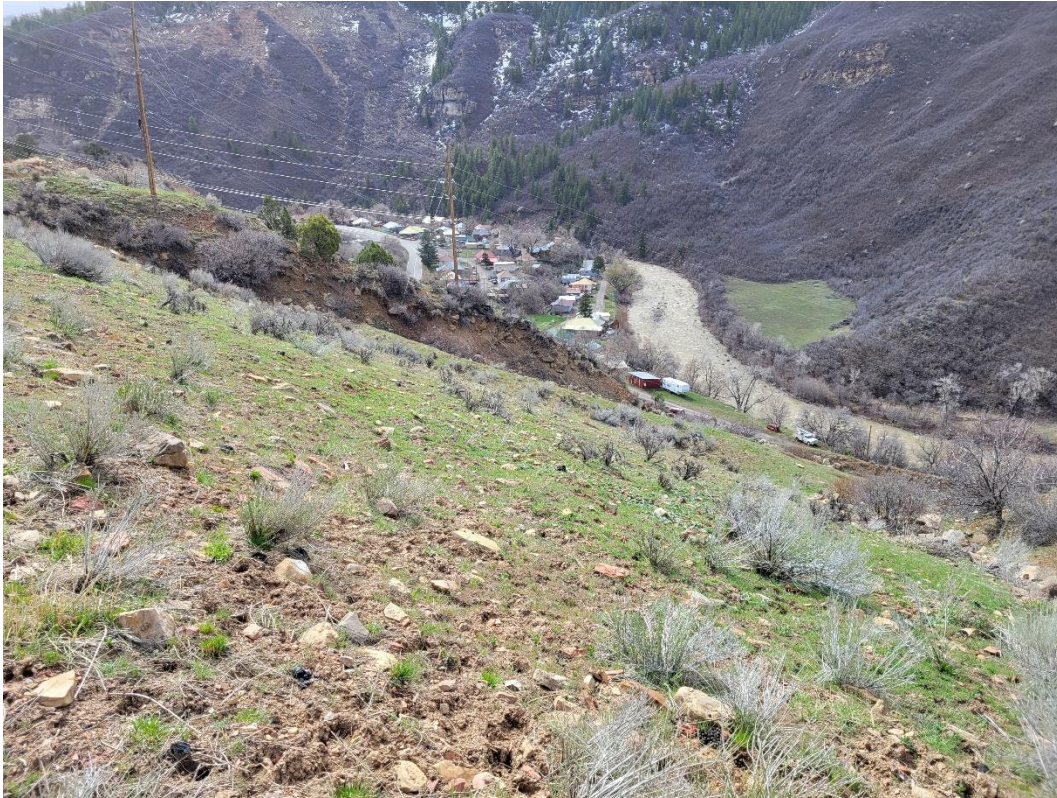
figure 7 – Lower portion of west valley fill looking southeast.

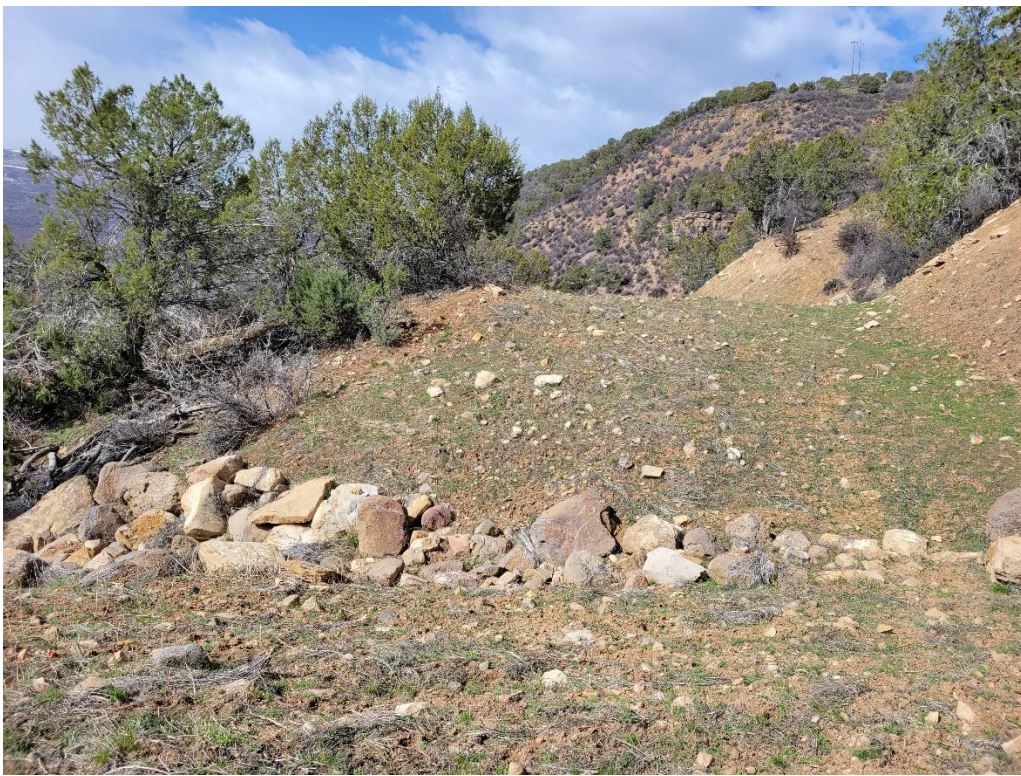
**Reclaimed road from west valley fill to II west fill.** The reclaimed road was stable and well vegetated with signs of wildlife browsing. No water was flowing in the constructed drainages at the time of inspection. See figure 8.

figure 8 – Reclaimed road looking west towards II West fill.

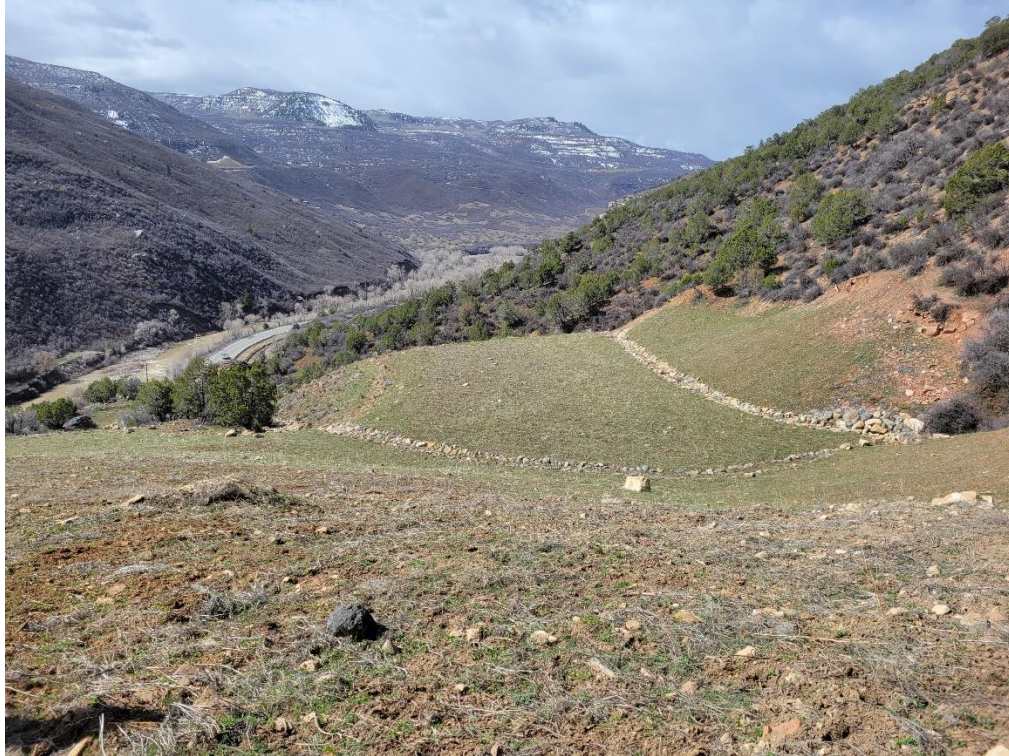
**II west fill and topsoil storage area.** Both the II west fill and topsoil storage areas were stable and well vegetated with no signs of erosion. Vegetation appeared sufficient to control erosion even with signs of heavy wildlife browsing. See figures 9-12.

figure 9 – II west reclaimed topsoil pile in the foreground looking west with the II west reclaimed fill in the background outlined by constructed drainage channels.

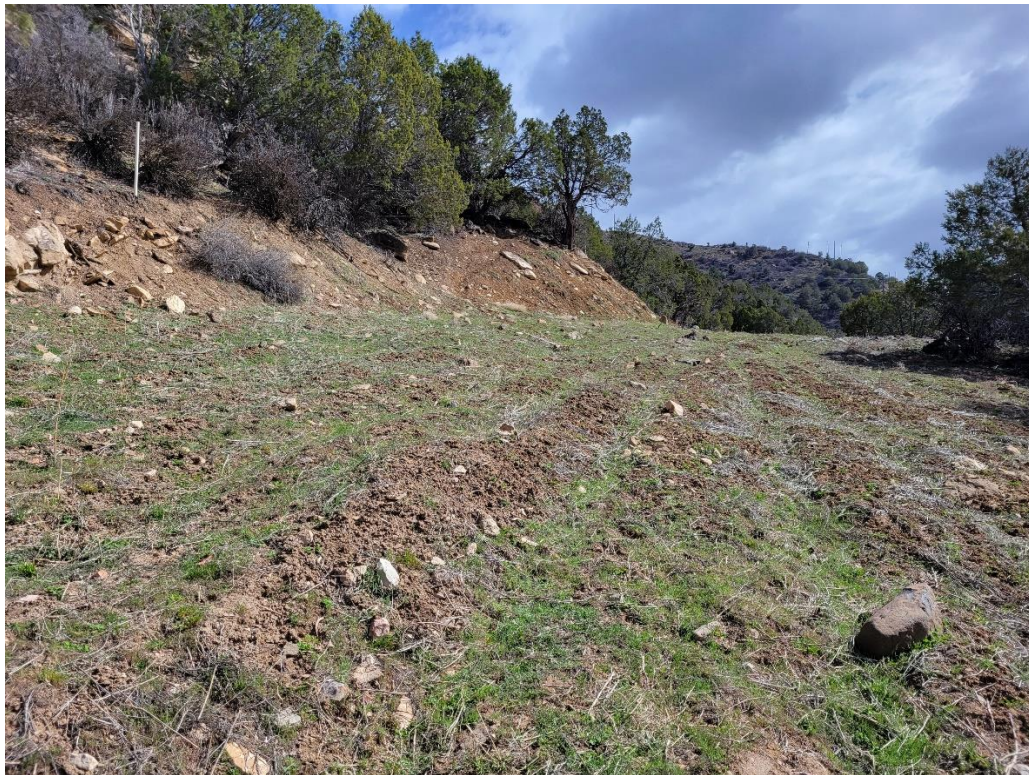
figure 10 – II west reclaimed topsoil storage area looking east.

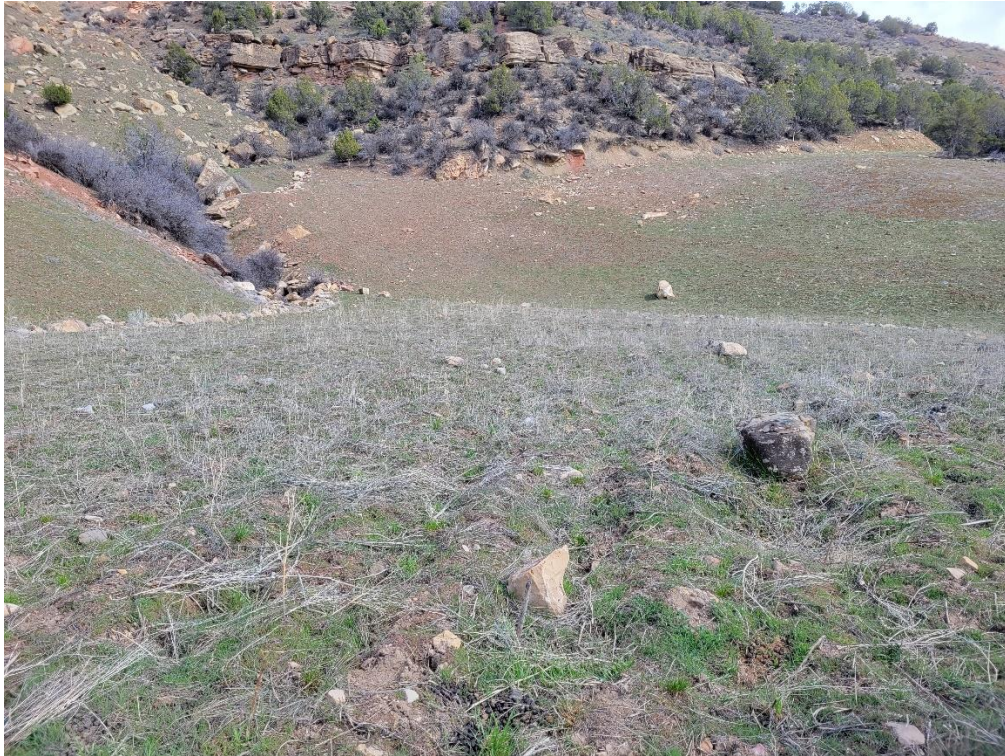
figure 11 – II west reclaimed fill looking northeast.

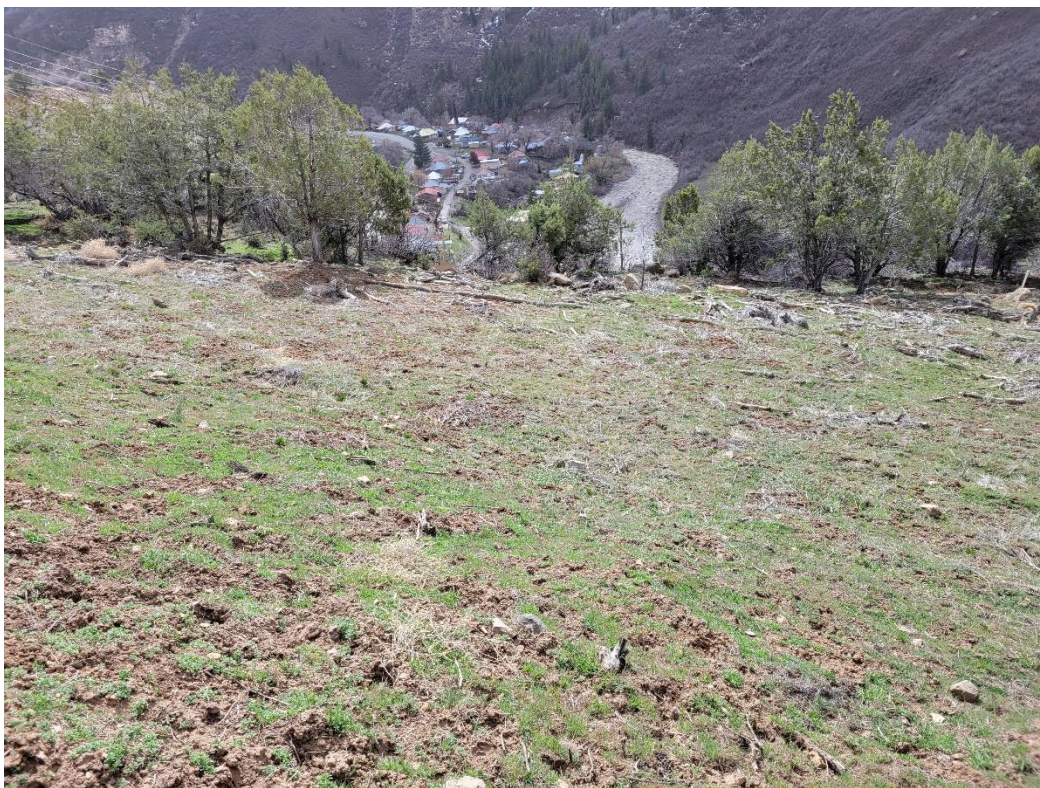
figure 12 – II west reclaimed fill looking southeast.
