MINERALS PROGRAM INSPECTION REPORT

MINE NAME: Miller Gravel Pit	MINE/PROSPECTING ID#: M-1982-112	MINERAL: Sand and gravel	COUNTY: Elbert
INSPECTION TYPE: Monitoring	INSPECTOR(S): Amy Eschberger	INSP. DATE: March 24, 2022	INSP. TIME: 10:00
OPERATOR: Schmidt Construction Company	OPERATOR REPRESENTATIVE: Mark Heifner	TYPE OF OPERATION: 112c - Construction Regular Operation	
REASON FOR INSPECTION: Normal I&E Program	BOND CALCULATION TYPE: Partial Bond	BOND AMOUNT: \$146,646.00	
DATE OF COMPLAINT: NA	POST INSP. CONTACTS: None	JOINT INSP. AGENCY: None	
WEATHER: Clear	INSPECTOR'S SIGNATURE:

M-1982-112 / Miller Gravel Pit / Schmidt Construction Company / 112c

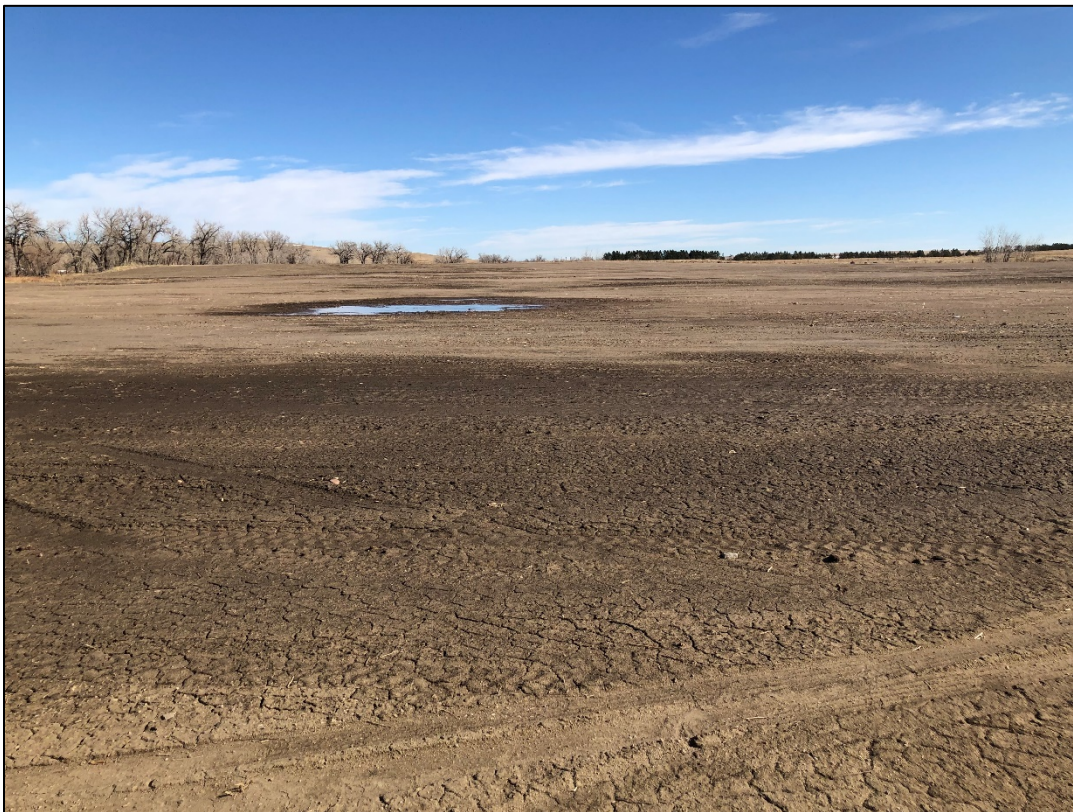
Photo 1. View looking north across northern portion of disturbed area which has been graded and retopsoiled. This area will be seeded this spring.

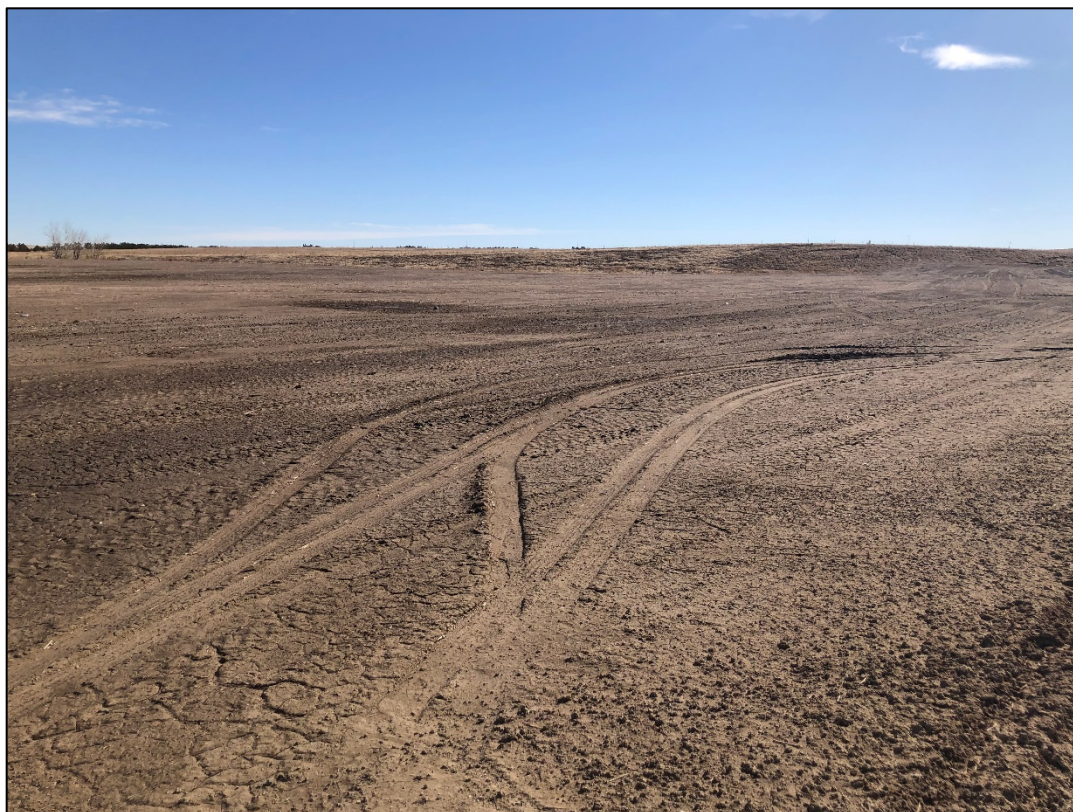
Photo 2. View looking northeast across northern portion of disturbed area which has been graded and retopsoiled. This area will be seeded this spring.

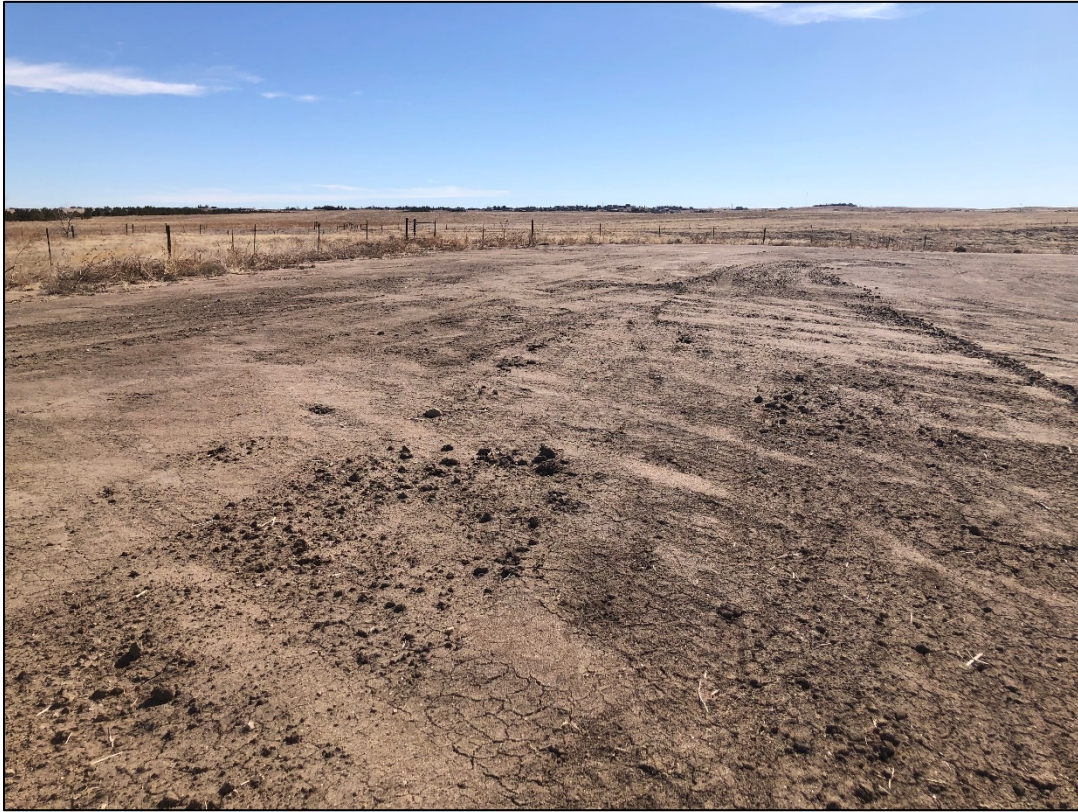
Photo 3. View looking east across northern slope of disturbed area which has been graded to 3H:1V or flatter and retopsoiled. This area will be seeded this spring.

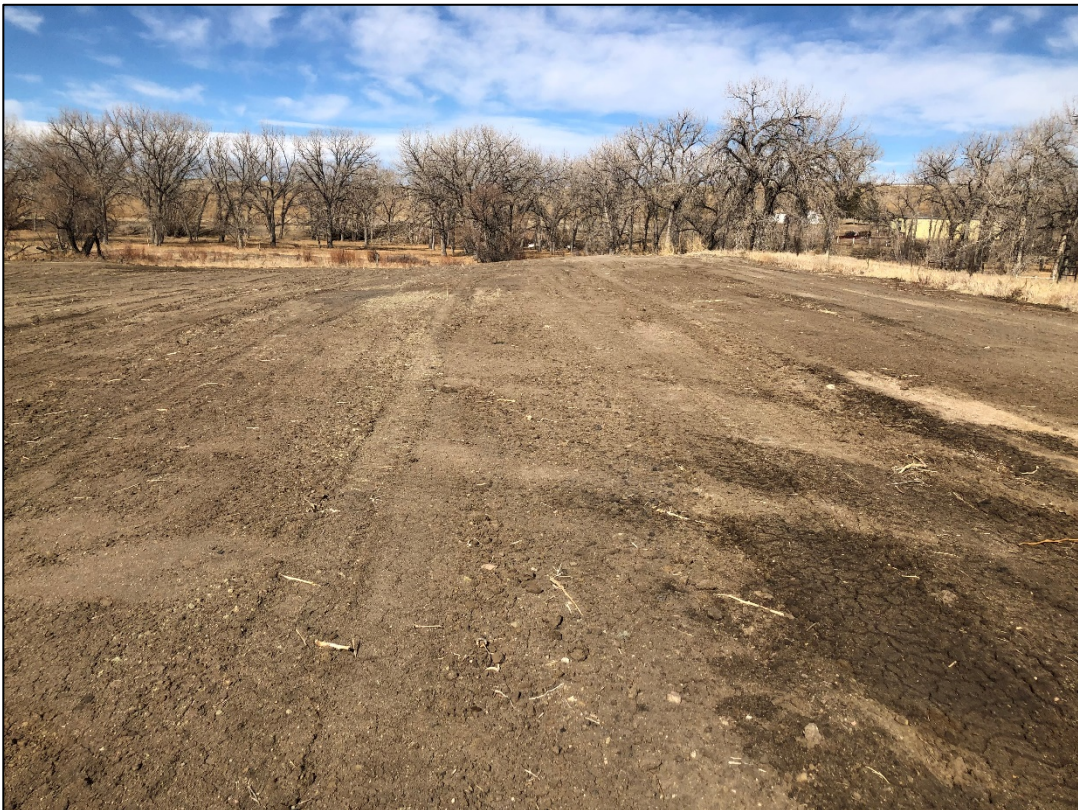
Photo 4. View looking west across northern slope of disturbed area which has been graded to 3H:1V or flatter and retopsoiled. This area will be seeded this spring.

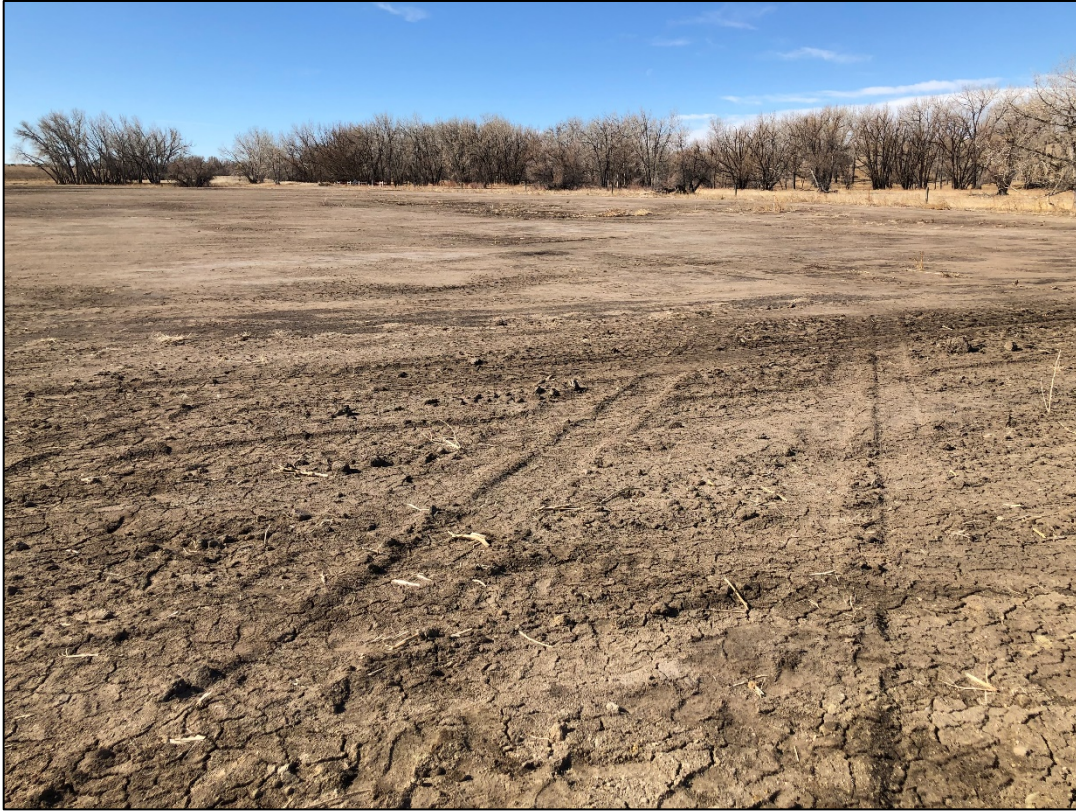
Photo 5. View looking southwest across northern portion of disturbed where wash pond has been backfilled and the area graded and retopsoiled. This area will be seeded this spring.

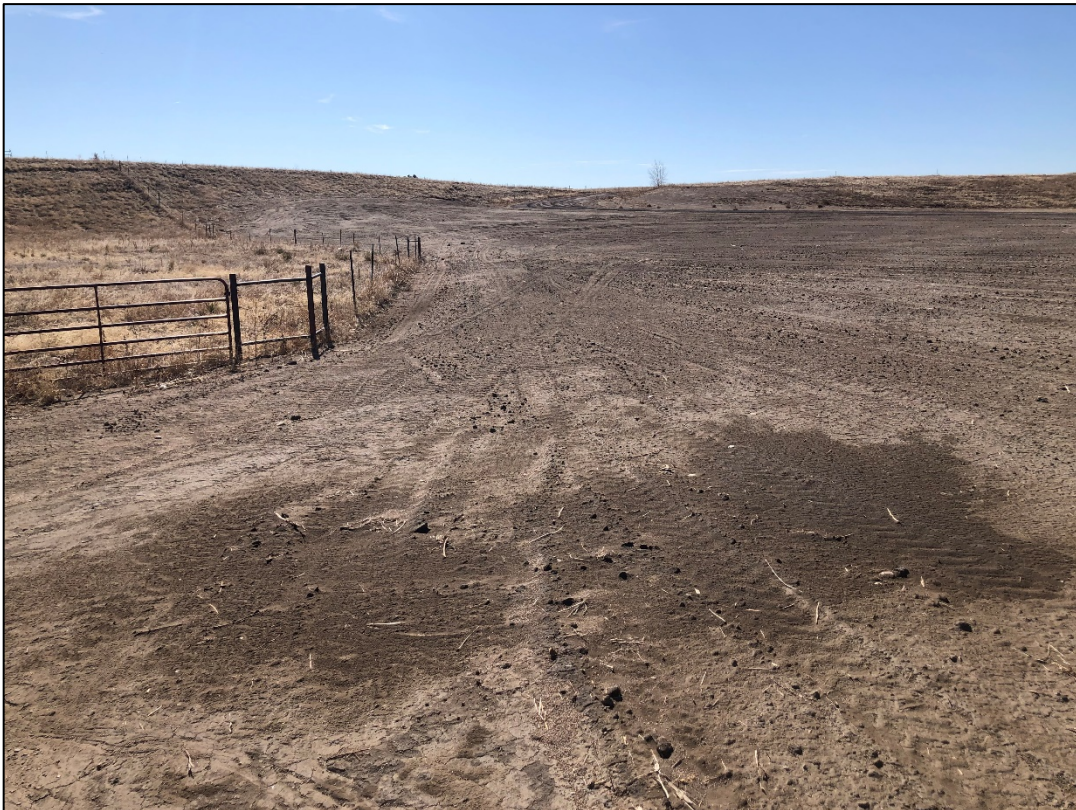
Photo 6. View looking southeast across eastern edge of disturbed area that was raised to prevent future flooding of the realigned access road. This area (besides the access road) was retopsoiled and will be seeded this spring.

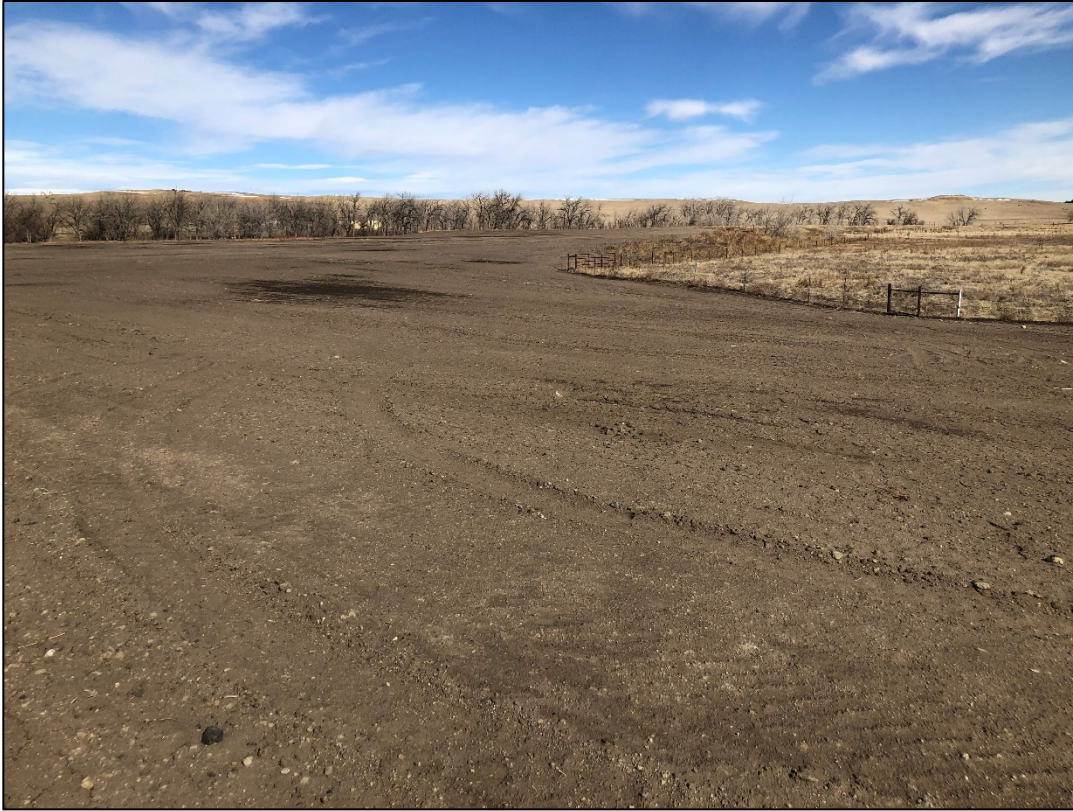
Photo 7. View looking north across eastern edge of disturbed area that was raised to prevent future flooding of the realigned access road. This area (besides the access road) was retopsoiled and will be seeded this spring.

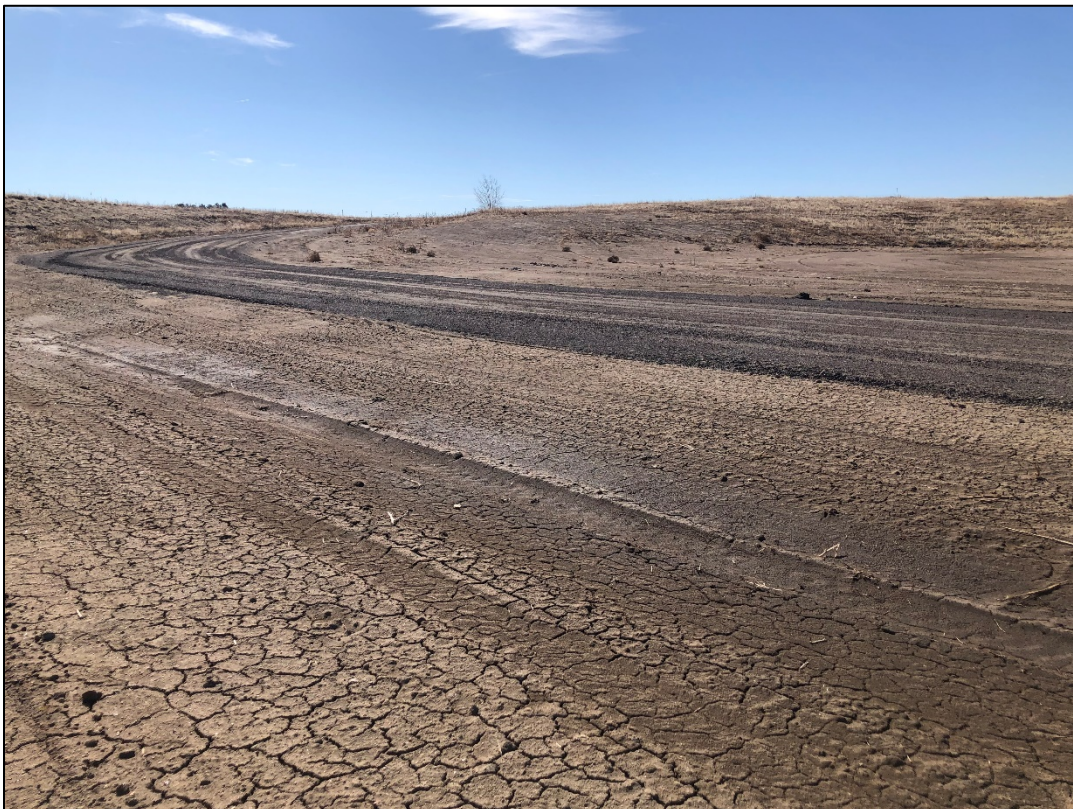
Photo 8. View looking south/southeast at realigned access road (resurfaced with crushed asphalt) which will remain for reclamation.

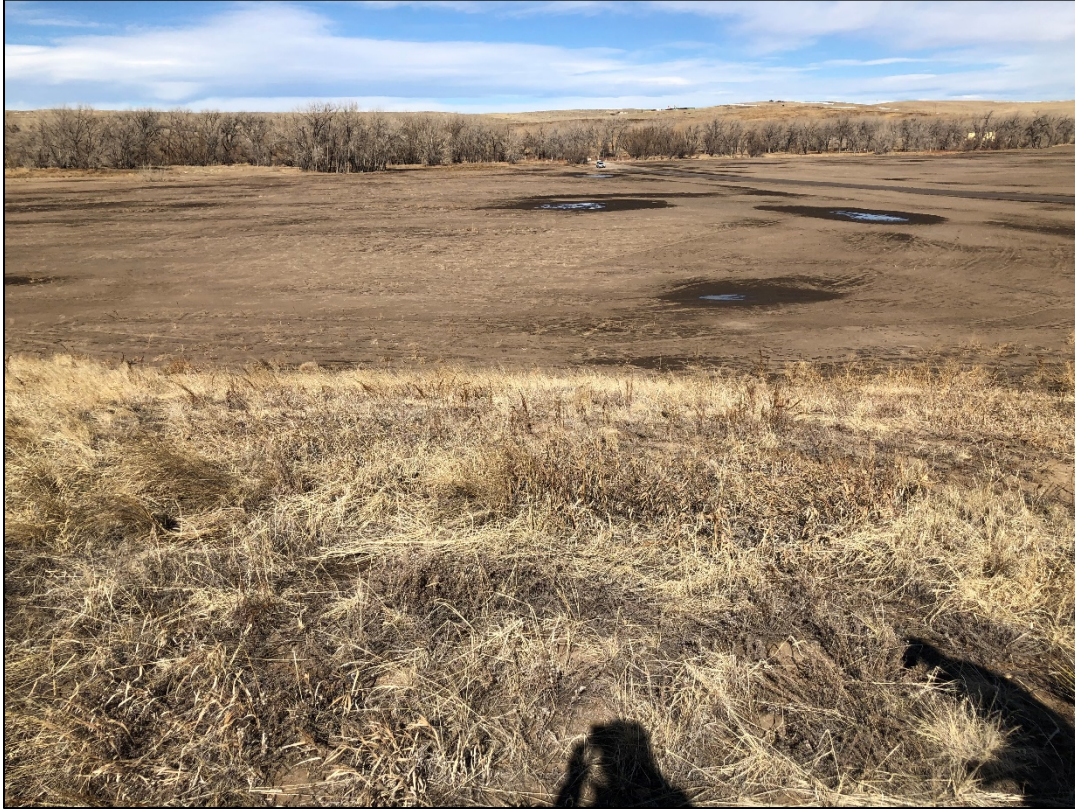
Photo 9. View looking south across southern portion of disturbed area which has been graded and retopsoiled, and will be seeded this spring. Note reclaimed eastern portion of southern pit wall (in foreground) with good grass establishment.

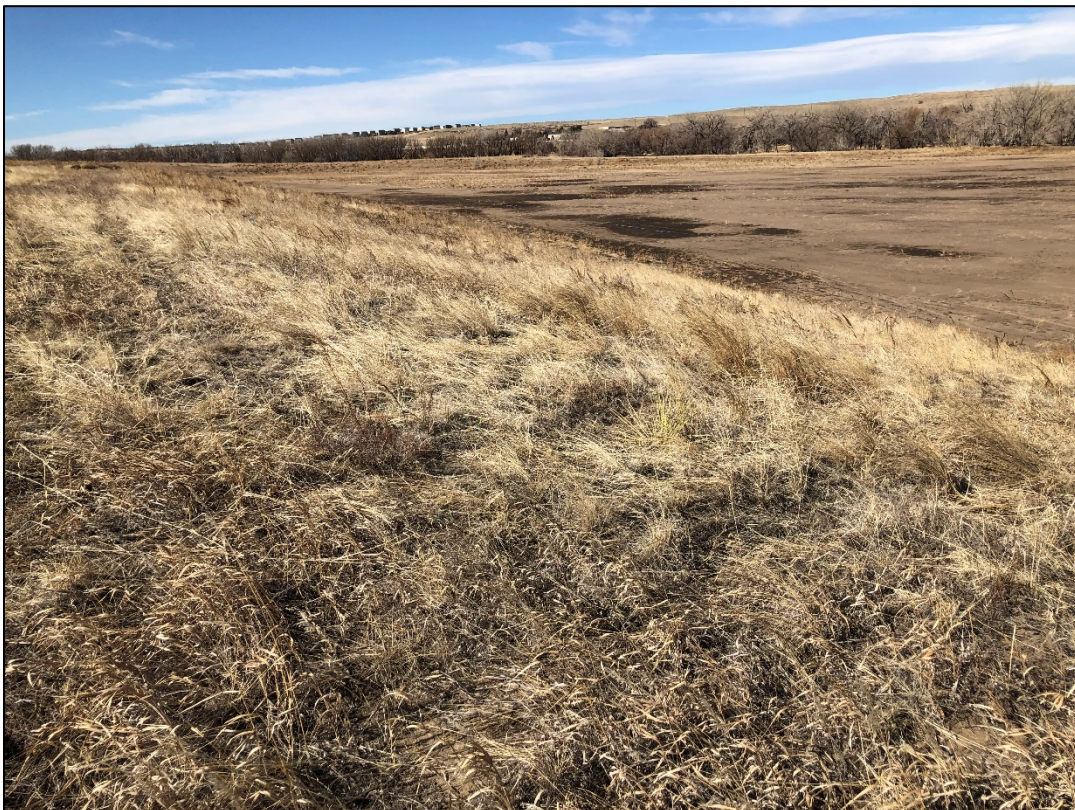
Photo 10. View looking southwest across reclaimed eastern portion of southern pit wall with good grass establishment.

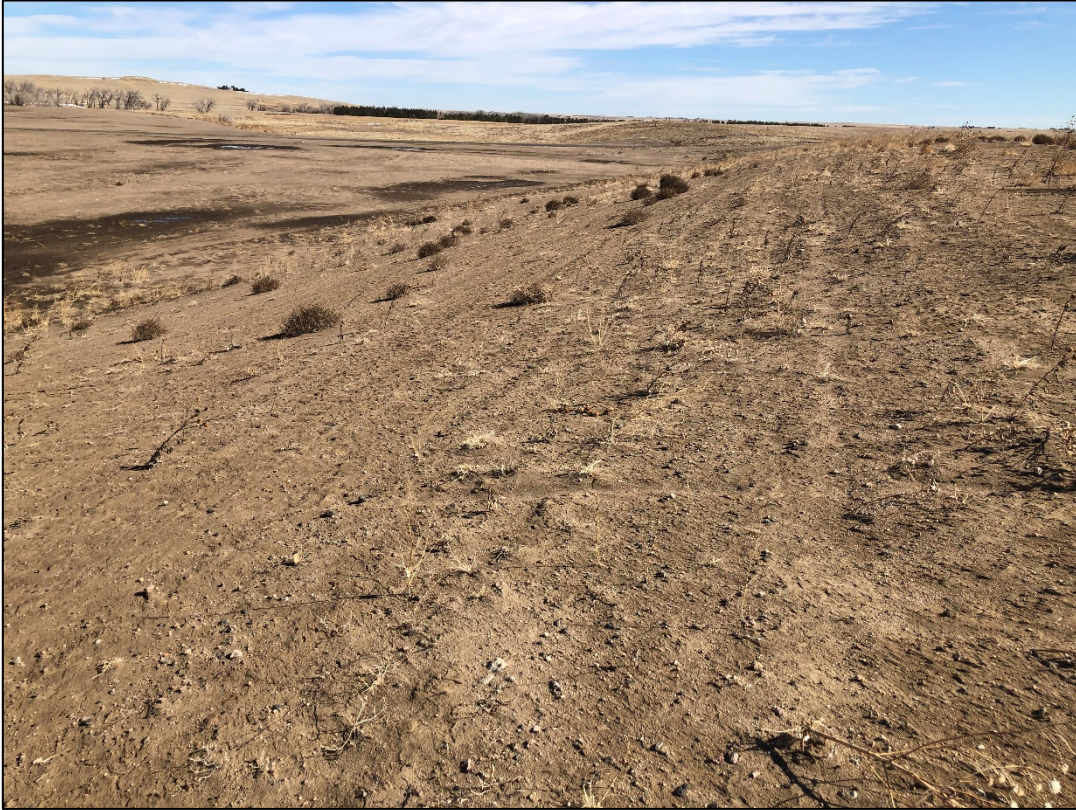
Photo 11. View looking northeast across central portion of southern pit wall which has been graded to 3H:1V or flatter and retopsoiled. This area will be seeded this spring.

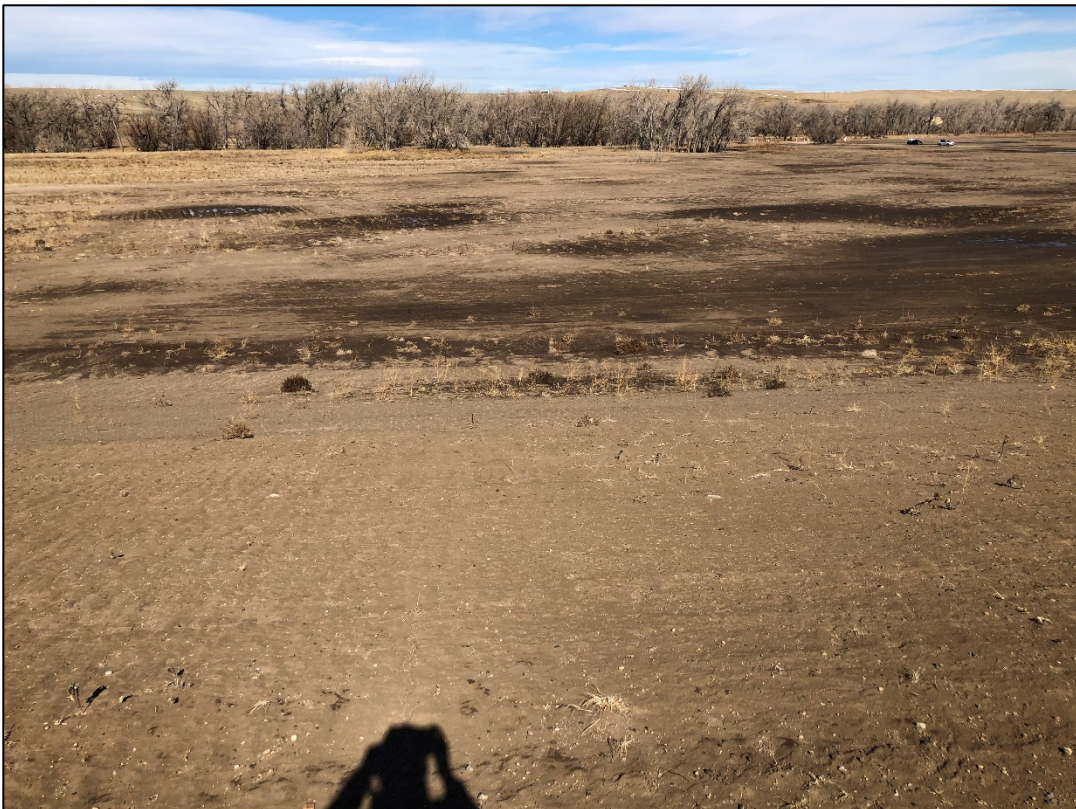
Photo 12. View looking north across southern portion of disturbed area which has been graded and retopsoiled. This area will be seeded this spring.

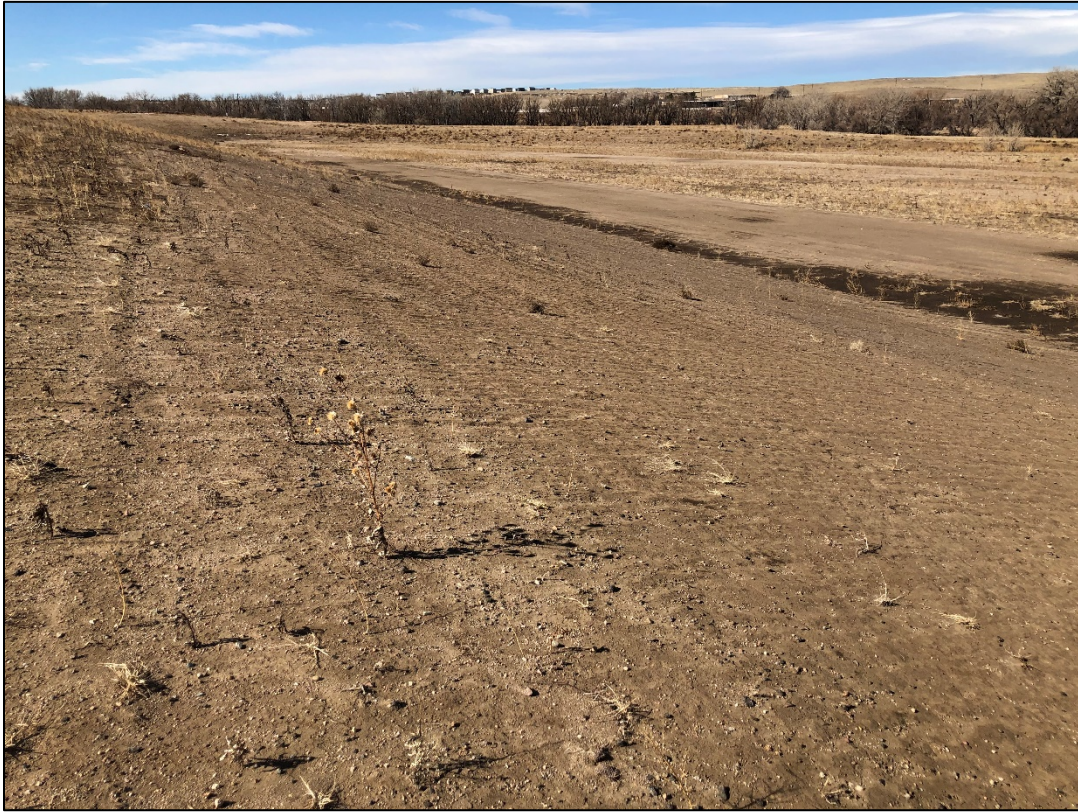
Photo 13. View looking southwest across central portion of southern pit wall which has been graded to 3H:1V or flatter and retopsoiled. This area will be seeded this spring.

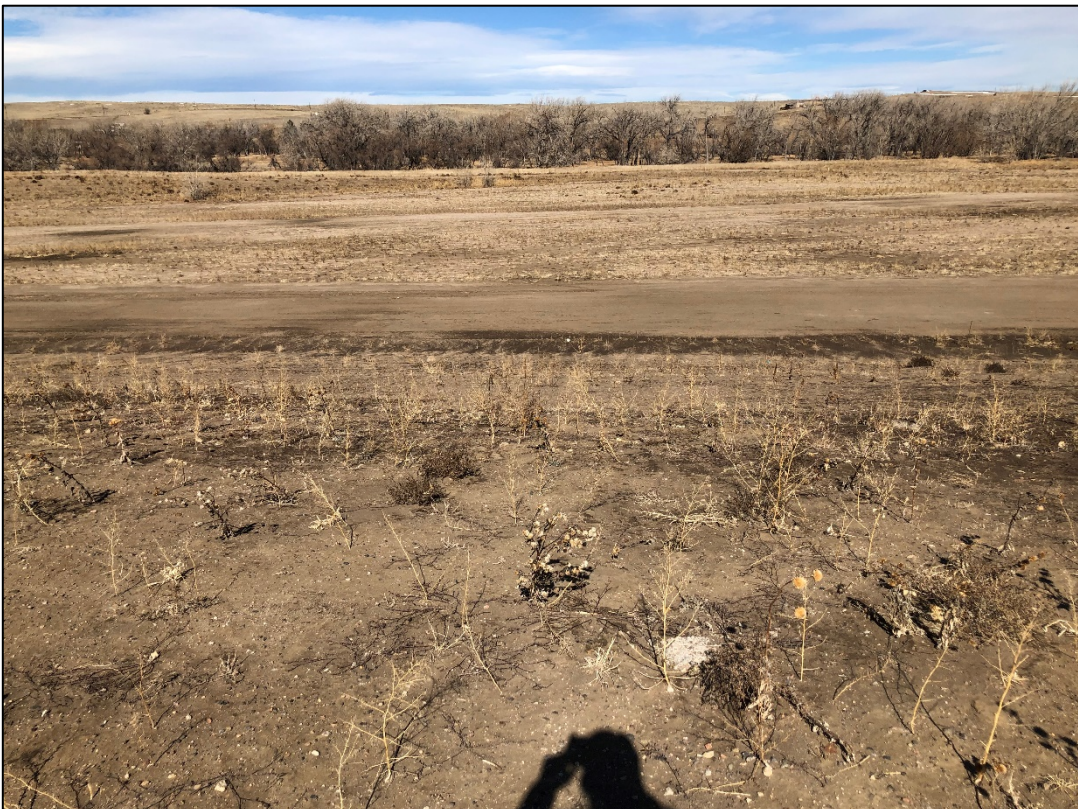
Photo 14. View looking northwest across southern portion of disturbed area which has been graded and retopsoiled. This area will be seeded this spring. Note annual weeds volunteering into this area.

The operator has done a great job with the reclamation grading. As revegetation efforts are underway, the operator should continue to monitor the site and address any erosion or weed issues that might arise during this period. The site will be eligible for release once the land has been revegetated in such a way as to establish a diverse, effective, and long-lasting vegetative cover that is capable of self-regeneration without continued dependence on irrigation, soil amendments or fertilizer, and is at least equal in extent of cover to the natural vegetation of the surrounding area in accordance with Rule 3.1.10(1).

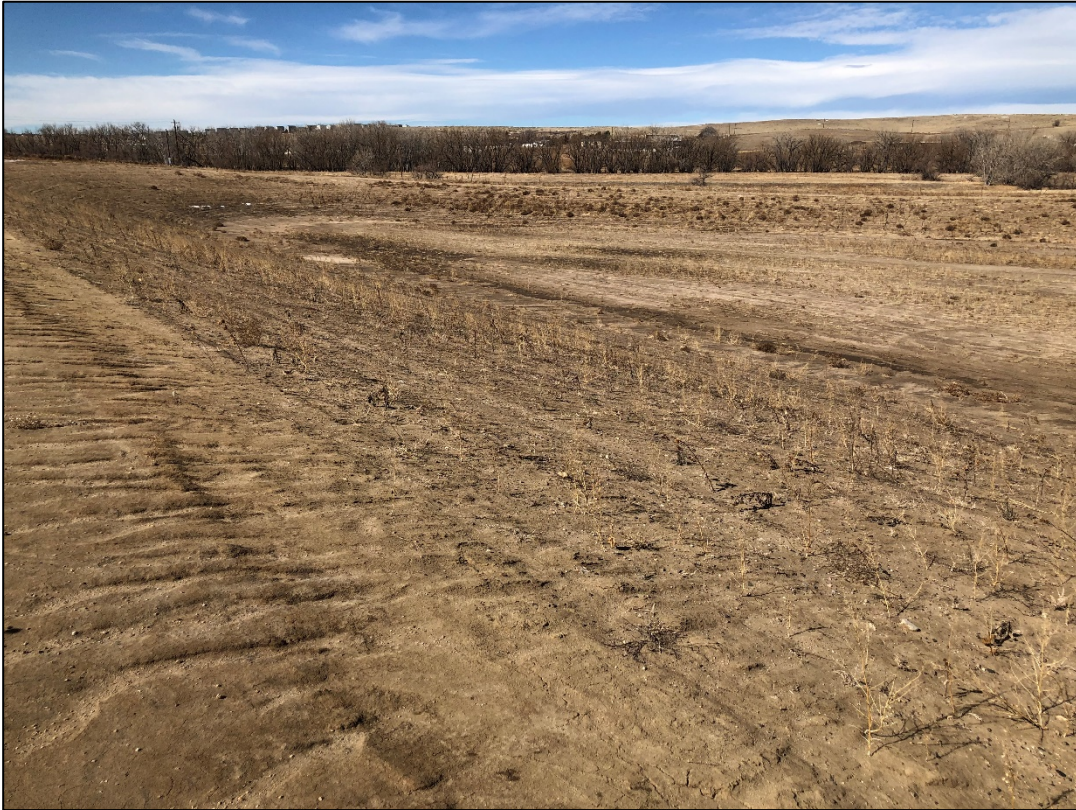
Photo 15. View looking southwest across western portion of southern pit wall which has been graded to 3H:1V or flatter and retopsoiled. This area will be seeded this spring.

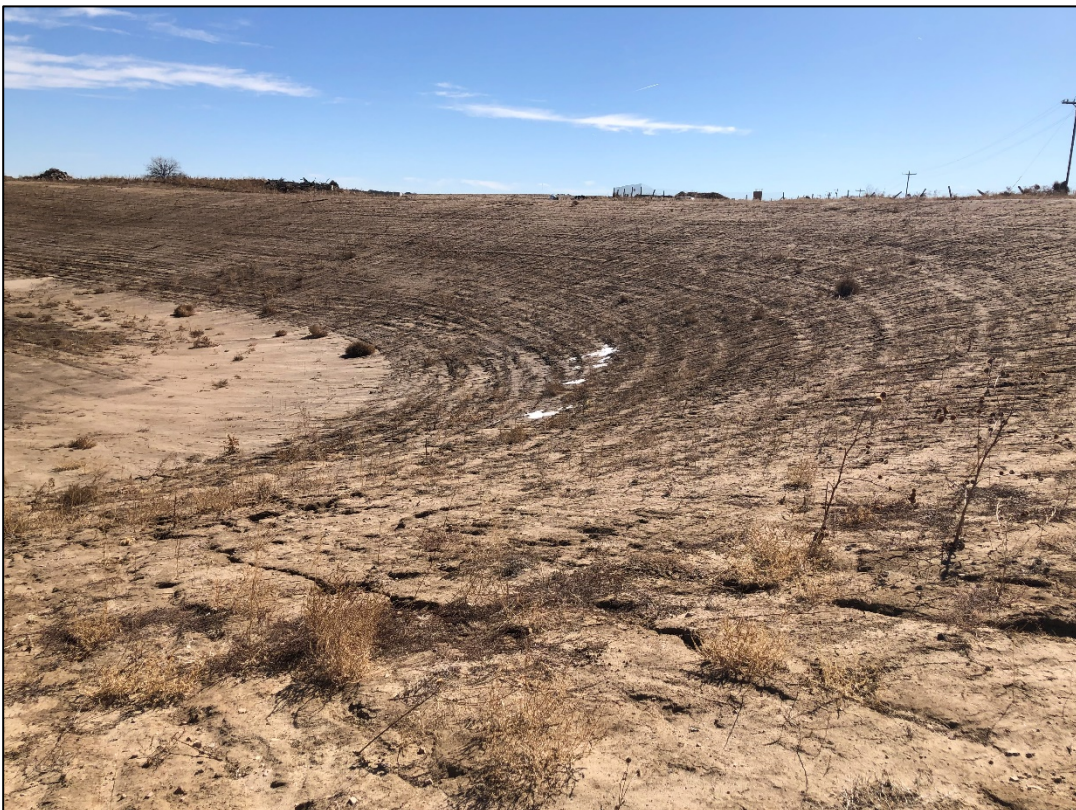
Photo 16. View looking east across southwestern corner of southern pit wall which has been graded to 3H:1V or flatter and retopsoiled. This area will be seeded this spring.

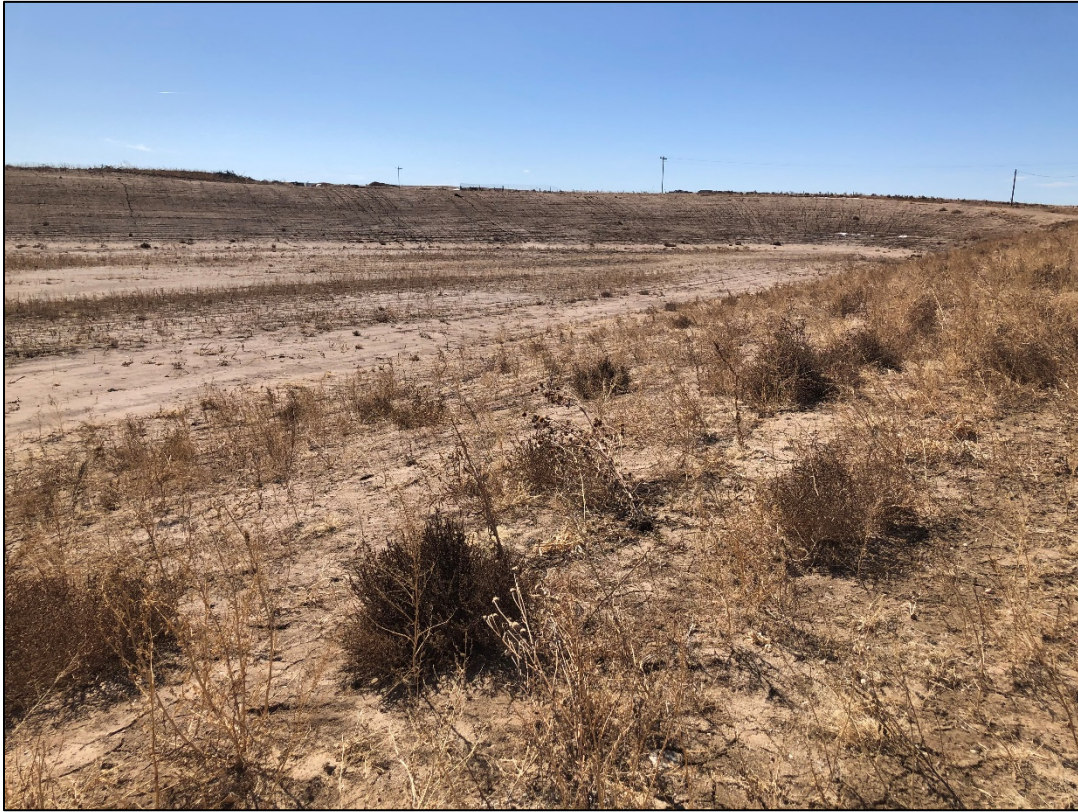
Photo 17. View looking south across western pit wall which has been graded to 3H:1V or flatter and retopsoiled. This area will be seeded this spring. Note annual weeds volunteering into this area.

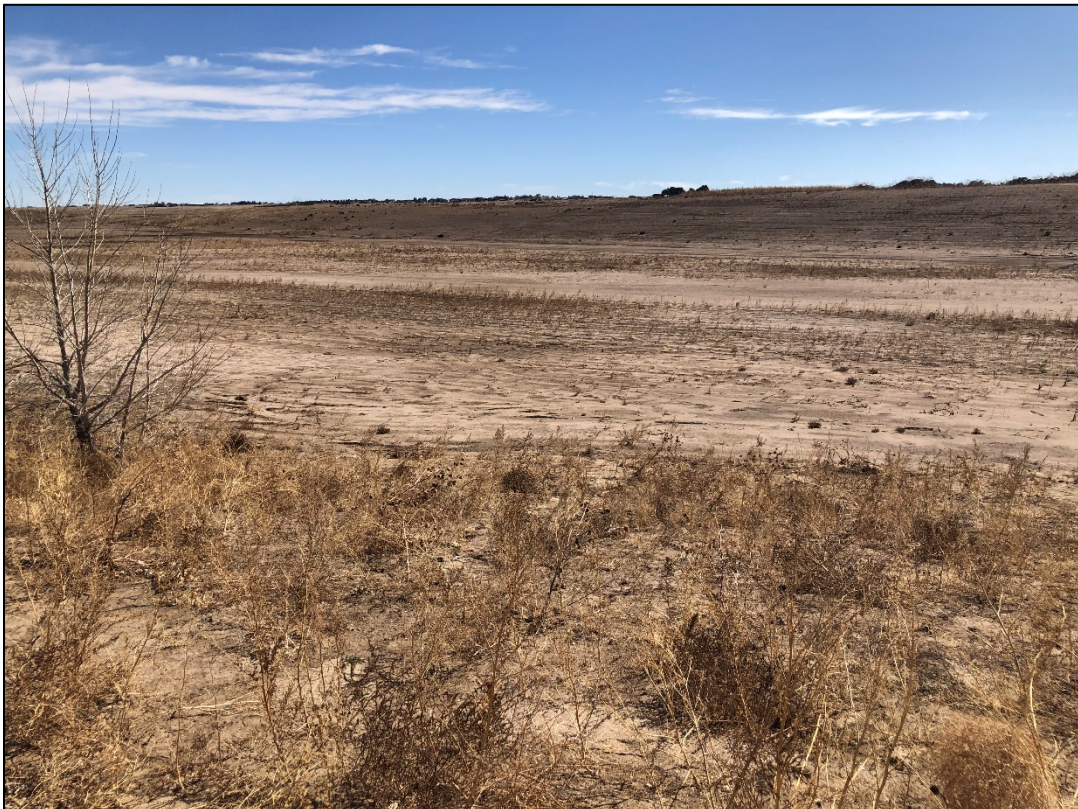
Photo 18. View looking east across western pit wall which has been graded to 3H:1V or flatter and retopsoiled. This area will be seeded this spring. Note annual weeds volunteering into this area.

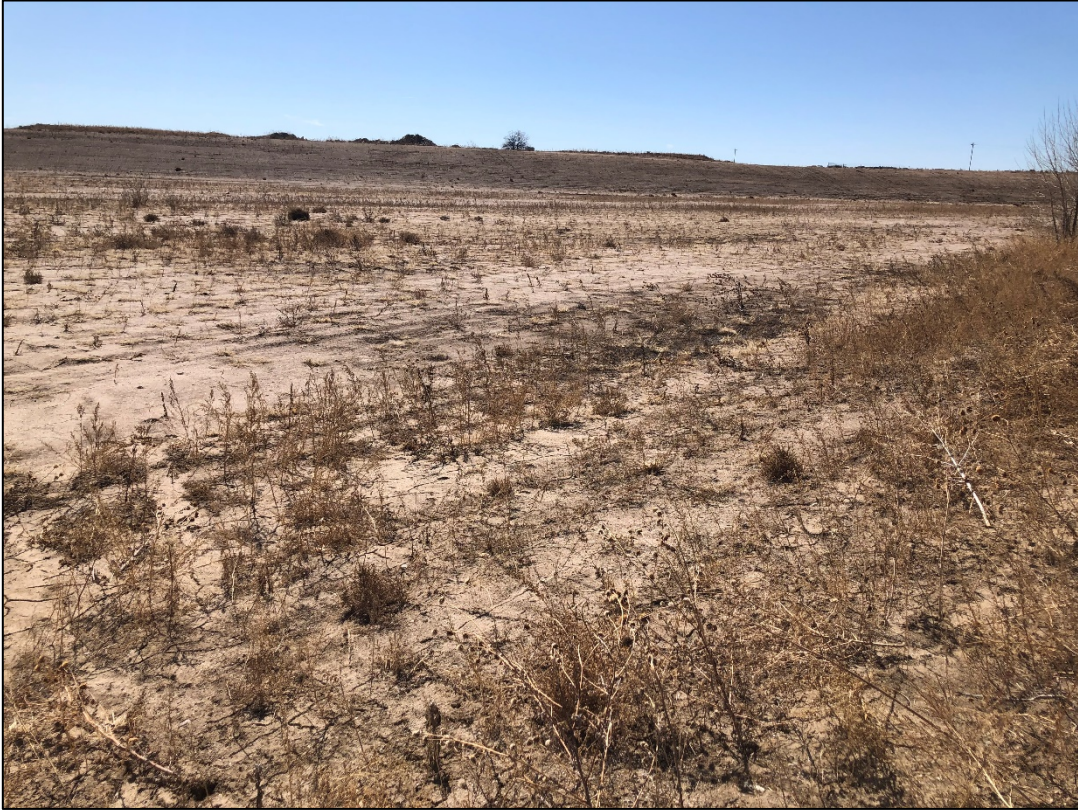
Photo 19. View looking southeast across western pit wall which has been graded to 3H:1V or flatter and retopsoiled. This area will be seeded this spring. Note annual weeds volunteering into this area.

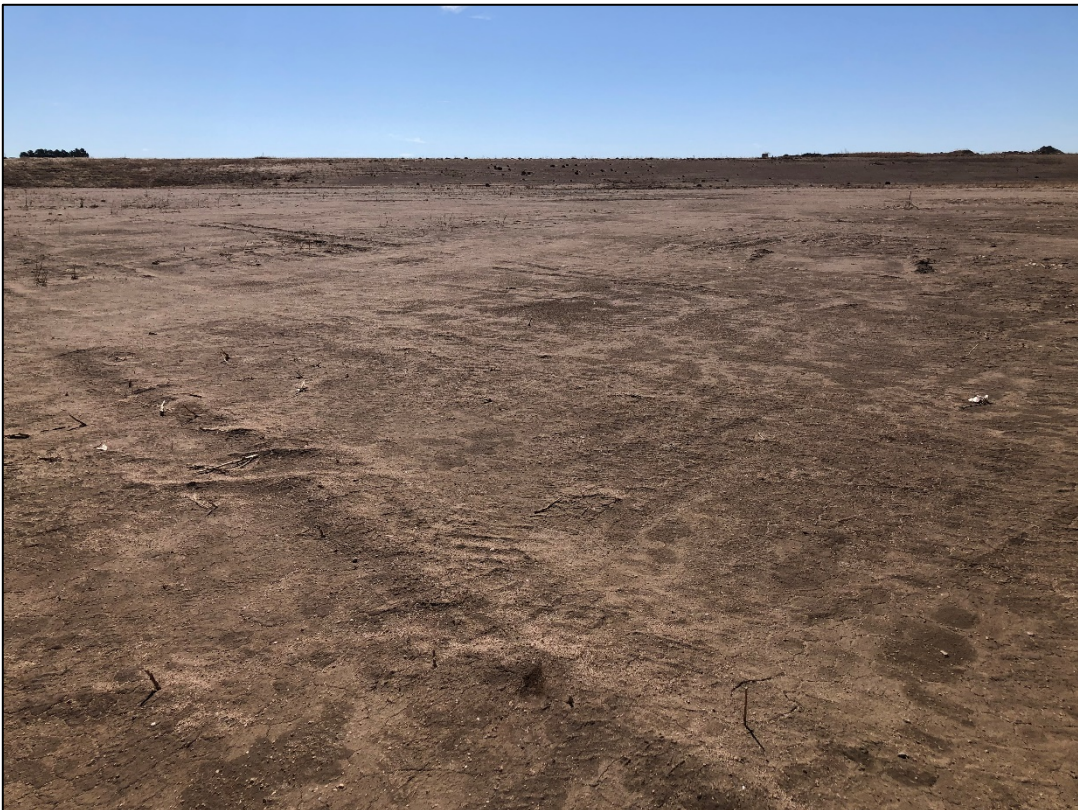
Photo 20. View looking southeast across southern portion of disturbed area which has been graded and retopsoiled. This area will be seeded this spring.

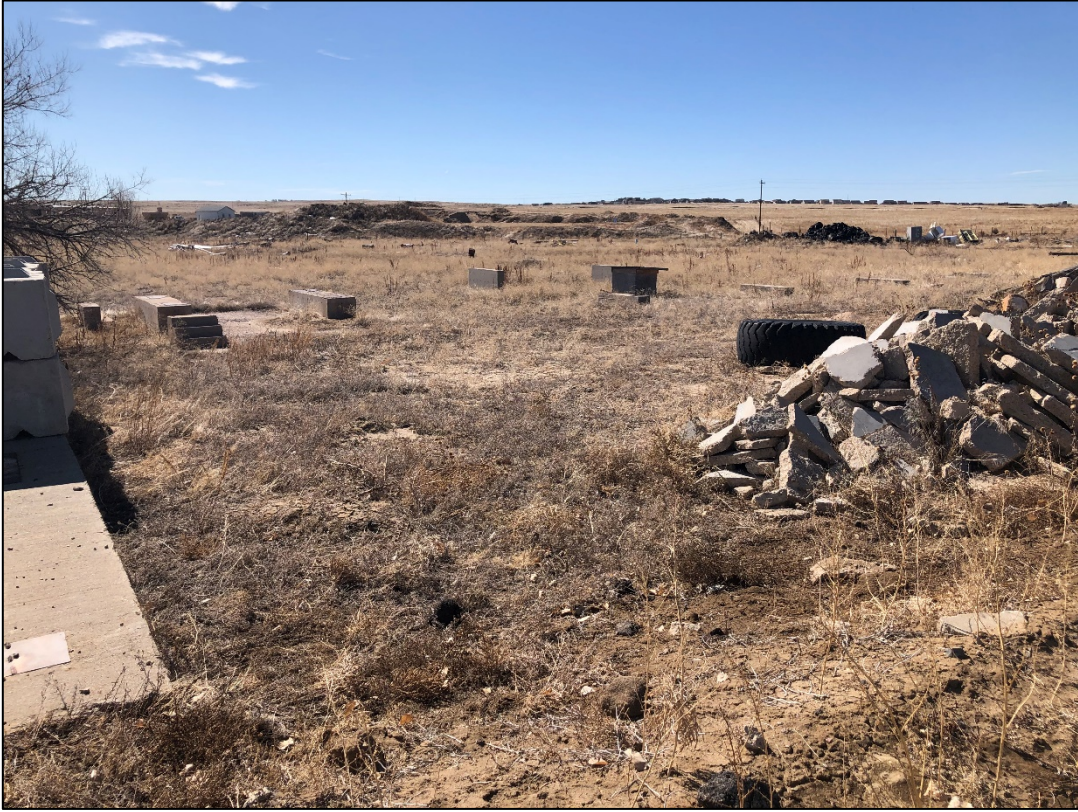
Photo 21. View looking south across landowner's storage area located south of pit which was not disturbed by operation, and therefore, will not be reclaimed.

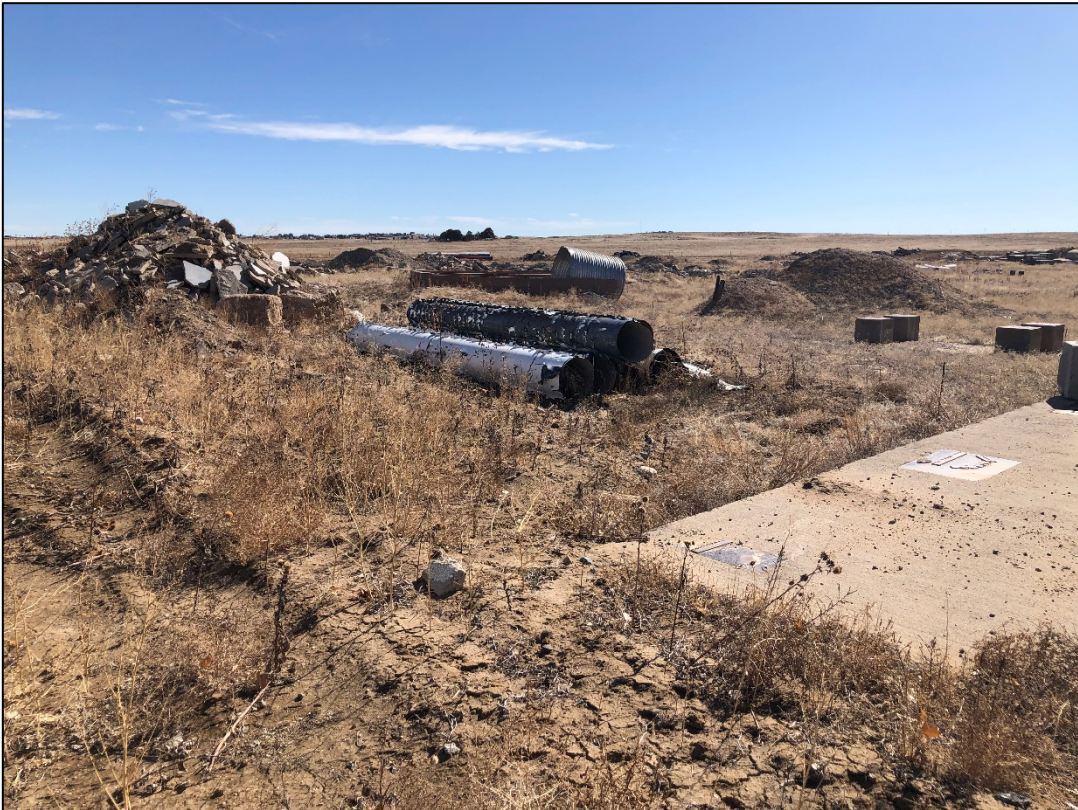
Photo 22. View looking southeast across landowner's storage area located south of pit which was not disturbed by operation, and therefore, will not be reclaimed.
