Re: GCC Energy, LLC, King II Mine
CDRMS Permit # C-1981-035
Stoner Engineering: Quarterly Inspection: Refuse Pile
1st Quarter 2022

Re: King Coal I – Quarterly Waste Pile/Embankment Inspection

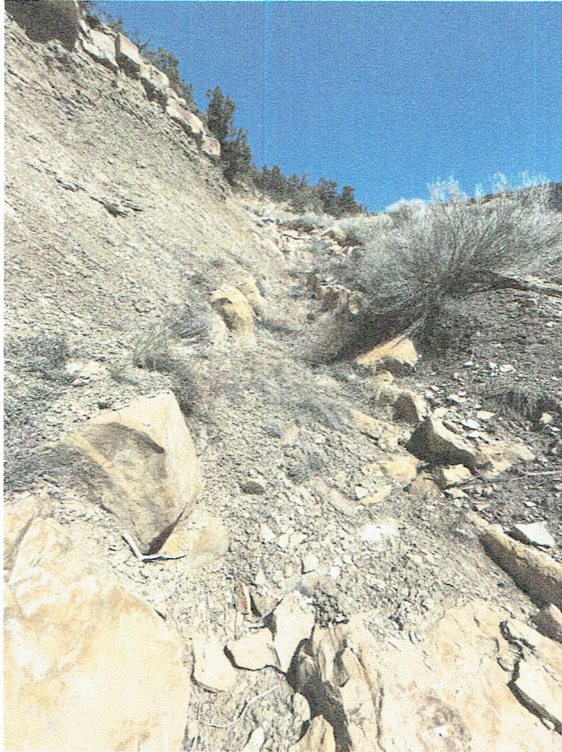
The south treated water ditch (Reach 10) and the south clear water ditch (Reach 1) are in generally good condition but, require some cleaning as a result of the recent thawing/melting of the snow. There has been some erosion of the bank located north of the clear water ditch that needs to be cleaned out to maintain ditch capacities (see Pic. 1). There has also been some soil sloughing of the embankment material located at the downstream side of the culvert under the haul road located at the upper switchback (see Pic. 2). Snow removal at the northeast corner of the lower waste pile has resulted in the waste pile material being pushed against the clear water ditch (see Pic. 3). This will potentially allow treated runoff to enter the clear water ditch during a storm event. The waste pile should be pulled away from the clear water channel to prevent treated runoff from entering the channel.

Pic. 1 –Reach 1 clear water channel with soils from erosion.

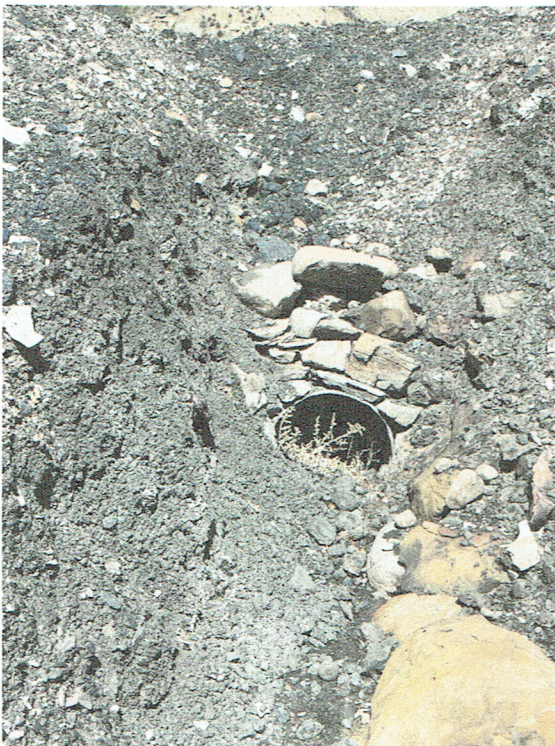
Pic. 2 –Culvert under haul road, upper switchback-downstream side.

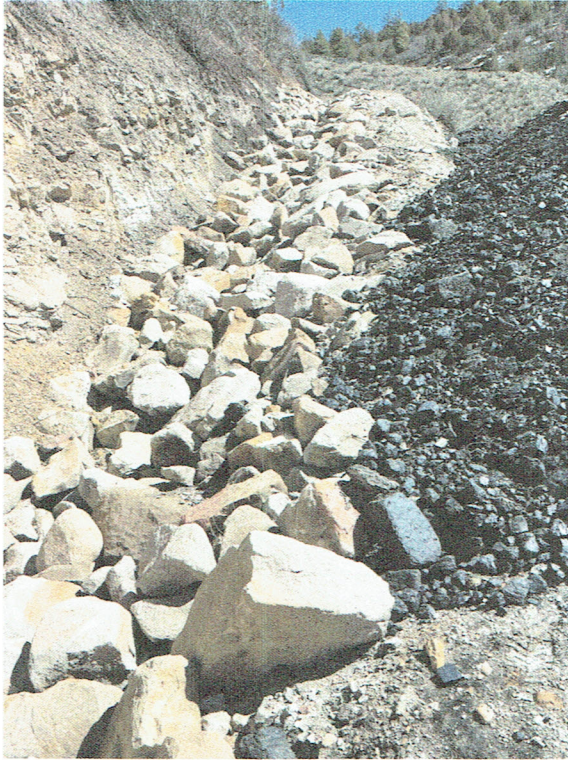
Pic. 3 – NW corner of lower waste encroaching into clear water channel.

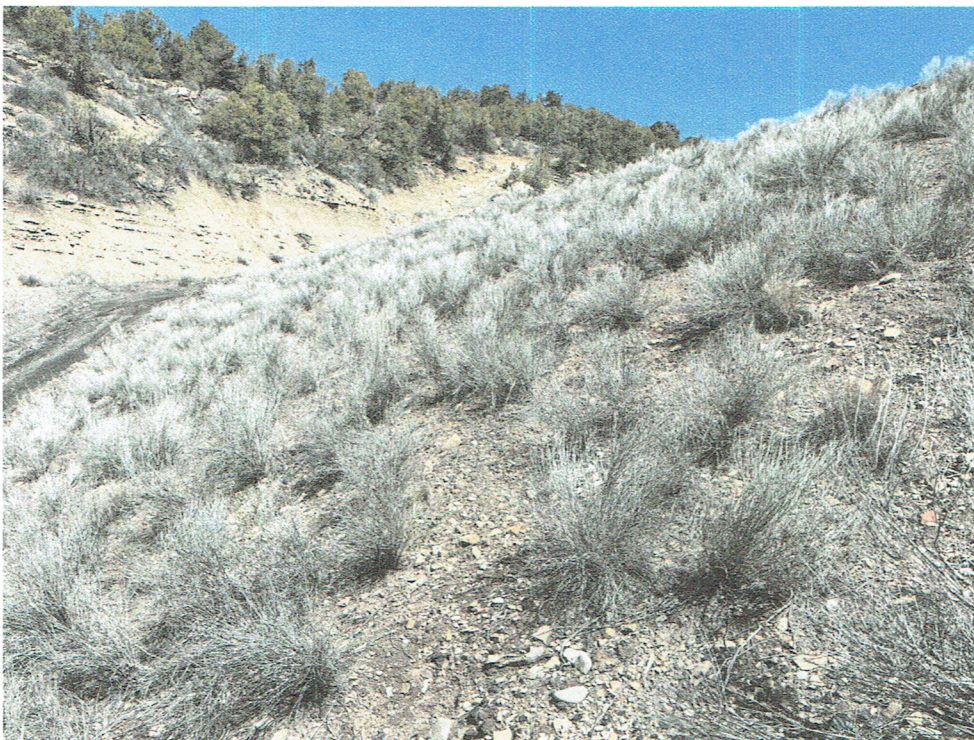
The face of the embankment appeared to be in generally good condition. There were no signs of excessive erosion, instability, sloughing or weakness observed on the face of the embankment of either of the waste embankment piles at the time of the inspection (see Pic. 4).

Pic 4 – Face of the main waste pile in good condition.
