Re: GCC Energy, LLC, King II Mine
CDRMS Permit # C-1981-035
Stoner Engineering: Quarterly Inspection: Water Quality Improvements
1st Quarter 2022

Date: April 6, 2022

Re: King Coal I – Quarterly Water Quality Improvements Inspection

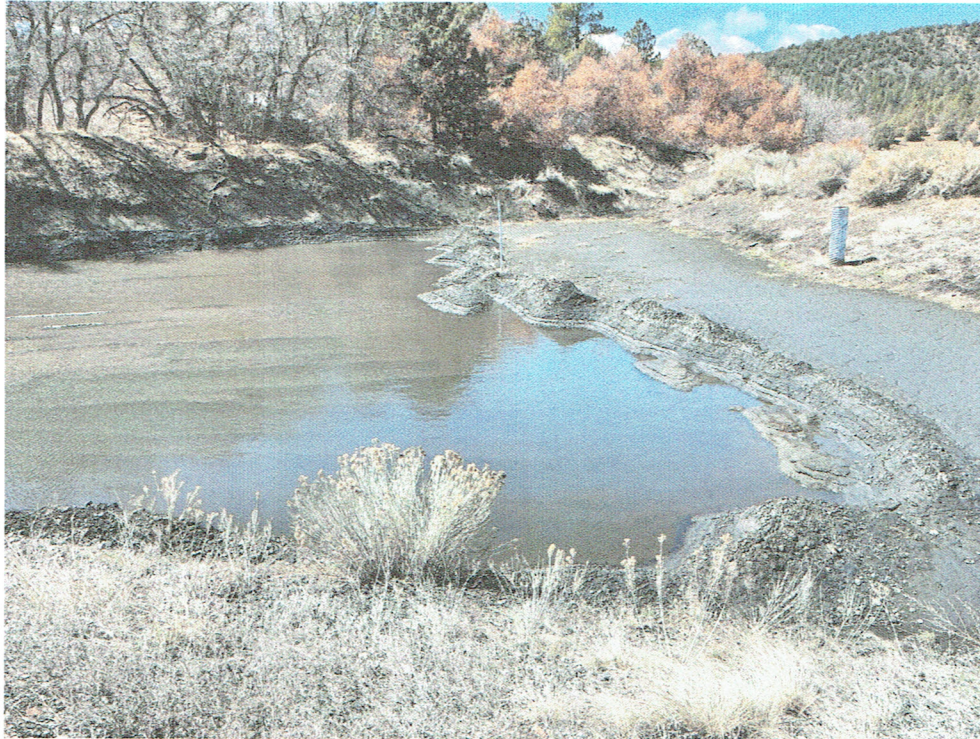
Both ponds held water at the time of the inspection. The water level in the west pond was near the depth of the sediment level removed last year (see Pic. 1). The east pond water level was also at the approximate level of sediment removed from the pond (see Pic. 2). It is assumed that the pond maintenance begun last year will be completed this summer once the ponds are dry. The ponds should continue to be monitored after storm events to ensure that excess sediment does not reduce the required storage capacity available for storm water runoff.

Pic. 1 – Water level below last year's sediment removal, West pond.

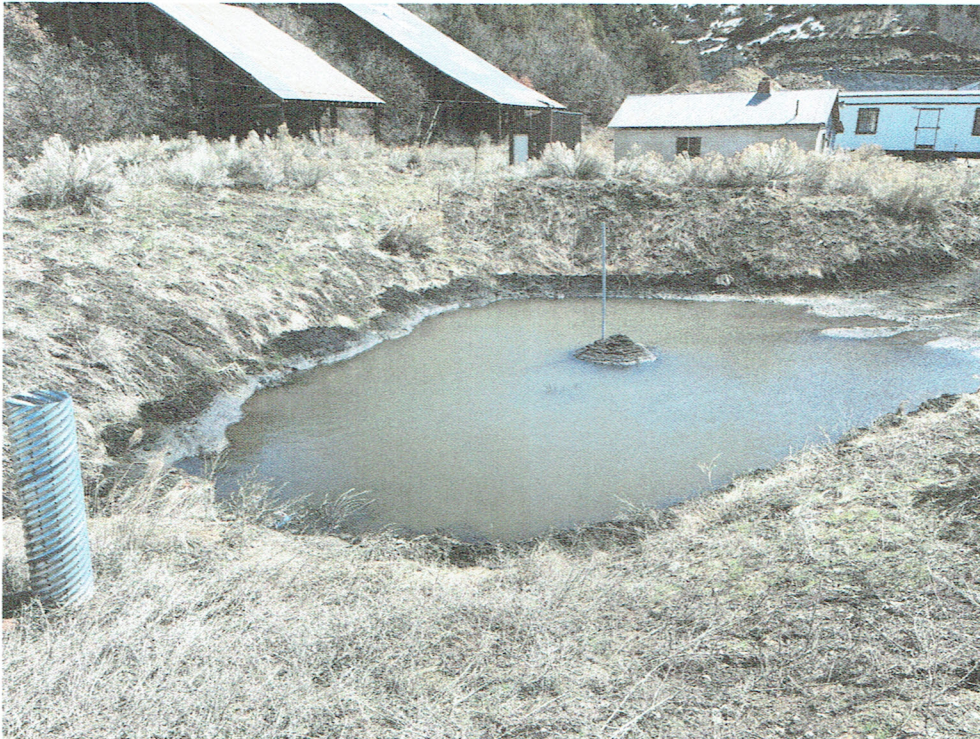
Pic. 2 – Water level near sediment removal level, East pond.

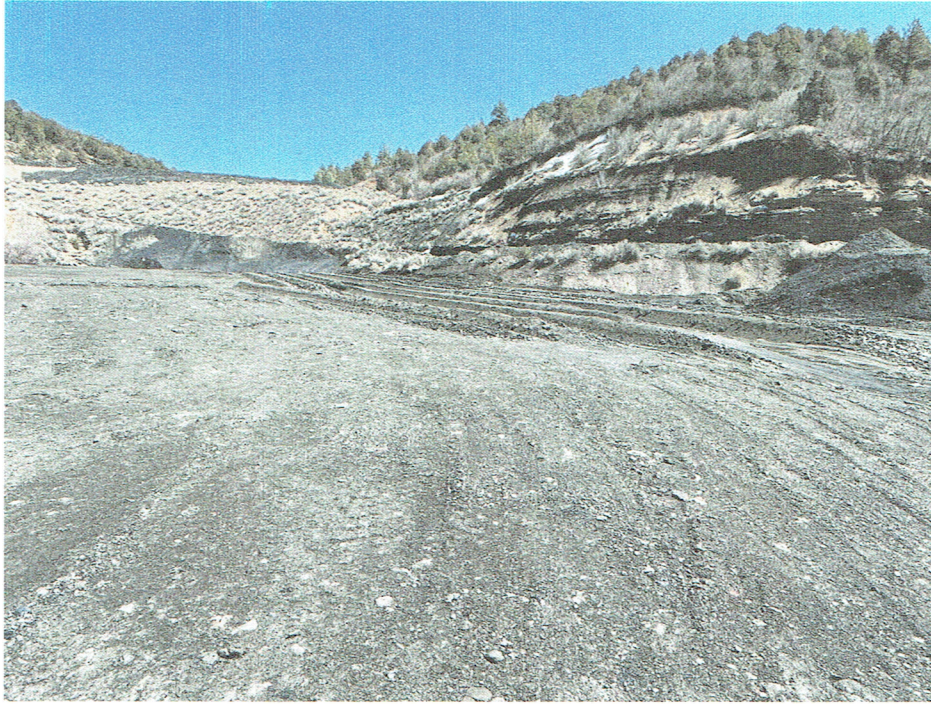
The sedimentation traps at the entrance to the site are generally in good condition. Waste material has been placed on the lower waste pile since the previous inspection (see Pic. 3). The grading of the lower waste embankment pile generally directs surface runoff generally to the south and west as required in the design documents. The grading at the northeast corner of the lower pile has been improved although the grading improvements and/or snow removal at this location has resulted in the waste embankment pile encroaching up to the clear water ditch (see Pic. 4). This could result in surface runoff from the slope of the lower waste embankment pile entering the clear water ditch. This grading situation needs to be correcting by pulling the waste material back from the clear water ditch to ensure treated surface water runoff cannot enter/sheet flow into the clear water ditch. The grading at the top of the lower waste embankment pile should continue to be improved to ensure that surface runoff is directed away from the face of the waste embankment pile. While this is a minor concern noted during previous inspections, it is important to protect the temporary fuel storage tanks added below the lower waste pile at this location.

Pic. 3 – Lower waste pile, placement of embankment material.

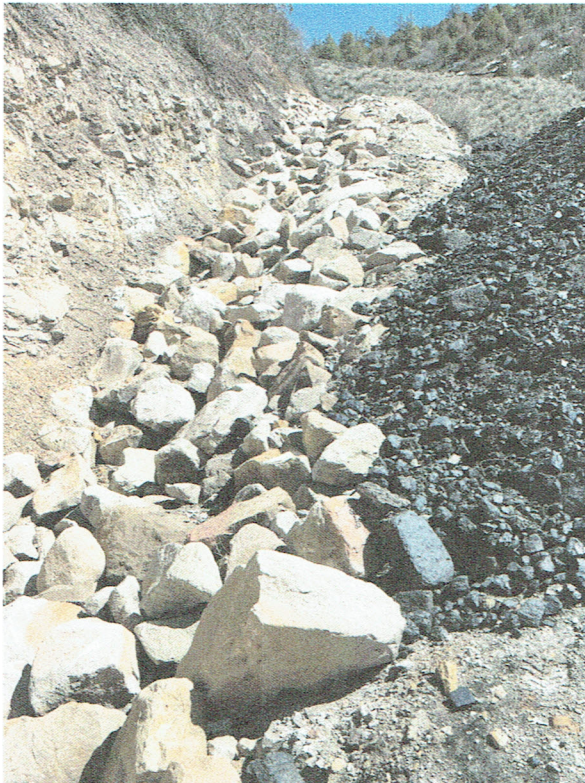
Pic. 4 – Encroachment of lower waste pile to clear water ditch.
