**MINERALS PROGRAM INSPECTION REPORT**  
**PHONE: (303) 866-3567**

<b>MINE NAME:</b> Fassler Gravel Pit	<b>MINE/PROSPECTING ID#:</b> M-1988-032	<b>MINERAL:</b> Sand and gravel	<b>COUNTY:</b> Washington
<b>INSPECTION TYPE:</b> Monitoring	<b>INSPECTOR(S):</b> Brock Bowles	<b>INSP. DATE:</b> March 16, 2022	<b>INSP. TIME:</b> 09:00
<b>OPERATOR:</b> Washington County	<b>OPERATOR REPRESENTATIVE:</b> Danny Rogers	<b>TYPE OF OPERATION:</b> 110c - Construction Limited Impact	
<b>REASON FOR INSPECTION:</b> Normal I&E Program	<b>BOND CALCULATION TYPE:</b> None	<b>BOND AMOUNT:</b> \$0.00	
<b>DATE OF COMPLAINT:</b> NA	<b>POST INSP. CONTACTS:</b> None	<b>JOINT INSP. AGENCY:</b> None	
<b>WEATHER:</b> Cloudy	<b>INSPECTOR'S SIGNATURE:</b>

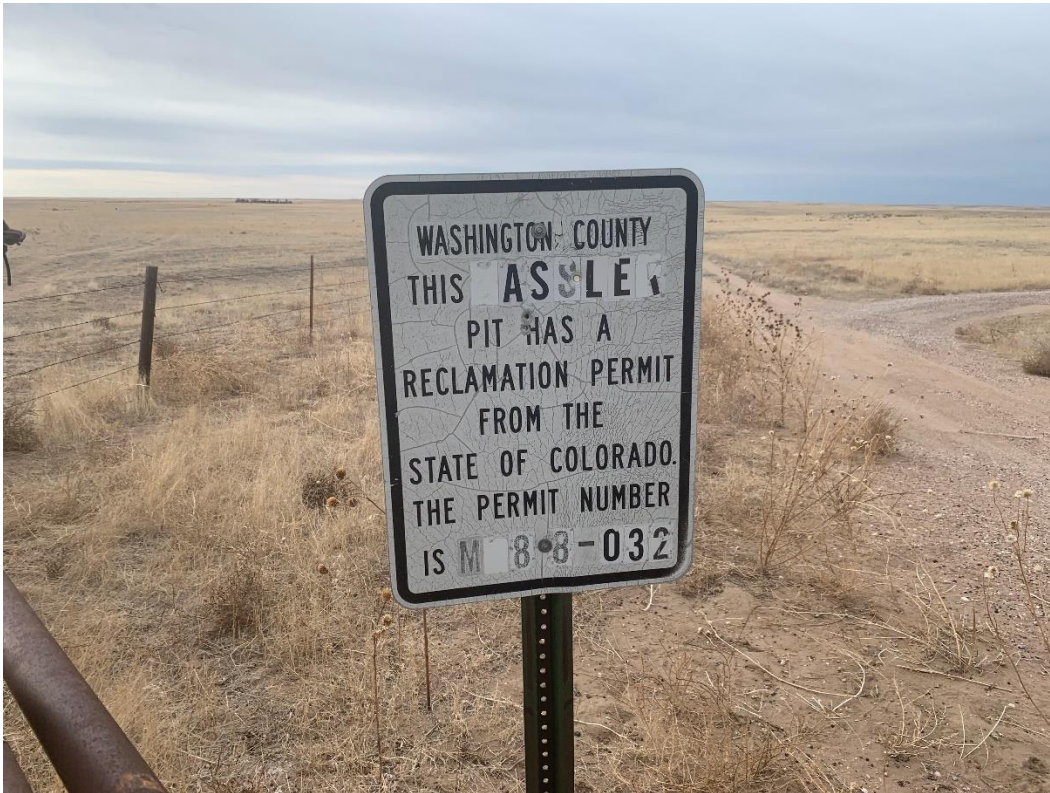
The mine entrance sign was in place facing CR 40 (photo 1). The permit markers were in place and the site was surrounded by a fence.

Photo 1 – Entrance sign facing CR 40

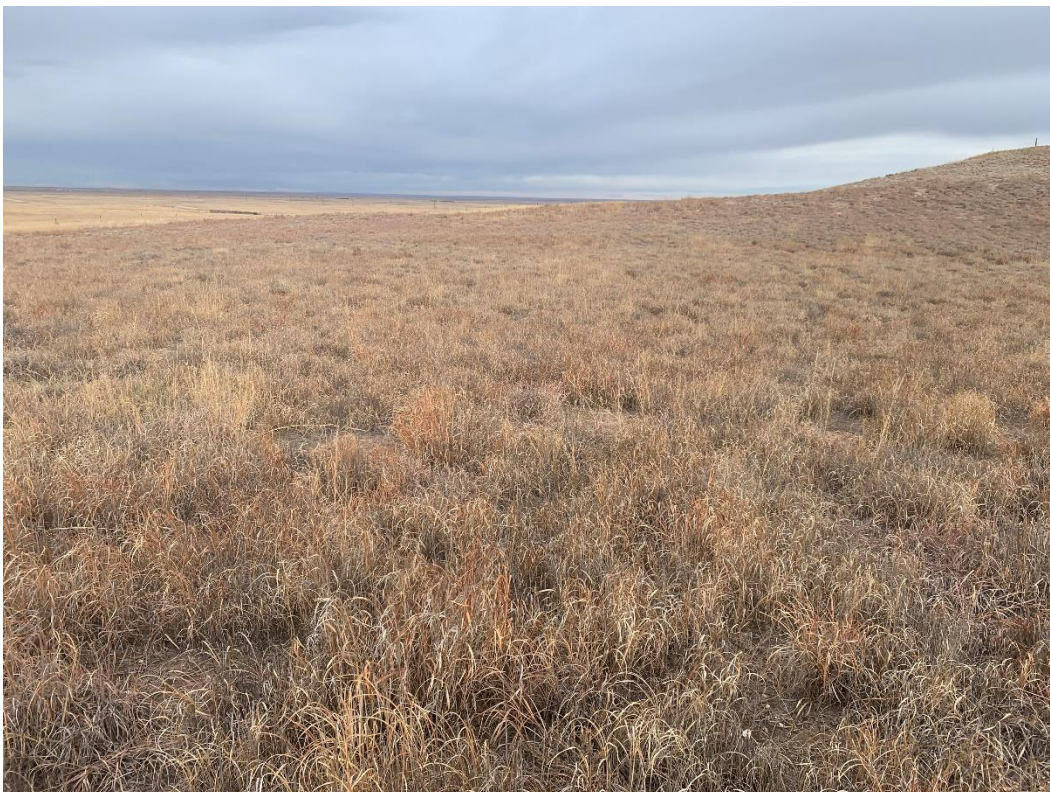
The vegetation was well established and was consistent with the surrounding vegetation. The vegetation within the permit area might be a little better because it has not been grazed recently (photo 2).

Photo 2 – Pit area looking northwest

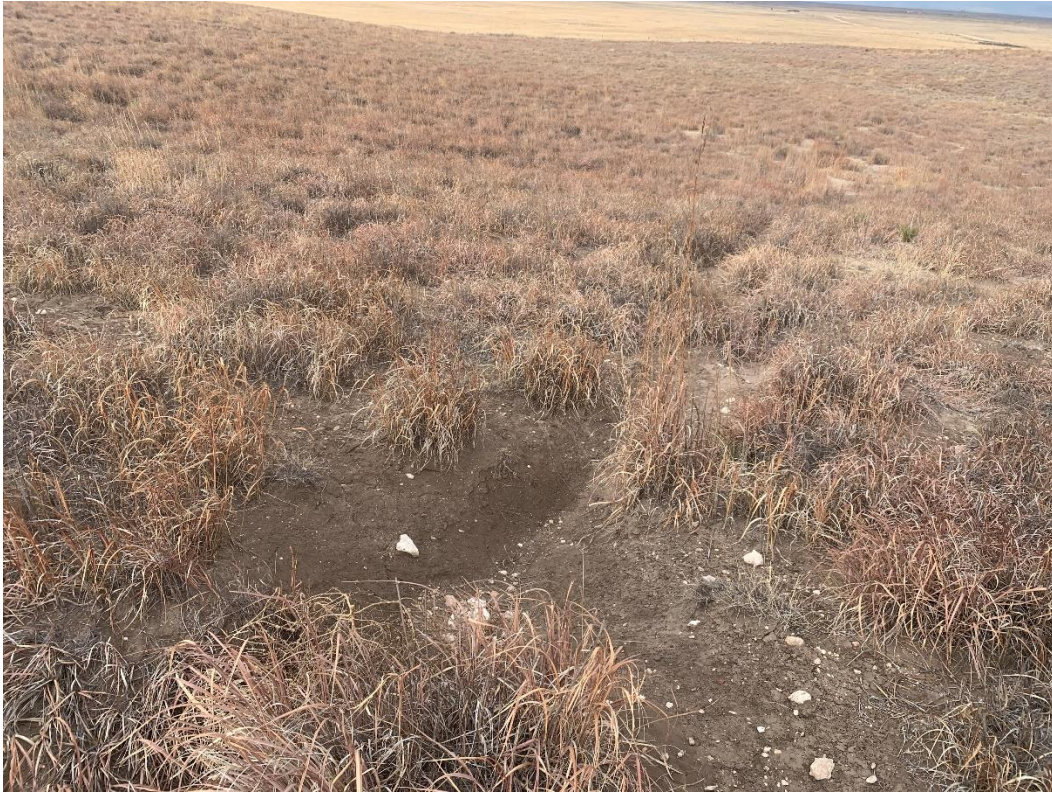
A couple of small gullies were noted in the south east corner. These gullies formed on the higher part of the pit. They were about 6 inches deep and 30 feet long and ended in dense grassy area. The gullies looked like they were older and appeared to be filling in. Probably a remnant from when the pit was first reclaimed. This is an indication that the vegetation is effective at controlling erosion (photo 3).

Photo 3 – Bottom of a gully where the grass controlled the erosion.
