MINERALS PROGRAM INSPECTION REPORT
PHONE: (303) 866-3567

MINE NAME: Starlin Pit	MINE/PROSPECTING ID#: M-2004-021	MINERAL: Sand and gravel and (general)	COUNTY: Washington
INSPECTION TYPE: Monitoring	INSPECTOR(S): Brock Bowles	INSP. DATE: March 16, 2022	INSP. TIME: 10:00
OPERATOR: Washington County	OPERATOR REPRESENTATIVE: Danny rogers	TYPE OF OPERATION: 112c - Construction Regular Operation	
REASON FOR INSPECTION: Normal I&E Program	BOND CALCULATION TYPE: None	BOND AMOUNT: \$0.00	
DATE OF COMPLAINT: NA	POST INSP. CONTACTS: None	JOINT INSP. AGENCY: None	
WEATHER: Cloudy	INSPECTOR'S SIGNATURE:

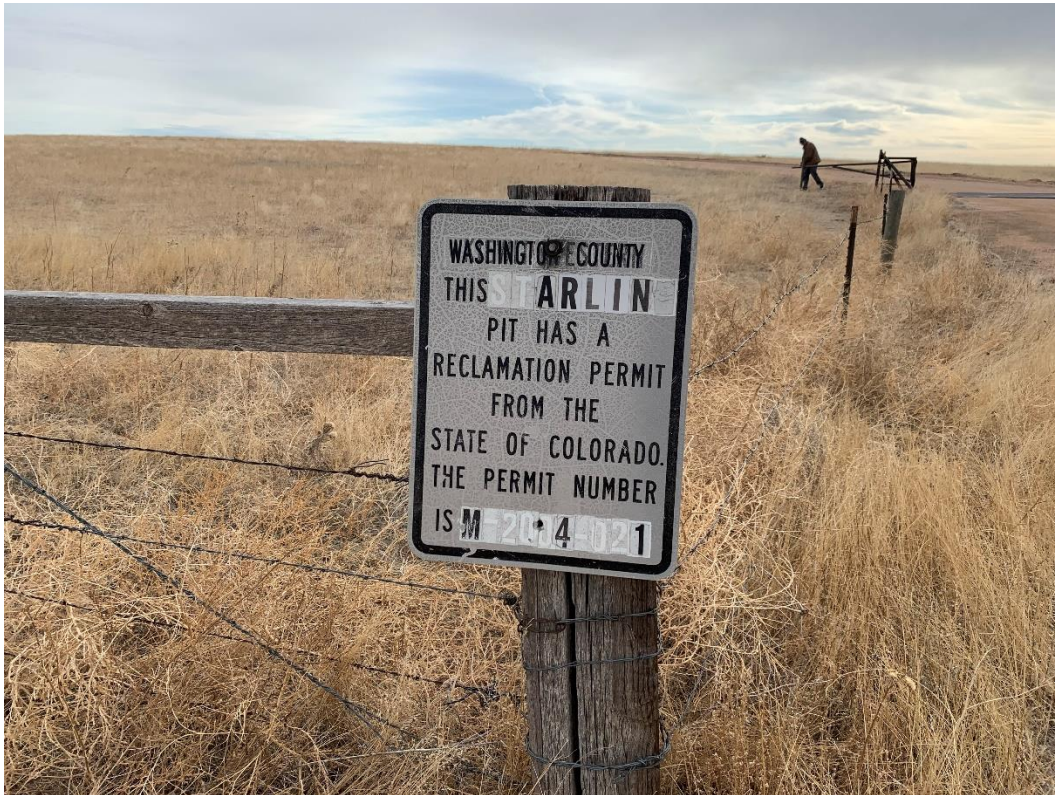
The mine identification sign was in place facing CR X (photo 1). The permitted area was enclosed by a fence.

Photo 1 – Mine entrance sign facing CR X

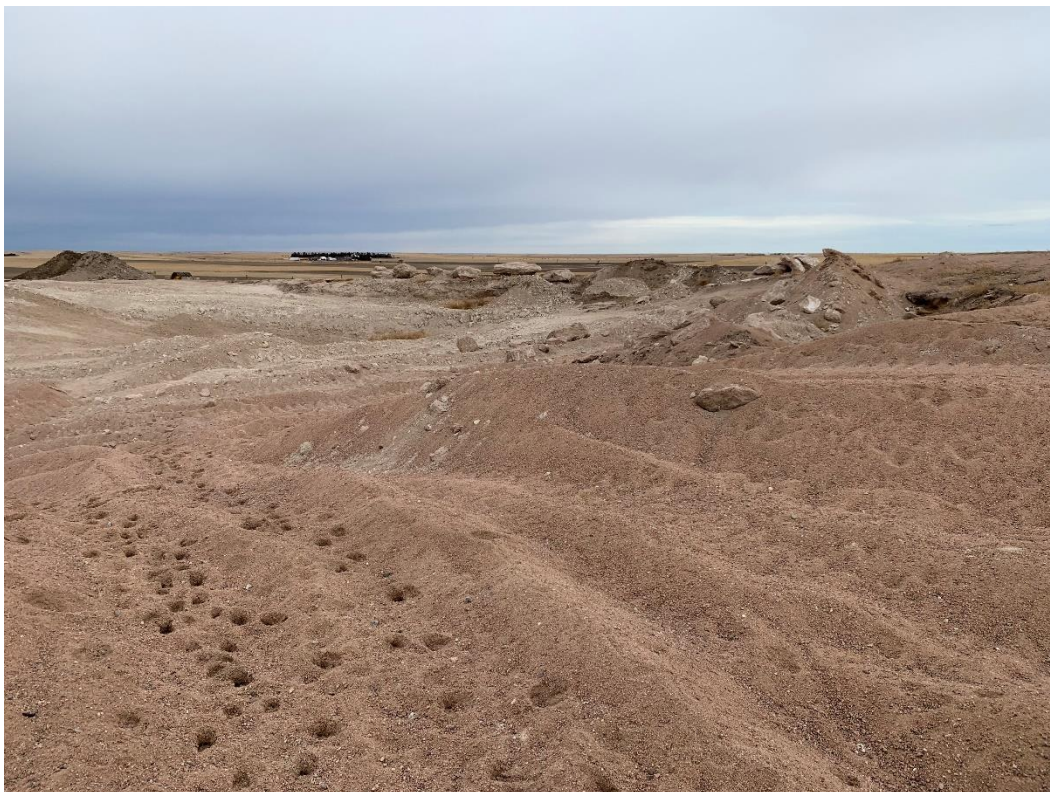
Mining started in the northeast corner of the permit area and is proceeding to the west along the east/west fenceline (photo 2). As the mining advances west, the area behind the active mining is reclaimed. The mine plan specifies that 20 acres will be reclaimed at a time. It appears the first 20 acres have been reclaimed and that mining is taking place in the 2nd 20 acre parcel.

Photo 2 – Mined area looking north

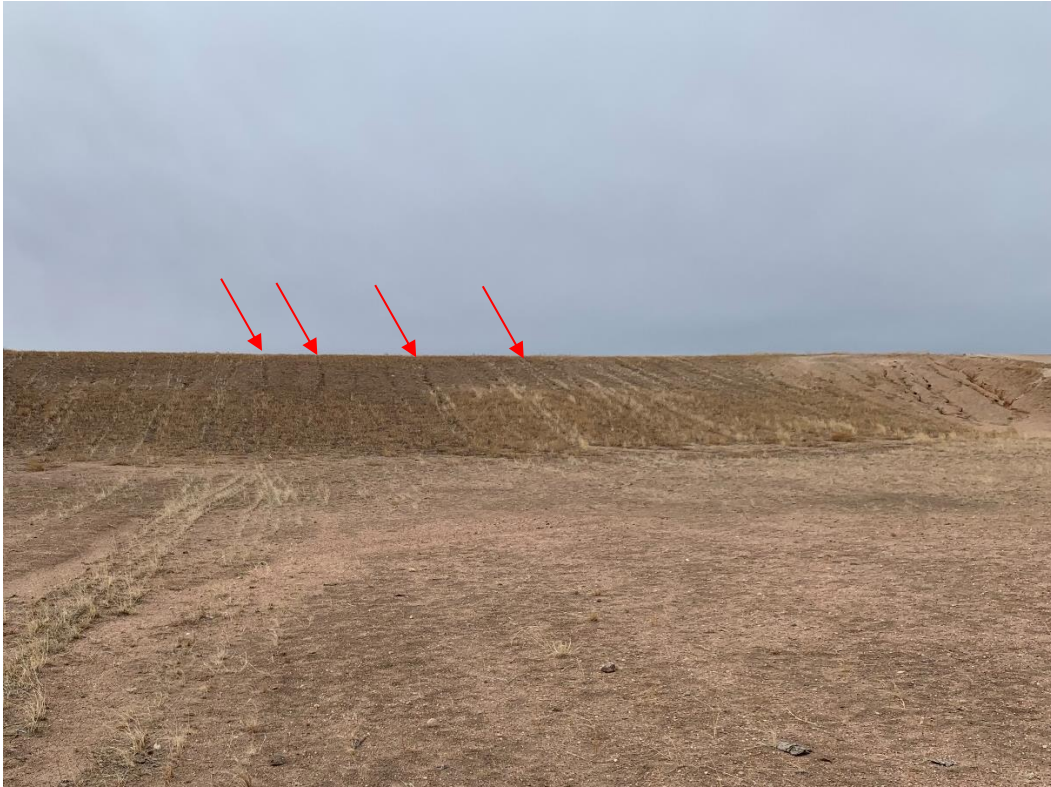
The slopes in the reclaimed area have been graded to about 3h:1v and were seeded. The seeder machine was run up and down the graded slopes. The tracks lines left behind by the seeder are parallel to the slope and became channels which direct water down the slope causing rills and gullies, ultimately resulting in topsoil loss (photo 3). The rills on the slopes need to be repaired and the slopes reseeded. The seeder machine needs to run perpendicular to the slope resulting in the seeder tracks also being perpendicular to the slope. The tracks then create little check dams along the slope slowing surface flow, slowing erosion and increasing water infiltration into the soil.

Photo 3 – Rills developing in the seeder track lines

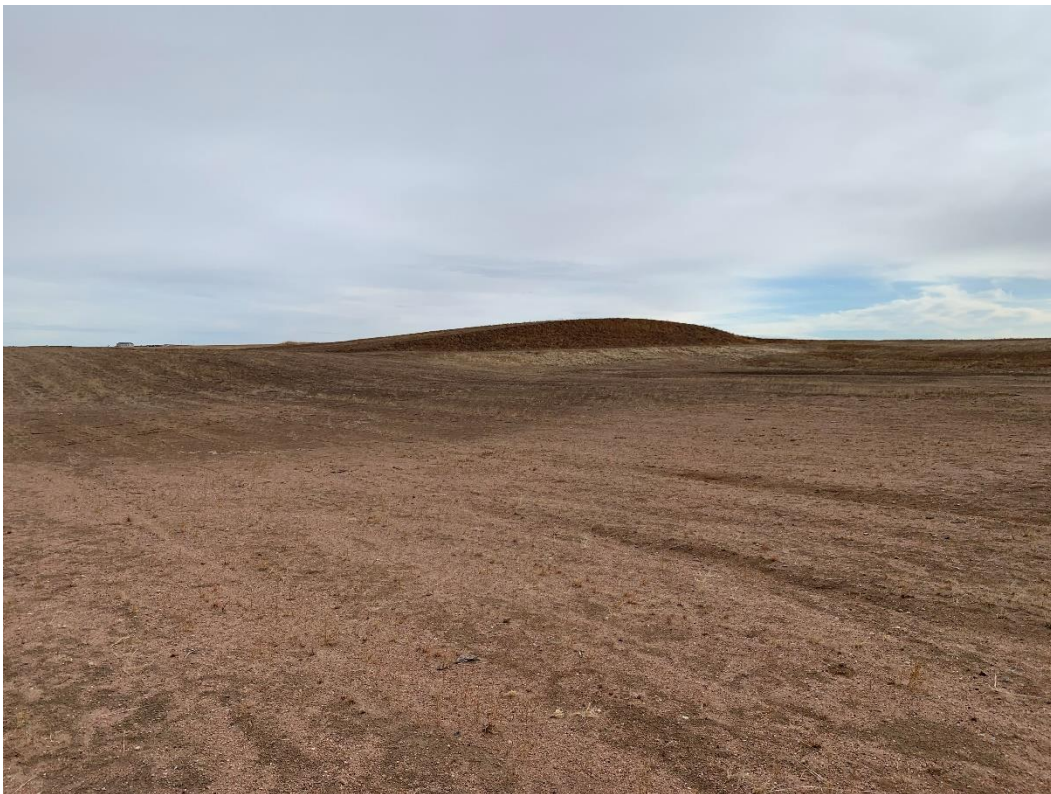
A topsoil pile is located in the northeast corner and is well vegetated (photo 4).

Photo 4 – Topsoil pile in northeast corner of permit area
